No. 1457512.0

SAMPLE DESCRIPTION:
Luxury Vinyl flooring tiles – Code 470666 AVVIO GH fixed to a clear Perspex base using:
- Rapid set smoothing compound and absorbent mat used to prepare Perspex to receive the planks.
- Adhesive Polyurethane 1 part.

ISO 4760:2022(E) - LAMINATE FLOORING – TOPICAL MOISTURE RESISTANCE – ASSEMBLED JOINT (MODIFIED)

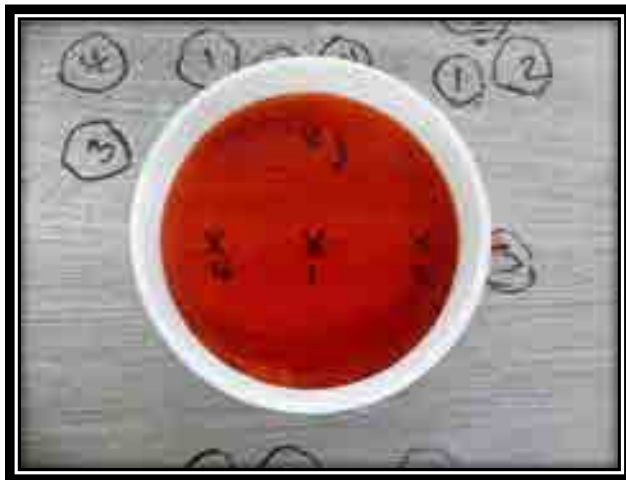
24 hrs With Water

100 mls of dye solution was applied onto the sample surface. It was poured into a cylinder 100mm diameter placed in the centre of the sample at the “T joint.” Sealant was used at the plank/cylinder interface to avoid leakage.

The underside of the sample was inspected through the clear Perspex to enable detection of any dye penetration through the sample.

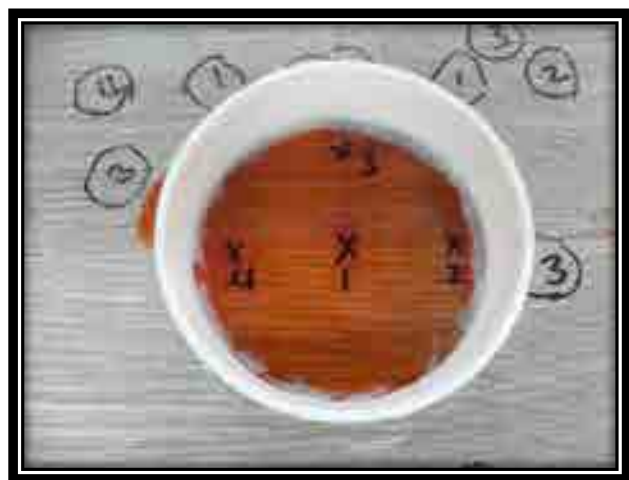
24 hrs With Water (sample 1)

Observations:	Specimen 1	Specimen 2	Specimen 3
Migration of water along the upper surface:	Yes	Yes	Yes
Migration of water to the underside:	No	No	No
