No. 1461765.8

SAMPLE DESCRIPTION:
Luxury Vinyl flooring planks – Code 475335 GH LVP
R1219X178 fixed to a clear Perspex base using:
- Rapid set smoothing compound and absorbent mat
used to prepare Perspex to receive the planks.
- Adhesive Polyurethane 1 part.

ISO 4760:2022(E) - LAMINATE FLOORING – TOPICAL MOISTURE RESISTANCE – ASSEMBLED JOINT (MODIFIED)

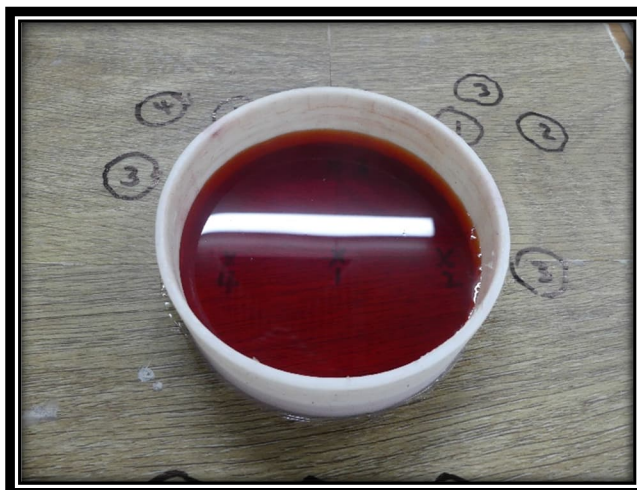
After 24 hrs With Water

100 mls of dye solution was applied onto the sample surface. It was poured into a cylinder 100mm diameter placed in the centre of the sample at the “T joint.” Sealant was used at the plank/cylinder interface to avoid leakage.

The underside of the sample was inspected through the clear Perspex to enable detection of any dye penetration through the sample.

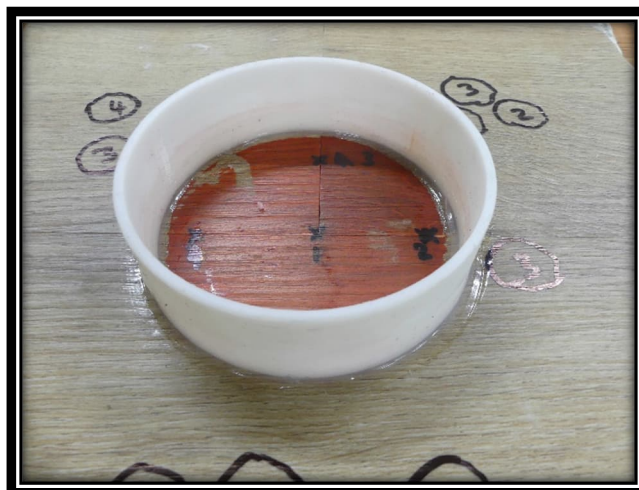
Wet Swell

Quantitative Results:	Wet Swell (mm)			Recovered Swell (mm)		
	Specimen 1	Specimen 2	Specimen 3	Specimen 1	Specimen 2	Specimen 3
Final Average (Positions 2 to 4)	0.00	0.00	0.00	0.00	0.02	0.00
Final average (Position 1)	0.02	0.00	0.00	0.00	0.00	0.00

Wet Swell			Recovered Swell		
	Specimen 1	Specimen 2	Specimen 3	Specimen 1	Specimen 2	Specimen 3
Qualitative Ratings (individual results):	1	1	1	1	1	1

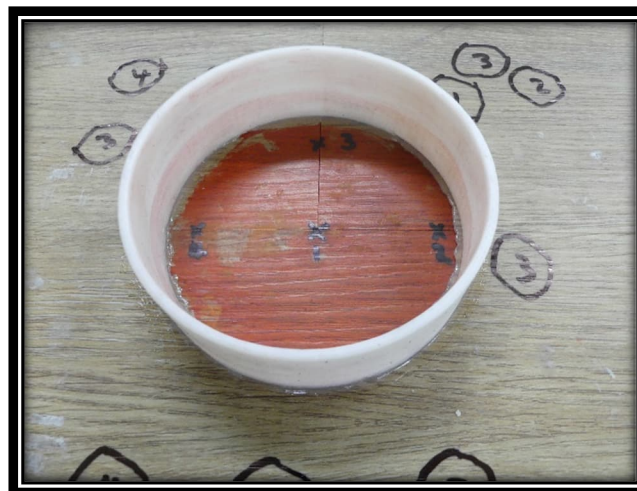
Recovered Swell
