No. 1461766.6

SAMPLE DESCRIPTION:
Luxury Vinyl flooring planks – Code 475371 GH LVP
R1524X178 fixed to a clear Perspex base using:
- Rapid set smoothing compound and absorbent mat
used to prepare Perspex to receive the planks.
- Adhesive Polyurethane 1 part.

ISO 4760:2022(E) - LAMINATE FLOORING – TOPICAL MOISTURE RESISTANCE – ASSEMBLED JOINT (MODIFIED)

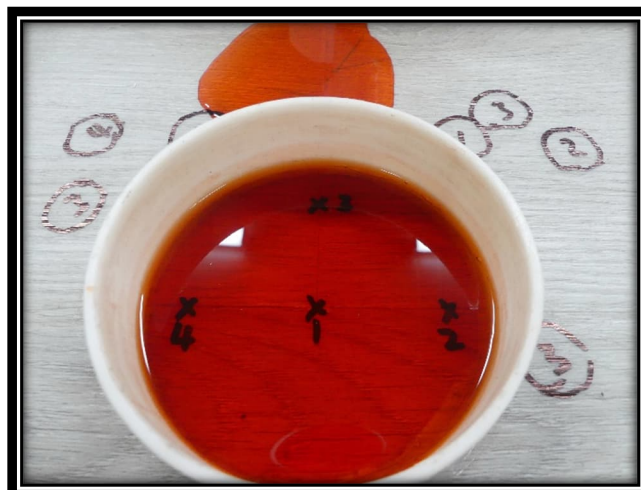
After 24 hrs With Water

The underside of the sample was inspected through the clear Perspex to enable detection of any dye penetration through the sample.

Observations:	Specimen 1	Specimen 2	Specimen 3
Migration of water along the upper surface:	No	Yes	Yes
Migration of water to the underside:	No	No	No

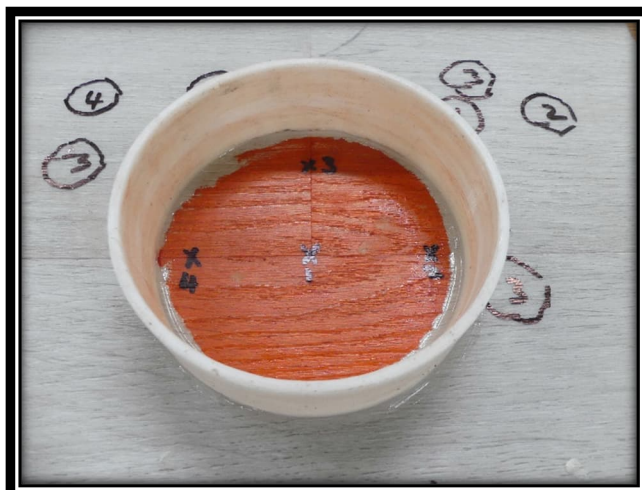
Wet Swell

Quantitative Results:	Wet Swell (mm)			Recovered Swell (mm)		
	Specimen 1	Specimen 2	Specimen 3	Specimen 1	Specimen 2	Specimen 3
Final Average (Positions 2 to 4)	0.00	0.00	0.00	0.03	0.00	0.00
Final average (Position 1)	0.00	0.00	0.00	0.00	0.00	0.00

Wet Swell			Recovered Swell		
	Specimen 1	Specimen 2	Specimen 3	Specimen 1	Specimen 2	Specimen 3
Qualitative Ratings (individual results):	1	1	1	1	1	1

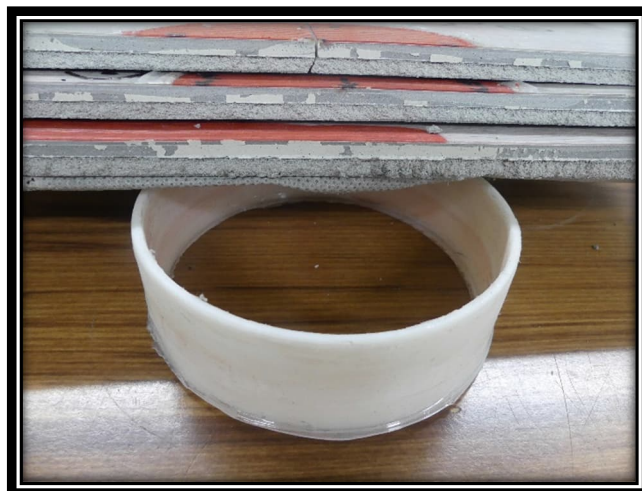
Recovered Swell (Disassembled)

Disassembly Observations:	Specimen 1	Specimen 2	Specimen 3
Migration of water along the upper surface:	No	Yes	Yes
Migration of water to the underside:	No	No	No
