No. 1449750.7R

SAMPLE DESCRIPTION:
Laminate flooring planks assembly with standard Arriba
underlay attached to the bottom as a complete system:
GH LAM F0V216x192
Code: 479655-H1

ISO 4760:2022(E) - LAMINATE FLOORING – TOPICAL MOISTURE RESISTANCE – ASSEMBLED JOINT (MODIFIED)

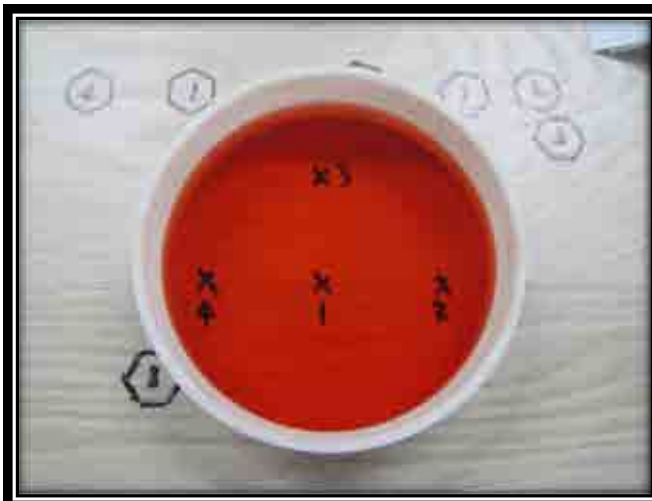
24 hrs With Water

100 mls of dye solution was applied onto the sample surface. It was poured into a cylinder 100mm diameter placed in the centre of the sample at the "T joint." Sealant was used at the plank/cylinder interface to avoid leakage.

The sample was placed on white paper towels prior to testing to enable detection of any dye penetration through the joints.

The sample was left at 20°C, 65% Relative Humidity room conditions for 24 hours after the dye was added and then examined for dye penetration through the backing (not 23°C, 50% RH as stated in the method).

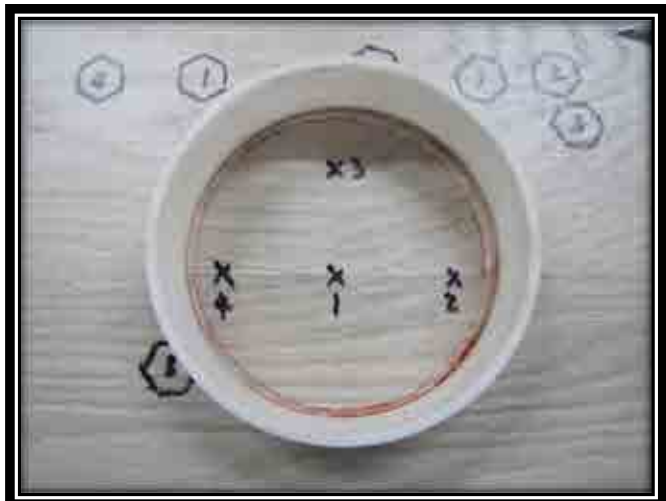
Wet Swell

Quantitative Results:	Wet Swell (mm)			Recovered Swell (mm)		
	Specimen 1	Specimen 2	Specimen 3	Specimen 1	Specimen 2	Specimen 3
Final Average (Positions 2 to 4)	0.21	0.14	0.14	0.11	0.08	0.04
Final average (Position 1)	0.26	0.31	0.30	0.16	0.16	0.14

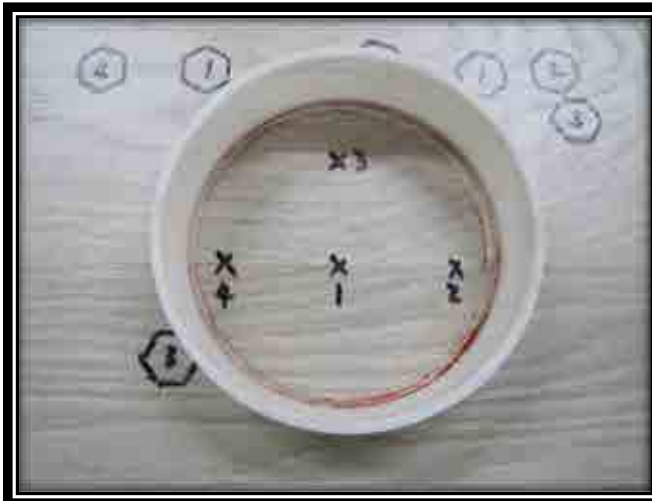
Recovered Swell

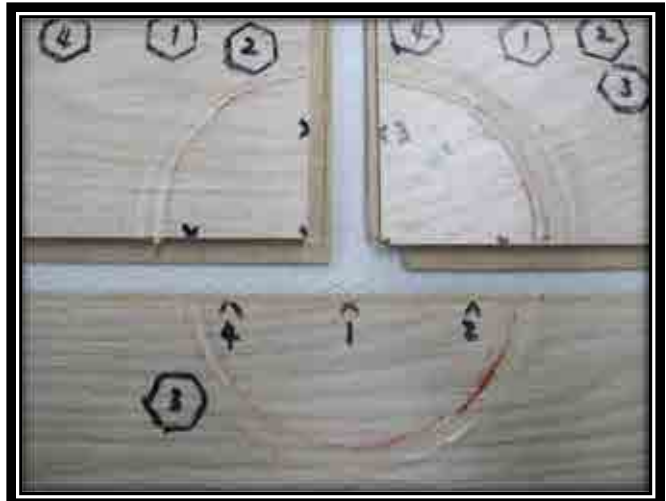
Recovered Swell (Disassembled)

Disassembly Observations:	Specimen 1	Specimen 2	Specimen 3
Migration of water along the upper surface:	No	No	No
Migration of water to the underside:	No	No	No
