**No. 1487219.6**

SAMPLE DESCRIPTION:  
Luxury Vinyl flooring planks – Code 483883 GH LVP  
GU1320X196 fixed to a clear Perspex base using:  
- Rapid set smoothing compound and absorbent mat  
used to prepare Perspex to receive the planks.  
- Adhesive Polyurethane 1 part.

**ISO 4760:2022(E) - LAMINATE FLOORING – TOPICAL MOISTURE RESISTANCE – ASSEMBLED JOINT (MODIFIED)**

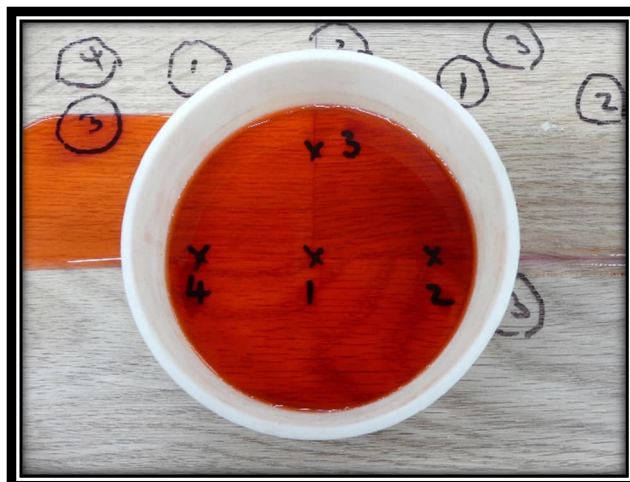
After 24 hrs With Water

100 mls of dye solution was applied onto the sample surface. It was poured into a cylinder 100mm diameter placed in the centre of the sample at the "T joint." Sealant was used at the plank/cylinder interface to avoid leakage.

The underside of the sample was inspected through the clear Perspex to enable detection of any dye penetration through the sample.
