CASE STUDY

Leveraging Acoustic Imaging for Proactive Maintenance in Conveyor Systems

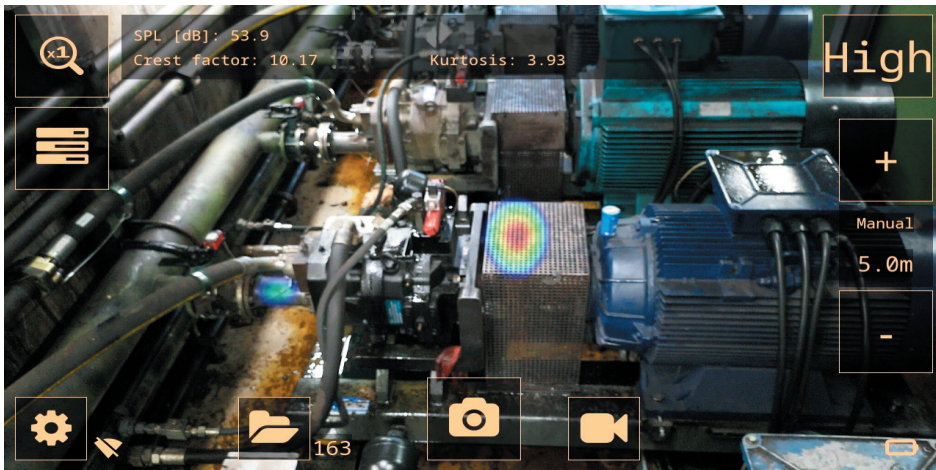
Snapshot of a mechanical fault taken with the FLIR Si2 Acoustic Imager: A high SPL (Sound Pressure Level), crest factor and kurtosis are often signs of potential issues with bearings. For most reliable results it is recommended to always compare the readings to healthy bearings of the same type, measured from a similar distance.

the detected faults with the acoustic camera, which they found extremely helpful and easy to interpret. Utilizing the decision support provided by the FLIR Si2 acoustic camera, a plan was immediately put in place to replace various chains and bearings.

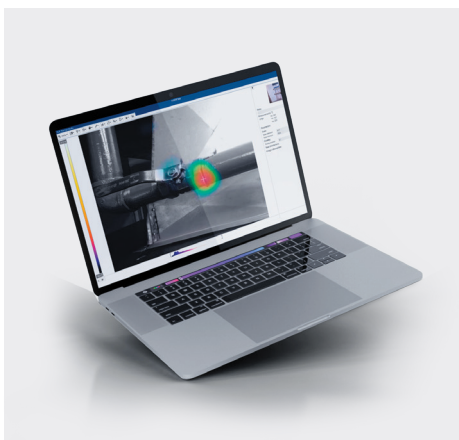
Machine learning-powered analytics provide data-driven decision support on the Acoustic Viewer and FLIR Thermal Studio.
