APPLICATION NOTE

CNA Insurance Saves Clients More Than €11 Million Per Year in Energy and Repair Costs with Thermal Imaging Surveys

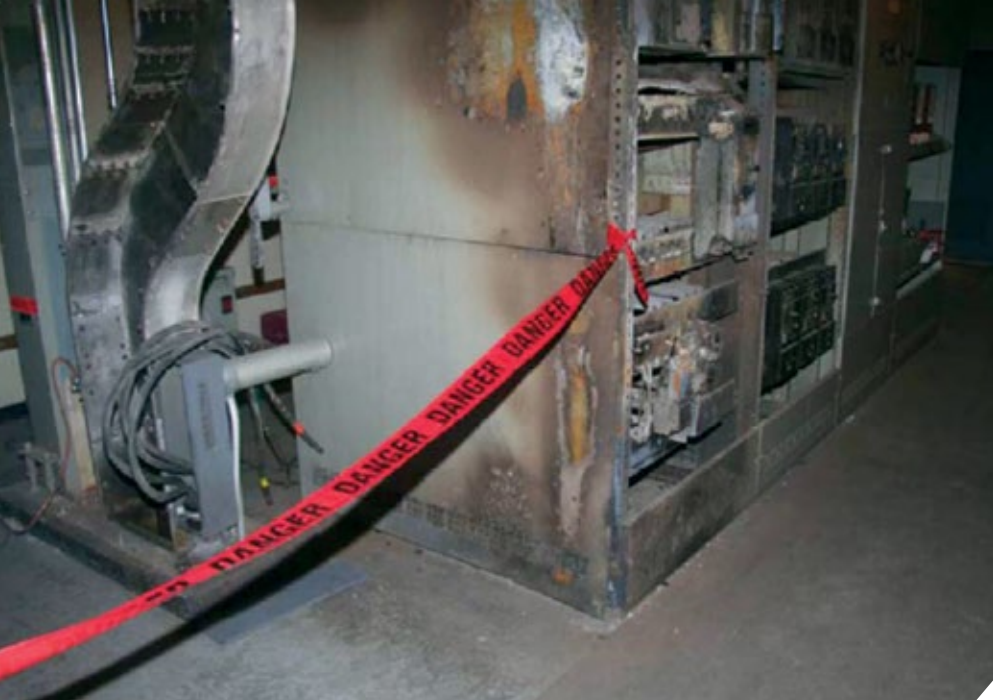
Figure 2. Switchgear fire that resulted in €2.3 million in damage. This facility declined an IR survey offer by a CNA thermographer just months before the fire happened.

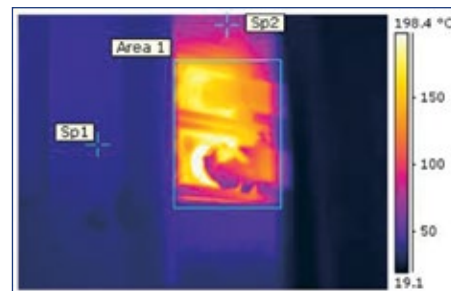
Figure 3. IR image showing a critical thermal fault on an electrical conductor at a fruit processing plant.

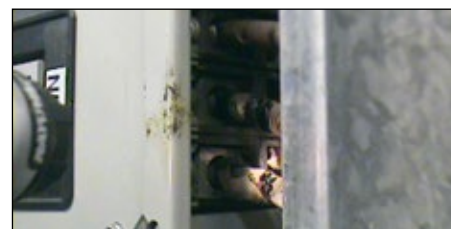
Figure 4. Comparison visual image shows charring of the conductor insulation in the area of the thermal fault.
