Preliminary Assessment of Water Quality in Riviera Grise near Port-Au-Prince, Haiti

YSI Multiparameter Handheld, Haiti Application Note A605

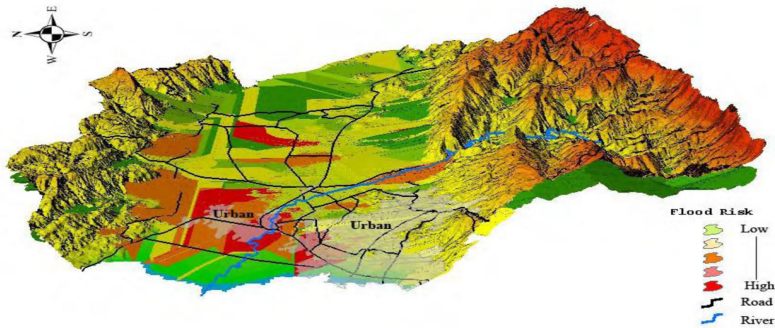
Flood risk map of Cul-De-Sac watershed showing the extent of erosion in the flood plains if Riviera Grise, Port-Au-Prince, Haiti.

The Riviera Grise drains water from the Cul-de-Sac watershed, Haiti, which covers most of the rural areas along the flood plains and areas that extend into steep hillsides. It also covers urban areas of Port-Au-Prince, the capital city of Haiti. The river drains approximately 290 km² of watershed area and attains a maximum flow 475 m³/s during its peak flow and a minimum flow 0.3 m³/s during drought conditions (US COE, 1999). The head waters start in the Massif De la Selle mountains and during peak flows, the river discharges into the Gulf of Gonave in the Caribbean sea, which serves as the natural harbor for the port city, Port-Au-Prince.

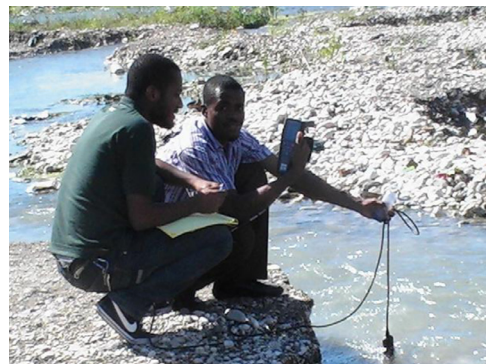
FAMV students using the YSI Pro Plus multiparameter water quality instrument in the Riviera Grise near SUH, FAMV campus. Students monitor basic parameters under the supervision of Dr. Nedunuri.

Very little information exists on the assessment of water quality in Riviera Grise. During the project, the river was monitored using a YSI Professional Plus multiparameter handheld. Basic water quality parameters such as pH, total dissolved solids (TDS), dissolved oxygen, specific conductivity, and temperature were measured. Turbidity of the samples was also measured.

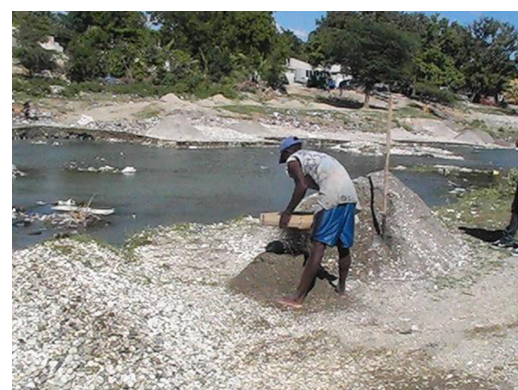
Riviera Grise experiencing artificial channelization as gravel and silt is manually removed.

The section of the river surveyed is approximately 2 km from FAMV and drains water from agricultural lands close to FAMV. Visual observations indicate the river habitat is severely impacted by artificial

channelization. The river carries a lot of sediment which is being manually removed from the river bed to the banks to sieve gravel from silt. Local residents collecting the gravel sell it for construction purposes. The river is losing significant substrate at the same time providing livelihood to the poor people who are surviving on the river. There is no riparian
