Hamptonne Conservation Statement 2017

INTRODUCTION

The subject of the Conservation Statement is Hamptonne in St. Lawrence, Jersey. The primary purpose of the statement is to draw together existing information, to set down a brief history for the site, a description of the principal elements, an assessment of significance, the identification of major conservation issues and a series of policies. The Conservation Statement is intended to inform and advise the management of the site and future decisions concerning its alteration and use.

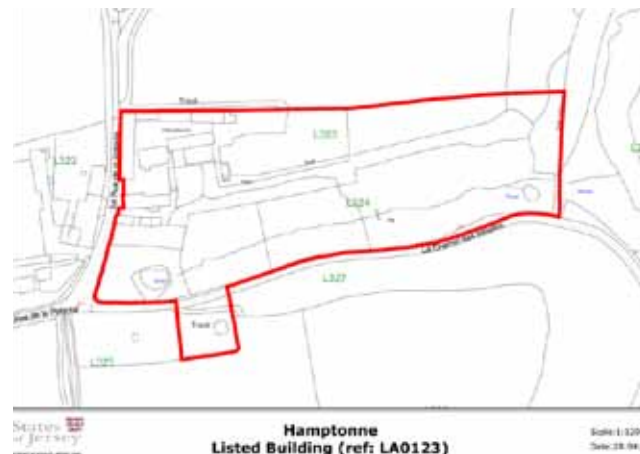
Figure 20: The boundary of the Listed Building is shown in red (States of Jersey)

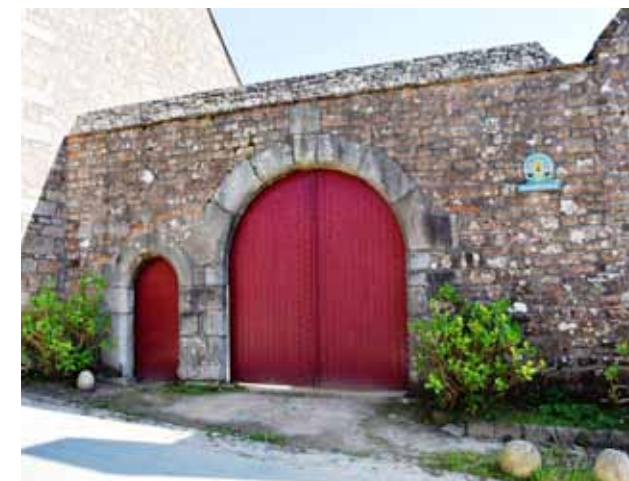
Figure 21: The entrance gateway (March 2017)

At the south-west corner of the complex is a twin-arched stone gateway, historically the principal entrance. The gateway is constructed in Mont Mado granite, set within a frontage wall which is set back from the road edge. Part of the frontage comprises the west gable-end of the Langlois building, and the remainder is formed by the courtyard wall. The arch comprises two linked openings, both with semi-circular heads. The southern is the larger and was provided for vehicular access, while the much smaller northern opening accommodated pedestrians (porte piétonne). The arches are of integrated construction and both are moulded in a similar fashion on the external face. The larger arch is composed of seven voussoirs, symmetrically arranged about the central axis and graduated in size; the first voussoir on each flank is shouldered. The smaller arch comprises just three symmetrically arranged voussoirs, the lowest again being shouldered. The gate arches are unusual in Jersey in having both externally chamfered angles and roll mouldings. Set into the wall immediately above the keystone of the vehicular arch is a separate, square block of granite carved in relief with the Hamptonne arms and inscribed LH · 1637 EH. The initials are identifiable as those of Laurens and Edouard Hamptonne - an unusual father and son combination rather than the more usual husband and wife. The door leaves were renewed in 1992.

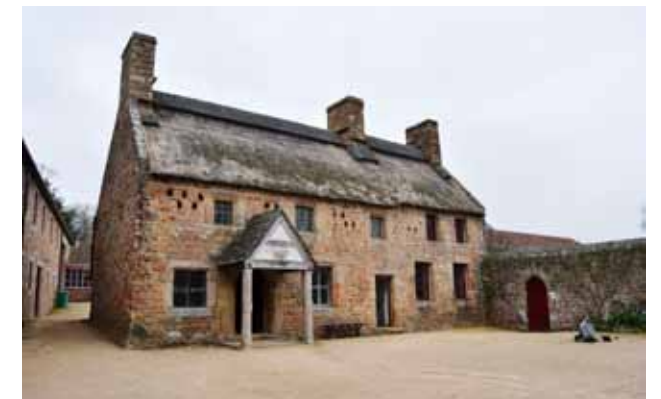
Figure 22: The Hamptonne building, front south elevation (March 2017)

The two storey **south elevation** includes the principal distinguishing features of the house. On the ground floor are two doorways and four windows, and on the upper floor five windows; nothing is synchronized between the two levels. The 1990s restoration left as found all window and door openings. The windows are restored with 17th century fenestration in the main block; oak-frames with diamond-shaped panes held in a net of lead comes. The 18th century character of the east wing is treated differently with sash windows at ground level and casements on the upper floor. The outshot has unglazed oak window frames with simple mullions.

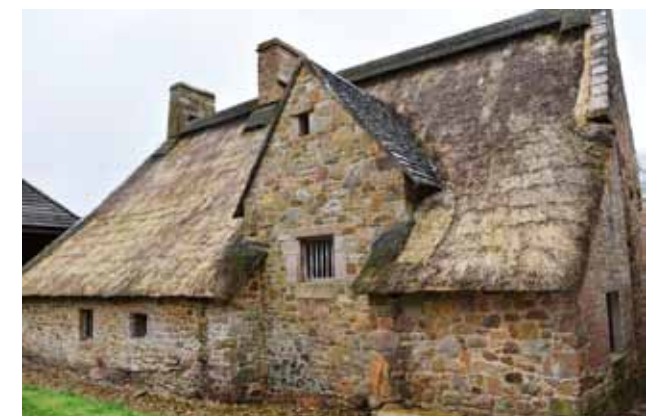
Figure 23: The Hamptonne building, rear north elevation (March 2017)

The Hamptonne house is aligned east-west, and is broadly divisible into three components. The principal element is the rectangular, gable-ended block which forms two-thirds of the front range: its external plan measures 10.1m long by 6.4m deep. Internally, it is divided into four bays. Adjoining this block on the east is the gabled parlour wing of two bays, which extends the length of the house by 4.9m, giving an overall dimension of 15.0m. The third component is the single-storied range, or outshot, of four lean-to rooms running along the whole of the north side; they vary in depth from 2.1m to 2.75m. The basic construction materials used in all phases is shale and granite rubble, with granite dressings to the major openings. Occasional pebbles and other stone-types are included. Externally, the walls are repointed in lime mortar.

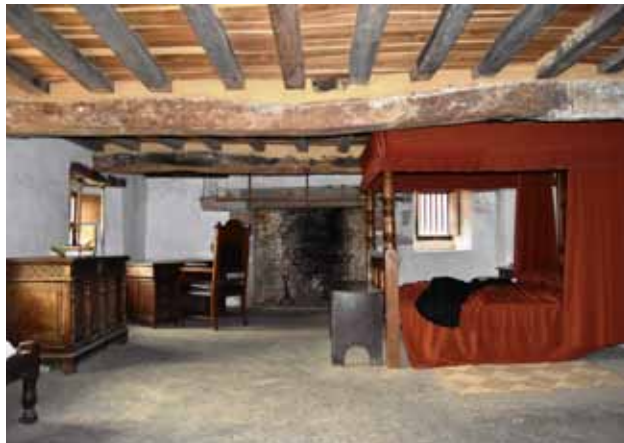
Figure 29:
Hamptonne
house,
upper floor
chamber
looking west
(March 2017)

The upper floor of the main house comprises a single **principal chamber**. There is a substantial granite fireplace in the west wall (restored in 1990). It is composed of nine principal stones: the original granite reveals and corbels, with a new lintel and repaired shoulder-stones. Each reveal is formed with one upright and one flat stone, with a hollow-chamfered aris. The basal stop to the southern chamfer is damaged, but its northern counterpart has a conical, triple-ringed stop. Both chamfers have bull-nosed stops at the top. The quadrant-shaped corbels are decorated with an ogival motif on the upper band. The new shoulder-stones are near-square in section and have joggled joints into which a one-piece lintel is dropped. The rendered hood was also reinstated in the 1990s. To the north of the fireplace is a window

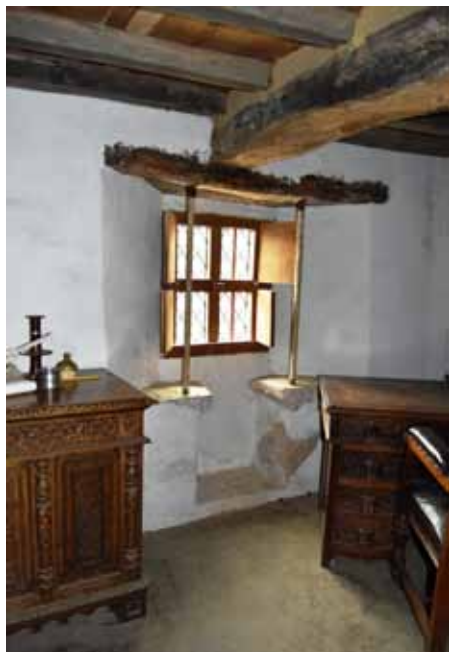
Figure 30:
Hamptonne
house,
upper floor
chamber
window seat
(March 2017)

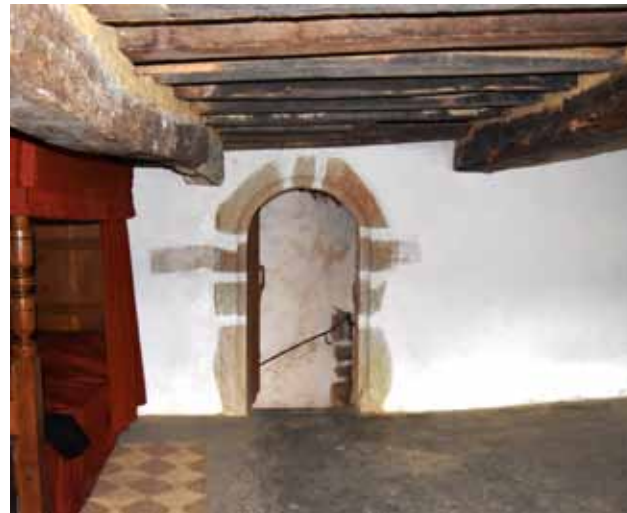
Figure 31: Hamptonne house, upper floor chamber arched doorway and 17th century ceiling (March 2017)

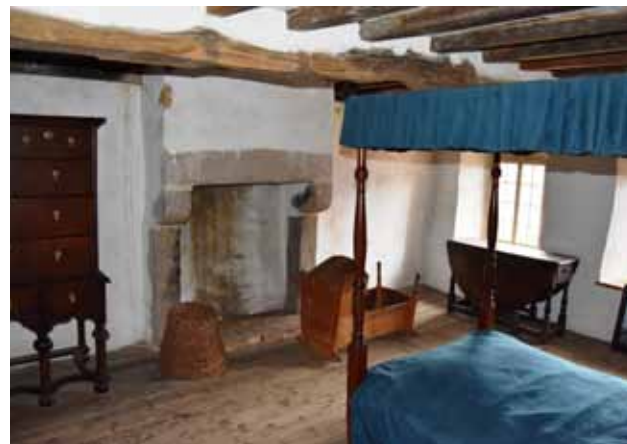
Figure 32: Hamptonne house, east wing chamber (March 2017)

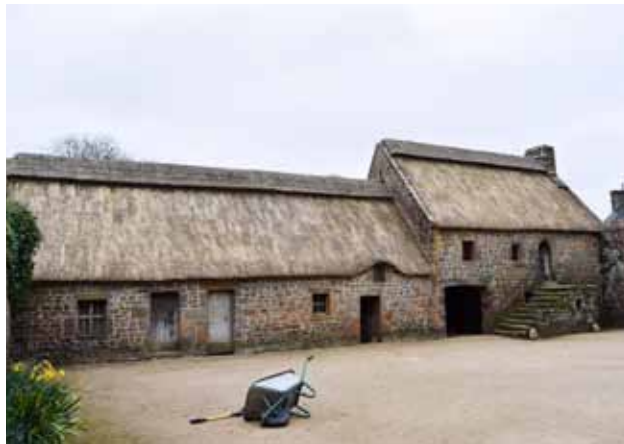
From east-to-west on the **north elevation**, bay 1 of the south range has a rectangular window of dressed granite without chamfers or internal rebates. The

Figure 33: The Langlois building and South Range, front north elevation (March 2017)

sill is an irregular slab with a flat upper face, and the lowest block in each jamb is upright. To the right of the window is a doorway with rebated but unchamfered jambs of dressed granite. The head comprises four oak lintels laid side by side. There is a new stone threshold. In bay 2 is another internally rebated but unchamfered doorway, the eastern jamb of which is linked to the previous doorway by a single tying block. The lintel is of granite and the construction of the jambs is asymmetrical, the western one being built from seven roughly squared blocks of granite. There is no threshold. There is a square window in bay 3, with unchamfered jambs, sill and lintel, all in granite; the jambs formed with upright blocks. Bay 4 of the south range has a relatively low doorway, the rebated jambs of which are formed with squared blocks of granite; the lowest one on each side is upright. The well-worn threshold slab remains, but there is a new granite lintel.

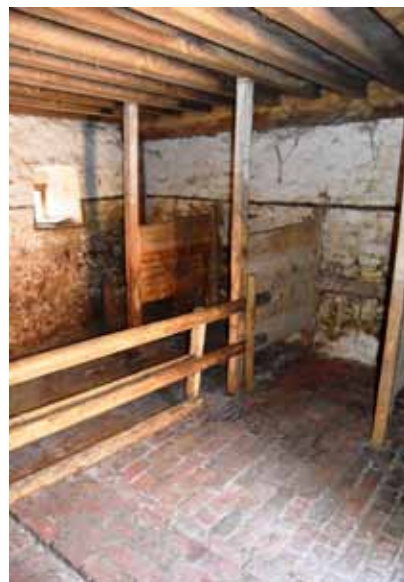
The westernmost **stable** room is divided by an original bridging-beam made from a single oak trunk with waney edges and crude chamfering. There is a broad doorway and small window in the north wall. The internal reveals of the rebated doorway are slightly

Figure 36: South
Range, cow stable
interior (March
2017)

splayed and of rather rough construction, with oak lintels. The window embrasure is internally splayed and lintelled with three timbers. The steeply sloping sill has been partially rebuilt and lowered. The west reveal is intact, but the eastern one was reformed when the cross-wall was inserted. Incorporated in this reveal is a large fragment of a lugged stone mortar of late medieval type. The south wall contains a late inserted doorway. The inserted cross-wall on the east has only a single rectangular keeping-place. There is a brick and concrete floor, and cow stalls have been reinstated using the original granite base stones. There are various pieces of iron, including several recognizable tethering-rings, embedded in the masonry.

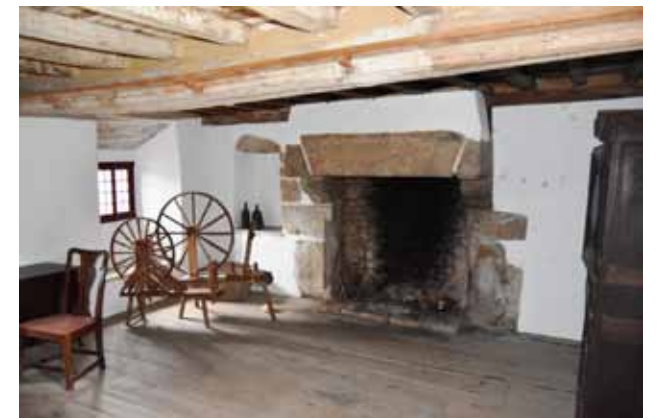
The principal feature of the room is the substantial fireplace in the west gable wall, composed of nine blocks of granite. Each jamb comprises a large upright stone and one laid flat: they do not project beyond the wall face. The jambs have hollow chamfers, stopped at both ends: a large fleur-de-llys at the bottom and a bullnose at the top. The corbels are elaborate: they have a double quadrant-shaped profile and hollow chamfers on the outer arrises. The upper quadrant moulding is bold, the lower one diminutive, but they

Figure 37: Langlois house, upper floor hall looking west
(March 2017)

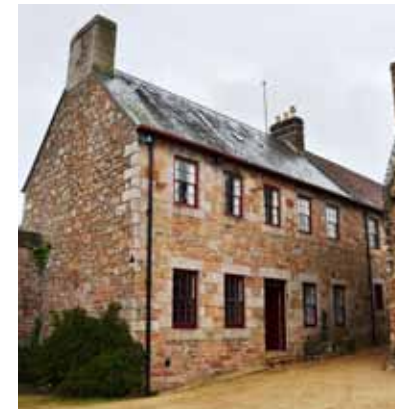
Syvret house presents a near-symmetrical 5-bay appearance to its east front: a central doorway (with new front door) flanked by two sash windows on each side; with five symmetrically disposed sash windows, their sills all aligned, on the upper floor. The sashes have six-over-six panes. The west (roadside) elevation has two windows lighting the ground-floor rooms: a small six-over-six pane sash with granite dressings, and a larger brick-dressed window with a segmental arch and two-over-two sash. There is a sizeable stair window at an intermediate height with restored 12-over-12 sash. On the first floor are three identical small six-over-six sashes. The south gable wall of the house is of stone rubble and devoid of architectural features; it is abutted by the gated wall enclosing the courtyard. Rising from the apex is a chimney stack of dressed granite, with a projecting course of Welsh slate.

Figure 40: Syvret house, front east elevation (March 2017)

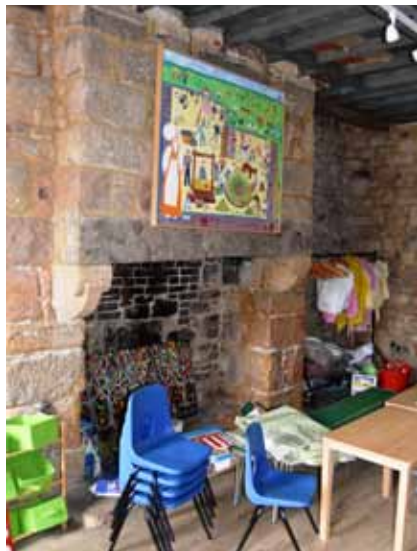
The **kitchen** has a large granite fireplace in the south gable wall, which reuses old materials. The fireplace cheeks are built of granite ashlar and incorporate a pair of late 17th century quadrant-shaped corbels, each boldly chamfered to give the appearance of a central tongue flanked by bullnoses. There is a new stone

Figure 45: Syvret house kitchen (March 2017)

lintel and hood. The south-west corner of the house may incorporate some earlier masonry *in situ*, and reuse older foundations. The masonry walls, beams and ceiling joists with pine boarding over are currently exposed. The **parlour** has a plastered ceiling and walls, deep moulded skirting boards, and panelled backs and linings to the windows. The fireplace in the north wall has a plain late 19th century timber surround. There is a stone-lined well shaft under the east side of the room. On the exterior east wall is a reinstated hand-pump standing on stone slabs (three of granite and one of Purbeck limestone), with a rectangular trough of grey granite – the outlet flowing southwards into a channel formed from hollowed blocks of granite, laid alongside the house wall.

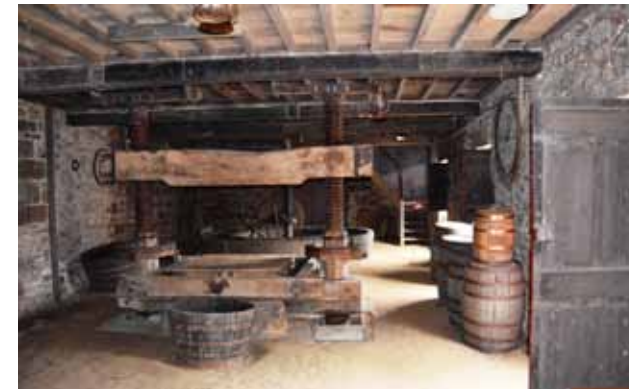
Figure 47: The Syvret building, restored cider-press house interior (March 2017)

The interior of the **cider press-house** is restored as an exhibit, also as a working unit, with a new twin-screw cider press constructed in oak and set up on the site where the original had been. A replacement apple crusher in Chausey granite is installed where its predecessor had stood. This dates to 1718 and was salvaged from another farm. There is exposed stone walling and a loess floor. The former agricultural store on the first floor is converted as holiday-letting accommodation. 'The Cider Barn Apartment' retains some original features including the original plaster work in the double bedrooms, early 19th century graffiti and wooden beams and joists.

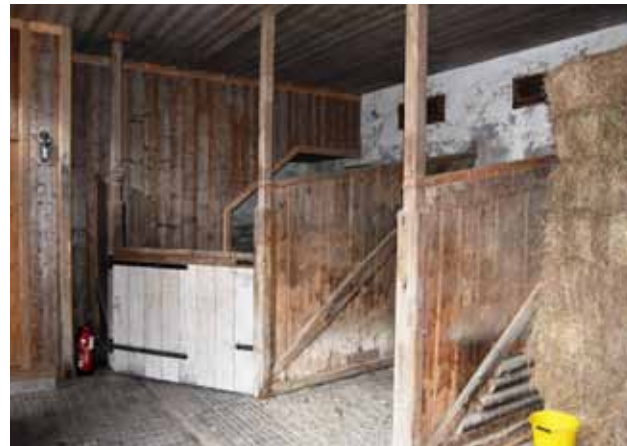
Figure 51: The Northern yard, interior of horse stable (March 2017)

Internally, the walls are coated with Portland cement slurry, and limewashed. The ground floor is divided into two parts by a light timber-boarded partition. This defines the tack room, which occupies the easternmost bay. The floor in the tack room has been concreted. The remainder of the stable is sub-divided to provide loose-boxes. The floor comprises blue Staffordshire pavements, laid to fall to an open drain, which discharges through the south wall. The ceiling of the stable is of pine boards, nailed to the joists of the floor above. In the south-west corner is new stairs giving access to the former hayloft above - now converted into holiday-letting accommodation, the 'Stable Barn Holiday Apartment'.

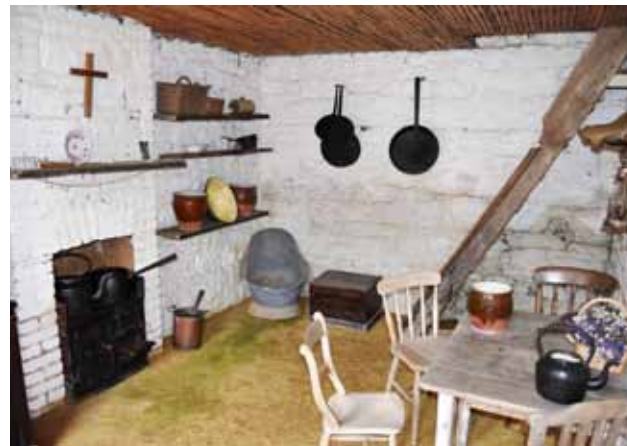
The **farm labourer's cottage** has a narrow door and a sash window in the south wall, and an original small fireplace on the west side - the chimney breast built of red brick. The interior masonry of the walls is unplastered, but variously painted and limewashed. The ceiling is exposed lathing attached to slender pine joists. At the north-east corner of the room is a ceiling hatch and a simple timber ladder-stair leading to the loft which runs the full length of the building. There is a loess floor. The **coach house** is a near-square room entered through outward-opening double doors; it has no windows or other features. The double doors are reinstated (the western leaf, complete with its hinges, reused). The floor is paved with square-cut, pink granite flags, laid to courses in an east-west direction. The ceiling is of lath and plaster. The walls are also lime plastered and line-incised as false ashlar, then limewashed. The walls of the **bakehouse** are plastered and limewashed, with the ceiling showing the undersides of the floorboards above on exposed pine joists. There is a loess floor. The timber back-plates for architraves remain around the window and door openings. A later doorway is broken through the east wall to interconnect with laundry. On the east wall, a replacement bread oven was constructed, to the original dimensions, using salvaged materials. A large open fireplace, built with a mixture of stone and brick, dominates the west wall of the **laundry** room. The floor comprises a cement screed, and the ceiling shows the blackened undersides of the floorboards

Figure 52: The Northern yard, interior of farm labourer's cottage (March 2017)

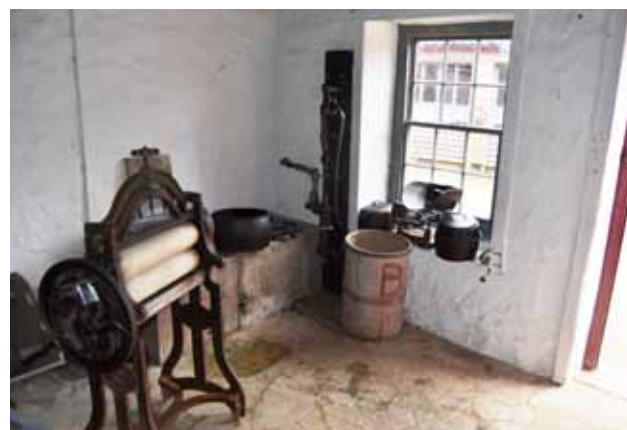
Figure 53: The Northern yard, interior of laundry room (March 2017)

above. Timber back-plates for architraves are again present around the doorway and window. Inserted in the north-west corner of the room is hot-water boiler 'copper' for washing clothes; a replacement

constructed in 1993 using salvaged materials. In the south-east corner of the room is a granite sink, mounted on a low stone plinth, with a reinstated water pump attached to the south wall.

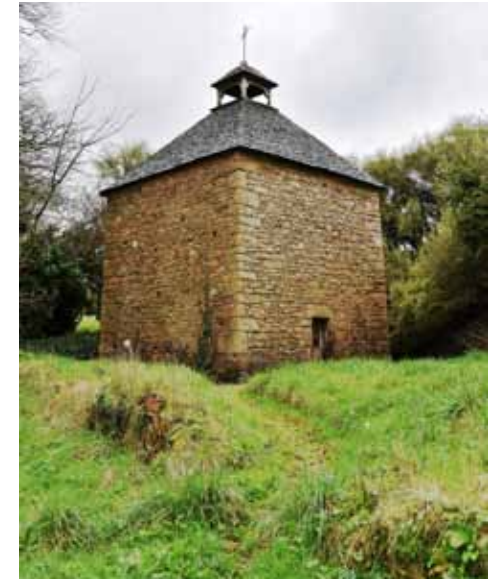
Figure 60: The colombier (dovecote) (March 2017)

The colombier was repaired and restored in the 1990s, including reinstatement of the pyramidal oak roof,

The colombier measures 5.9m square overall and its walls stand to a height of 5.0m above the foundation offset. The walls are consistently built of small, mixed rubble, laid in loess mortar with no evidence for the use of lime. The masonry mainly comprises granite, although there is much use of shale in small pieces, some French slate for levelling, occasional lumps of quartz and one piece of French millstone. The quoins are made of blocks of hammer-dressed Mont Mado granite of varying sizes, laid in side-alternate fashion. A single block, in the north-west quoin, exhibits quarry wedge-marks, and one re-used in the north-east quoin bears the eroded remains of some initials. A few

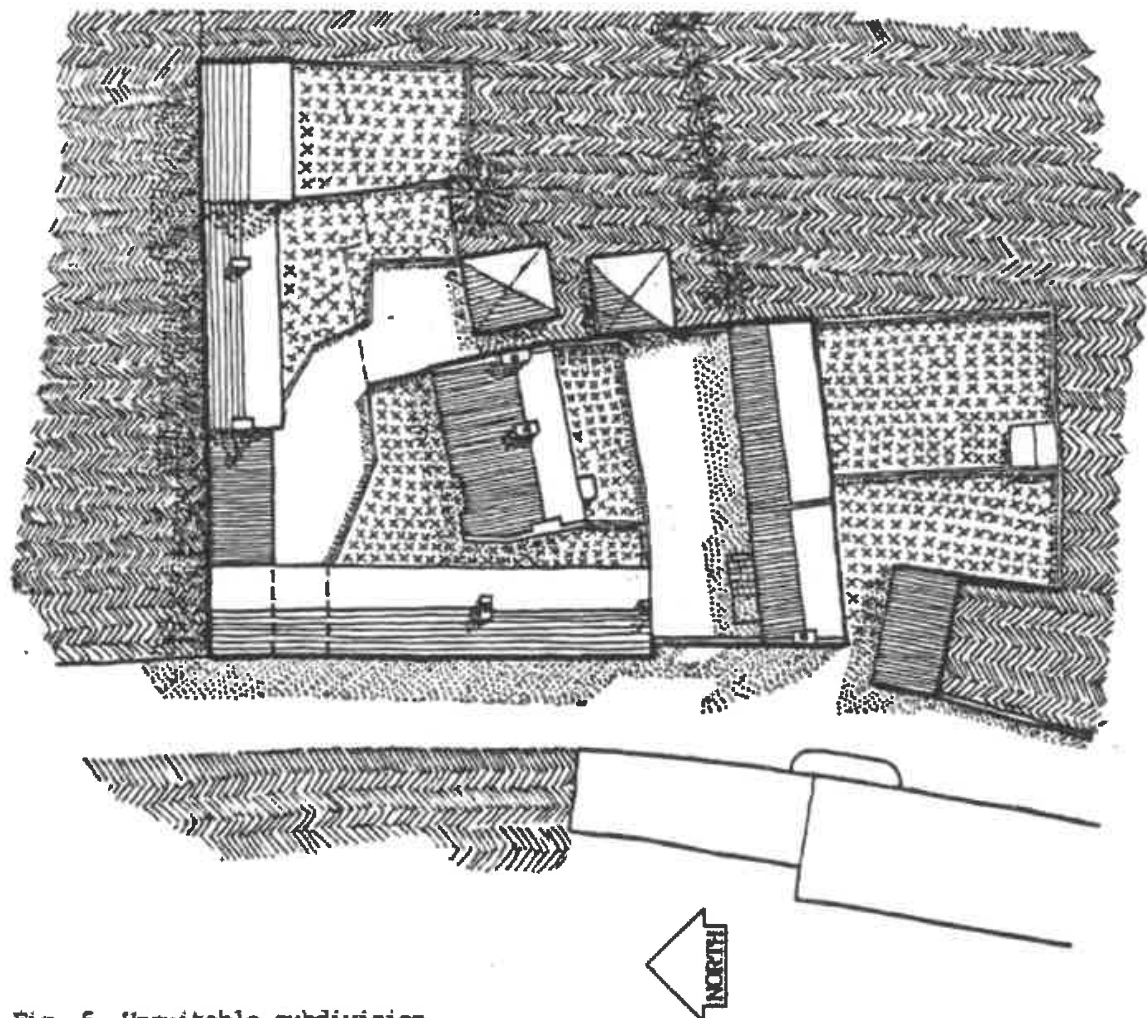
Fig. 5 Unsuitable subdivision

Proposals should be resisted that would result in the subdivision of the existing yards and their splitting up into a number of individual curtilages. The plan view (Fig. 5) demonstrates the damaging effects resulting from the provision of individual garden plots. They can be seen to be destructive of the strong relationship between buildings and yards, and the complex as a whole and the landscape. The addition of minor structures such as sheds, domestic greenhouses or garages can also be seen to severely compromise the pleasing and functional geometry of the existing complex.

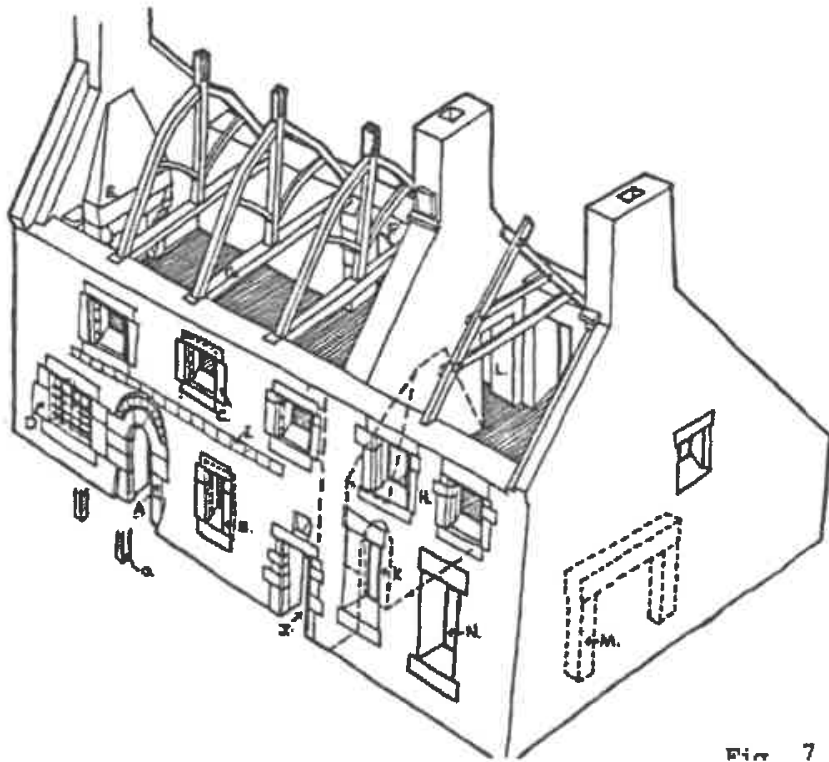
Fig. 7

- A1.6 There are two obvious parts of the building, a larger left hand part and a short extension block on the eastern end. The main elevation faces south and has two doorways and a multi farious collection of window openings as shown in Fig. 7.

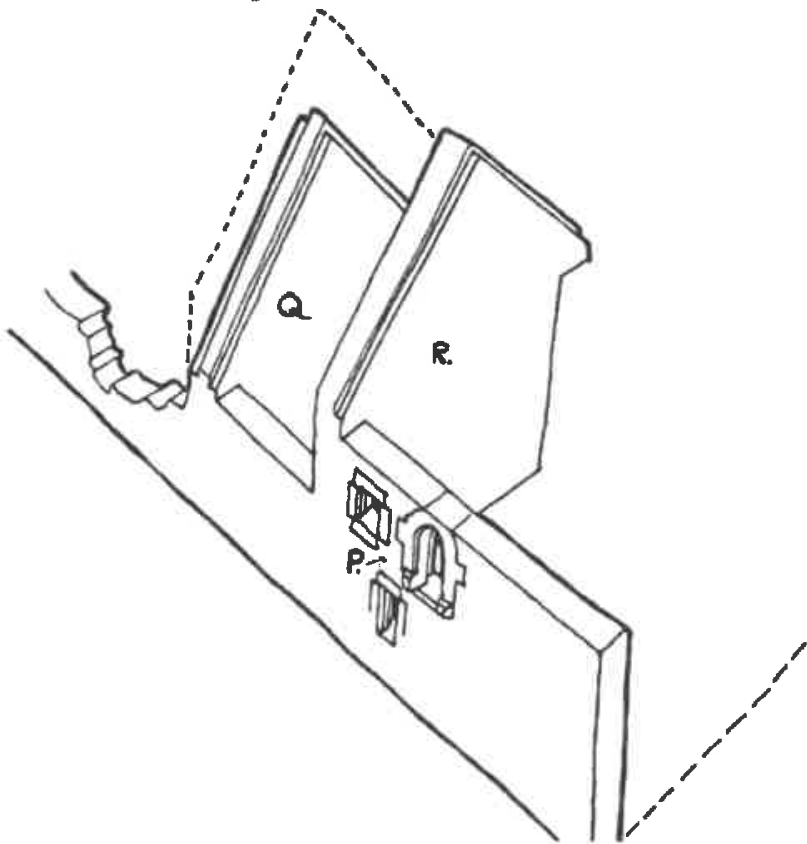
A1.18 Looking at the northern wall at Fig. 8, we see a typical Jersey entrance arch at first floor level and a pair of hollow chamfered windows. These seem to form a group (P) in which each component is of the same character, and one which probably represent, with the area of wall between, one building phase. About four metres to the east, there is a gable wall (Q) which forms the eastern end of the two-storey building. Examining the western face of this gable, within the present roof space, a triangular area of stonework can be discerned. This shows that it has probably been raised in height. If this wall was once only of single-storey height, then there must have been another two-storey gable (R). The two-storey building would then be very much shorter and the Jersey arch noticeably off-centre.

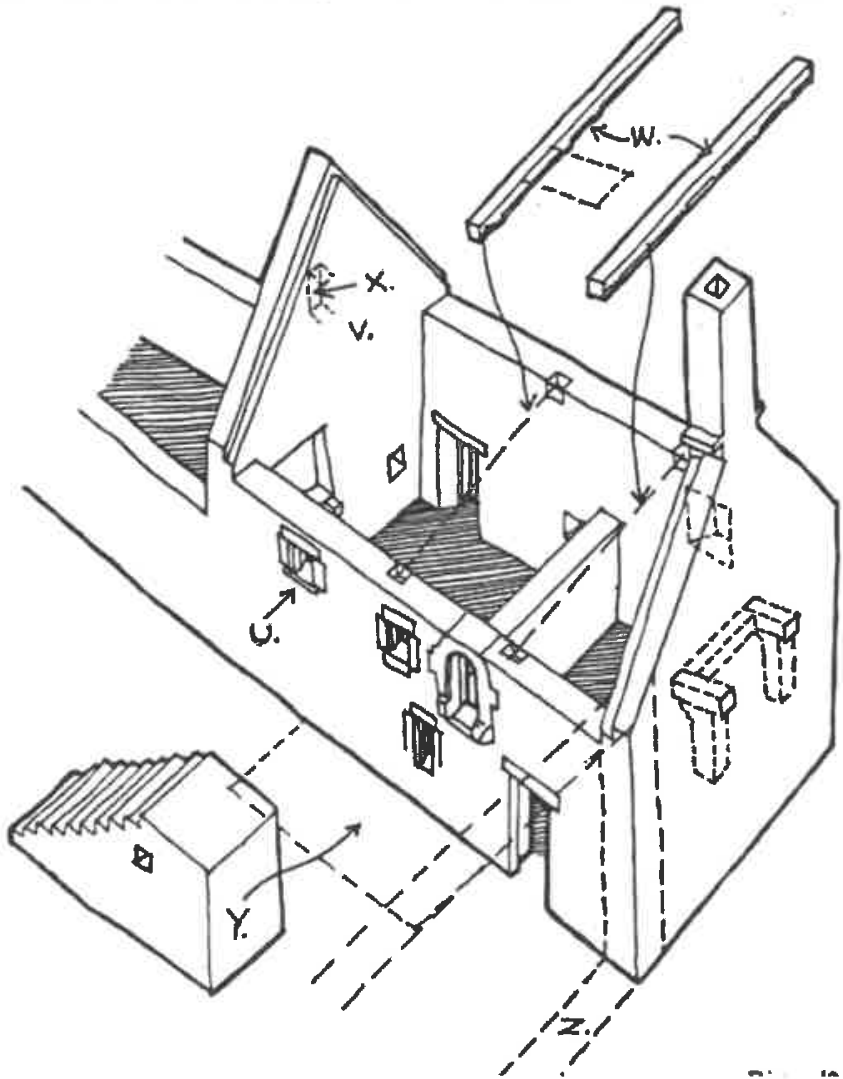
- A1.22 The first-floor hall appears to be a later extension to its present length as shown in Fig. 10. Window (U) has flat chamfers akin to the majority of the windows in building A and may represent a mid-17.C. phase. The raised wall (V) forms an extremely asymmetrical gable of very steep pitch on its southern side. This seems to be the result of the abnormal geometry and was necessary to form an abuttal for an extended roof. The building now has an attic floor of mud over a layer of rebated boards. The forming of usable attics at the vernacular level is something that seems to begin in the late 16.C. The structure that carries this floor comprises a pair of bridging joists and square longitudinal rafters (W). The former have interrupted chamfers and a series of peg holes.

- On close inspection the peg holes are seen to be dummies and it is possible to see that there are no proper mortices for studs. This arrangement obviously represents an effort to provide the appearance of a board and stud partition but not the real thing! Once this is realised, the fact that only one of the joists is grooved for boarding makes a little more sense. The rafters are moulded on their ossifts with a series of passable grooves of varying profile. This is an early to mid-17.C. feature when found in East Anglia. The arrangement of the chamfers suggests that, at this stage, the first floor was subdivided very much as at present. Two end rooms are provided with a lobby and the head of the stairs, and a small central room. Such an arrangement can be found in certain late 16.C. Welsh houses, where the little central room has a service function. The ceiling or attic floor joists contain a hole for an original ladder access leading up from the entrance lobby.

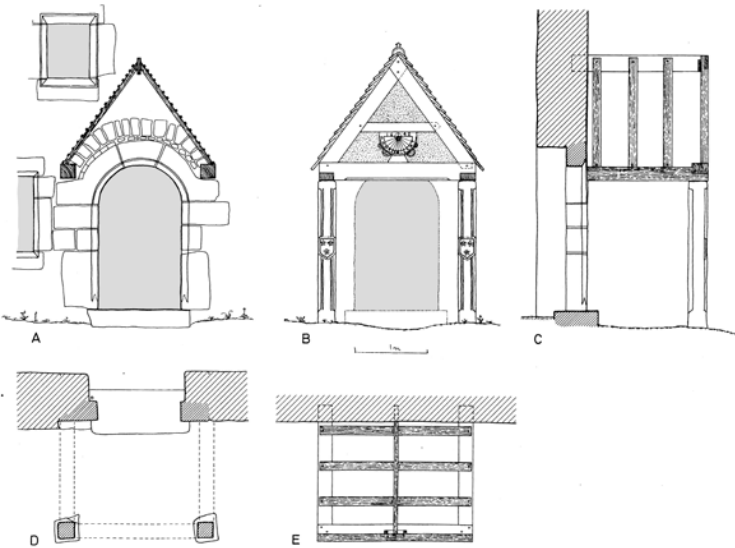
Hamptonne: drawings prepared for the reconstruction of the porch, 1990. A. Sectional elevation against the house wall. B. South elevation of the porch. C. Sectional west elevation. D. Plan at ground level. E. Roof plan. Warwick Rodwell

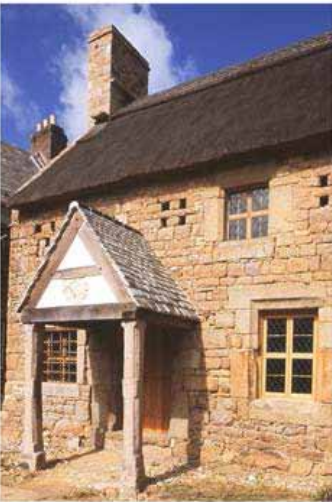
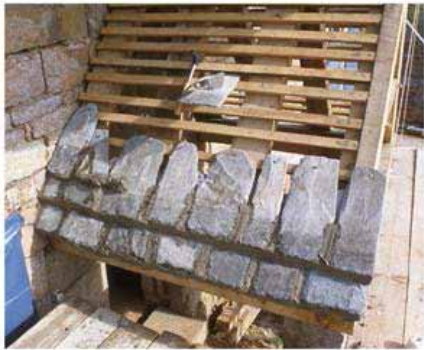
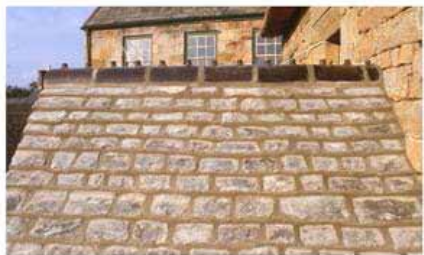
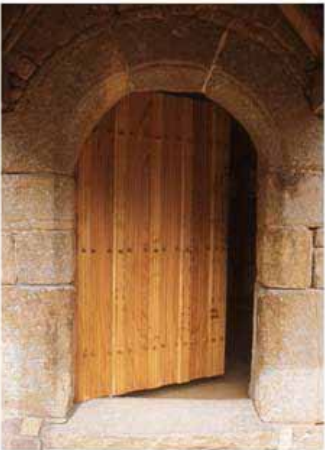
Hamptonne: the reconstructed porch. A. View from the south-east. B. Roof of French graduated slates with ceramic ridge tiles. C. Slating in progress. D. New entrance door to the house. Warwick Rodwell

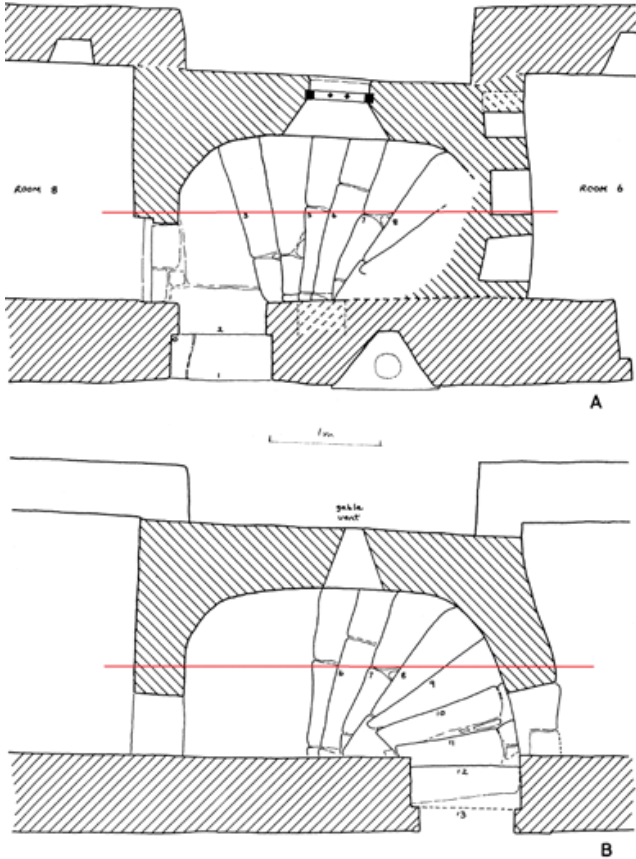
Hamptonne: reconstructed plans of the tourelle. A. Ground level. B. First-floor level. Warwick Rodwell

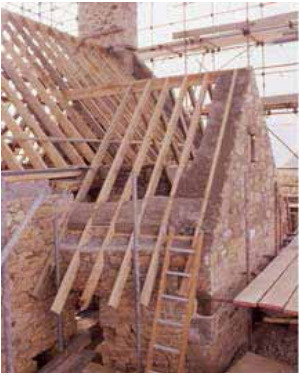
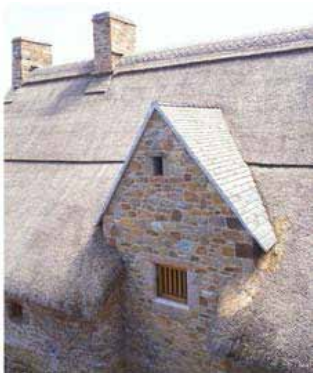
Hamptonne: restoration of the tourelle. A. The new gable and roof under construction. B. The completed tourelle, with a French slate roof and ceramic ridge tiles. Warwick Rodwell

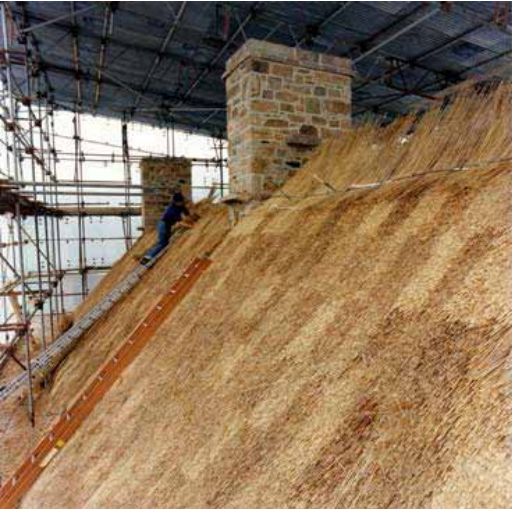
Hamptonne: thatching in progress, 1990. Société Jersiaise

It was determined at the outset that the roofs of Hamptonne and Langlois should be returned to thatch, and this involved replacing the lightweight, softwood framing that supported the corrugated iron with robust structures in oak. In the case of this building, it was important to retain in situ the sixteenth-century roof trusses and purlins, which were too decayed to perform any structural function. Hence a new over-roof was designed by the project's structural engineer, Clive Dawson, which allowed the historic timberwork to be freestanding within, and the original thatch profile to be recreated externally. It was thatched in water reed, 30 cm thick, and finished with a combed wheat-straw ridge. The remains of the original king-post roof – possibly the only one of its type still surviving in Jersey – can be viewed through the ceiling hatch in the chamber.

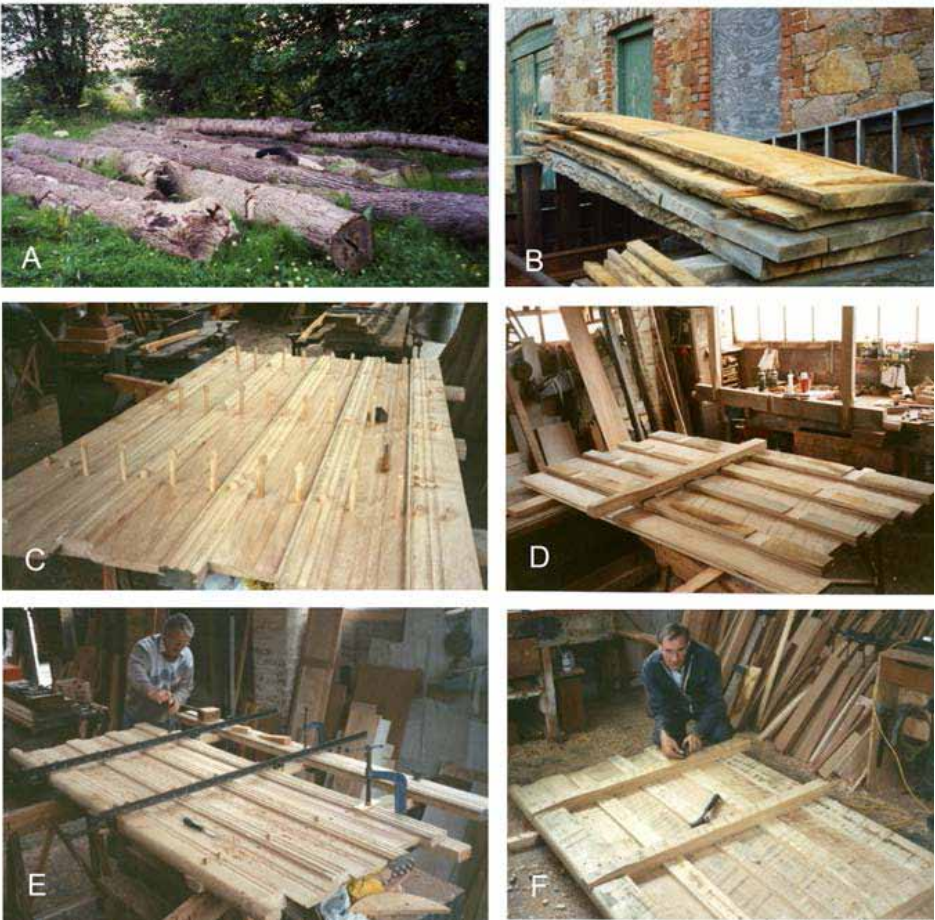
New oak carpentry: constructing a traditional harr-hung door for Hamptonne, 1991. A. Fallen oaks dragged from the woods in Rozel Valley, ready for transporting to a sawmill. B. After being planked, the boards were allowed to season naturally. C. Planks and muntins cut, moulded and fitted with trenails, ready for attaching the ledges. D. Trenching the muntins and fitting the ledges to the back of the door. E. Pegging the construction with the trenails. F. Trimming the ends of the trenails and finishing the back of the door. Harry Tumblety

A considerable quantity of oak was required for the roofs, floors and internal fixtures at Hamptonne, and much of this was locally sourced, although it had to be supplemented by some imported timber. The local source was Rozel Manor (St Mt.), where thirty-two of the oaks that fell in the great storm of 1987 were hauled out of the woods in 1989, and taken to a sawmill for planing.

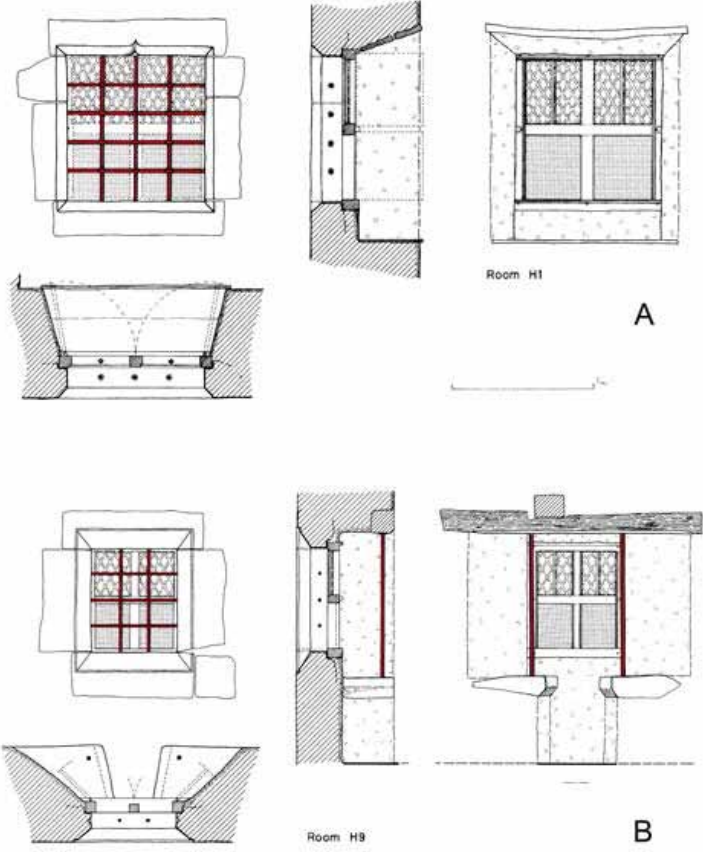
Hamptonne: drawings prepared for the manufacture of new window frames and glazing. A. Pantry, with original external iron grille. B. Chamber, with a reconstruction of the lost external grille. Warwick Rodwell

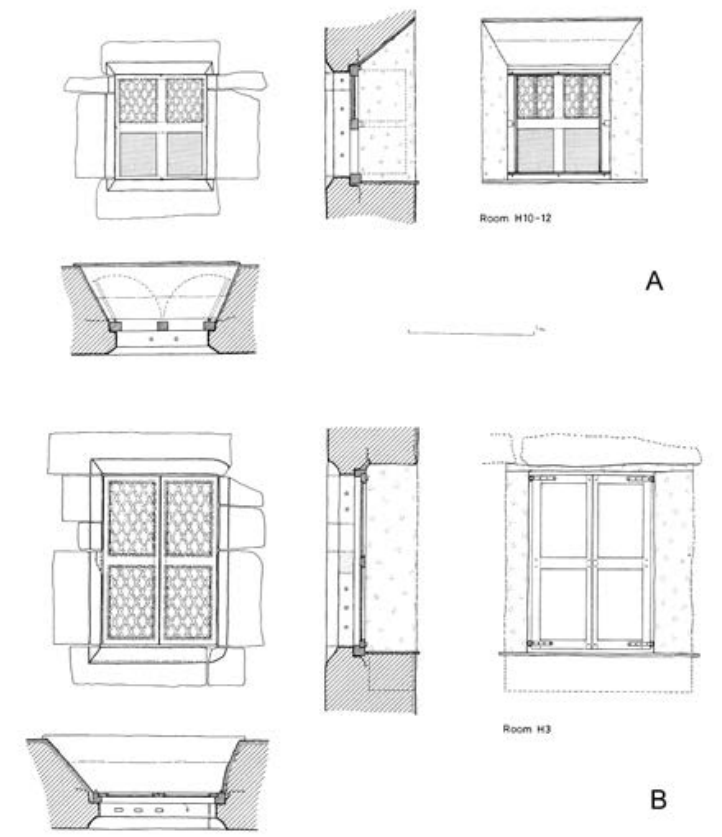
Hamptonne: drawings prepared for the manufacture of new window frames and glazing. A. Chamber. B. Kitchen. Warwick Rodwell

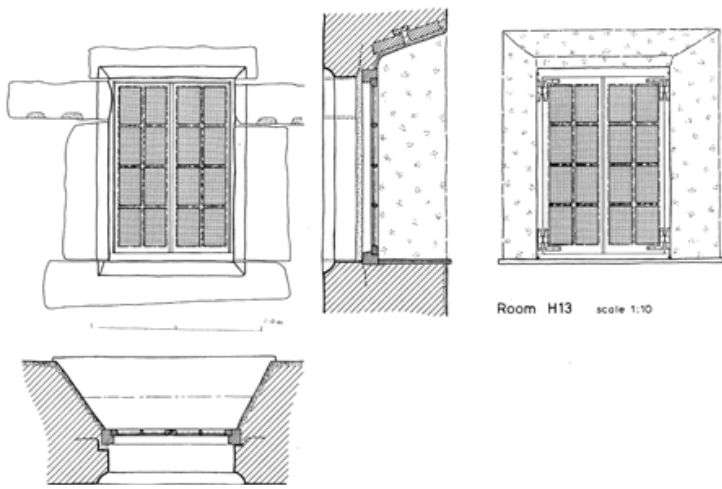
Hamptonne: drawings prepared for the manufacture of new window frames and glazing. East wing chamber. Warwick Rodwell

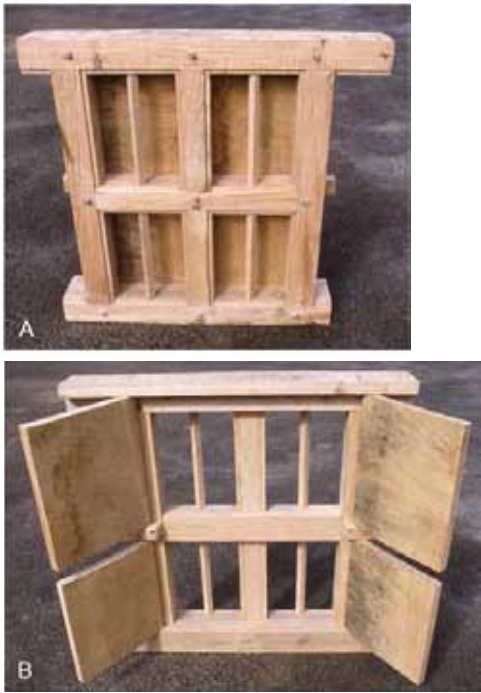
Hamptonne: new oak window frame for chamber. A. Exterior, with the shutters closed, and showing the rebates to hold leaded glazing. B. Interior, with the shutters open, and showing the scratch-moulded mullions. The slender oak bars are for tying the leaded glazing. Warwick Rodwell

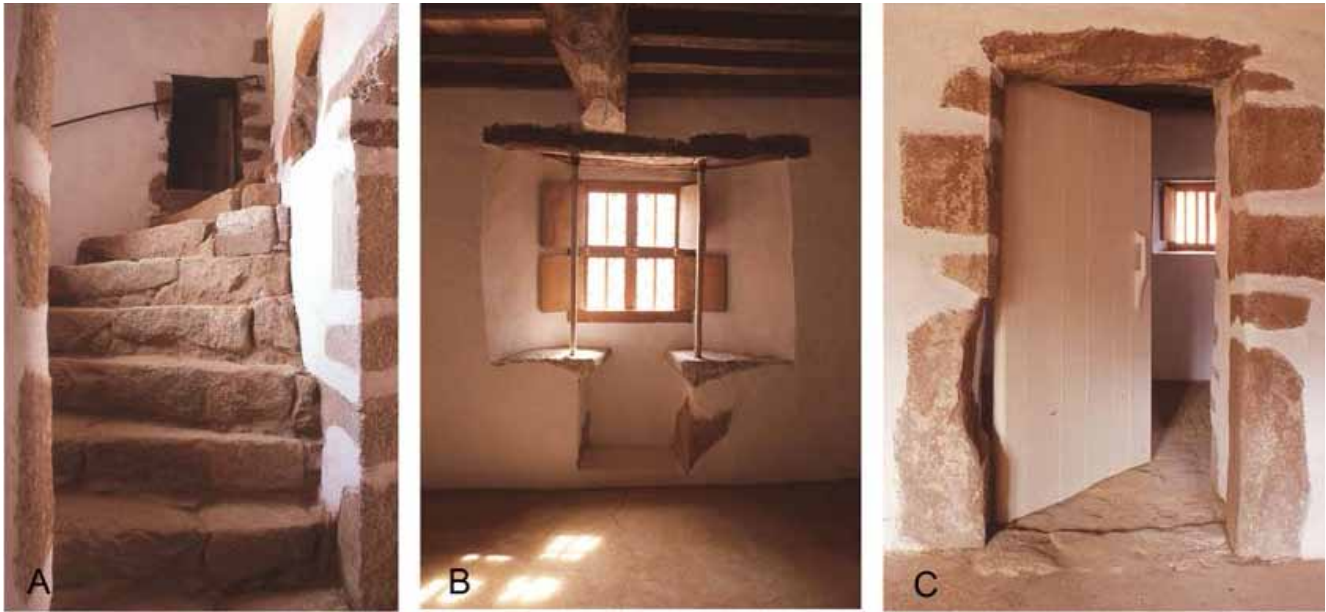
Hamptonne: internal features revealed during archaeological investigation. A. Granite steps of the tourelle, which had been encased in timber. B. Window embrasure, which had been infilled with masonry. C. Doorway between kitchen and scullery, which has been infilled with concrete blockwork. Note the concave cutaway in the left-hand jamb. Warwick Rodwell

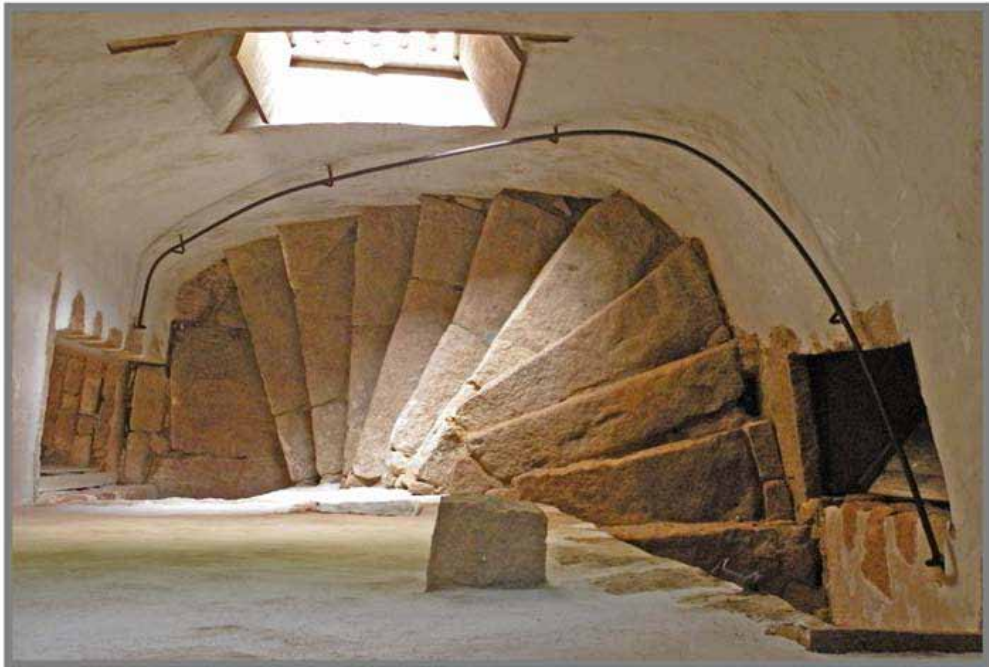
Hamptonne: the restored tourelle with the granite treads exposed. John Lord

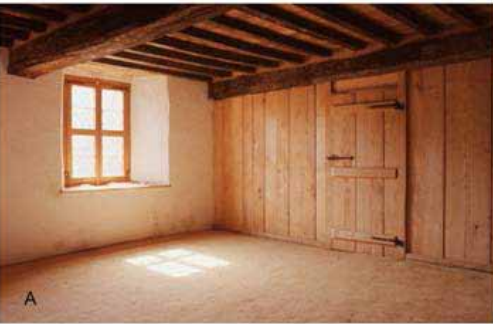
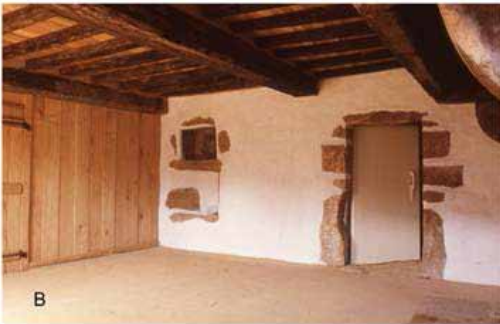
Hamptonne: restored rooms, 1991. A. Kitchen, view south-west. B. Kitchen, view north-west. C. Chamber, view south-west. D. Chamber, view north-west. Warwick Rodwell

repel dampness and decay, and the principal hearths have been restored to working condition. Since it is not practicable to keep a fire burning continuously in the kitchen, it was necessary to introduce a form of low-level heating that could be maintained all year round. The only inconspicuous way of achieving this was to install underfloor heating. A puddled loess floor was laid at ground level throughout the house, and piping to carry hot water was incorporated in it.

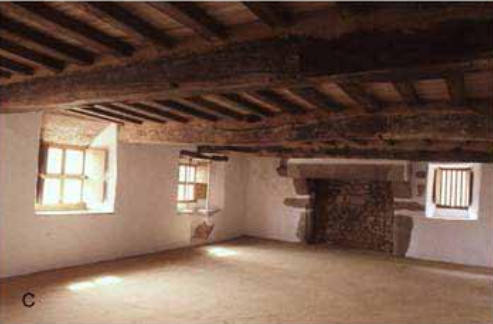
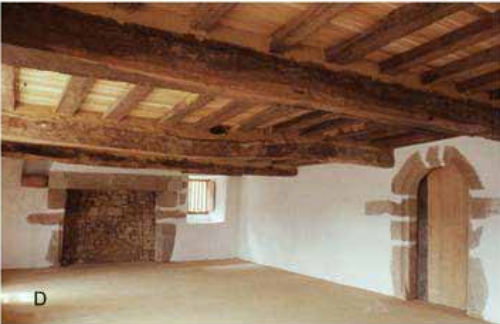
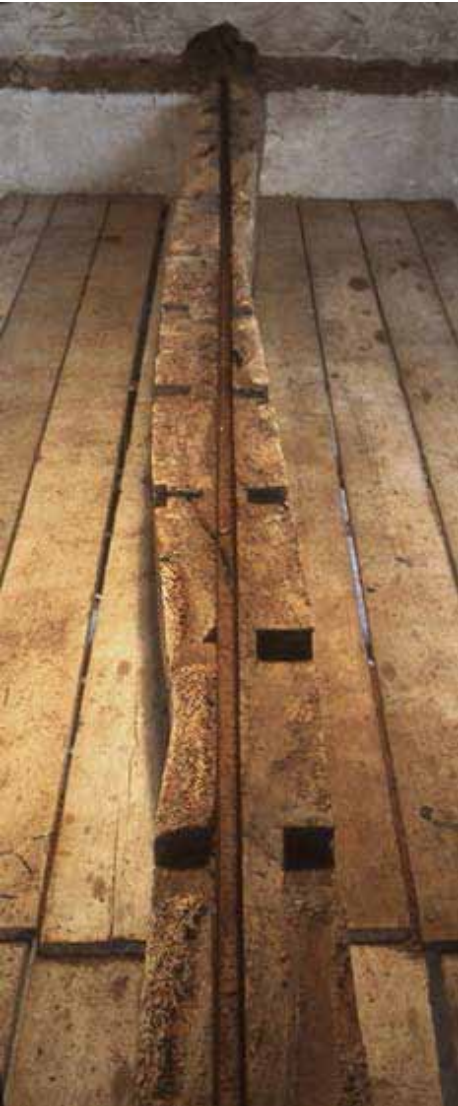
Hamptonne, east wing chamber. Slot cut to receive a stainless steel flitch plate in the upper face of the bridging-beam that supports the first floor. Warwick Rodwell
Hamptonne, chamber. Terre battue floor under construction, 1992. View east. Warwick Rodwell

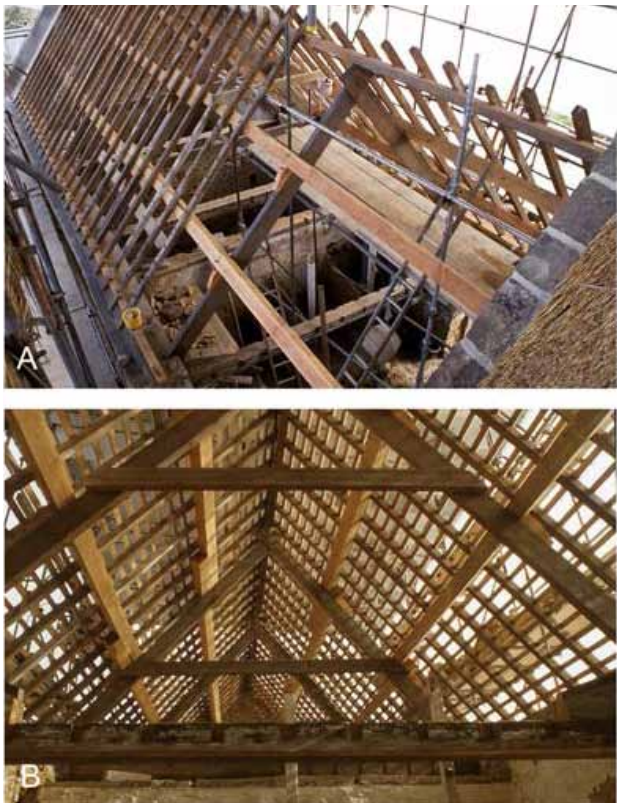
South Range. Construction of the new roof with A-frame trusses in progress, 1994. A. Exterior, looking south-east. B. Interior, looking east. Warwick Rodwell

Most of the operations required for the restoration of the Hamptonne house were replicated for Langlois. Nothing remained of the historic roof to the single-storied South Range, and thus a wholly new one was designed, based on typical A-frame trusses of the eighteenth century. The ‘eyebrow’ hatch in the north side was reinstated, along with the thatched roof. The concrete floors were replaced with loess, but the mixed brick and stone paving in the cow stable was retained. Blocked openings were cleared, and simple windows and doors made and fitted throughout, some based on surviving fragments found *in situ*.
