Hamptonne Conservation Statement 2017

INTRODUCTION

The subject of the Conservation Statement is Hamptonne in St. Lawrence, Jersey. The primary purpose of the statement is to draw together existing information, to set down a brief history for the site, a description of the principal elements, an assessment of significance, the identification of major conservation issues and a series of policies. The Conservation Statement is intended to inform and advise the management of the site and future decisions concerning its alteration and use.

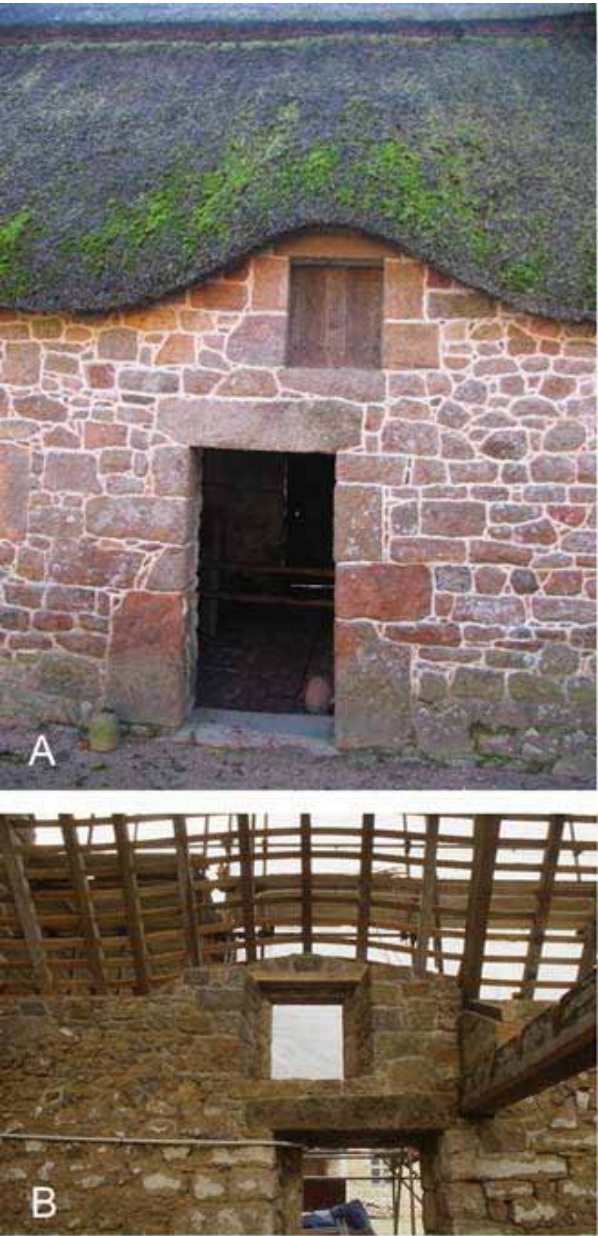
South Range: north doorway with ‘eyebrow’ hatch above. A. As reconstructed. B. Internal view of reconstruction in progress. Warwick Rodwell

The 1990s restoration replaced the modern roof on the single-storied south range with a new one based on typical 18th century A-frame trusses, with an 'eyebrow' hatch in the north side reinstated. Nothing remained of the two roof trusses, apart from the tie-beams, on Langlois house and there was a full-scale recreation of an upper king-post roof. The entire building is thatched in water reed and finished with a combed wheat-straw ridge. Blocked openings were cleared and new doors and fenestration fitted throughout - unglazed oak window frames to the south range and small-paned casements on the upper floor of the Langlois building.

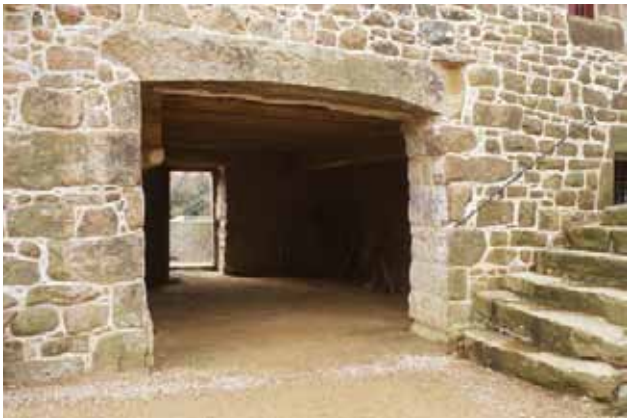
Langlois: entrance to the open-fronted implement shed, after removal of later partial infilling. Warwick Rodwell

Little was done to the lower part of the Langlois house, the two compartments of which were retained as a stable and open-fronted implement shed, respectively. The partial blocking of the wide entrance to the shed was removed, restoring its original proportions. Similarly, the doorway to the stable from the courtyard was reopened, and the cow stalls repaired.

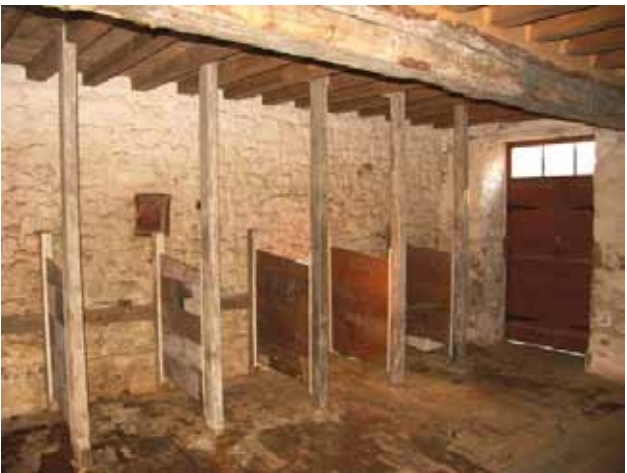
Langlois: stable. Eastern row of repaired cow stalls. View south-east. Warwick Rodwell

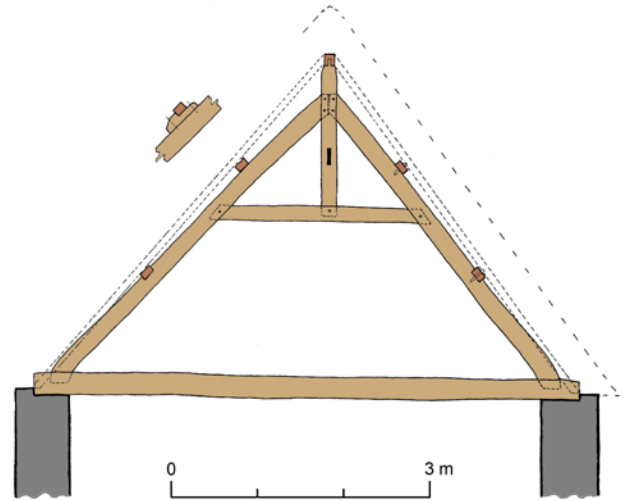
Langlois: reconstruction of the eastern upper king-post roof truss. West face. Warwick Rodwell

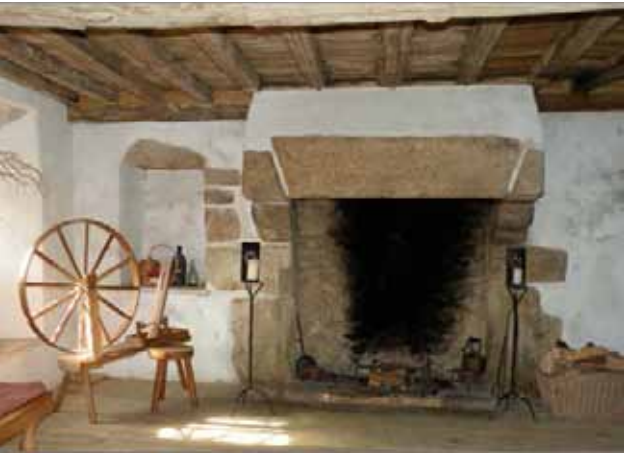
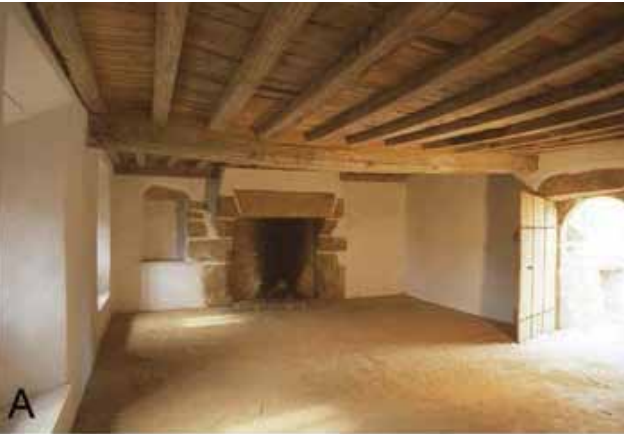
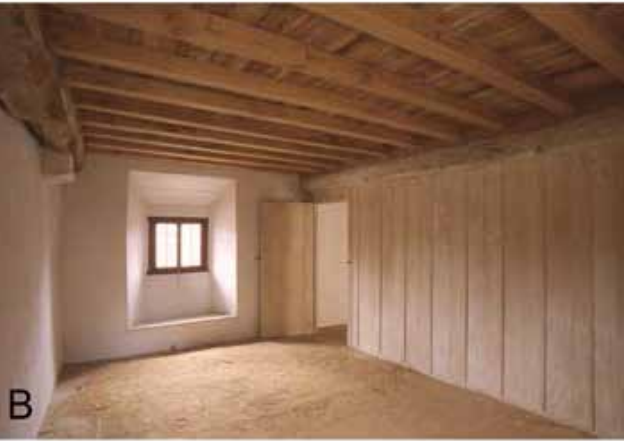
Langlois: first-floor rooms after restoration, 1995. A. Hall, looking north-west. B. Chamber, looking south-west. Warwick Rodwell

Nothing historic survived of the timber first floor, apart from one bridging-beam. New beams and joists had therefore to be fitted, and a terre battue floor laid for the rooms above. A new harr-hung door, similar to that on Hamptonne, was made for the arched entrance, and the windows were all repaired or reinstated with small-paned casements, maintaining the arrangement that had been adopted in the eighteenth century.

The original division of the upper floor into two rooms was reinstated by erecting an oak partition of in-and-out panelling, with an en suite door. Pegs have been inserted in the lateral holes in the tie-beams that have interrupted chamfers, and small shelves lodged upon them.

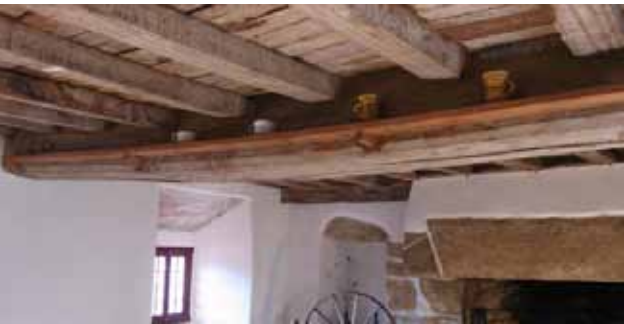
Langlois: hall. Note the reconstructed shelf supported by pegs on the side of a tie-beam which has interrupted chamfers. View south-west. Warwick Rodwell

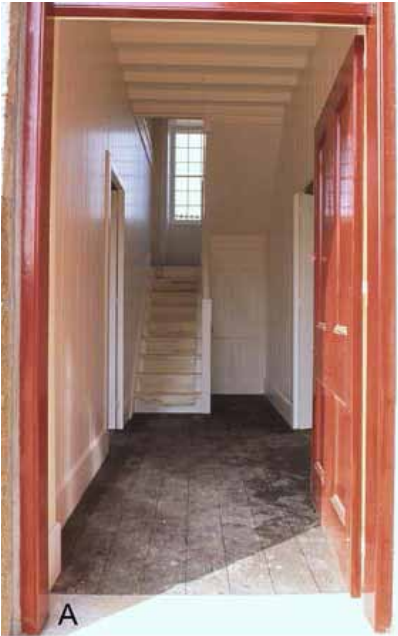
Syvret: restoration of the ground floor rooms. A. Entrance hall and staircase. B. Kitchen the fireplace restored with a granite lintel. Warwick Rodwell

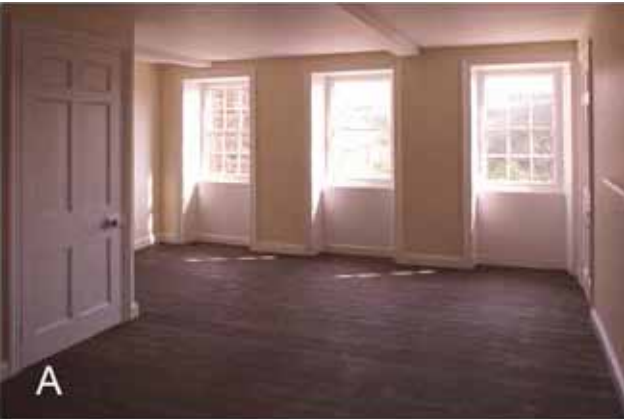
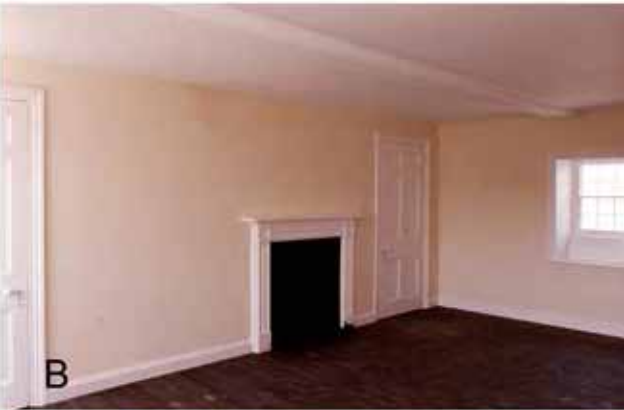
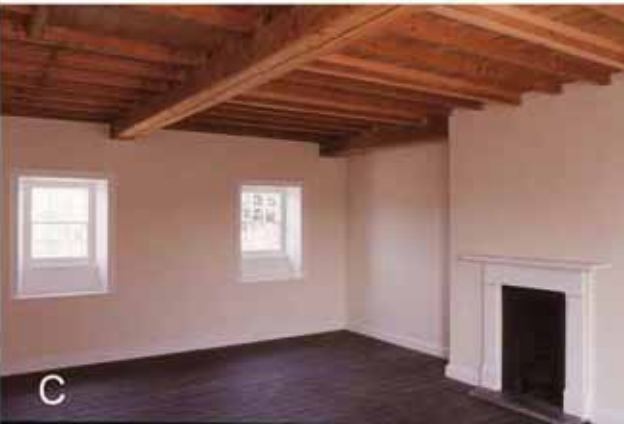
Syvret: restored chambers, prior to final decoration. A. Principal bedroom, east side with sash windows. B. The same, south side and south-west corner with a fireplace flanked by built-in cupboards. C. Second bedroom, north-west corner with a fireplace in the north wall. Warwick Rodwell

On the upper floor the two bedrooms were restored, but the tiny cabinet was not recreated. These rooms have been decorated and furnished in the nineteenth-century taste. The fireplace surrounds, although made of timber, have been painted as *faux* marble; this was common in Jersey, in houses where the owners could not afford true marble chimneypieces.

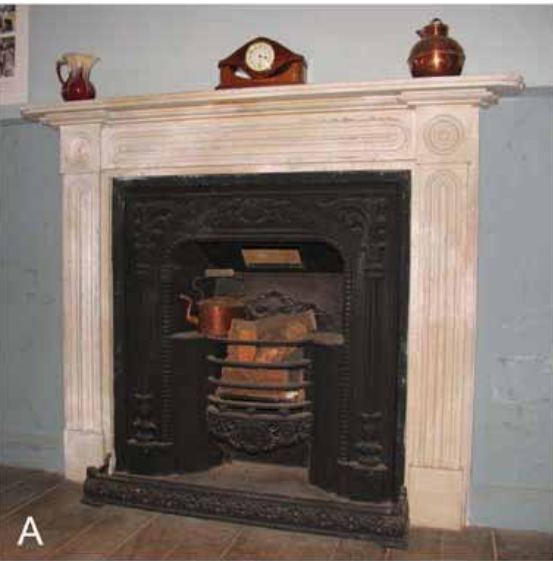
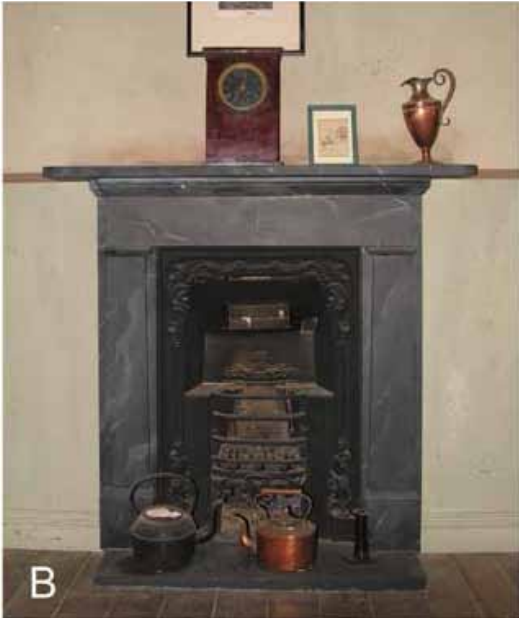
Syvret: chamber fireplaces. A. The timber surround painted to imitate Carrara marble. B. The timber surround painted to imitate veined black marble. Warwick Rodwell

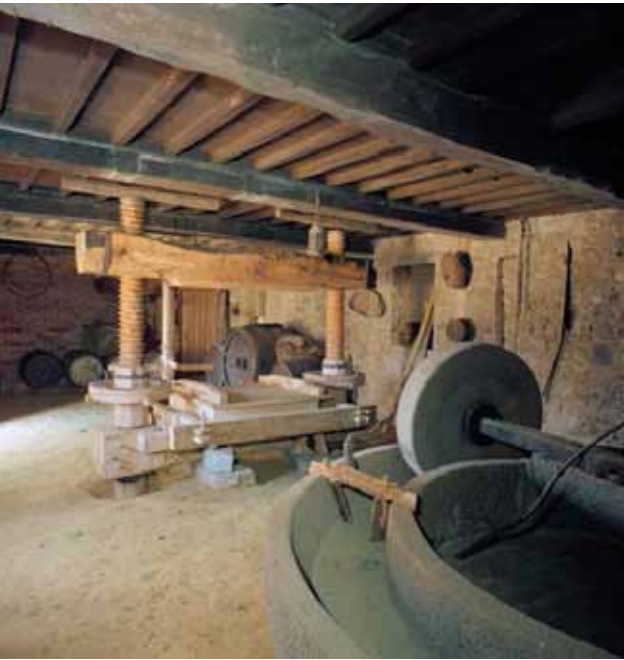
Syvret: press-house restored as a working exhibit with a new twin-screw wooden cider press (1993) and apple crusher of Chausey granite (dated 1718). View south-west. Société Jersiaise

house was overwhelming, and that was duly done: all the modern subdivisions were removed, thereby recovering the original voluminous space. Although the *pressoir* was restored as an exhibit, it is also a working unit where an annual production of Jersey cider takes place. A new twin-screw cider press was constructed in oak and set up on the site where the original had been. A replacement apple crusher in Chausey granite was installed where its predecessor had stood. This ‘new’ crusher, dated 1718, was one which had been salvaged from another farm long ago and was in store in Jersey Museum.

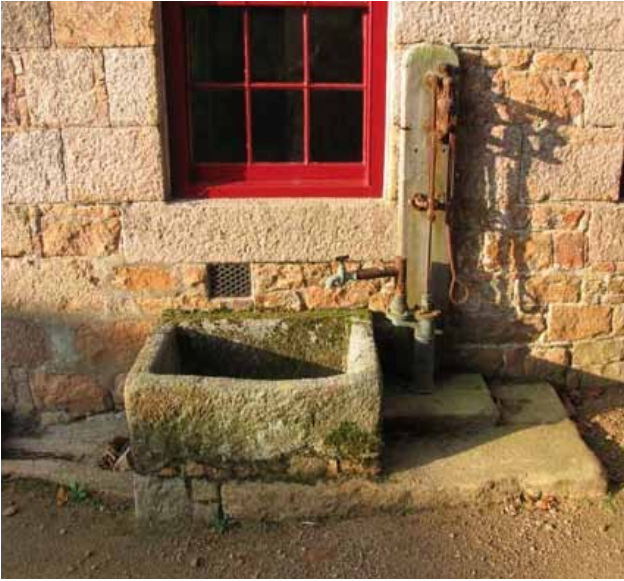
Syvret: east wall, exterior. Restored pump and cistern above the well. Warwick Rodwell

The well under the floor of Syvret, although still fed by natural springs, was not deemed suitable for drinking purposes, and a mains water supply was installed. However, a wall-mounted pump was reinstated

externally. The building was reroofed to reflect the original hierarchical arrangement: Welsh slate over the domestic part, and pantiles on the remainder.

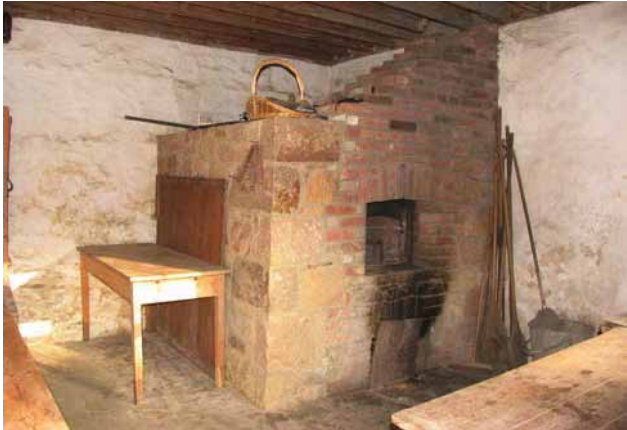
North Range. Bakehouse with a reconstructed bread oven in the north-east corner. This is a working oven which is lit periodically to display traditional baking techniques. Warwick Rodwell

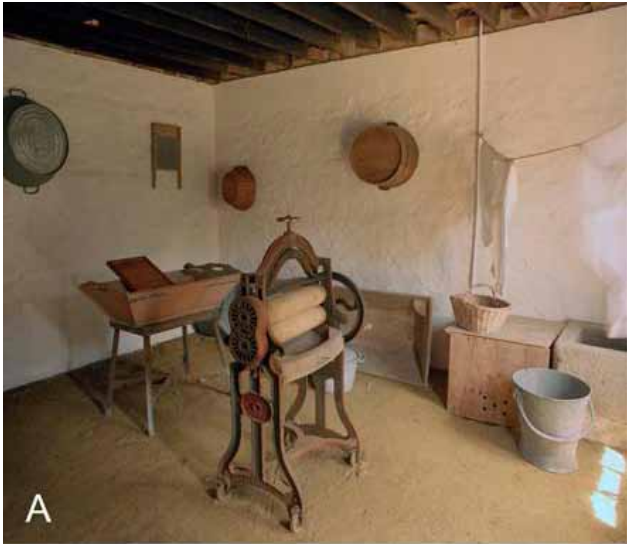
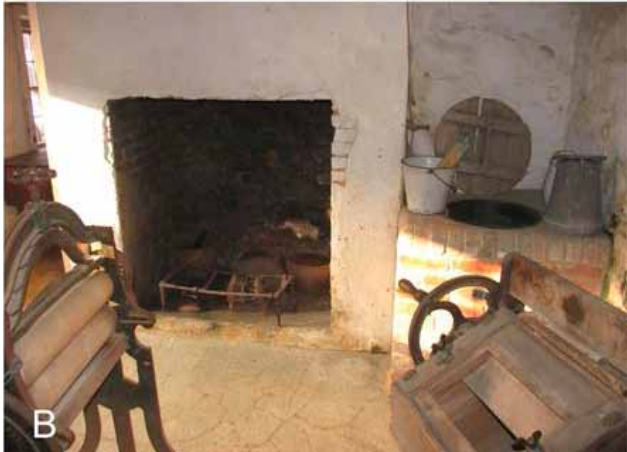
North Range. Wash house. A. General view, north-east. B. Fireplace and adjacent ‘copper’ on the west wall. A. Société Jersiaise; B. Warwick Rodwell

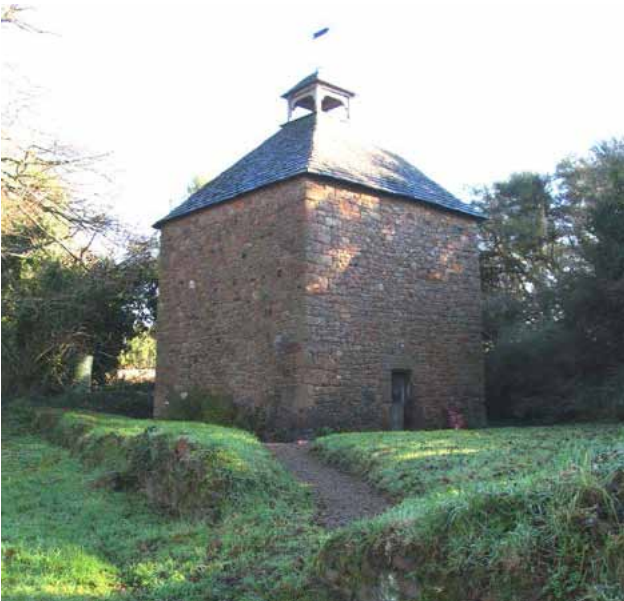
Dovecote. Viewed from the north-west, 2013. Warwick Rodwell

The colombier has been conservatively repaired and restored to as a dovecote, although it is not currently functioning in that capacity. The inserted modern upper floor and the Crittall windows that had been intruded into its north and south walls have all been removed. The enlarged entrance has been returned to its original dimensions, with the granite lintel and inscribed plaque correctly reinstated.

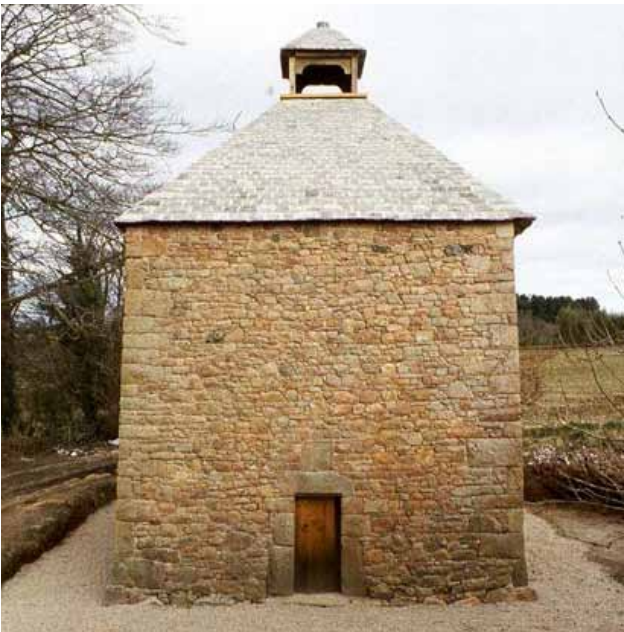
West side of the newly restored dovecote, 1996. Warwick Rodwell

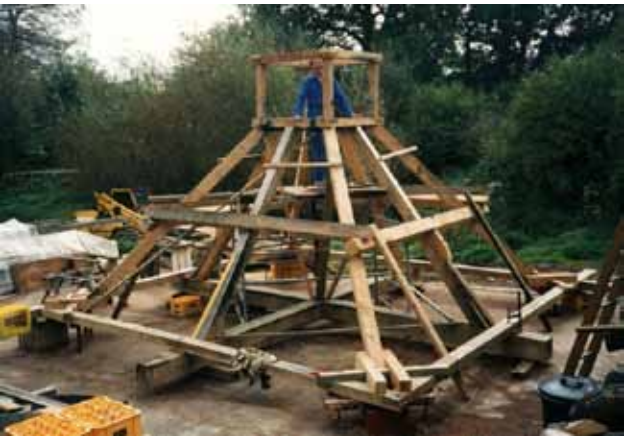
Dovecote: the new pyramidal roof frame under construction at ground level. Peter Huelin

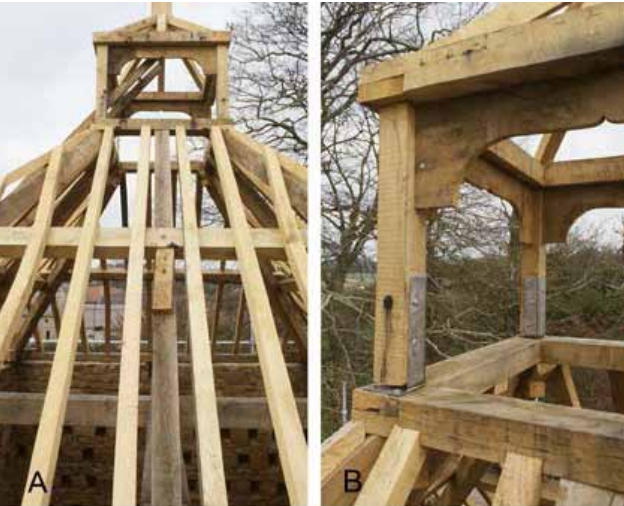
Dovecote: construction details of the roof and cupola. A. South side of roof. B. South-east corner of the cupola. Warwick Rodwell

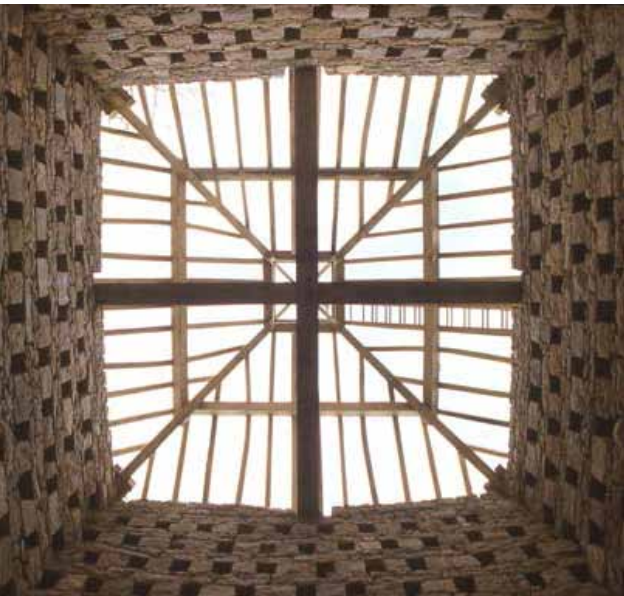
Dovecote: the skeleton of the new oak roof in situ on the dovecote, viewed from below. The structure is dominated by the two tie-beams which intersect at right-angles. Warwick Rodwell

The flimsy pyramidal roof with pantiles that had been constructed in the nineteenth century was in an advanced state of dilapidation, and was removed. In its place, a pyramidal oak roof incorporating a simple cupola of the type commonly found on unpretentious dovecotes has been built. The framing was constructed in the traditional manner, at ground level, then disassembled and reconstructed on the walls. The roof has been covered with reclaimed French slates, and is crowned by a wrought iron vane. No attempt was made to reconstruct an internal scaffold or walkways to access the nesting-holes.

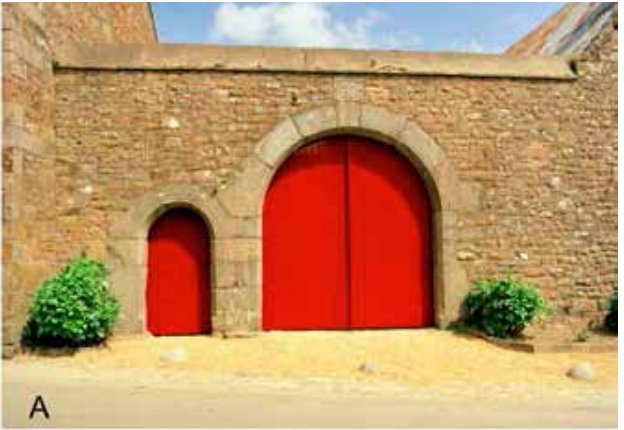
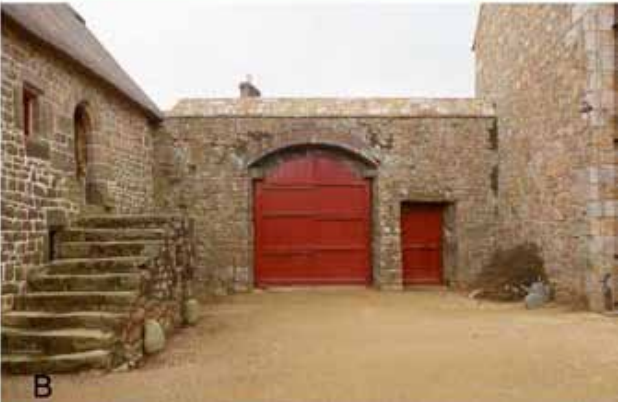
Twin-arched entrance to the courtyard, with new gates made by the National Trust for Jersey. A. View from the lane. B. Internal view from the courtyard, 1996. A. Société Jersiaise B. Warwick Rodwell

The twin-arched entrance to the south courtyard needed no restoration, but the gates were decayed beyond repair. A new set of gates was made for the arches in 1993, replicating the previous ones. The level of the courtyard wall on the east had twice been reduced, diminishing the sense of enclosure. Consequently, the wall was built up again to its former height.

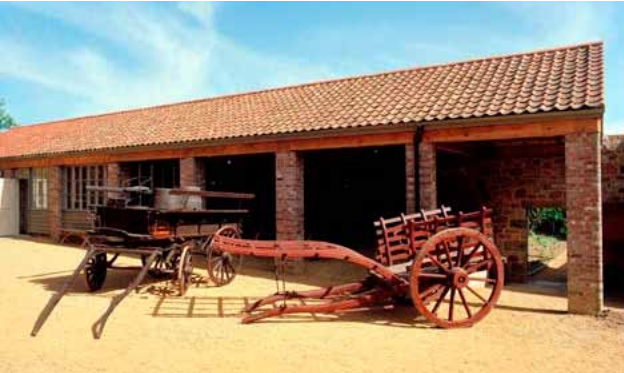
Northern yard. Rebuilt open-fronted implement shed and site café (glimpsed far left). Société Jersiaise

The open-fronted, lean-to shed in the northern yard, opposite the stables, was demolished and replaced by a new structure which combines an open shed where farm machinery is displayed, and a café for visitors. The high wall between the yard and the garden, against which the shed was built, largely collapsed in 1991 as a result of frost damage. The wall was taken down and rebuilt, and a new opening created in it, close to the corner of Hamptonne, providing a discrete connection between the garden and the northern yard.

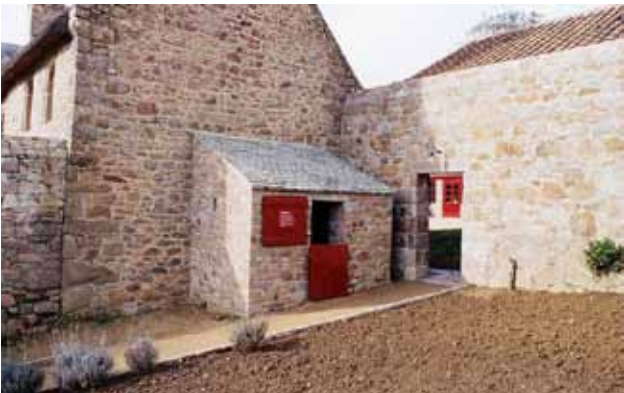
East Range: reconstructed dipping-well. View from the south-east. The high garden wall on the right forms the back of the open-fronted implement shed in the northern yard. Warwick Rodwell

The small rectangular structure – believed to be a dipping-well – abutting the east gable wall of Hamptonne, and discovered through excavation, was reconstructed on the old foundations. It has been roofed with French slate. The garden itself has been
