No 9 Pier Road Conservation Statement

July 2012

No 9 Pier Road is located between Pier Road and the Weighbridge in the Parish of St Helier, Jersey. The property is owned by Société Jersiaise and is managed by Jersey Heritage as part of the Jersey Museum. The property is Grade 1 listed.

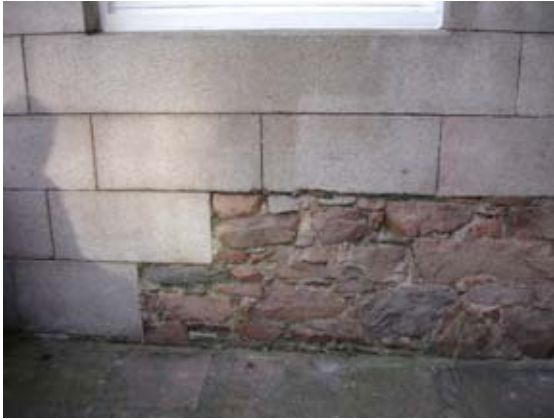
Figure 1.2 Base of north wall, possible remnants of an earlier structure

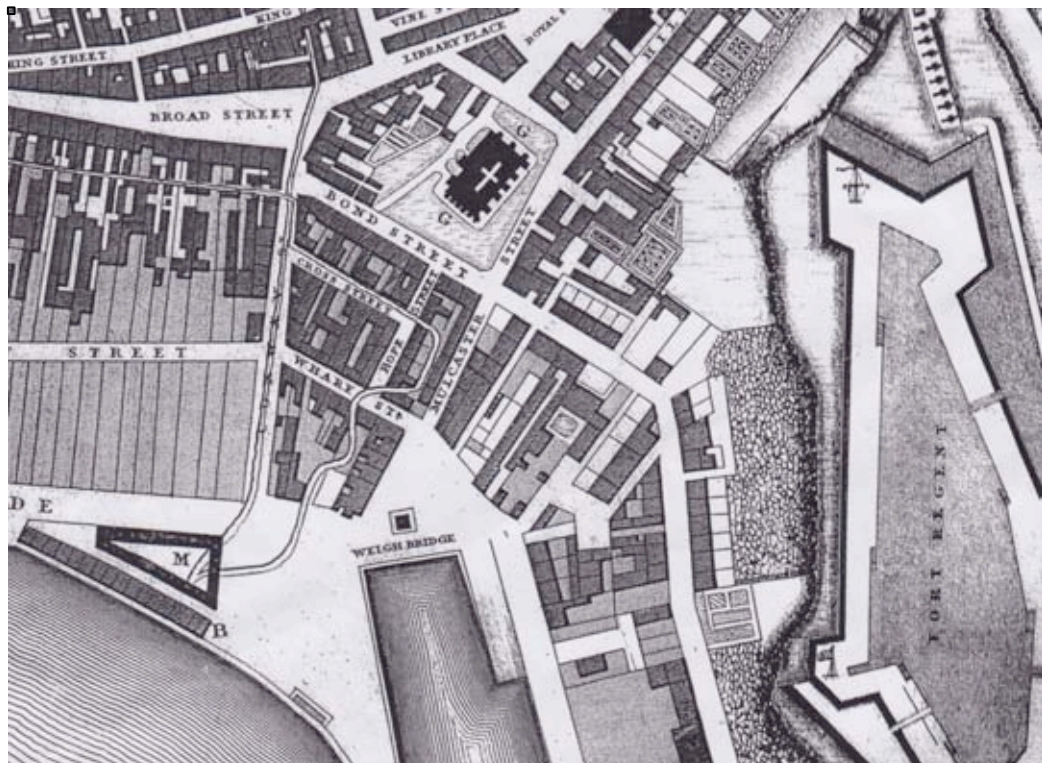
Figure 1.3 The property can be seen on the 1834 Le Gros map set back from Pier Road, with some form of formal garden also on the south side, and various outbuildings, sheds and stores on either side.

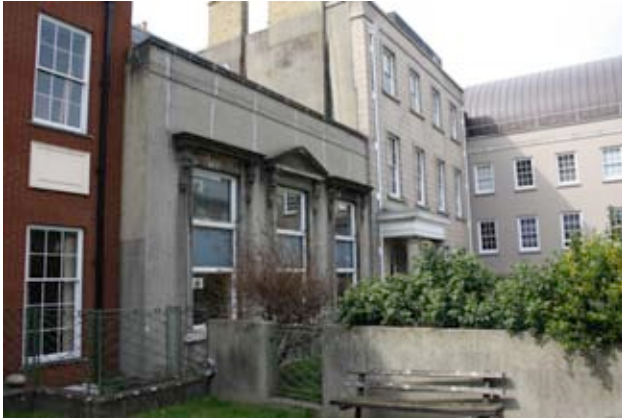
Figure 1.5 The Billiard Room was added c.1840, and is clearly not evident on the 1834 Le Gros Map.

It appears that a phase of work was undertaken at the house in c.1840, when notably the billiard room, and corresponding basement was added. It is unknown whether any other alterations were made to the property at this time. Several sources indicate that gas was installed in the house in the 1830s, soon after it arrived on the island.

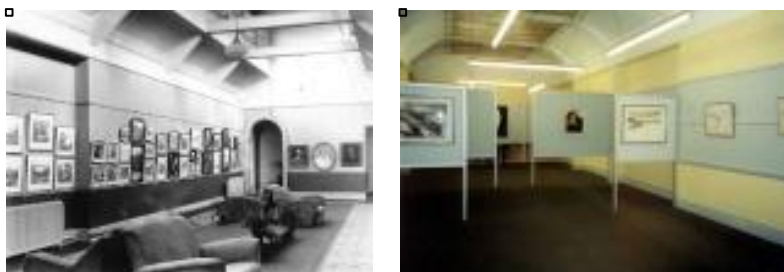
In 1925 a gallery was added to the building in memory of the Jersey artist Arthur Hamptonne Barreau, to house a collection of paintings by Channel Island artists. Designed by Percival Brown, a local architect, the long, narrow building was placed at right angles to the main building running parallel to the courtyard, with access through the historical room. The contractors were Baudet and Bouchard and the project was completed for a total cost of £1700 (Dickinson, 1973). This structure has since been replaced by the new Museum building, which was completed in 1989.

Figure 1.6 a The Barreau Art Gallery in 1940 (SJPA/010802) **b** and in 1988, shortly before it was demolished, photo by Geroge Drew (SJPA/011814)

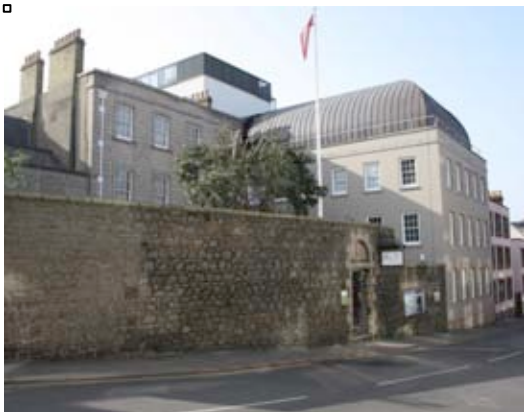
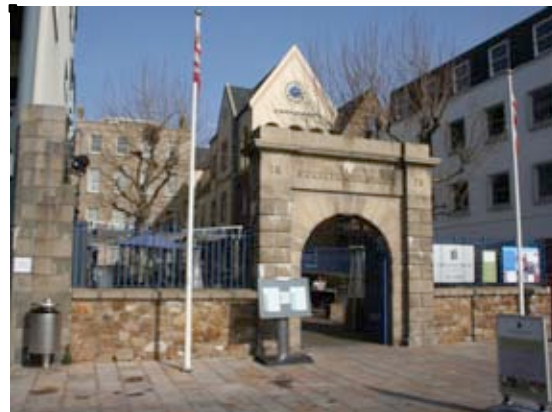
In 1988, the museum buildings to the east of the house were demolished and replaced with the new museum building that stands on the site today. At the same time No 9 Pier Road was re-interpreted as a merchant's house and the home of the Nicolle/Ginestet family.

Figure 1.7 a The new Societe building, **b** The new museum building

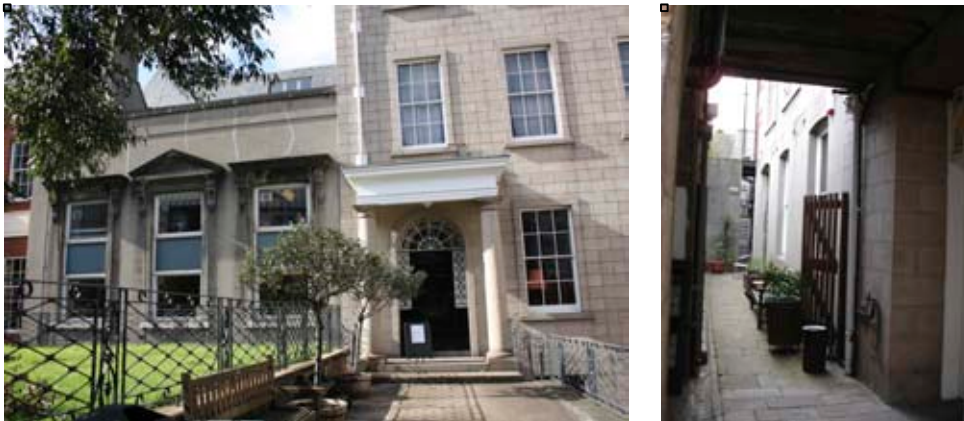
Figure 1.8 The front entrance with Billiard Room to the side, cellars below, the bays on the west side having been removed.

Both the north facing front elevation onto Pier Road and the south facing rear elevation onto Weighbridge Place are in uniformly sized cut and dressed stone. The windows on the north elevation are framed in stone. The hipped roof is set back behind a parapet delineated with a string course. Two brick chimneys are located on the east and west walls. A porch with granite Tuscan order columns and simple cornice frames the front door. The door is a good example of the period with a fanlight and side lights with decorative glazing patterns. The door is 6 panel, as is the lower ground floor door immediately below. This door has a rectangular overlight with a glazing bar pattern. The windows are 12 pane (6/6) sash windows, with internal shutters. The Billiard Room annexe to the east is stucco in ashlar effect with a string course similar to the house. The three full height windows are framed by console brackets, the centre one pedimented.

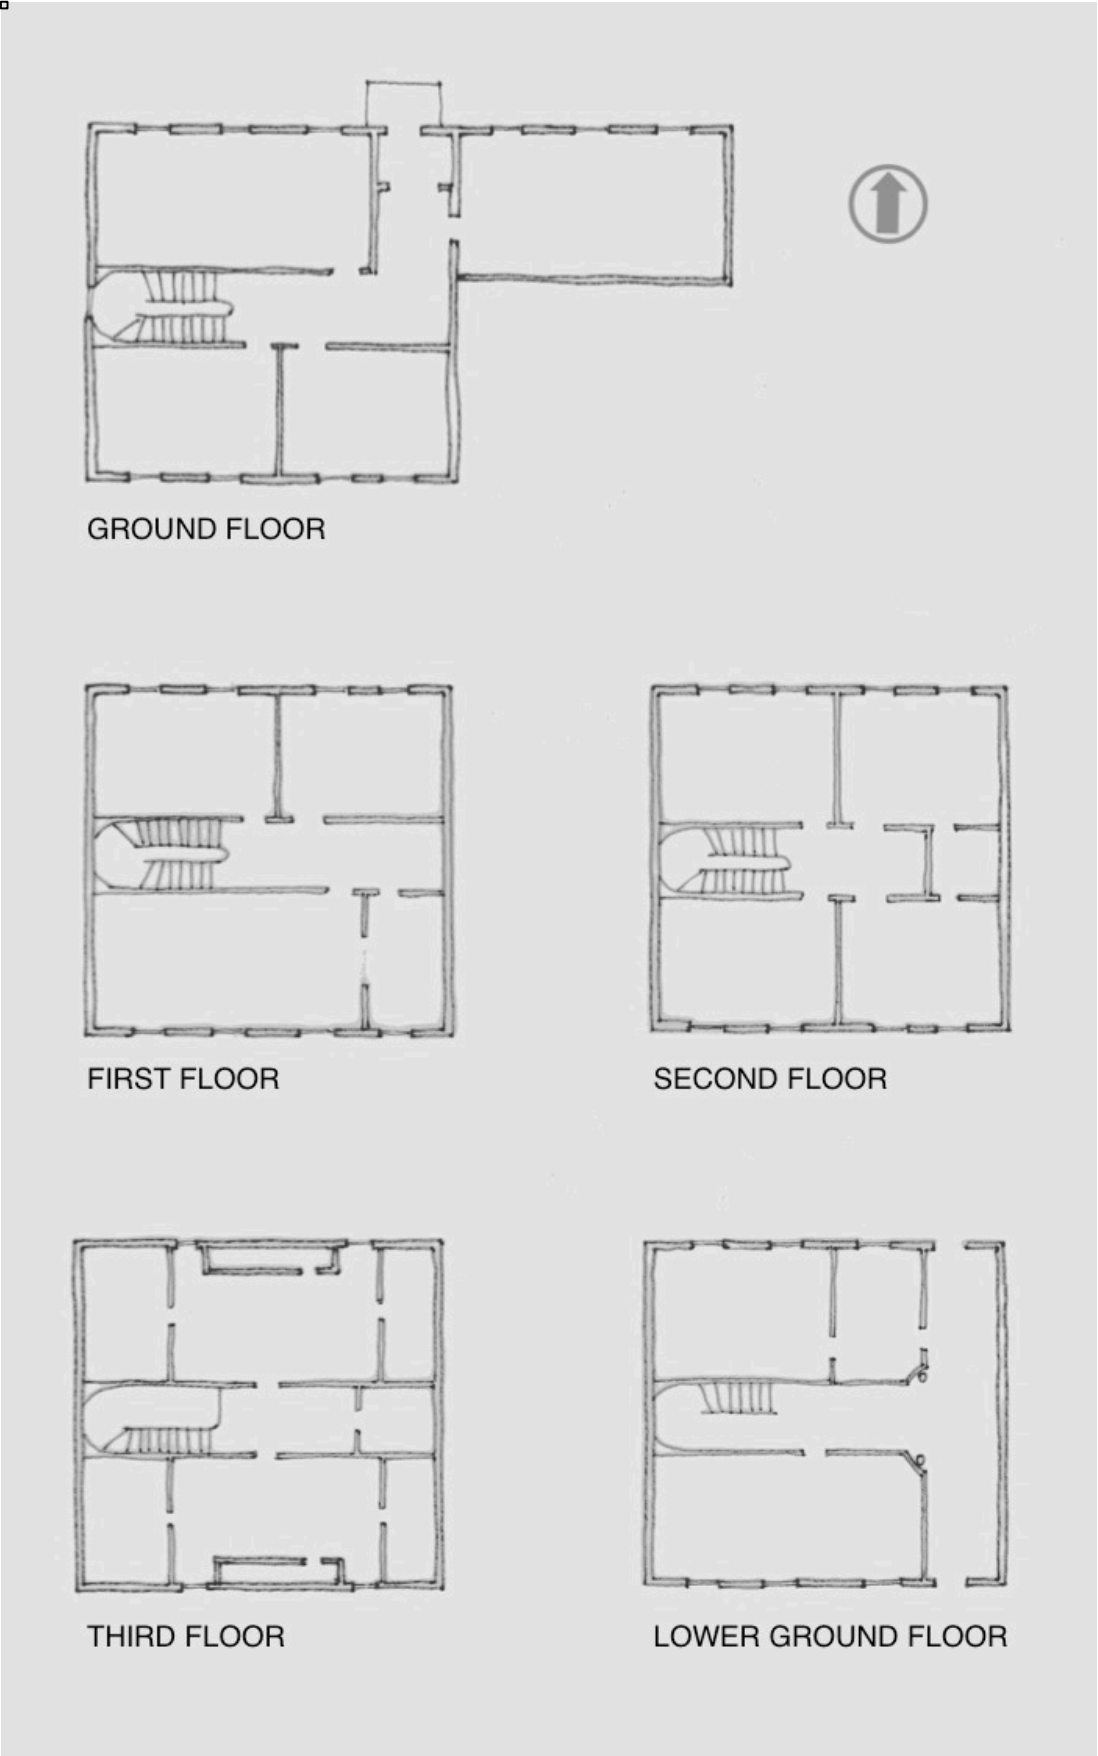
Figure 1.9 Sketch floor plan of No 9 Pier Road (not to scale)

Inside, a side passage runs front to back on the east side of the lower ground floor, connecting to the central staircase on the west side of the house through a set of marble columns halfway down. The first floor entrance is also to the side, the hall connecting through an arch to the east-west landing and staircase. On each floor an east/west landing with the staircase at its west end separates the rooms facing the north or south side. Although the house has the frontage of a terrace house, the interior layout has more similarities with a Palladian style layout around a central hall and staircase.

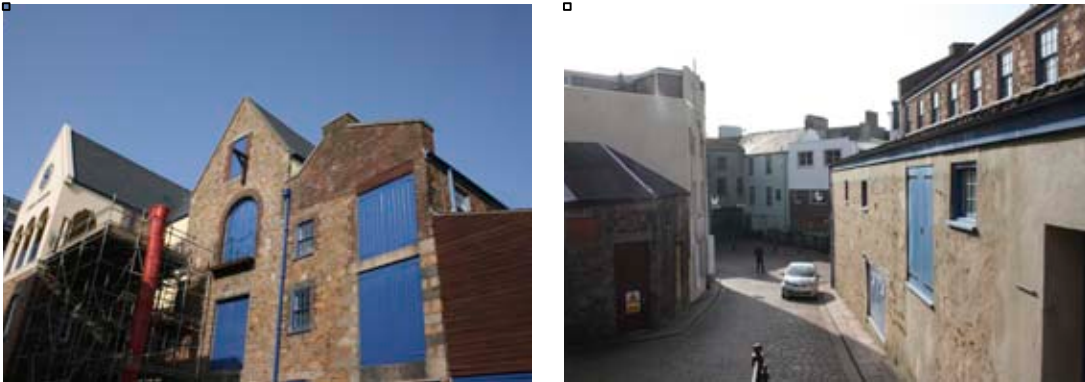
No 9 Pier Road also makes a significant townscape contribution with its frontage to Pier Road, a second frontage to Weighbridge Place and as part of a group with the various warehouses in Ordnance Yard, that it was once linked to.

Figure 1.10 The warehouses in Ordnance Yard are historically linked to No 9 Pier Road.

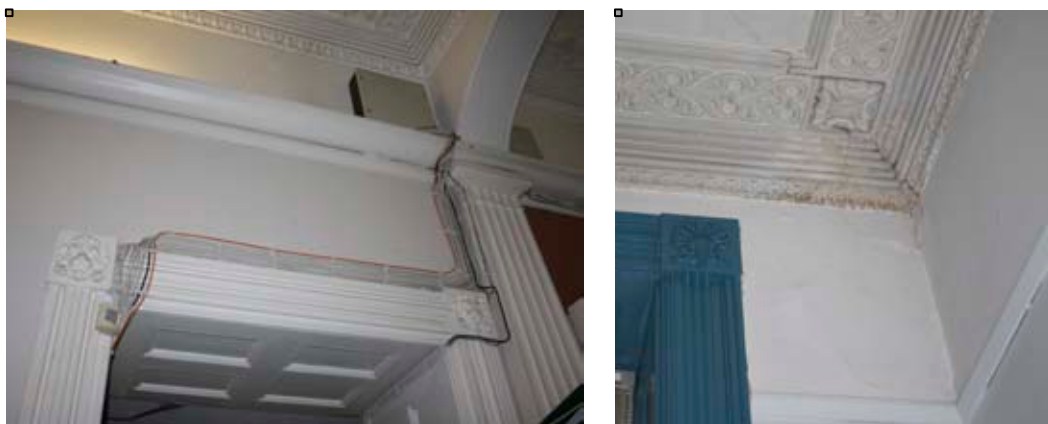
The external fabric of the building appears to be in very good condition. The only visible evidence of vulnerability is around the rooflight over the stairs. This is a later structure, and is causing some water ingress and damp.

Extensive telephone and computer wiring and cabling throughout the building has caused damage to door architraves, frames and skirting boards.

Figure 2.1 a. Cabling around doorframes in ground floor hall is both physically and visually damaging to the historic fabric **b** Isolated occurrences of damp should be carefully monitored.

CP5.4 Where modern materials have been used previously and are seen to be harming the fabric or integrity of the historic building, and where removal will not cause further damage, then these should where possible be removed and new repairs using traditional materials and techniques implemented.

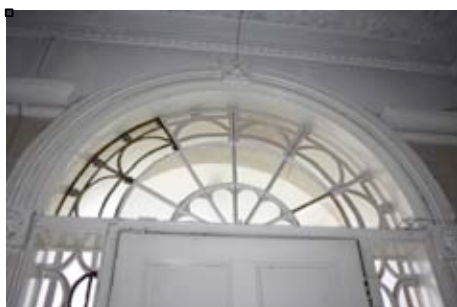
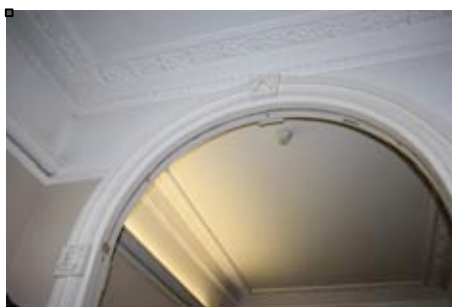
Room no, location	Ground floor, staircase landing
Current use	Circulation
Previous uses	Staircase landing, hallway

Floor	Timber boarding
Ceiling	Plaster. Moulded cornice, with running floral motif, reeding, egg and dart and bead and reel detail.
Walls	Plaster. Moulded skirting boards.
Windows	None, except on staircase: 2 pane (1/1) sash window with margins, currently glazed with frosted glass.
Doors	3 doors into the major rooms: Moulded architraves with lion head paterae. Panelled reveals, reeded. 6 panel mahogany doors, reeded. New door into museum.
Fireplace	
Other built in furniture	Elliptical arch forming division between landing and entrance hall.

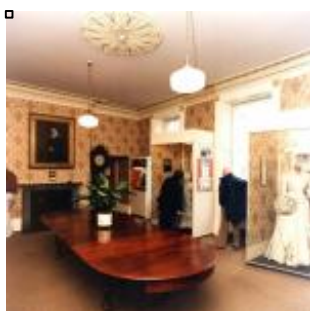
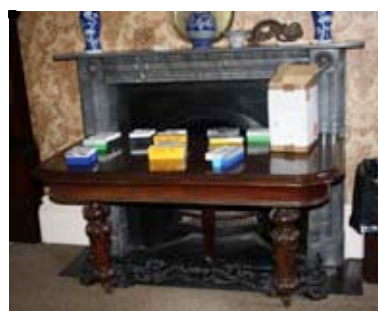
SJPA/010925 (Robin Briault, 1991)/ April 2012

Room no, location	Ground floor, southeast room
Current use	Office
Previous uses	Museum display (Historical room)

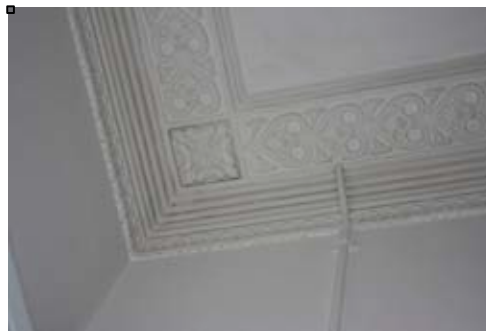
Room no, location	Ground floor, southwest room
Current use	Office
Previous uses	Museum display

Floor	Carpeted
Ceiling	Plaster. Moulded cornice, with Vitruvian scroll, Tudor flowers in the corners, bead, egg and dart, bead and reel.
Walls	Plastered. Moulded skirting boards. Picture rail.
Windows	2 windows: Moulded architraves with Tudor flower paterae. Panelled reveals with internal shutters.
Doors	Door to hall: Moulded architrave with Tudor flower paterae. 6 panel mahogany door, reeded. Modern door closer. Blocked in archway to adjoining room. Moulded frame with Tudor flower paterae at spring of arch.
Fireplace	Black marble fire surround with roundels in the corners, black marble ledge. Cast iron hobgrate with lions foot motifs on either side.
Other built in furniture	Arched niches to either side of chimney breast.

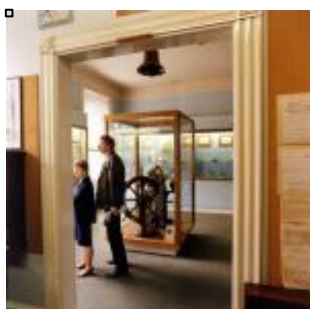
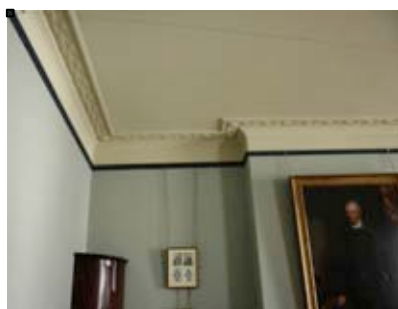
Viewed from adjoining room, SPJA/010939, photo by Robin Briault, 1991/ April 2012

Room no, location	First floor, northeast room
Current use	Museum display (bedroom)
Previous uses	Museum display (Chemist shop)

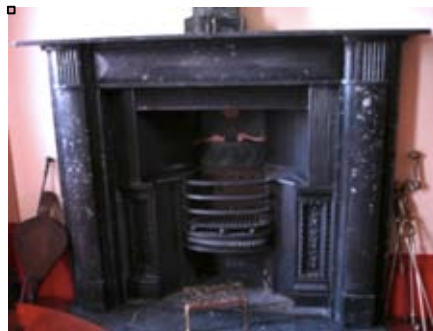
Room no, location	First floor, southwest room
Current use	Museum display (Drawing Room)
Previous uses	Museum display

Floor	Timber boards
Ceiling	Plaster. Moulded cornice, with Vitruvian scroll, Tudor flower paterae bead, egg and dart, bead and reel.
Walls	Plastered. Moulded skirting boards. Picture rail.
Windows	3 windows: Moulded architraves with Tudor flower paterae. Panelled reveals with internal shutters.
Doors	Double doors to southeast room: Reeded architrave with Tudor flower paterae. 6 panel mahogany doors, reeded. Door to hall: Reeded architrave with Tudor flower paterae. 6 panel mahogany door, reeded. Modern door closer.
Fireplace	Replica fireplace
Other built in furniture
