UNITY® – CHECK OF THE VACUUM SYSTEM

UNITY® – TROUBLESHOOTING

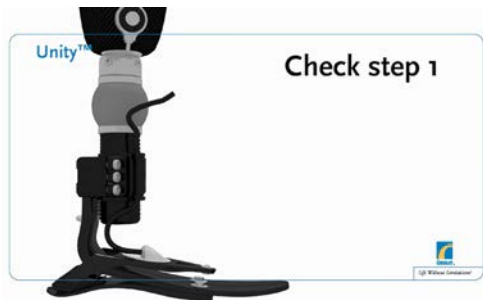
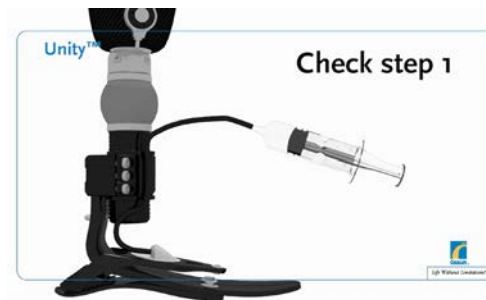
Connect a half-air-filled syringe to pump. Cycle pump housing to empty the syringe.

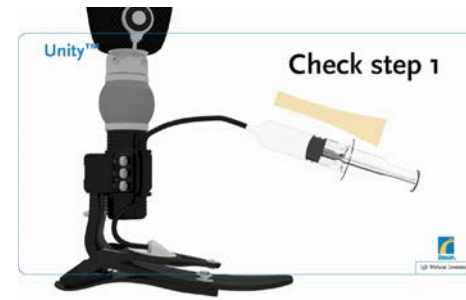
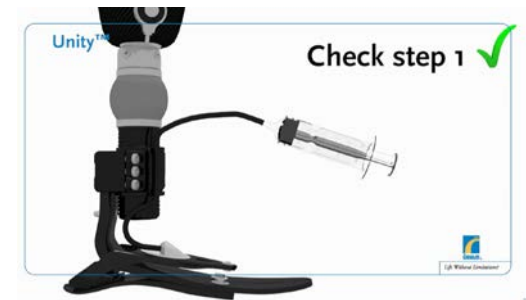
With an empty syringe, pull and hold for a few seconds. If syringe piston returns to original position, there is no back-leak in pump.

In case either of these tests fail: tear down, clean and rebuild pump. Clean water, mild soap and isopropyl alcohol are safe to use. Repeat test after rebuild.

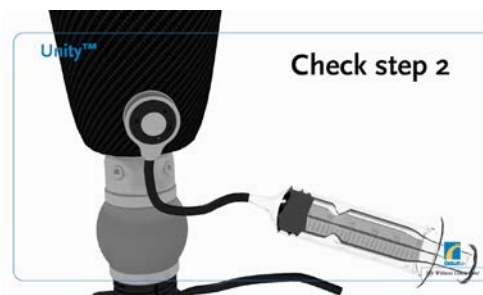
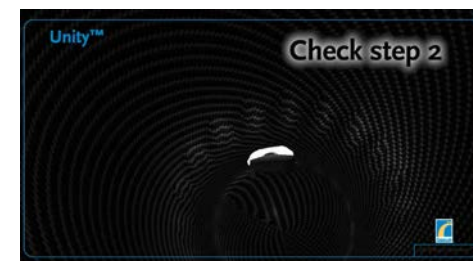
With inside of socket blocked with a piece of tape, pull and hold for a few seconds.

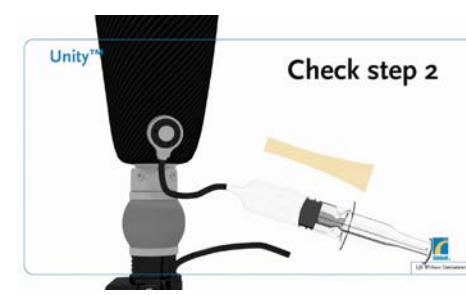
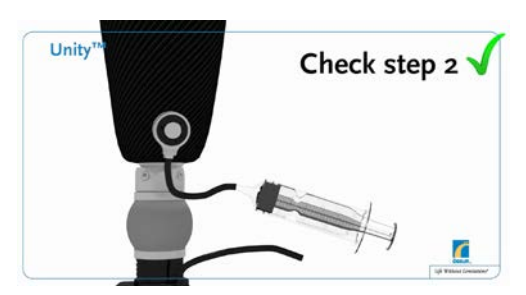
If syringe piston returns to original position, there is no leak in the valve. If not, clean valve and repeat.

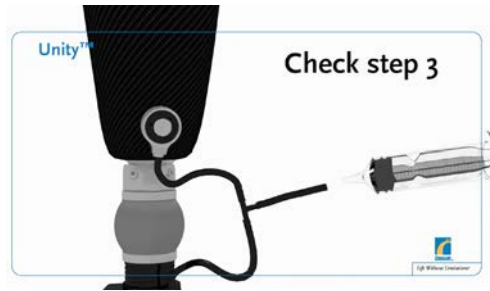
Using a T connector and with the user wearing the socket, cycle syringe a few times then hold for a few seconds.

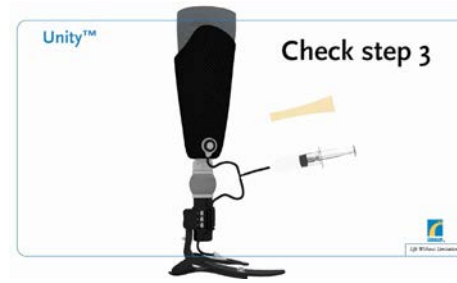
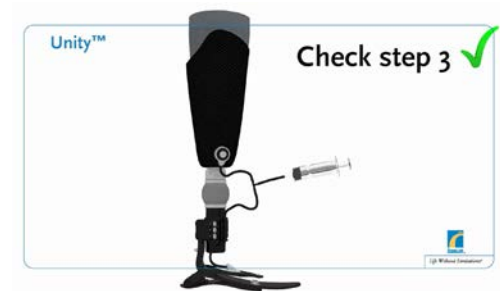
If the piston returns to original position there is no leak.
If not, check seal, socket and valve sealing to socket.
