ATTACHMENT "5"
LEASE AND DEVELOPMENT OF VACANT LAND
PALM BEACH INTERNATIONAL AIRPORT
(RFP #LN 17-7)

Phase I Environmental Site Assessment
Northern 19.110-Acre Parcel
Palm Beach County Park Airport
Lantana, Florida

December 17, 2006

**ENTEL Environmental Companies, Inc.
270 Las Palmas Street
Royal Palm Beach, Florida 33411-1323**

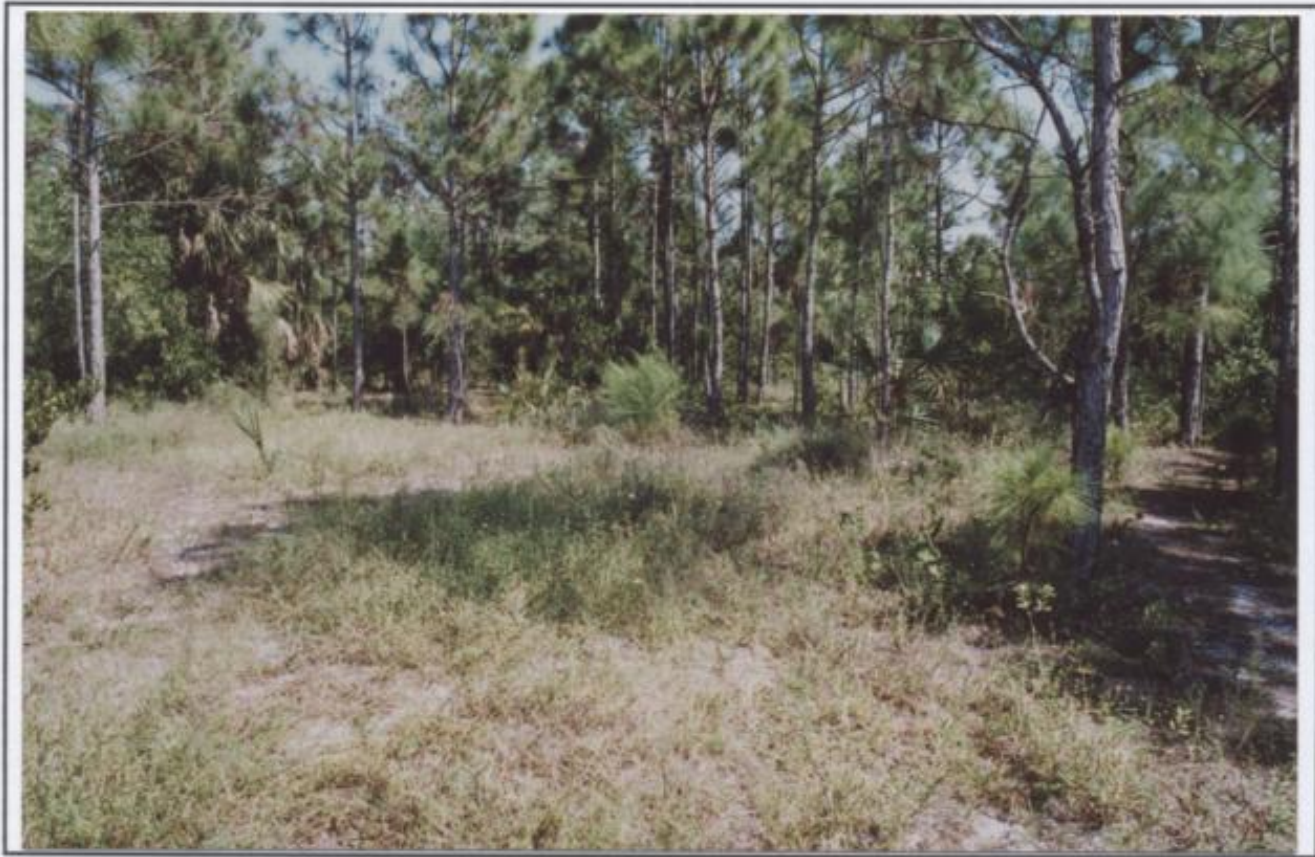
East View – Typical Piney Flatwoods in West Central Portion

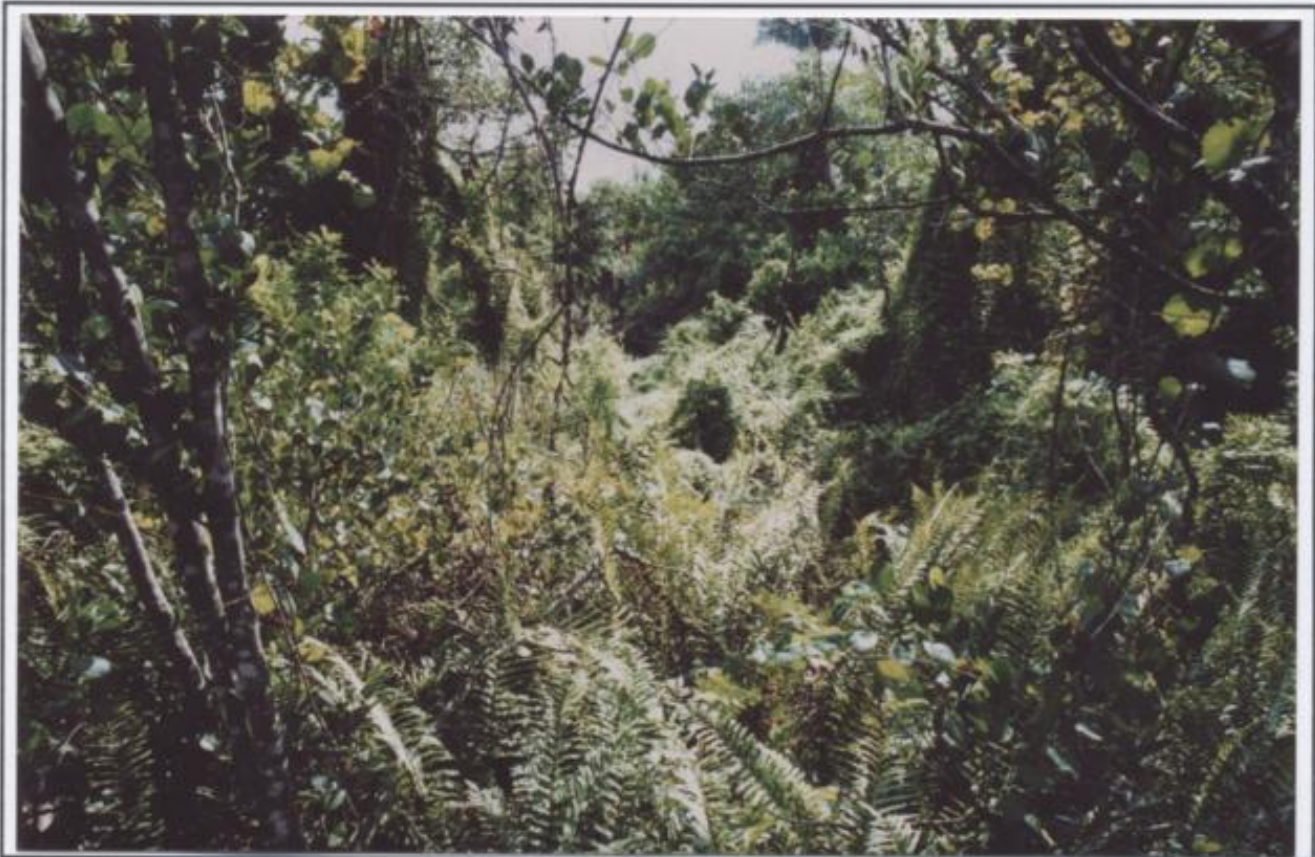
East View – Heavily Vegetated Eastern Portion of the Subject Property

The eastern part of the subject property was accessed by way of John Prince Park. Numerous castor beans (*Ricinus communis*) were observed. Castor beans typically grow in areas where the soil has been disturbed. This is also the suspected location of the former Lantana Trash Dump #2. This facility was opened in 1966 and closed in 1975 and is described as a trench and fill operation. The type and quantity of the materials deposited here are unknown, based upon SWA records. The Palm Beach County Solid Waste Authority identifies this site as a Class 520 facility (520 = old dump).

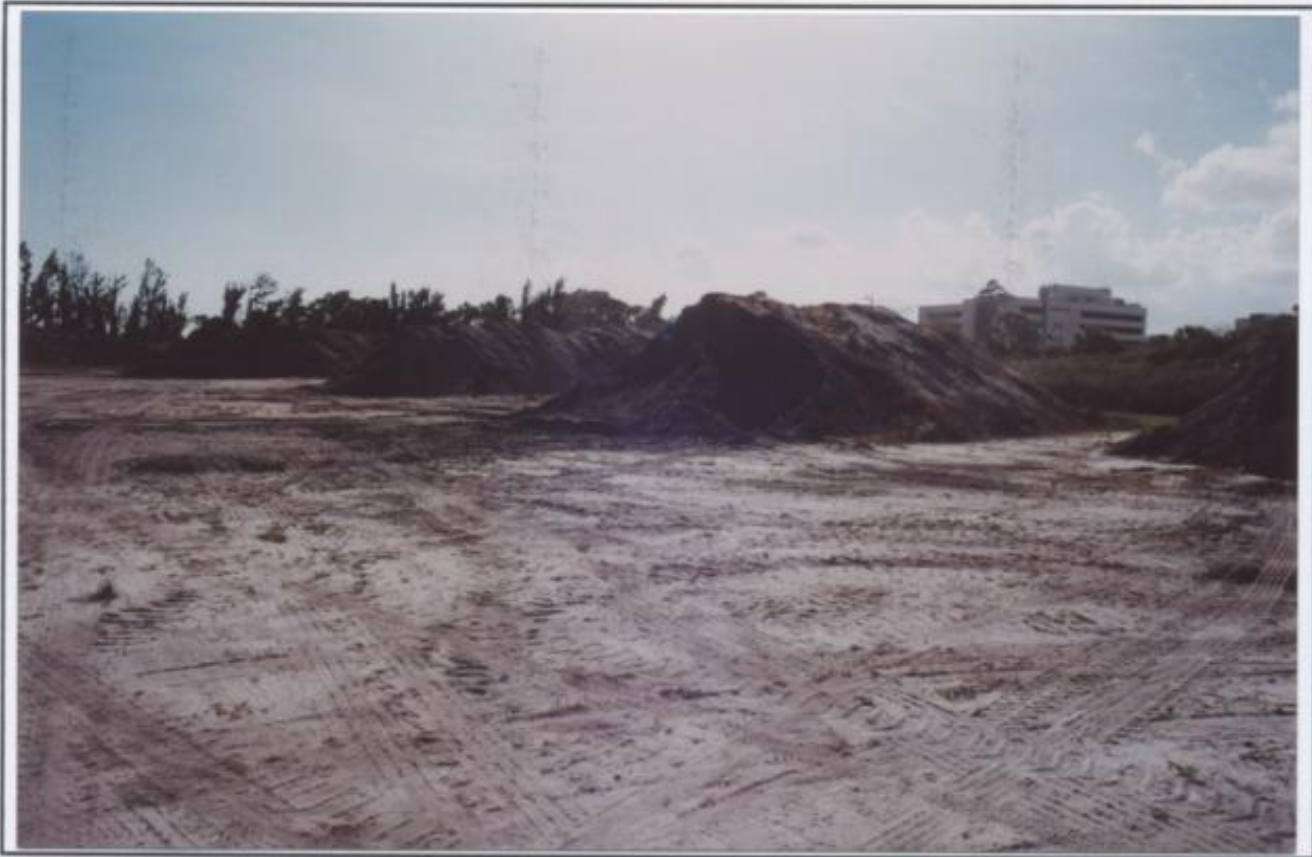
South View – Palm Beach County John Prince Park Maintenance Stockpile Area

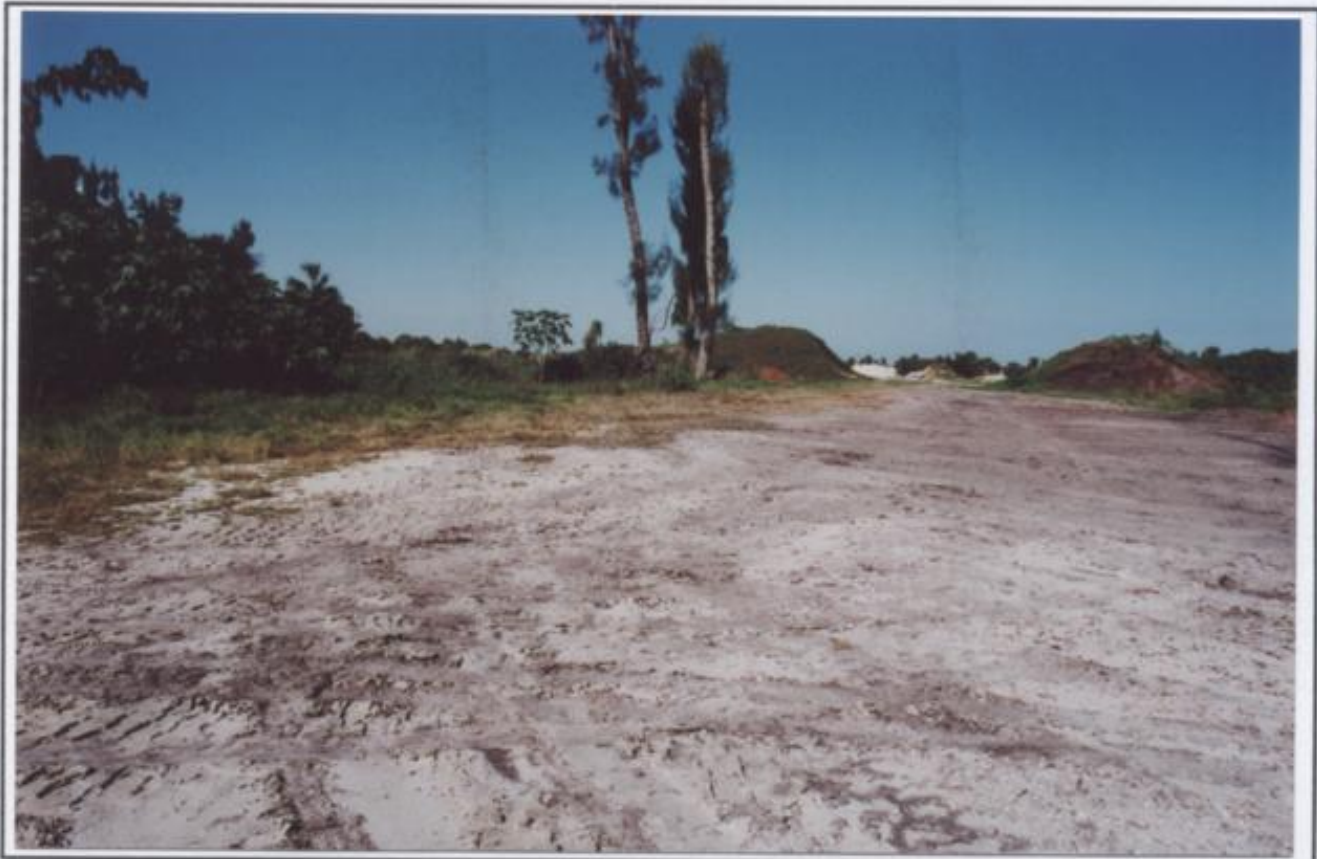
North View – Palm Beach County John Prince Park Maintenance Stockpile Area

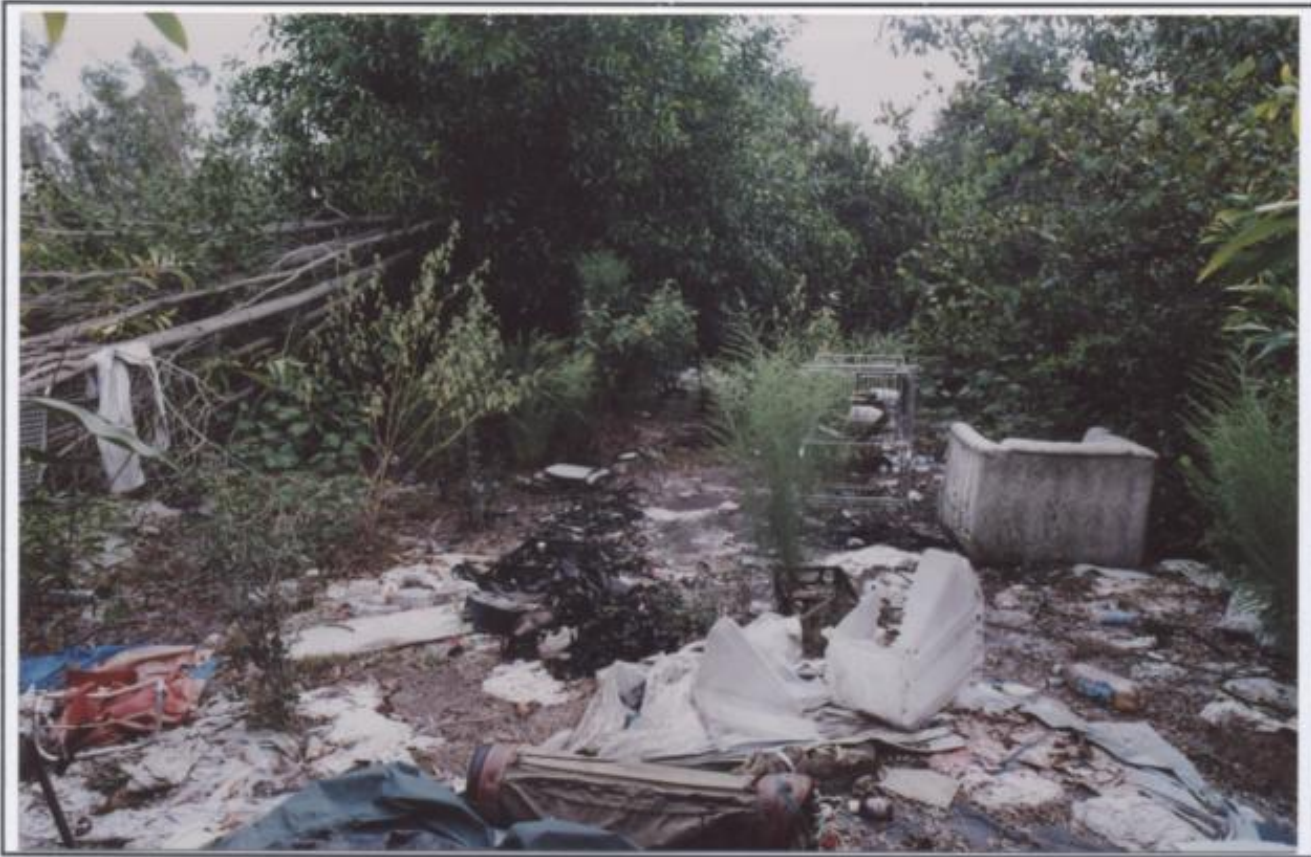
South View – Open Air Campsite in Central Part of Site

Numerous campsites were found in throughout the subject property. These campsites vary from open exposed sleeping and eating areas to more sophisticated tent encampments. One such location was guarded by two dogs. According to personnel at JFK Hospital, approximately 12 to 15 people residing on the subject property have requested shelter during the recent hurricanes. The total population living in these woods is unknown. Numerous debris piles consisting of household-like trash were observed in areas that were easily accessible from Congress Ave. The majority of the debris piles were associated with the campsites. One exception is the debris pile in the west central portion of the site which is accessible by automobile. This area had numerous bags of trash. Debris piles in the interior of the subject property consisted of beer cans, household waste, bicycle parts and fast food wrappers.

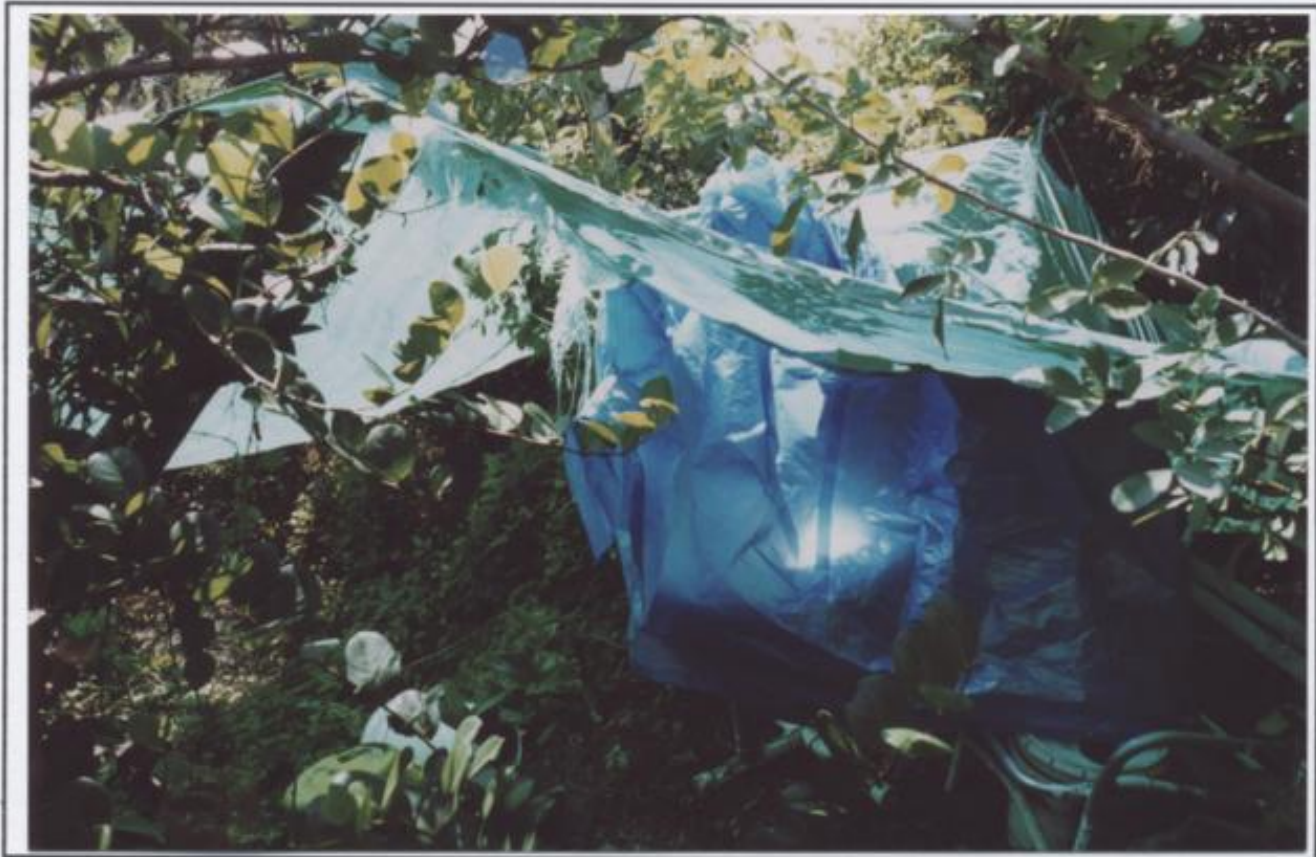
South View – Tarp Covered Campsite along Eastern Property Boundary

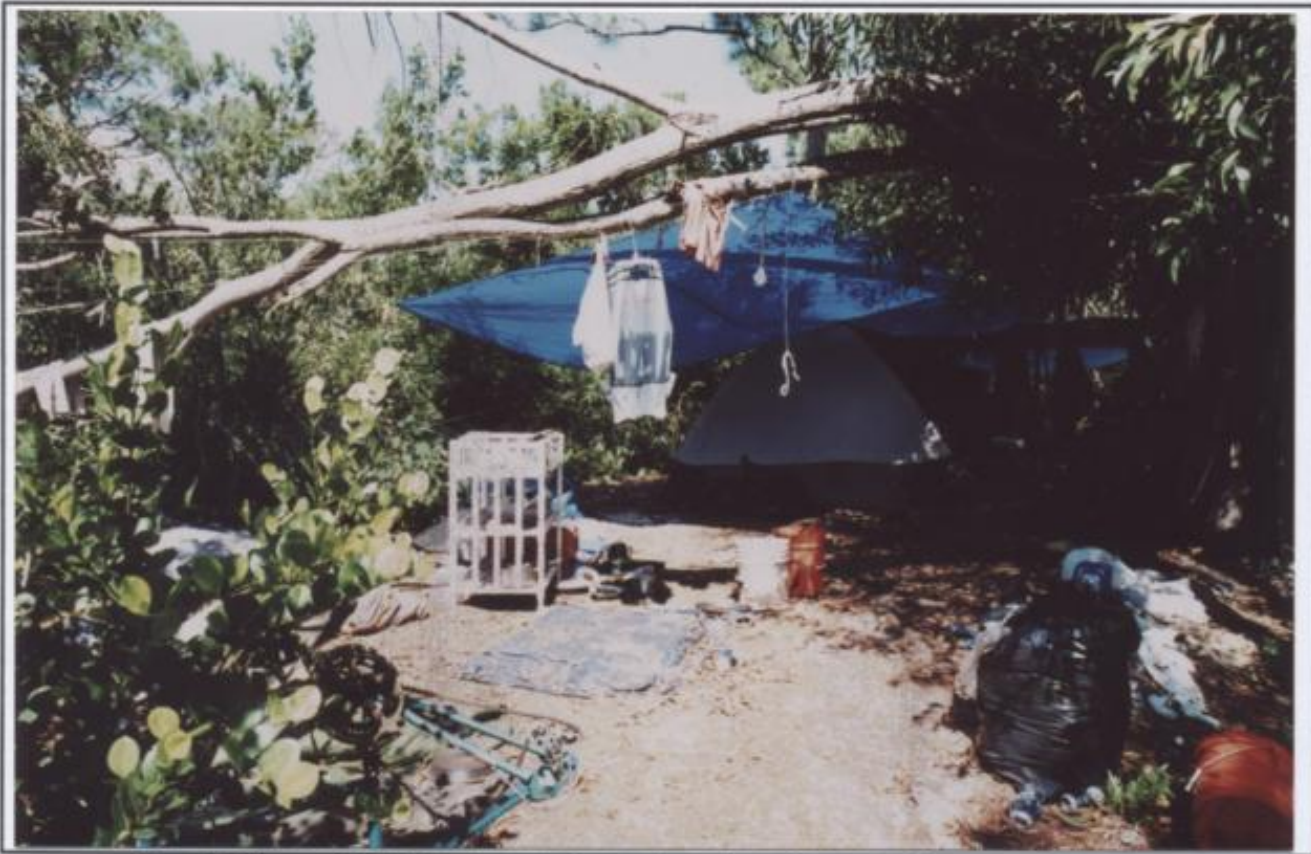
North View – Well Equipped Campsite along Eastern Property Boundary
NOTE: Area guarded by two tied up dogs

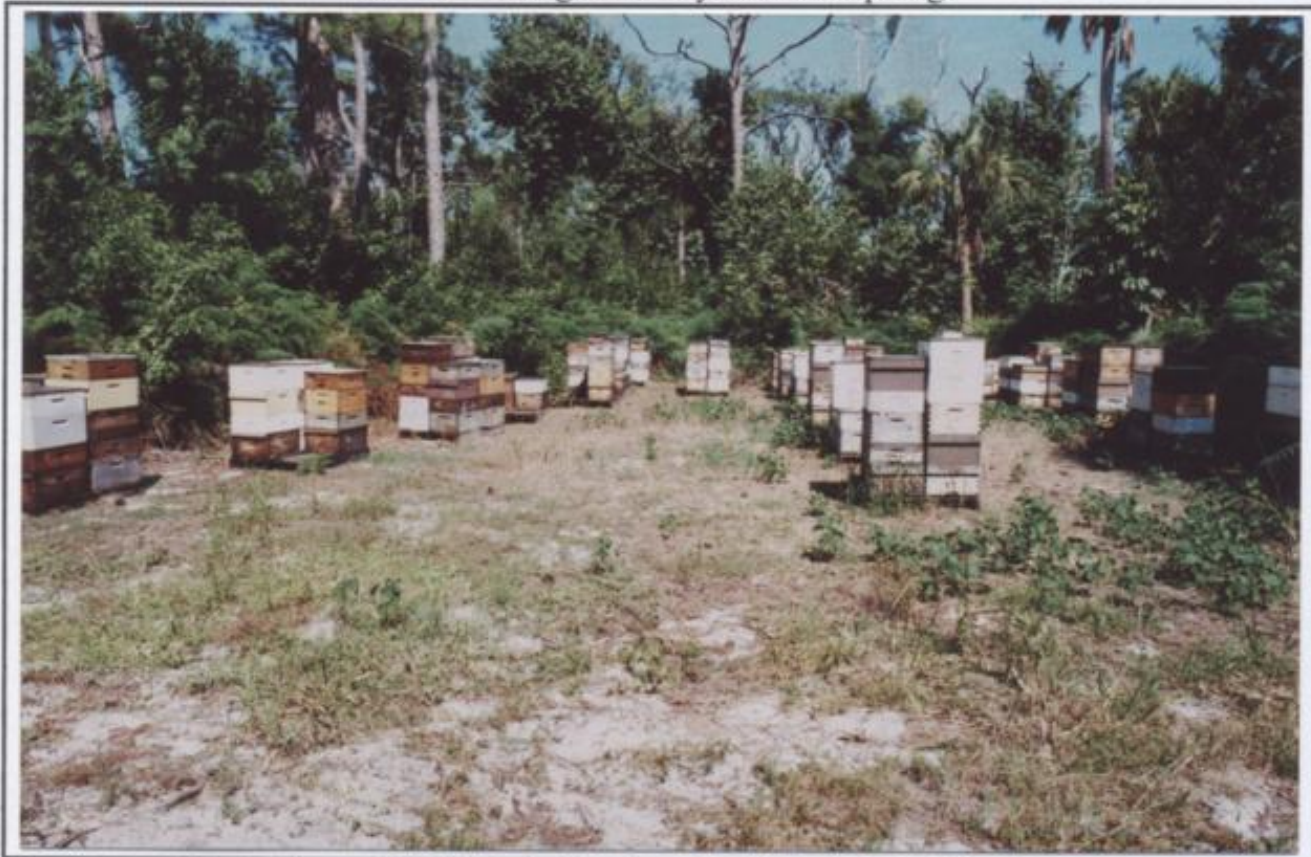
North View – Beehives in Northern Portion of the Subject Property

A large bee keeping operation was observed in the northern part of the subject property. Approximately 150 commercial-type bee hives were seen. The owner/operator of these hives is unknown. The bees have swarmed to other locations on the property and have made nests. Information regarding the safety hazards of the subject property was verbally communicated to DOA staff.

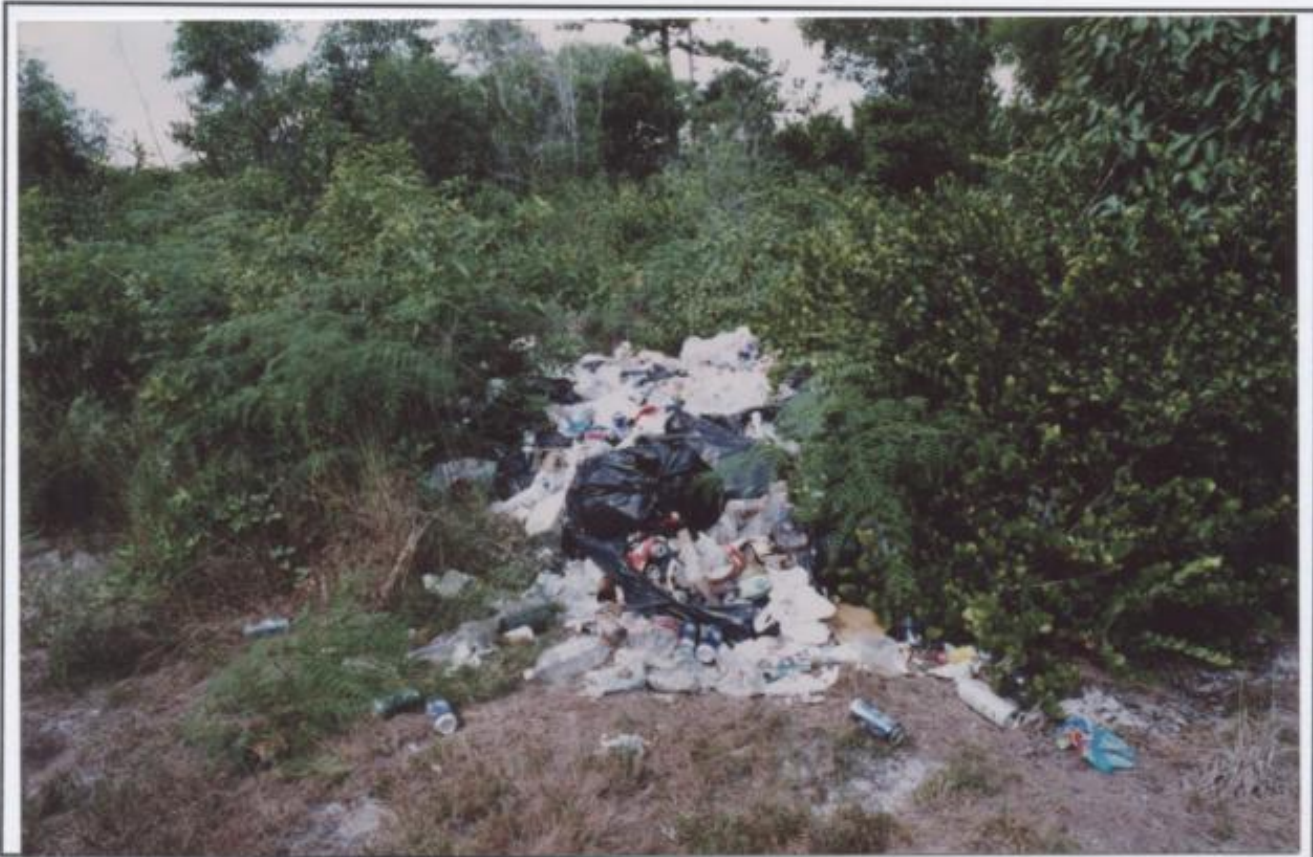
West View – Typical Trash and Debris in Central Portion of the Subject Property
NOTE: Most appears to be household-like waste material

4. Household-like debris piles were observed in numerous areas. Many piles are predominately beer cans while others were a dense mix of decaying household waste. No obvious sign of hazardous waste was observed.

1. Determine the composition of the southern elevated, irregular areas.
2. Remove and properly dispose of the identified debris.
3. Determine if gopher tortoises are present and how their presence will impact site development.
4. Further determination may be necessary to locate the actual boundaries of the Lantana Trash Dump #2 prior to development.
5. A limited soil and groundwater investigation of the airplane crash site may be warranted.

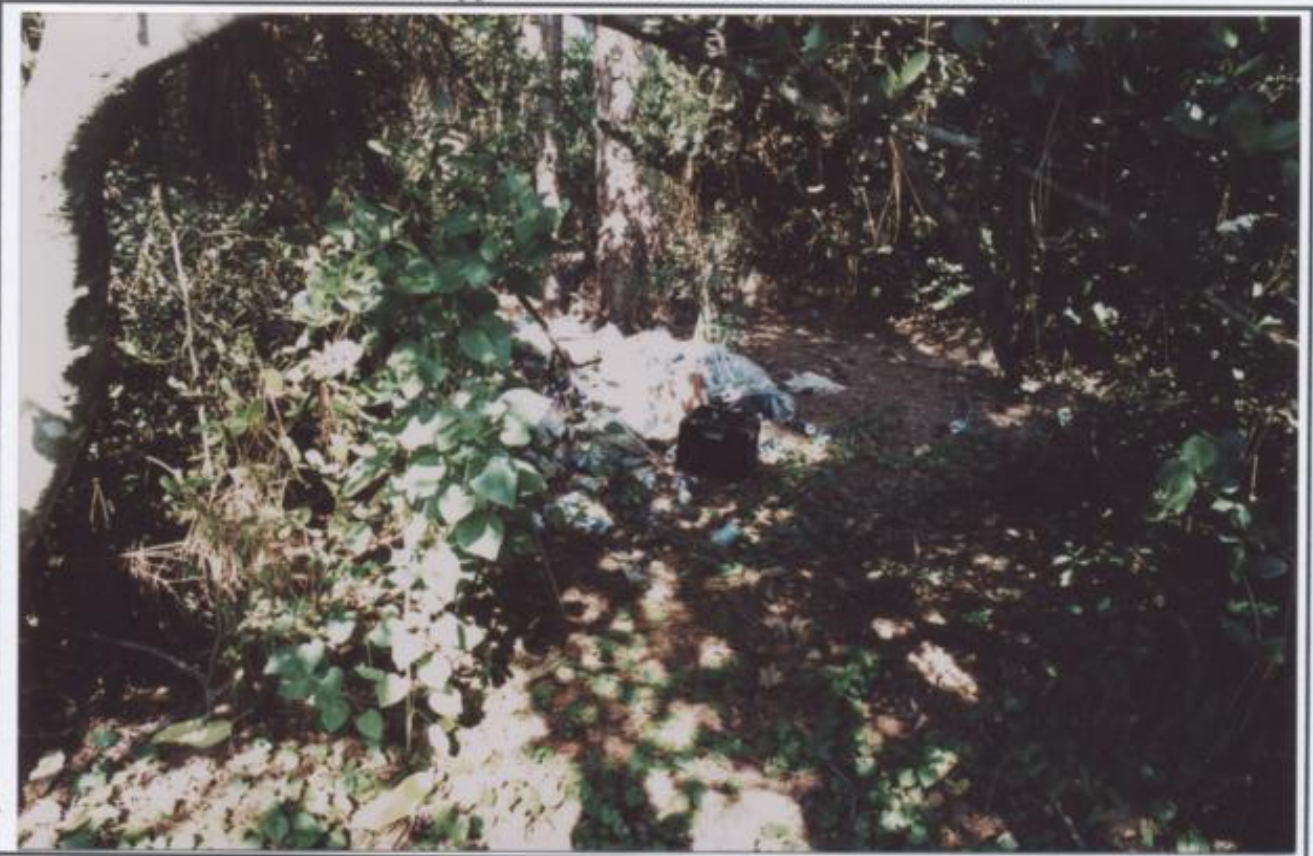
North View – Typical Trash and Debris in Northern Portion of the Subject Property
NOTE: Most appears to be household-like waste material
