**Fire performance of
innovative hanger
system**

Prepared for: Gripple Limited

Client report number 132129

BRE Global has undertaken nine fire tests to investigate the performance of an innovative hanger system used to support mechanical and electrical installations, services etc. Three different systems have been tested under load and exposed to a heating curve corresponding to 30, 60 or 90 minutes standard fire exposure^{1,2}. This report contains all relevant test results and observations.

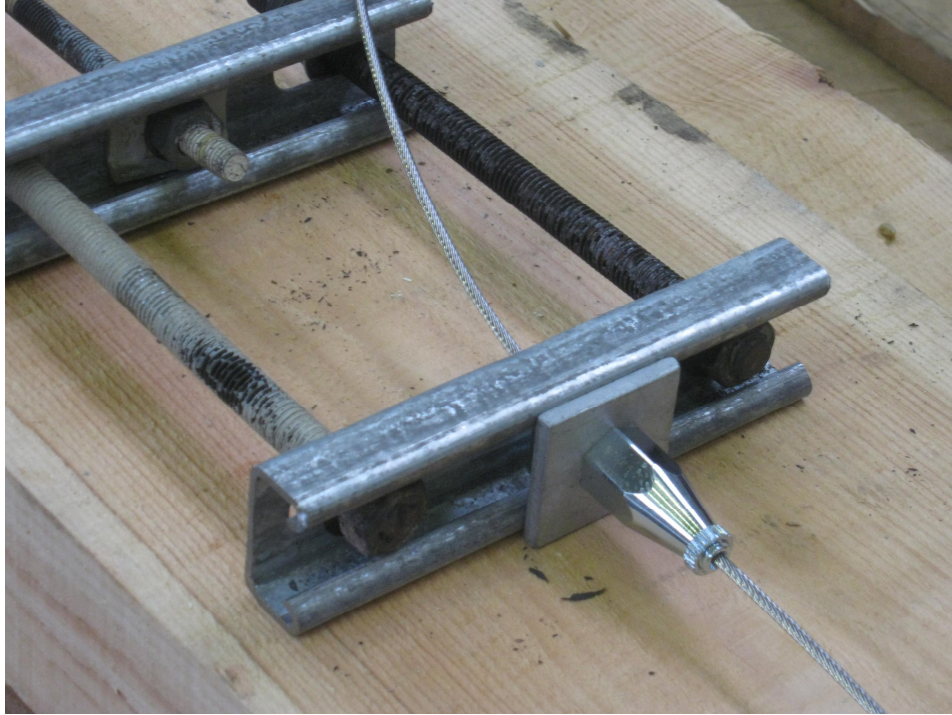
Figure 1 “Gripple” fixing attached to channel

In each case the load was applied by hanging a weight to a length of channel fixed to the cable by means of a “Gripple” fixing (Figure 1). The fixing to the other end was attached to a threaded bar suspended above the furnace and varied for each test in accordance with the description in the table above. The fixings are illustrated in Figures 2-4. In each case the cable was a stainless steel wire rope of 3mm diameter. In each case both fixings were entirely contained within the furnace.

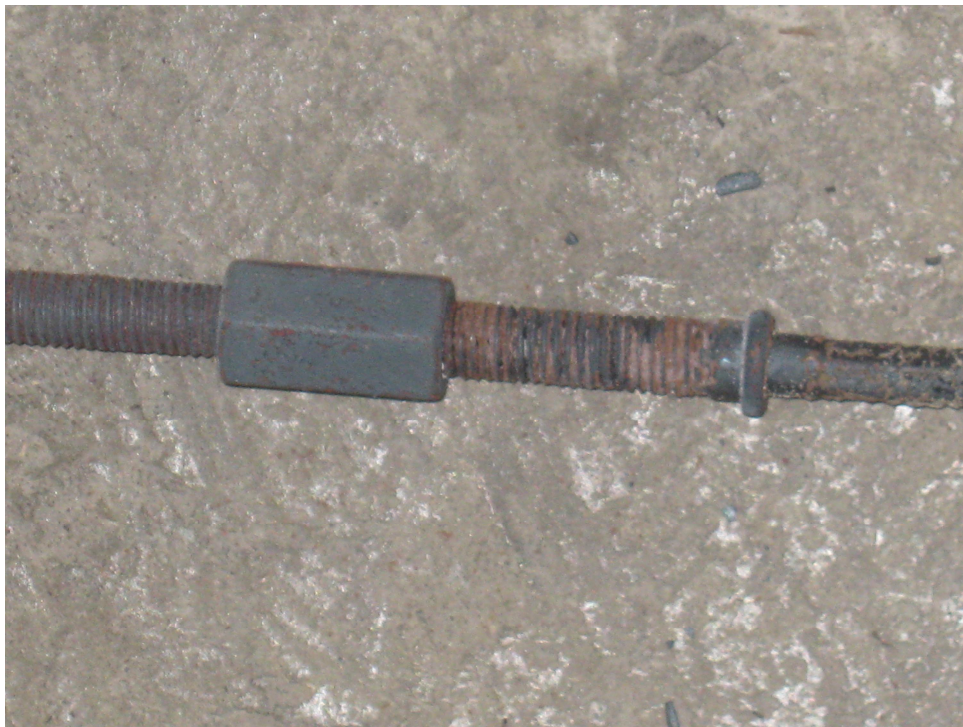
Figure 2 M8 stud end fixing connected to M8 stud

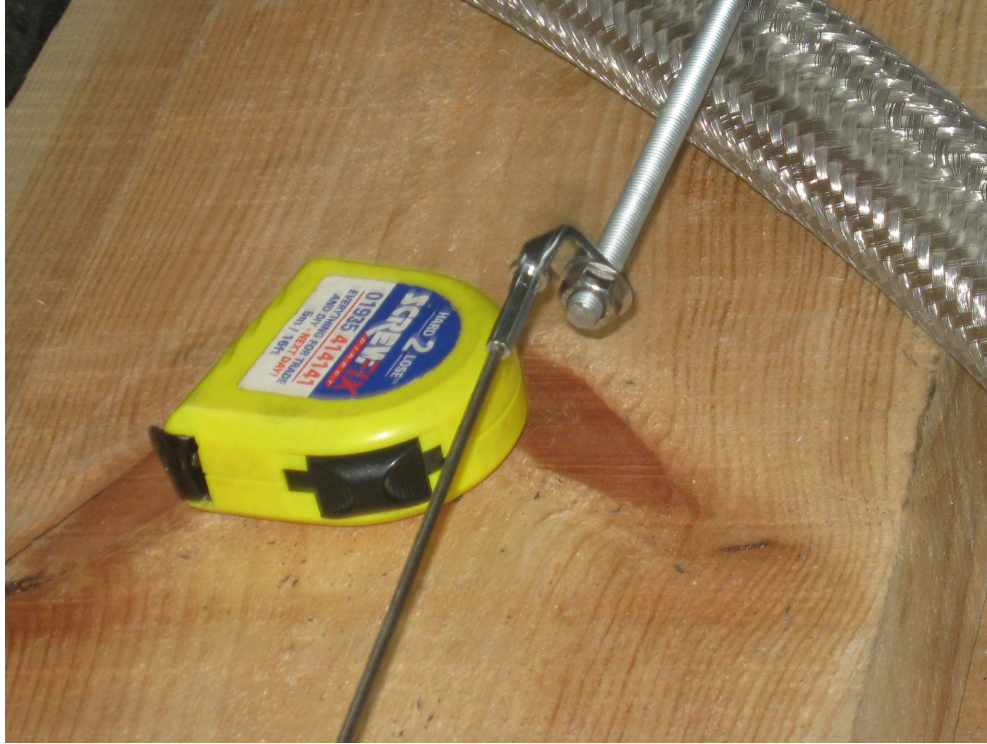
Figure 3 90° eyelet end fixing connected to M8 stud

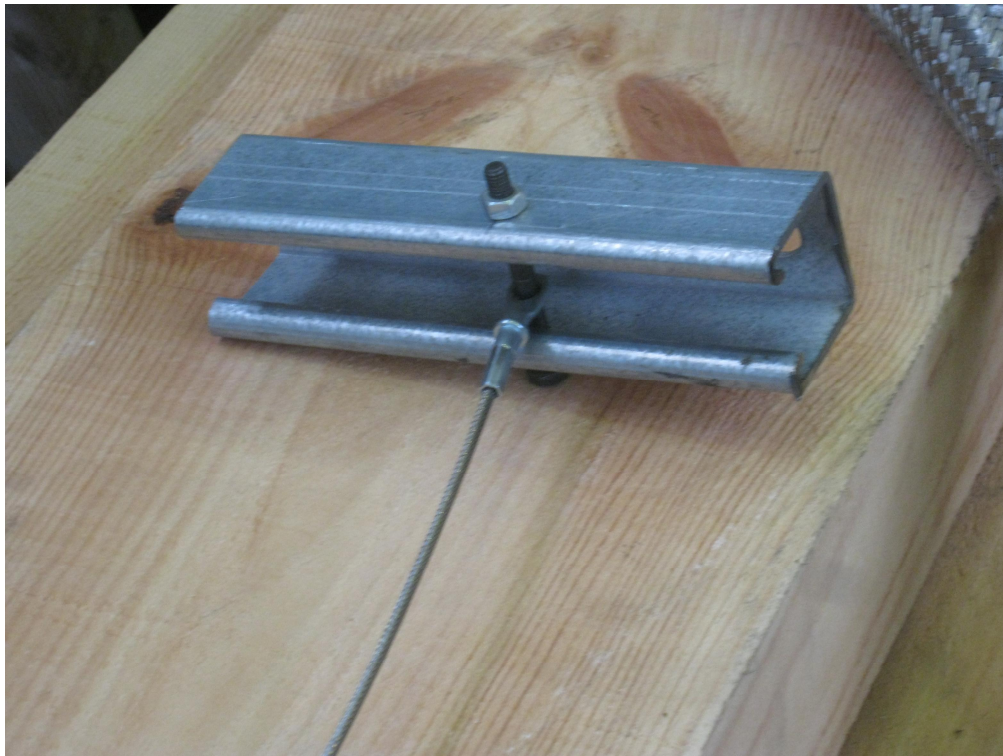
Figure 4 Straight eyelet end fixing connected to channel

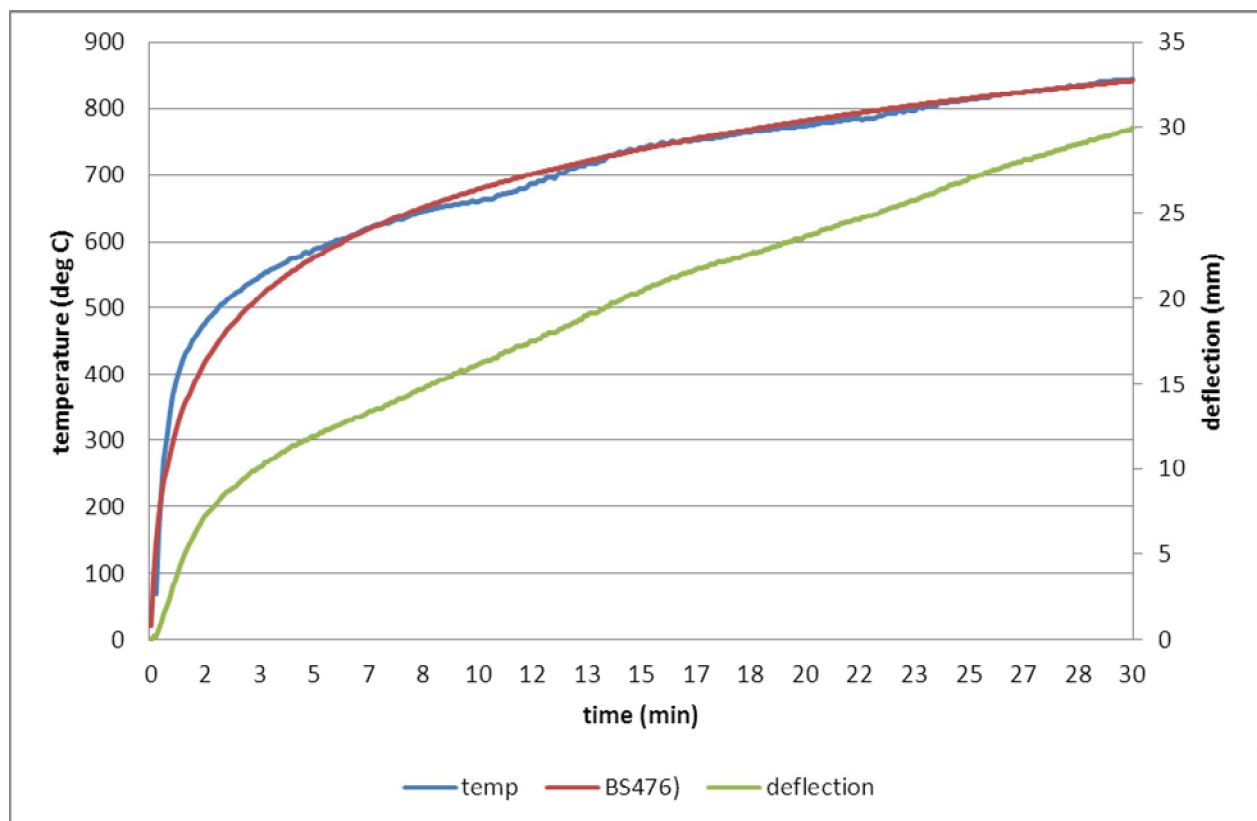
The results from the first fire test are shown in Figure 5 below. The measured temperature within the furnace is shown alongside the standard (BS476) fire curve. The results indicate a good agreement between the measured temperature and the standard curve. The maximum deflection was approximately 30mm after 30 minutes. The system continued to support the applied load for the test period. The sample is shown on removal from the furnace in Figure 6. The sample comprised both the Gripple unit and M8 stud end fixing and approximately 750mm of the wire rope. At the end of the test the sample appeared to be supported on the bottom of the furnace (Figure 7). However for the 30 minute test period the sample continued to deflect so it is likely that the sample was supported on the bottom of the furnace after the test was completed.

Figure 5 Results from Group 1 test 1

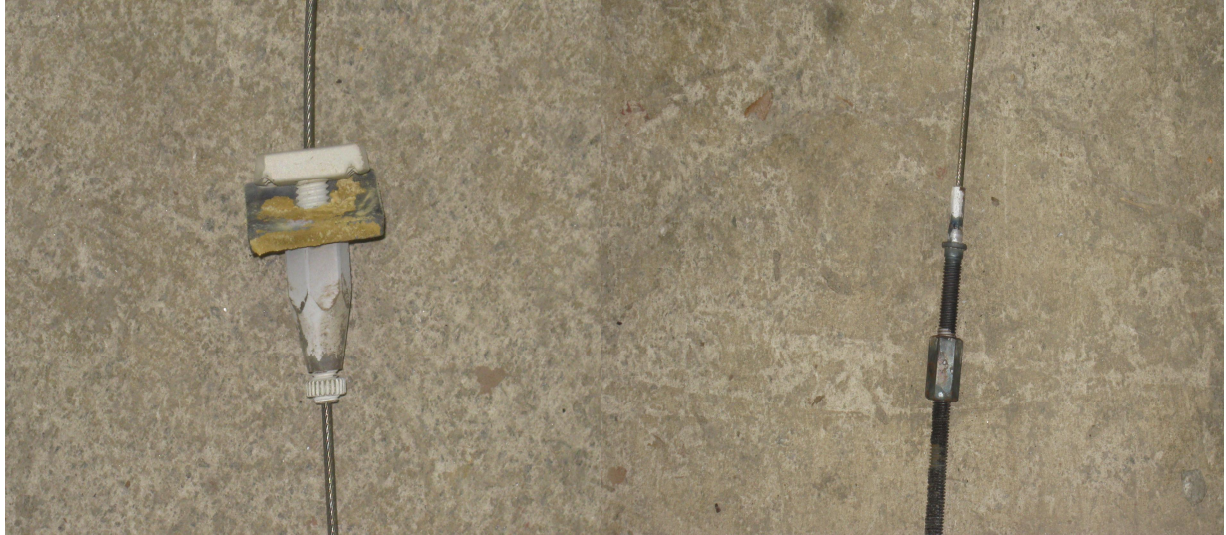
Figure 6 Fixings on removal from the furnace

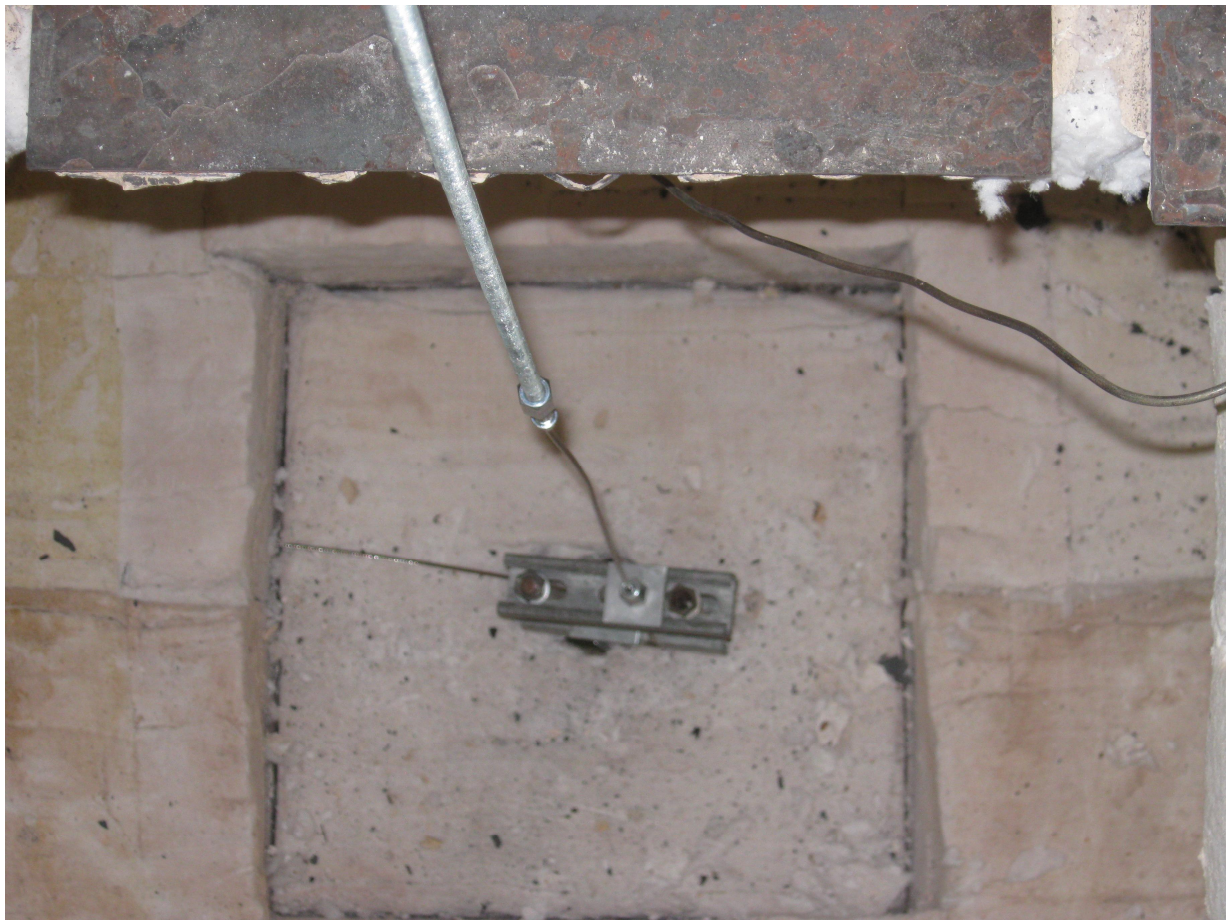
Figure 7 Sample supported on bottom of the furnace at the end of the test

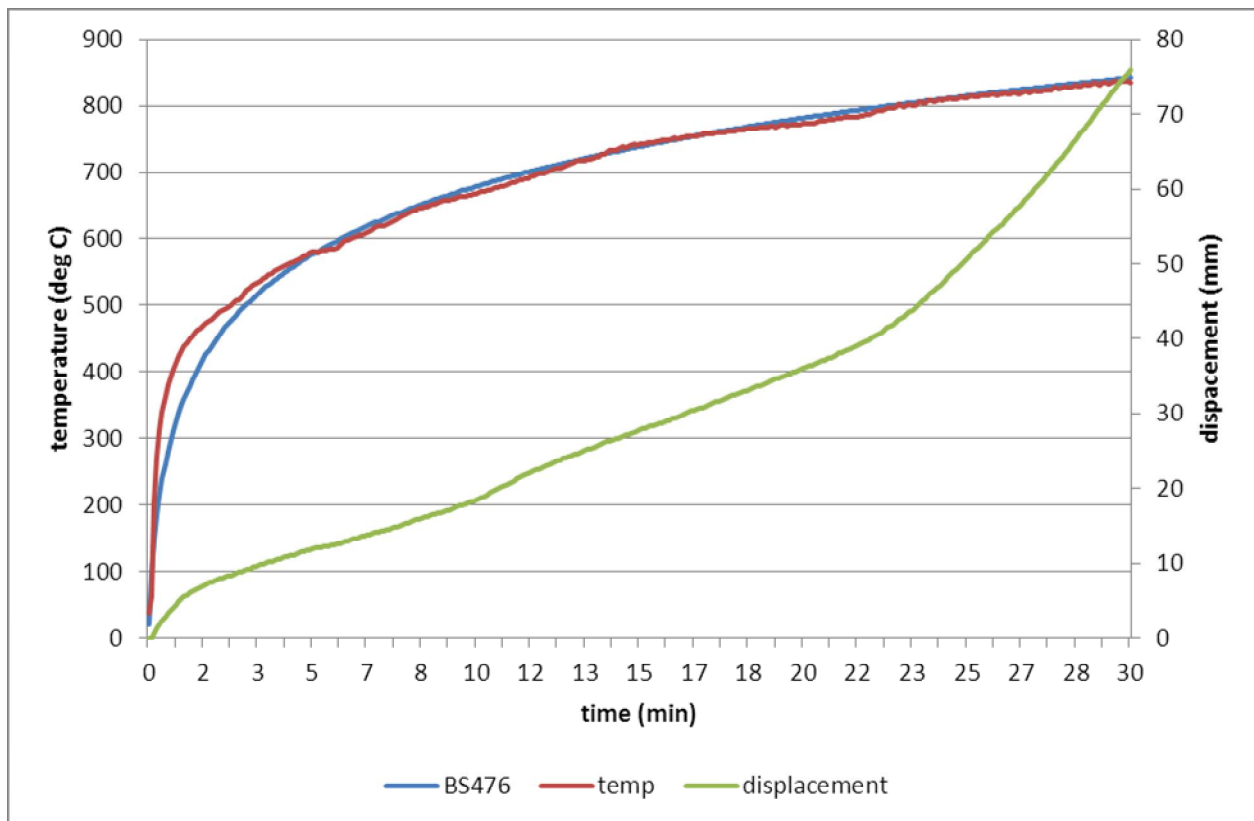
The results from the second test are shown in Figure 8. Again there is good agreement between the measured temperature within the furnace and the standard fire curve. The system supported the load for the duration of the test. The maximum deflection was approximately 76mm at 30 minutes. The sample is shown on removal from the furnace in Figure 9.

Figure 8 Results from Group 1 test 2

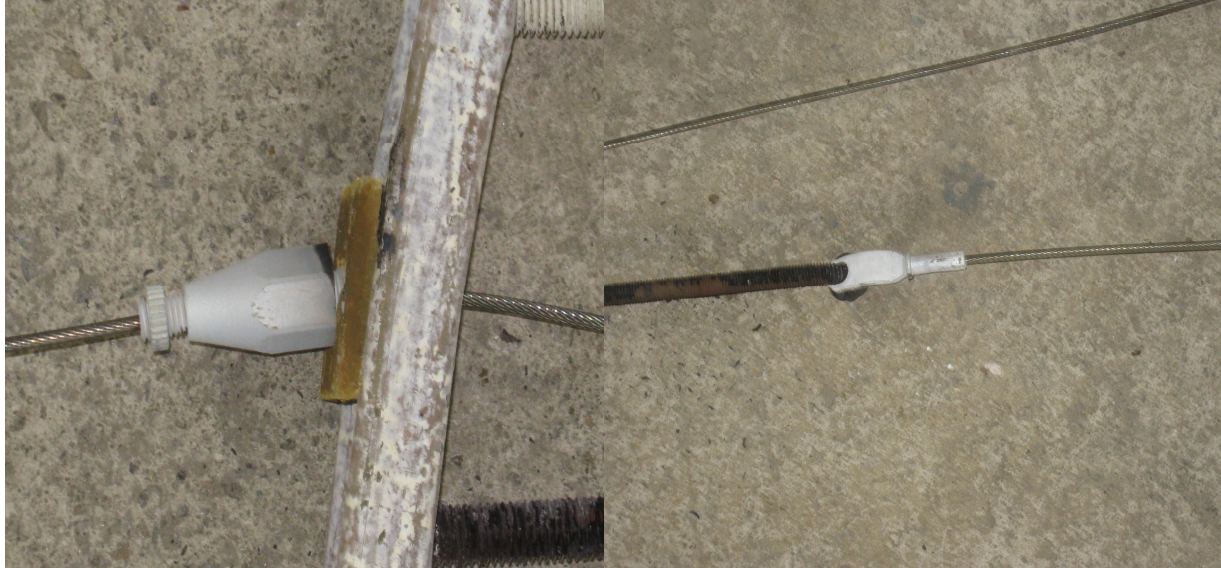
Figure 9 Fixings on removal from the furnace

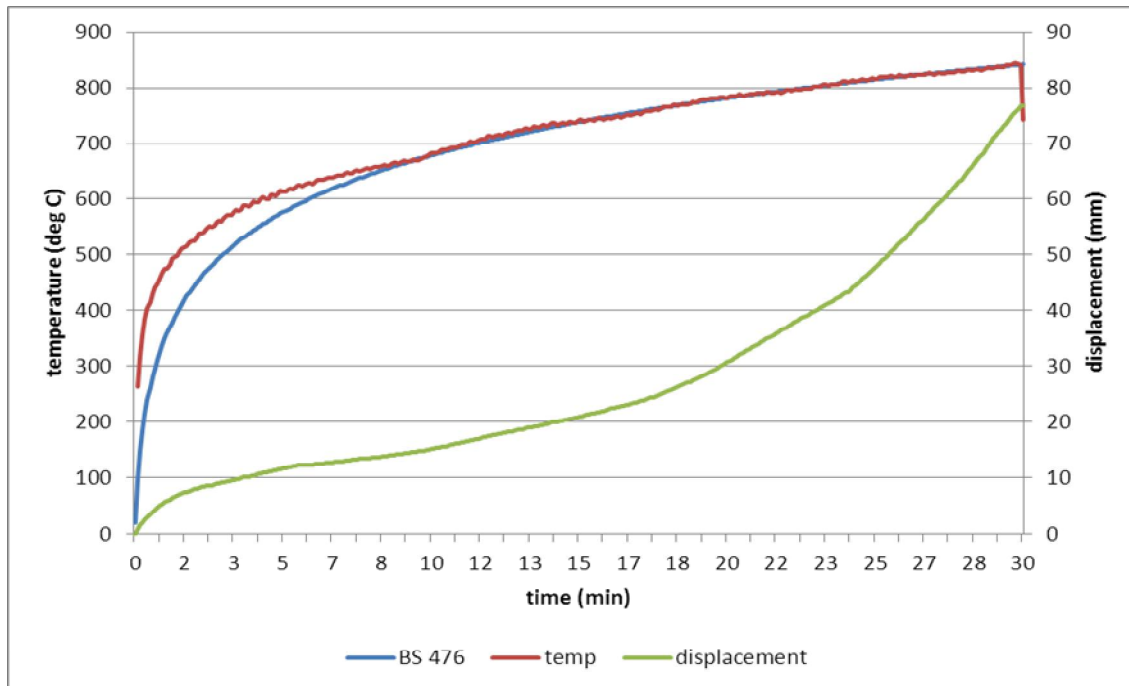
The results from the third test are shown in Figure 10. The system supported the load for the duration of the test. The maximum deflection was approximately 77mm at 30 minutes. The sample is shown on removal from the furnace in Figure 11.

Figure 10 Results from Group 1 test 3

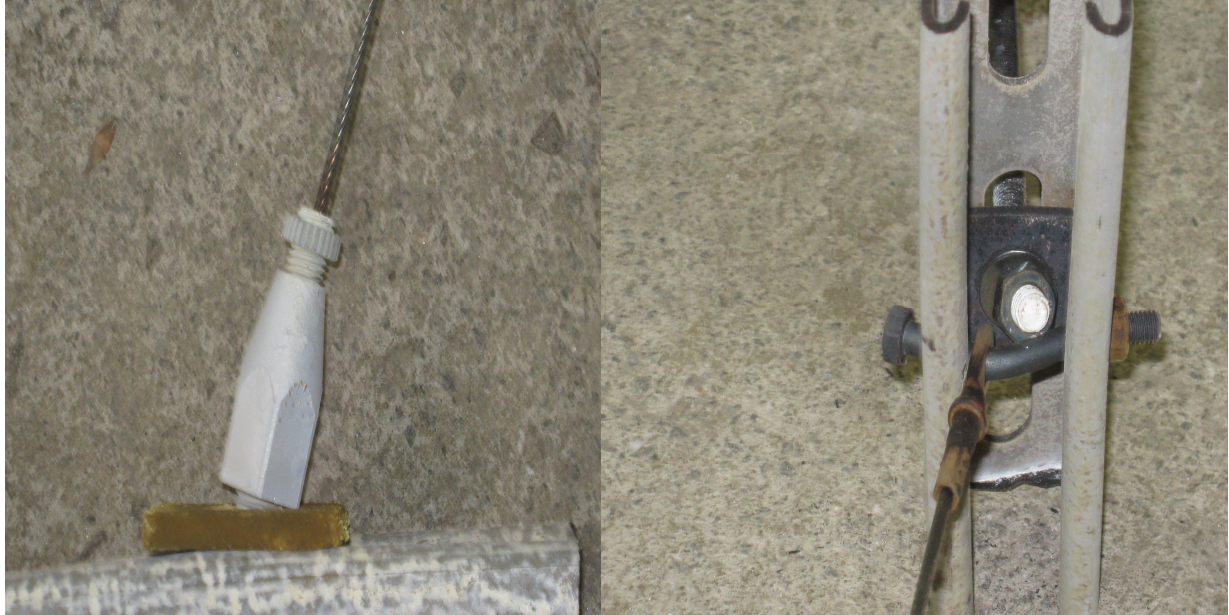
Figure 11 Fixings on removal from the furnace

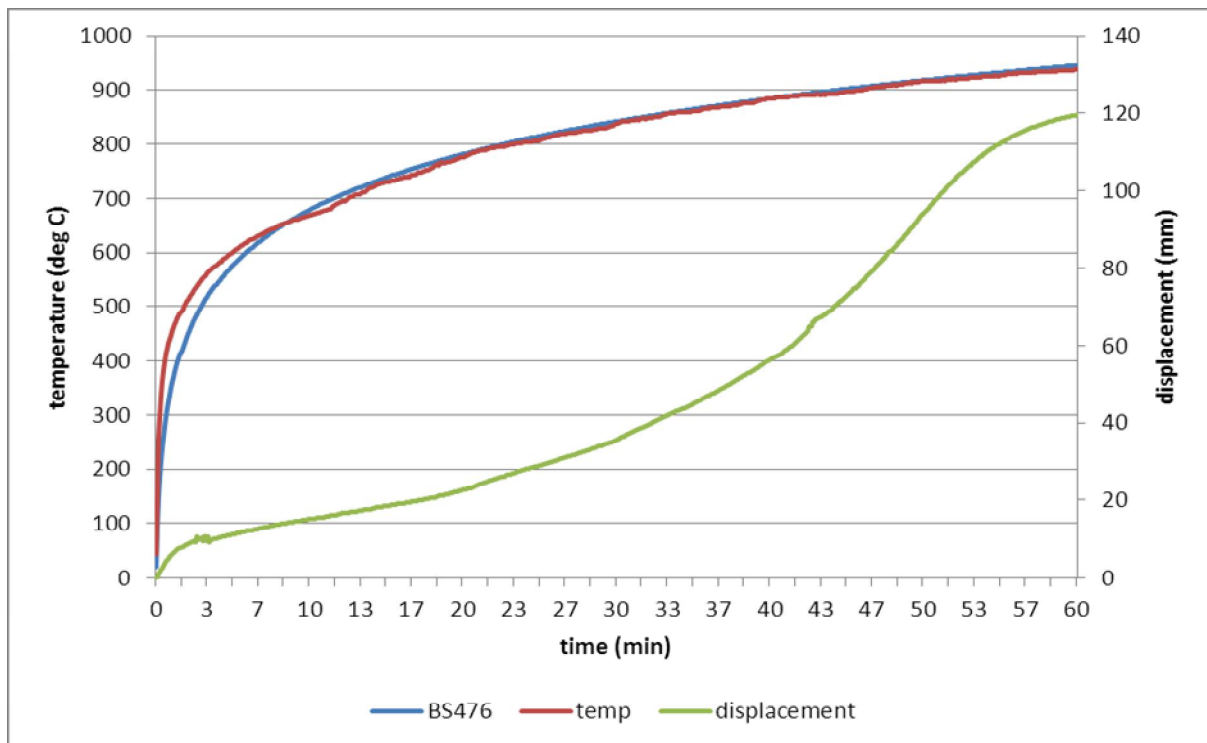
Figure 12 Results from Group 2 test 1

The system supported the load for the duration of the test. The maximum deflection was approximately 120mm at 60 minutes. The sample is shown on removal from the furnace in Figure 13.

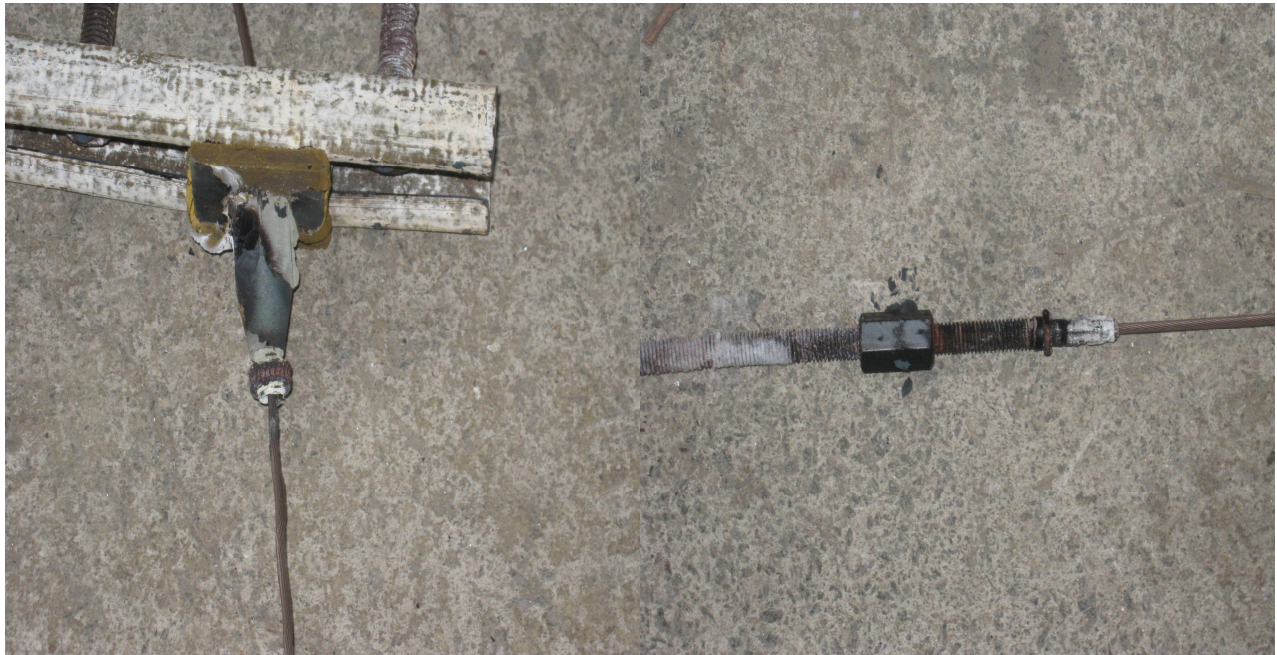
Figure 13 Fixings on removal from the furnace

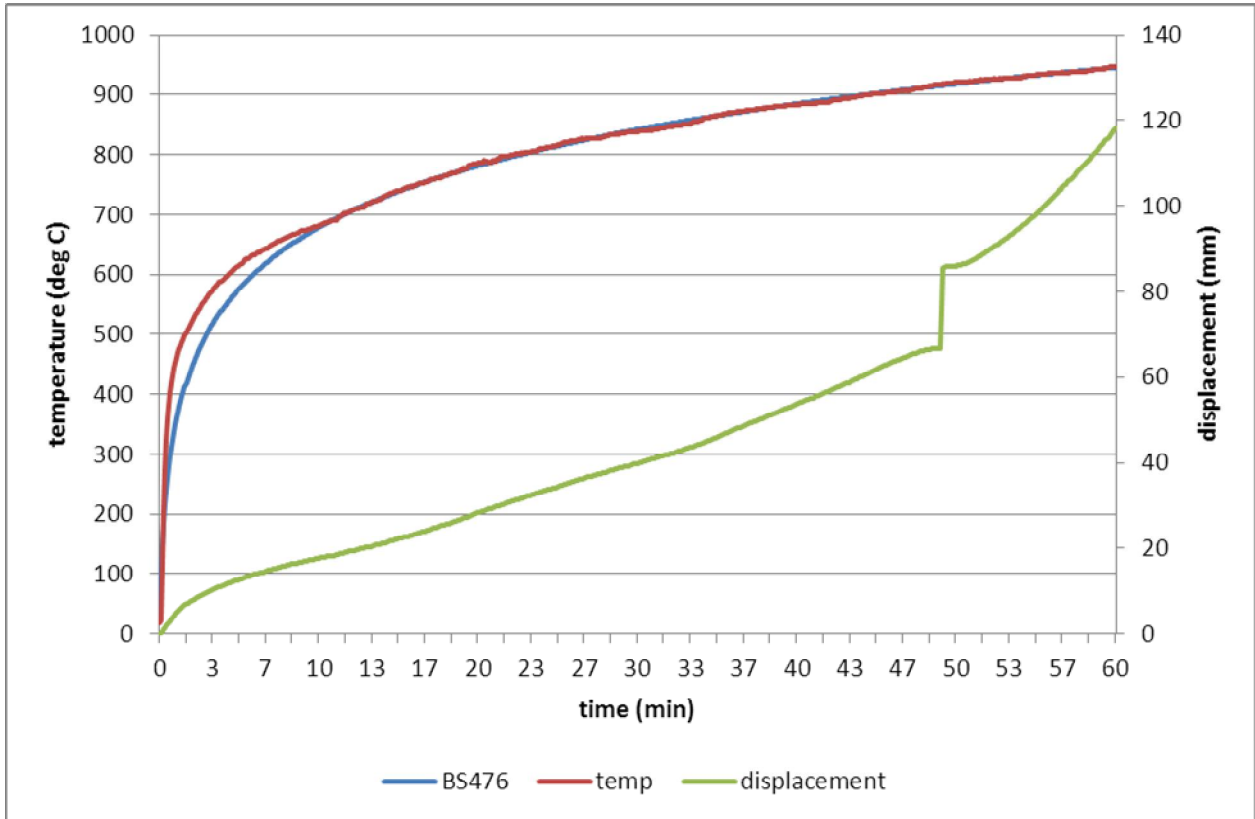
The results for the fifth test are summarised in Figure 14. The system supported the load for the duration of the test. The maximum deflection was approximately 118mm at 60 minutes. There is no clear reason for the increase in deflection between 48 and 49 minutes into the test although it may have been caused by deformation of the loading frame. The sample is shown on removal from the furnace in Figure 15. In this case the test was continued until failure which occurred at 69 minutes.

Figure 14 Results from Group 2 test 2

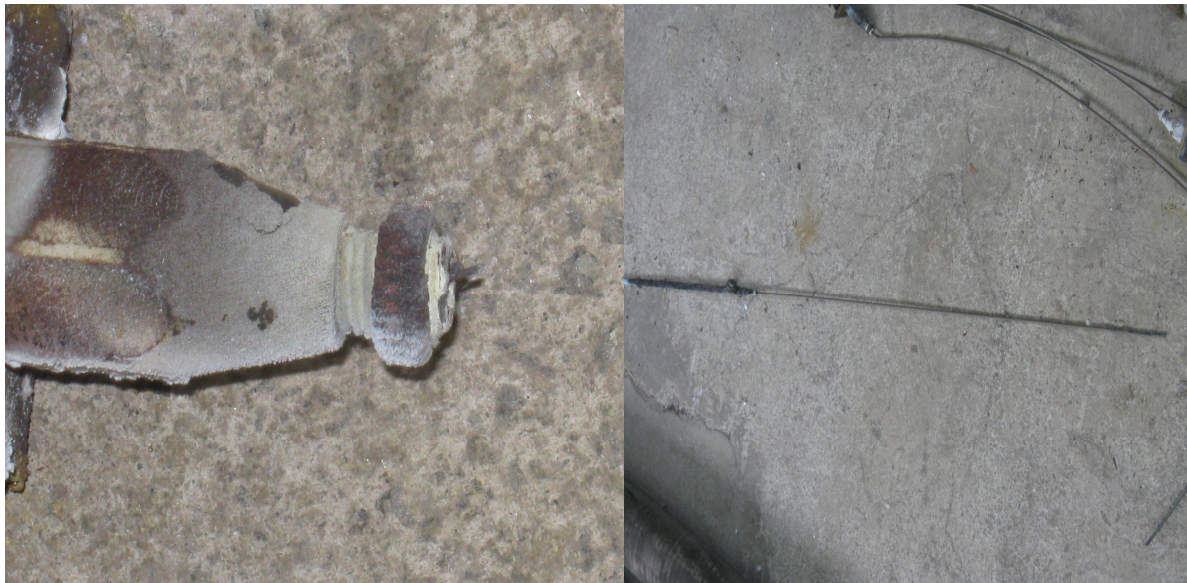
Figure 15 Fixings on removal from furnace

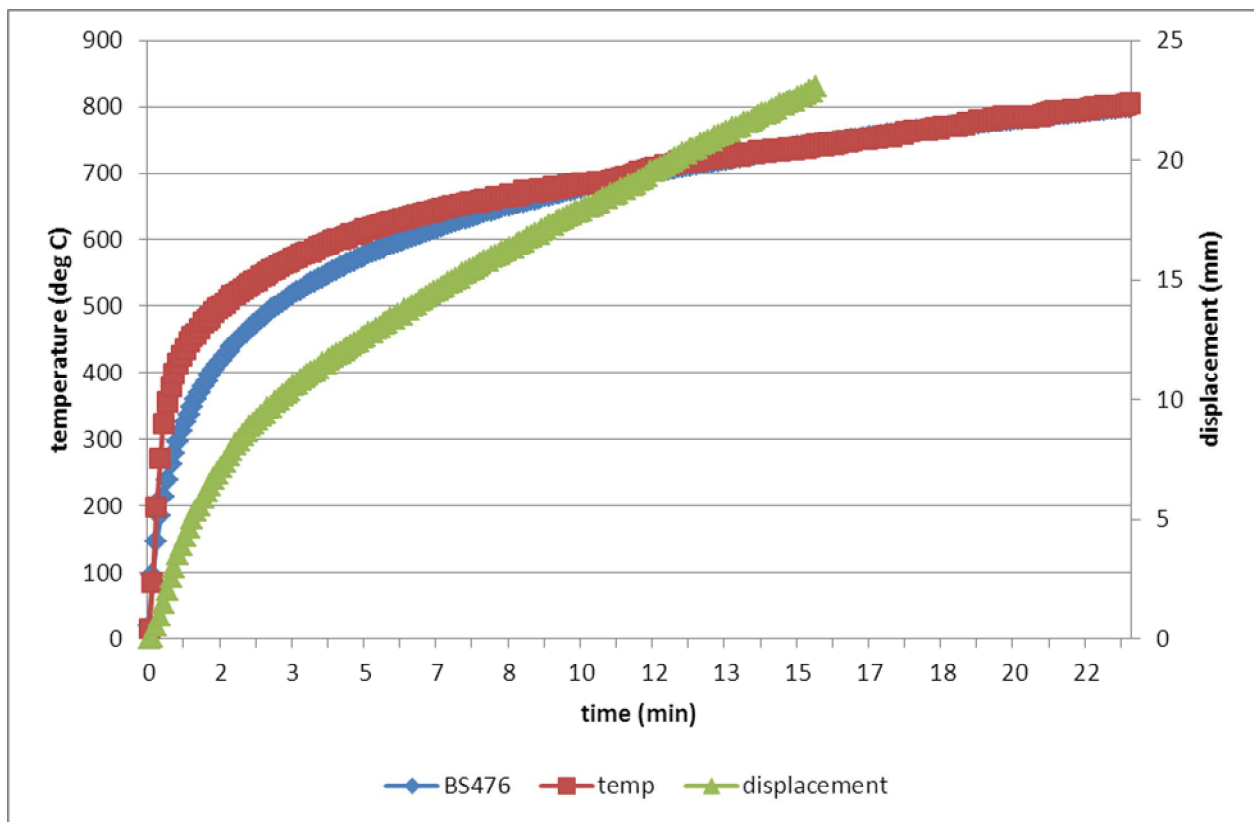
The results for the sixth test are summarised in Figure 16. There were problems with the data logging system for this test. The displacement transducer stopped recording after approximately 15 minutes and all communication with the data logging system was lost after approximately 23 minutes. The test was continued for 60 minutes. The system supported the load for the duration of the test. The sample is shown on removal from the furnace in Figure 17.

Figure 16 Results from Group 2 test 3

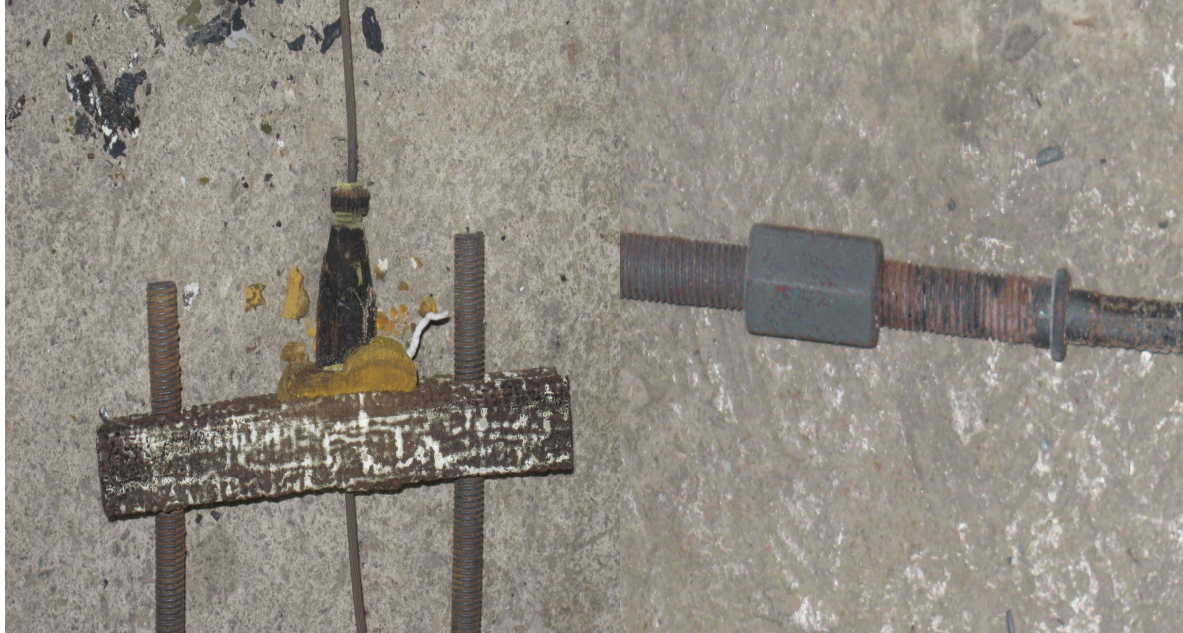
Figure 17 Fixings on removal from the furnace

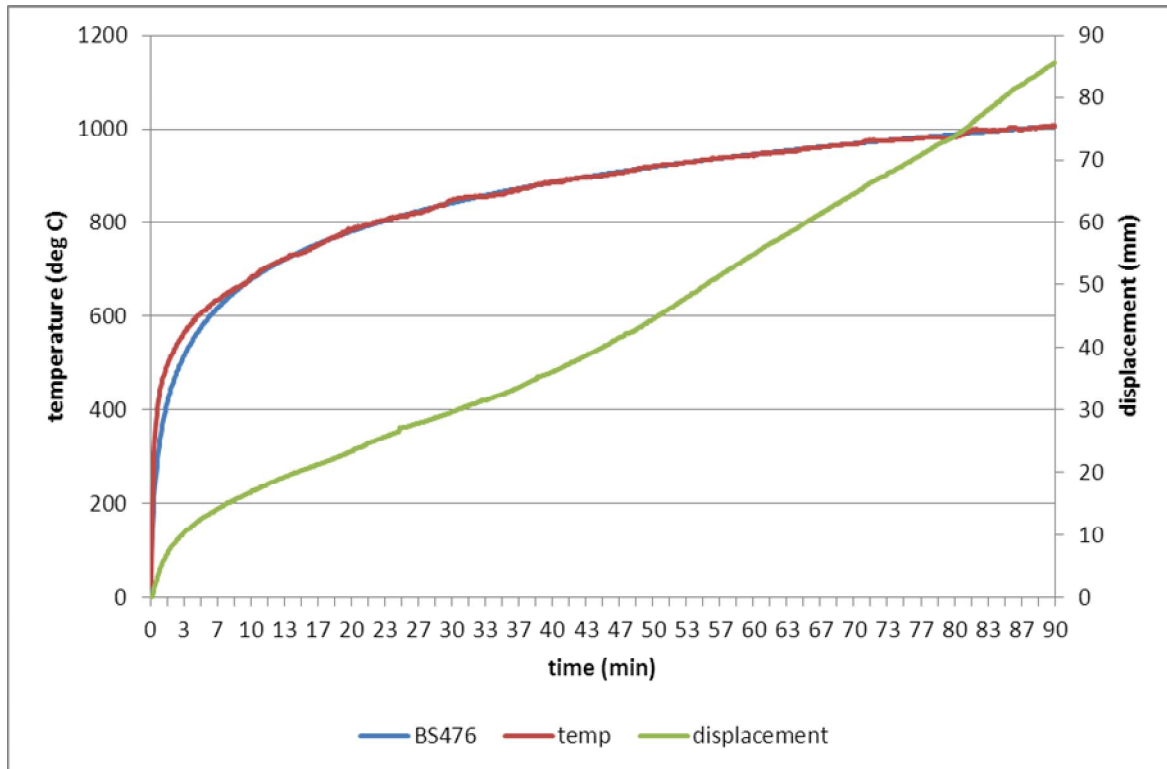
The results for the seventh test are summarised in Figure 18. The maximum deflection is approximately 86mm at 90 minutes. The system supported the load for the duration of the test. The sample is shown within the furnace in Figure 19.

Figure 18 Results from Group 3 test 1

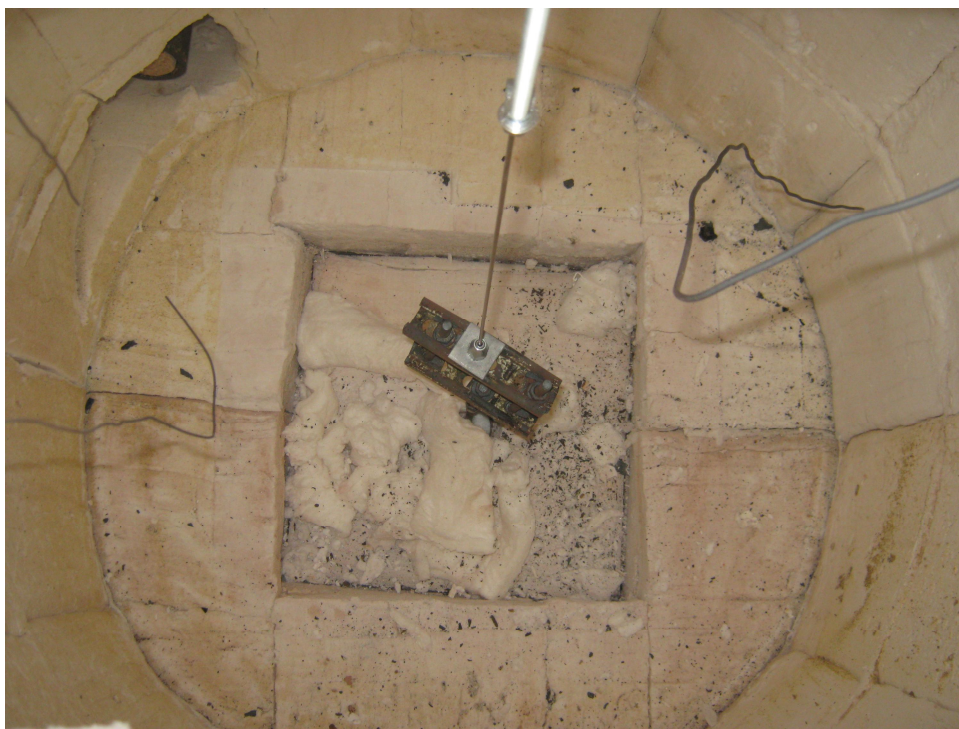
Figure 19 Sample within the furnace

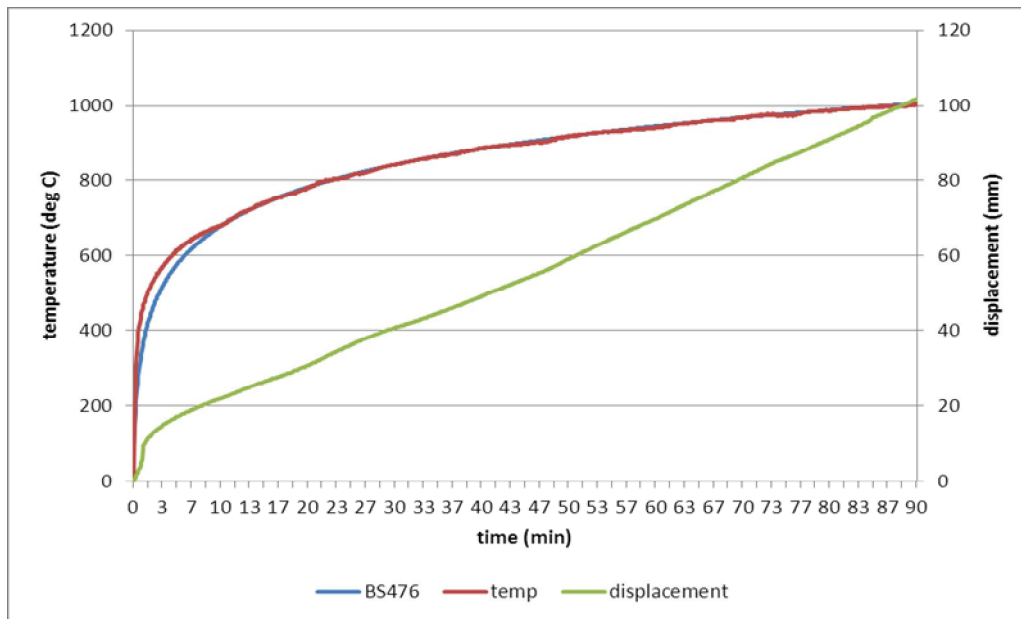
The results from the eighth test are summarised in Figure 20. The system supported the load for the duration of the test. The maximum deflection was approximately 101mm at 90 minutes. The sample is shown within the furnace in figure 21.

Figure 20 Results from test 8

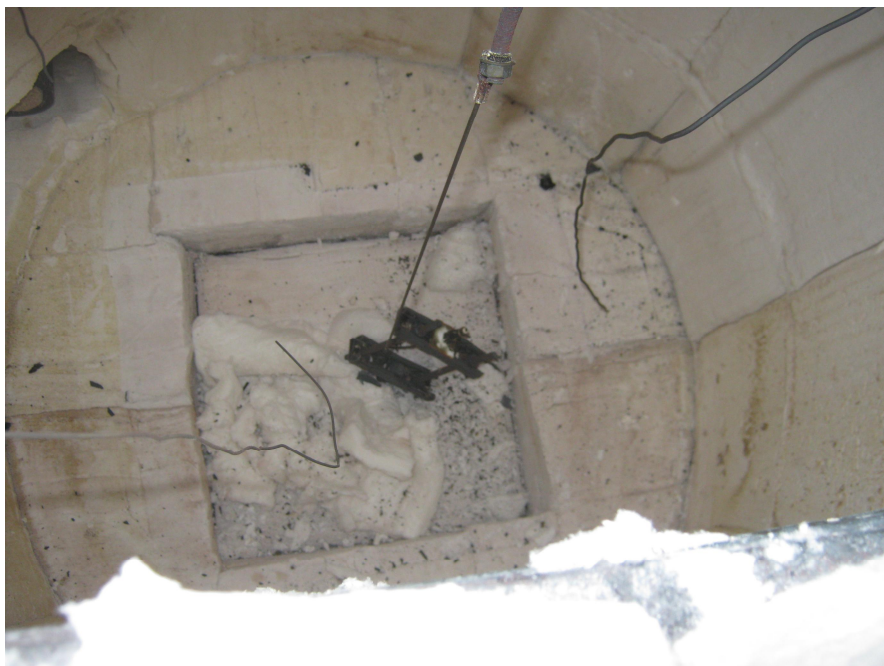
Figure 21 Sample within the furnace

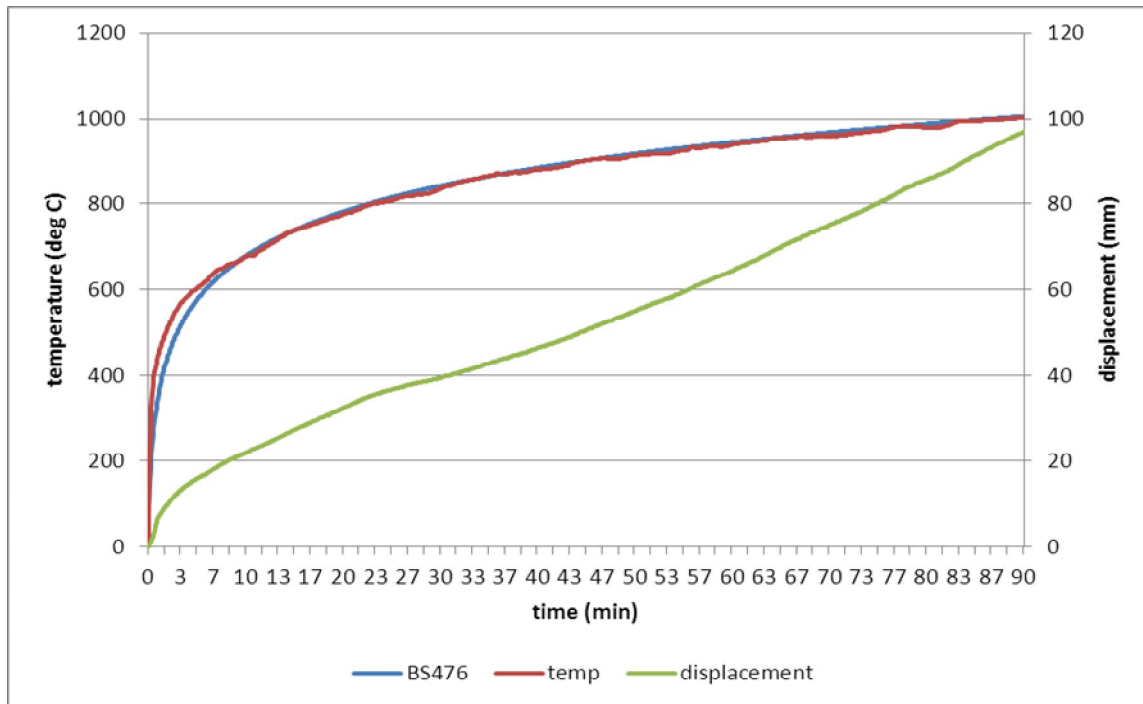
The results from the ninth test are summarised in Figure 22. The maximum deflection is approximately 89mm at 90 minutes. The sample is shown on removal from the furnace in Figure 23.

Figure 22 Results from Group 3 test 3

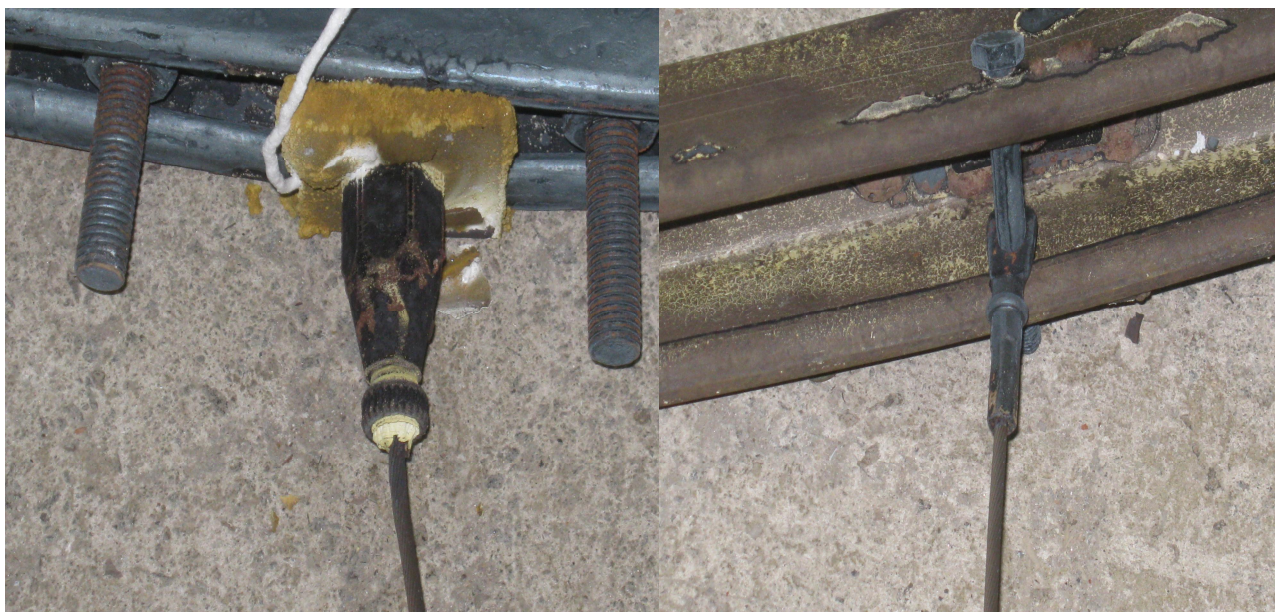
Figure 23 Fixings on removal from the furnace
