The purpose of this document is to explain the best case practice for maintaining the FJQCVR cleaver and how to determine if the ceramic blade or the base of the cleaver needs to be maintained or replaced.

3.0 Maintaining the Cleaver

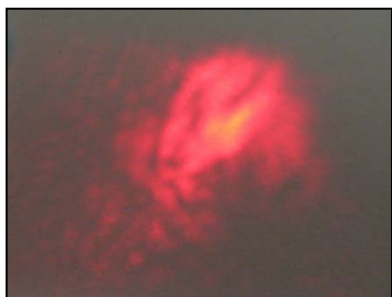
Figure 1 - Bad Cleave

One way is to check the spherical glow of the un-terminated end of the fiber cable by utilizing the visual termination indicator (VTI) of the OptiCam tool (OCTT). By holding a non-connectorized end of the fiber approx. 1" from a surface one can see if they have a quality cleave on the field fiber. The images below show the difference between a bad and a good cleave. Figure 2 shows a good cleave and should result in good insertion loss for the OptiCam connector that has been terminated.

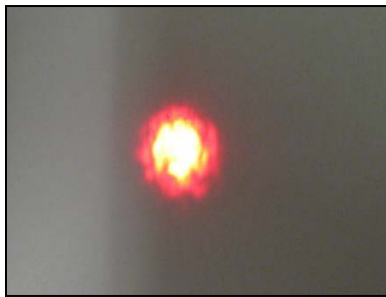
Figure 2 - Good Cleave

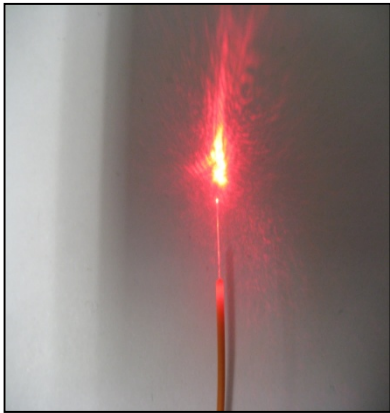
Figure 3 - Bad Cleave (side view)

Another way to check the cleave quality is to once again use the VFL, but this time lay the fiber on its side so you get a side view of the cleave. If there is any reflective light present (as seen in Figure 3) then the cleave is of poor quality. Figure 4 shows the side view of a good cleave where no reflective light can be seen.

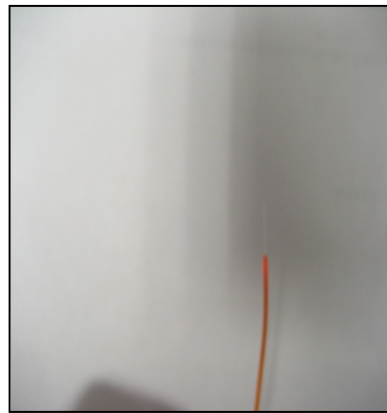
Figure 4 - Good Cleave (side view)

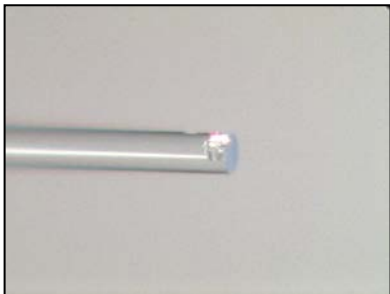
Figure 5 - Bad Cleave (microscope)

Another way to identify the difference between a bad and good cleave is shown in Figure 5 and 6. These figures show the cleaved edge of a fiber under a high powered microscope.

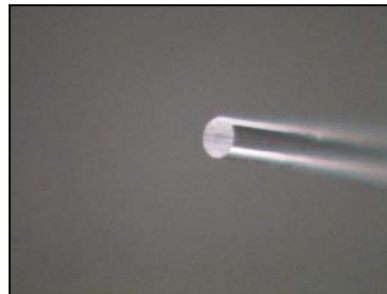
Figure 6 - Good Cleave (microscope)

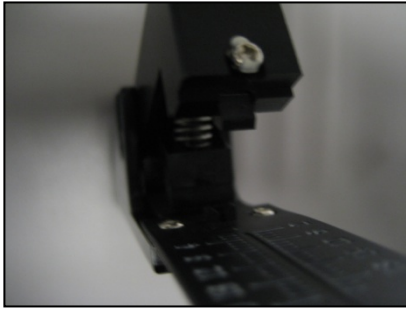
Figure 7

Step 1 - A small phillips type screwdriver will be needed to loosen the screw on the front of the cleaver. (See Figure 7). Once the screw is loosened, the ceramic blade, which is spring loaded, will come into sight. (See Figure 8)

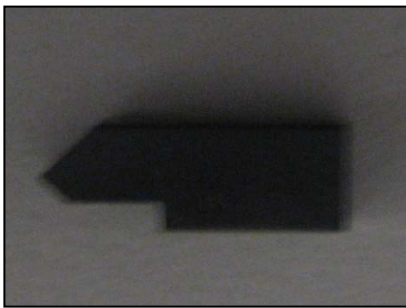
Step 2 - The old blade can be removed and the new blade inserted into the cleaver. Please note the orientation of the blade when installing. The stepped edge shown in Figure 9 should be inserted away from the screw.

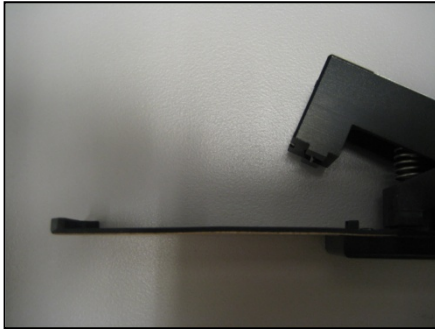
Figure 10 - Normal Base Plate

The base plate that holds and contains the scale to measure the fiber may become misshaped (rounded) and may need to be replaced. In the case of this rounding, it is recommended to purchase a new cleaver. See Figures 10 and 11 for examples of these conditions.

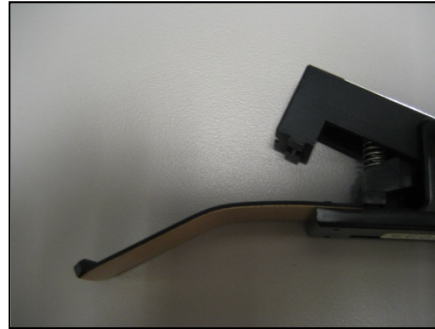
Figure 11 - Damaged Base Plate

In the case of Figure 11, it is recommended that a new cleaver be purchased to achieve optimum cleaves.
