Precise Pressure Measurement without Mercury

Extrusion. Pressure sensors that contain mercury can, in the event of improper handling, pollute the environment and be harmful to health. Newly developed mercury-free pressure sensors raise no health concerns and are highly accurate. In addition, they are extremely robust and have a very long service life.

Translated from *Kunststoffe* 4/2009, pp. 61–63

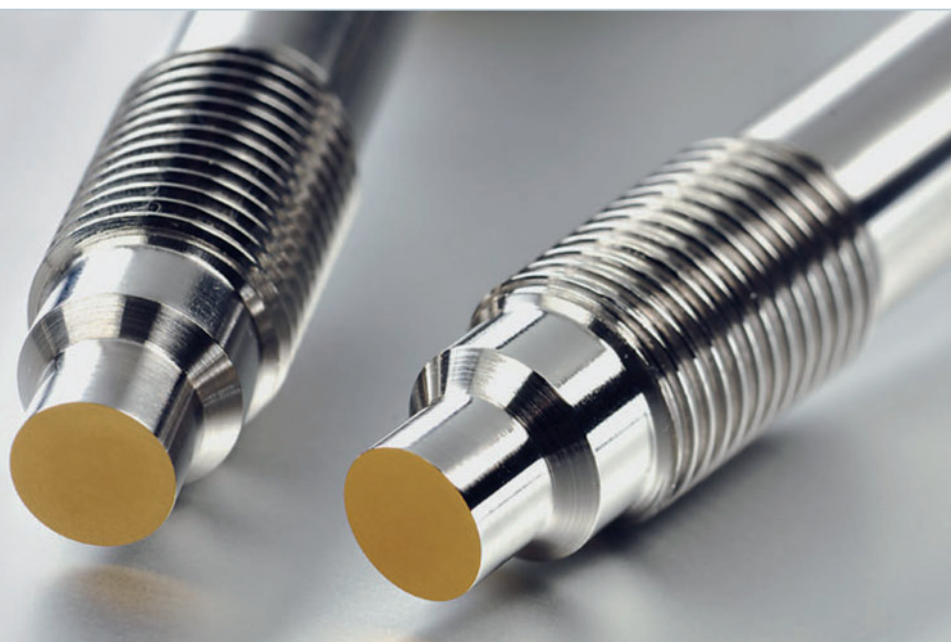
The heated sensor tip reduces the risk of diaphragm damage

As the results of the survey have shown, pressure sensors face a particularly high risk of being damaged during installation and removal. To reduce the risk of diaphragm damage to a significant extent, the new sensor was fitted with a heating capability (Title photo). This allows the tip of the sensor to be heated in only a few minutes. Removing the sensor from an already cooled system thus poses no problems. In so far as problems are to be expected due to the shrinking melt when a system is shut down, the sensor can also be heated to avoid diaphragm damage. Overheating of the sensor is prevented by a heater controller. The built-in thermocouple is helpful in this regard, since it can provide a control variable. The risk of diaphragm damage or sensor failure is thus reduced to a minimum. This extends the service life of the sensor significantly.

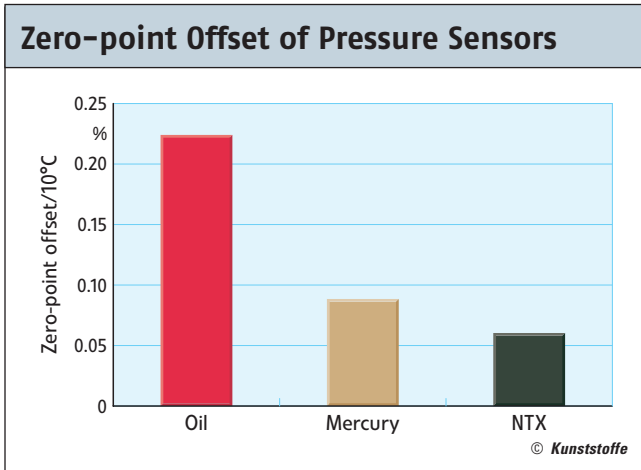
Fig. 1. Direct comparison of pressure sensors using different fill media

Using NTX technology, Gneuss Kunststofftechnik GmbH, Bad Oeynhausen, Germany, has developed a new mercury-free generation of pressure sensors. In contrast to mercury-containing sensors, they raise no health concerns and must not be disposed of as special waste. Additional benefits include the low zero-point offset and accuracy of up to 0.1 % of the final value. The sensors can be employed at temperatures up to 500°C and are also suitable for use in the pharmaceutical and food processing sectors. Fig. 1 shows the zero-point offset free pressure sensors with different fill media between room temperature and 200°C. It is obvious that the zero-point offset of pressure sensors utilizing NTX technology is less than that

of mercury-containing pressure sensors. Sensors based on NTX technology thus represent more than just an alternative to mercury-containing sensors.

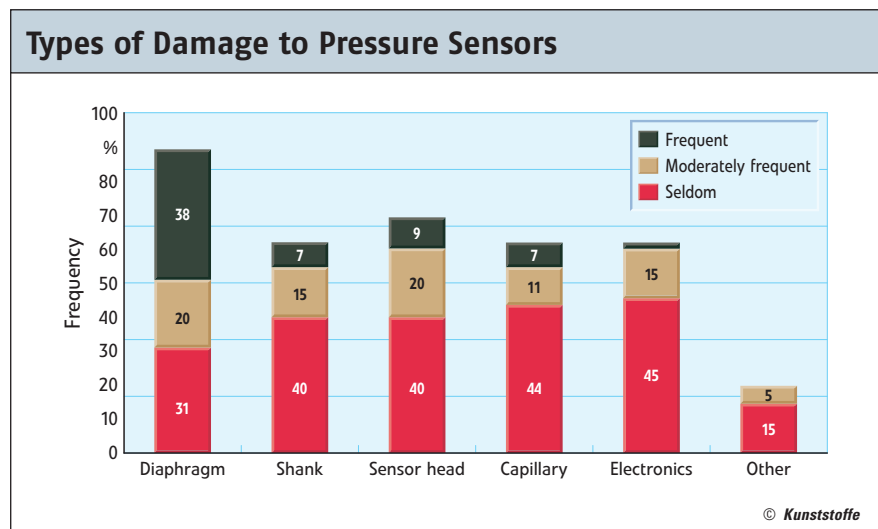
Fig. 3. Types of damage to the pressure sensor (from survey among 78 companies, multiple indications possible)

minor importance. Against this backdrop, the types of sensor damage presented in Fig. 3 can now be interpreted.

The most frequent damage by far occurs at the most sensitive spot in the sensor, namely, the diaphragm. Diaphragm damage can be caused by contaminant

particles in the melt, among other things. Diaphragm defects occur most commonly, however, when the membrane adheres to already cooled plastic when being removed, or cooling melt shrinks and the diaphragm tears. This type of damage regularly results in contamination of the area as the result of leaking fill medium when mercury-containing sensors are used. Of the companies that reported complaints about diaphragm defects, about two-thirds stated they have such problems frequently or moderately frequently. In comparison, the majority of the companies seldom had problems associated with the remaining defects, although in this regard the sensor head appears to be the next most vulnerable components, probably because of the plug-in connector.

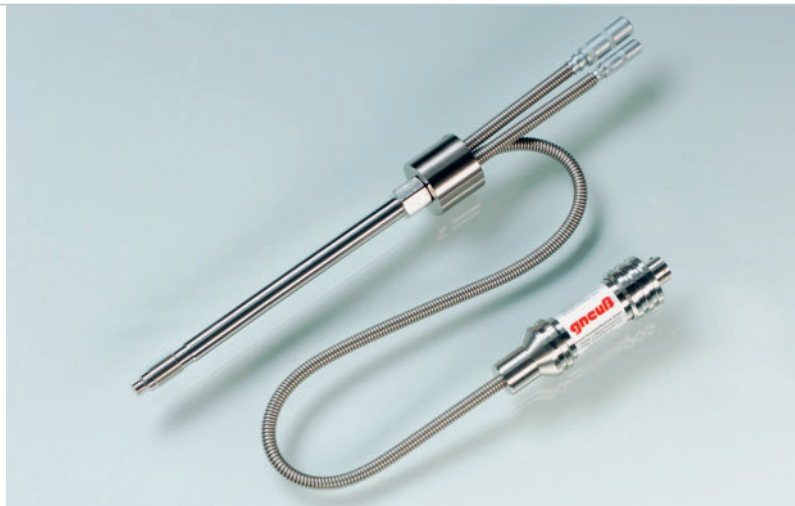
Fig. 4. The DAP pressure sensor is characterized by an extremely high accuracy of $\pm 0.2\%$

Against the backdrop of the problems presented above, a pressure sensor was developed that is extremely rugged on the one hand, yet simultaneously permits simple installation and removal. On the other hand, the intent was to also achieve technical improvements. During development, Gneuss was able to draw on its decades-long experience as a manufacturer of pressure and temperature sensors. The result of this development is the new DAP pressure sensor (Fig. 4). The sensor is characterized by noticeably improved accuracy ($\pm 0.2\%$) and a previously unattainable integrity. This is possible because of newly developed diaphragm technology.

Moreover, the sensor exhibits an extremely long service life. Special surface

characteristics make the shank extremely rugged. This attribute is found also in the plug-in connections, where only especially strong metals are employed. The flexible capillary, which is manufactured from a special material, is protected in an ideal manner thanks to a unique, very rugged spring design and can thus withstand loads several times higher than conventional designs. The sensor is also available with a built-in amplifier.
