Anja Haschenburger, Dr. Jan Stüve*

German Aerospace Centre (DLR e.V.), Institute for Composite Structures and Adaptive Systems

Influence of leaky vacuum bags on the quality of composite parts made from prepreg material

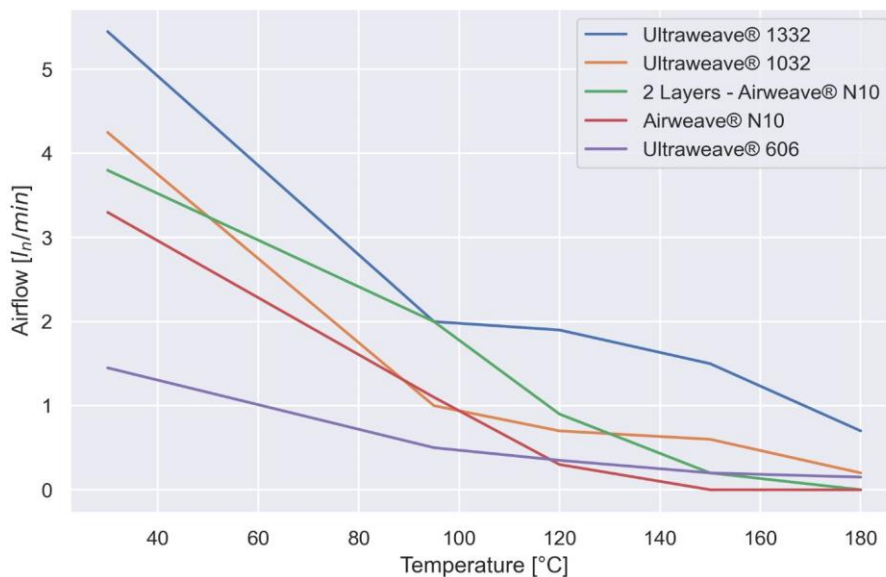
Figure 2: Airflow of Airtech breathers at 7 bar and increasing temperature cf. [5]

While the release and vacuum film are both barriers to prevent resin to leak out of the component or air to leak into the bag, the breather a coarse polyester fleece that is used to promote airflow across the entire surface of the laminate during evacuation. [5] This function is highly temperature and pressure dependent. The change in air flow of different breather materials at 7 bar and increasing temperature is shown in Figure 2. From this it can be seen that all breathers exhibit process-dependent permeability.

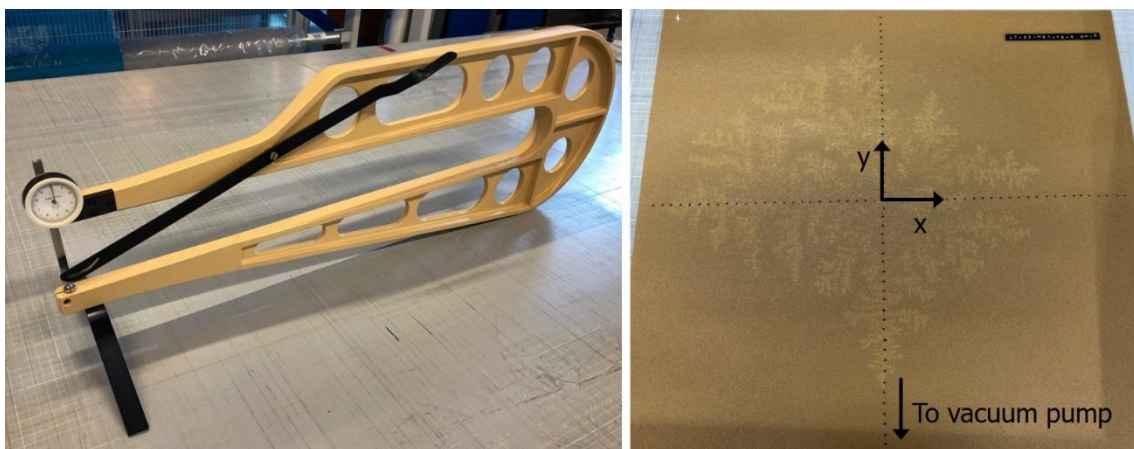
Figure 8: Thickness gauge and test grid on a test plate with the leakage at the origin

After the specimens have been cured in the autoclave, they have been examined and evaluated in various ways. One of the most important tests is the visual inspection of the laminates for porosity. In order to check whether a visual inspection of the glass laminates is sufficient to detect all porosities, additional ultrasonic tests in the form of a c-scan have been carried out on two plates. The tests have been carried out according to the Airbus test specifications AITM 6-4010 [19] and AITM 6-4012 [20]. The evaluation of the results has been carried out according to the airbus standard AITM 6-0011 [21]. These tests have been supplemented by micrographs and thickness measurement. To investigate the influence of leakage on the laminate thickness, thickness measurements have been carried out on some of the test panels. Figure 8 shows the measuring clamp used and the test plate with the measuring points drawn in. The leakage (if any) is located at the origin of the coordinate system used.

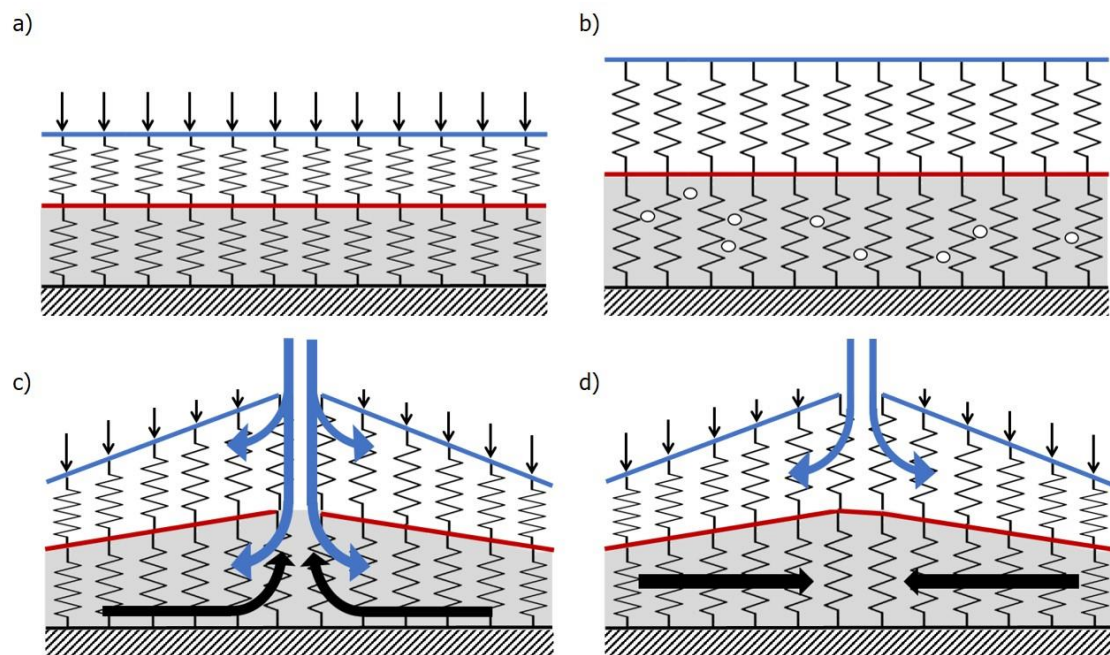
Figure 9: Schematic representation of the pressure inside the vacuum bag during curing. a) Reference without a leakage and full vacuum, b) Reference without vacuum and compaction, c) Vacuum bag with leakage in vacuum film and release film, d) Vacuum bag with leakage in vacuum film

Figure 9a shows the reference case where there is no leakage in the vacuum setup. The black arrows symbolize the ambient pressure in the autoclave acting on the vacuum bag and compressing both the breather and the laminate. Air trapped in the assembly during the manufacturing process has been evacuated and the part can cure without porosity or voids.

If no pressure difference can be built up between the laminate and the environment, e.g. because a pressure equalization takes place due to a large tear in the film, no compression of the laminate takes place. Figure 9b shows that entrapped air could not be removed from in-between the layers and that the laminate cures without any applied forces.

The leakage artificially introduced into the vacuum assembly by a needle has locally damaged not only the vacuum bag but also the release film, like shown in Figure 9c. In this case, the ambient air can enter the vacuum setup. It spreads both in the breather and in the laminate. The blue arrows symbolize the air flow. The effective pressure on the laminate and the breather decreases locally and there is a resetting of the materials in this area. The resin flow, represented by black arrows, goes in the direction of leakage, as the pressure on the laminate is lowest here.

Figure 9d shows the substitute model with a leak only in the vacuum film. This has been realised in the tests by punching the vacuum bag. The ambient air can penetrate the vacuum bag and spreads out in the breather material. The effective pressure on the laminate drops in the vicinity of the leakage, so the breather and laminate relax in this area and increase in thickness. The resin beneath the release film flows into the area with the lowest effective pressure on the vacuum setup, which is in the area of the leakage.

The tests show a high agreement with the spring model created in Chapter 3.6. In case of the continuous leak through the vacuum and release film, described by Figure 9c, the resin may leak out and spread in the breather material, as was observed in the trials. It can also be seen, that the air is flowing not only into the breather but also into the laminate, forming the porosity branches seen in Figure 13 and 15. In case of the no vacuum test panel the laminate thickness is very high and volatiles released during curing remain in the laminate and form additional voids, like seen in Figure 9b and 16.

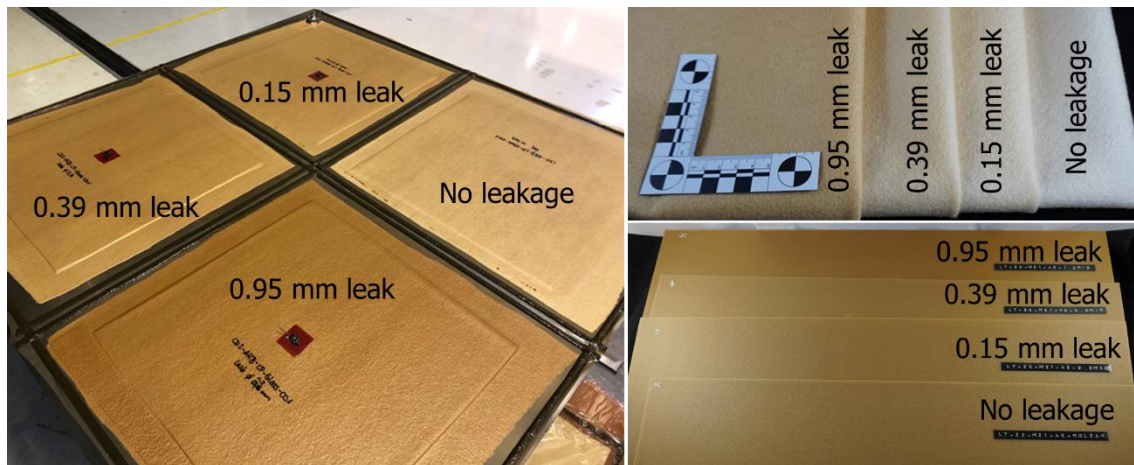
Figure 10: Colour gradation of vacuum bags, breather and laminate right after autoclave cycle

During the debagging of the experiments of the first trial, discolouration of the vacuum bags can be detected. The left side of Figure 10 shows the vacuum set-ups of the first test directly after the autoclave. It can be seen that the vacuum bag without leakage has the lightest colour. The greater the leakage, the darker the colour of the corresponding vacuum bag. The same can also be seen in the respective breather materials. These have darkened accordingly depending on the size of the leak, shown in Figure 10 on the top right-hand side.

In addition to the breather, the laminate also shows increasing discolouration with increasing leakage size, see Figure 10 on the bottom of the right-hand side. An explanation for this seems to be a side reaction of volatile, short-chain constituents of the EP resin with the residual oxygen, causing the discolouration, like described in Chapter 2. Since this is a chemical reaction, it may also be progressing under the film and in the laminate. This also fits with the increasing hole size: more air ingress leads to more side reaction. Even if the autoclave is filled with nitrogen during the process for safety reasons, a certain amount of residual oxygen will remain inside the pressure vessel. This seems to be sufficient to cause a side reaction with the epoxy resin.

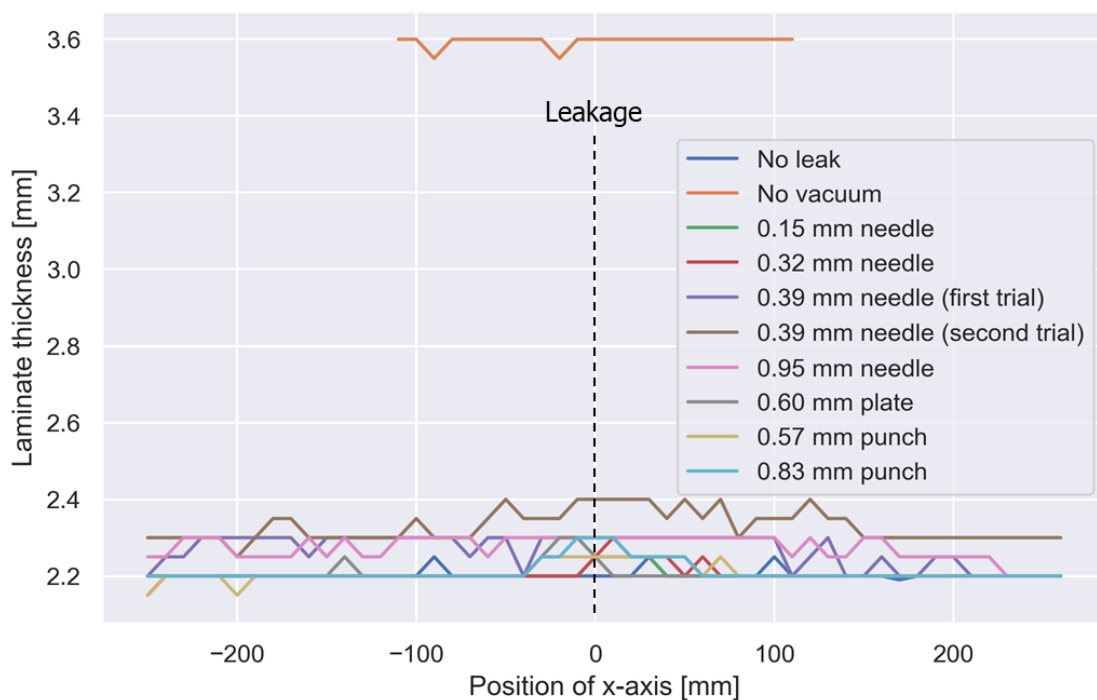
Figure 18: Laminate thickness of test plates in x-direction

The test component with the metal plate shows only a small change in thickness directly in the area of the leakage. The variation in thickness of the plates with the punched leaks is particularly interesting. Here it can be seen that an increased thickness occurs in the direct area of the leakage, even without porosities in the laminate. In the y-direction, the laminate thickness visibly decreases to 2.1 mm towards the vacuum pump and increases to 2.25-2.3 mm in the area of the leakage, before it returns to a normal level of 2.2 mm opposite the vacuum pump.
