## **WATER IMPERMEABILITY - OKTAGON® AND OKTAGON®-PLUS**

Water impermeability according to ÖNORM EN 12390-8:2019

## Analysis Report

“Oktagon” and “Oktagon-Plus” Plastic Spacers

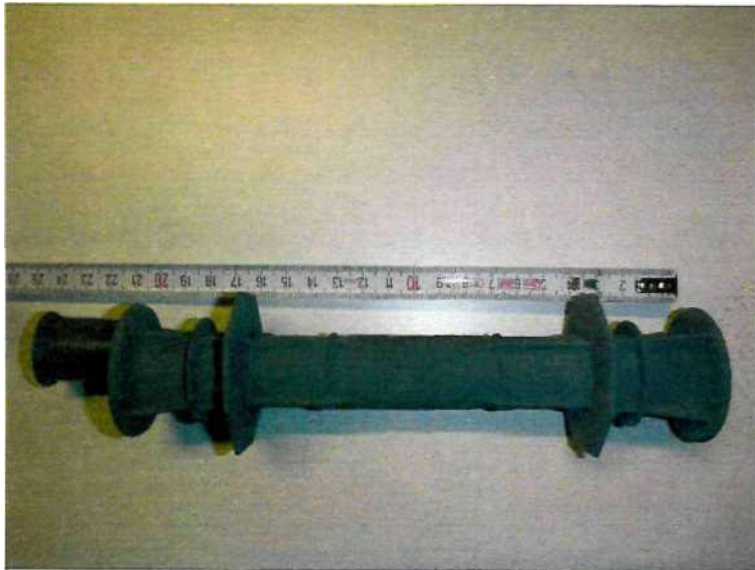
Figure 1:

“Oktagon” plastic spacer  
with sealing plug

Delivered condition

The plastic pipes had a length of 20 cm, and the sealing plugs were 3 cm long.

The appearance of the delivered test objects can be seen in the photographic documentation found in the appendix on page 5.

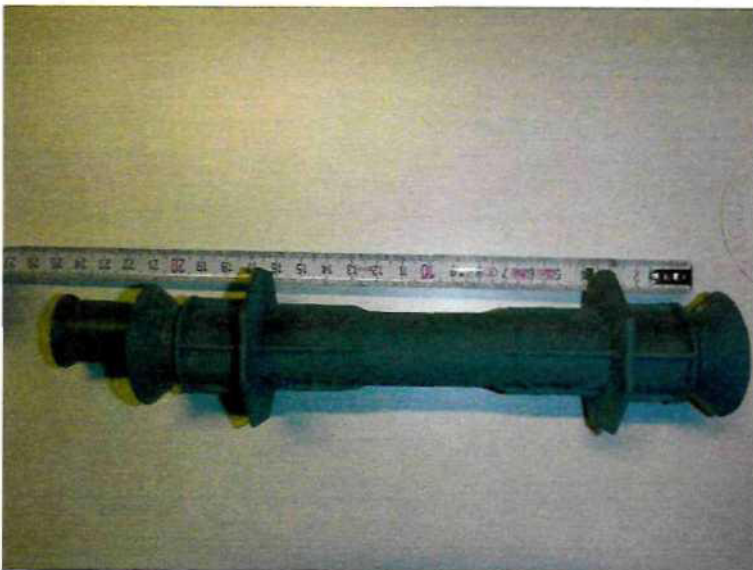
Figure 2:

“Oktagon-Plus” plastic  
spacer with sealing plug

Delivered condition

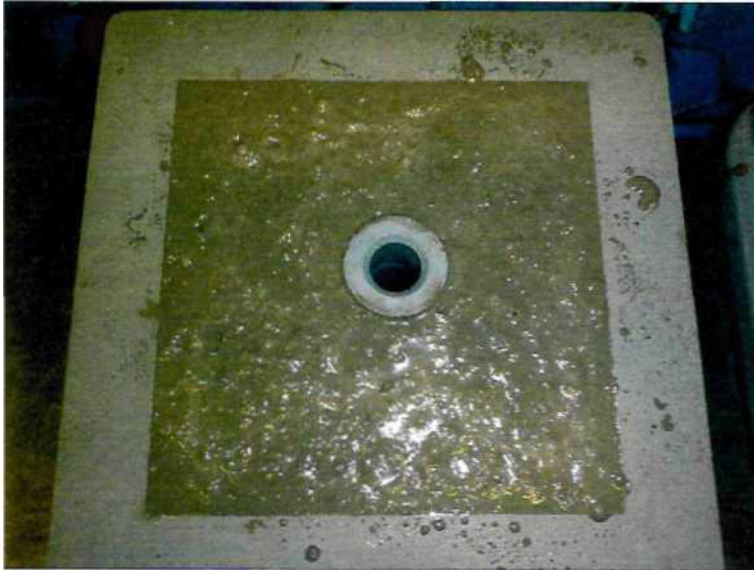
Figure 3:

Sample cube with encased  
"Oktagon" spacer

One "Oktagon" plastic spacer was embedded in the center of each of the sample cubes (see Figure 3 in the appendix).

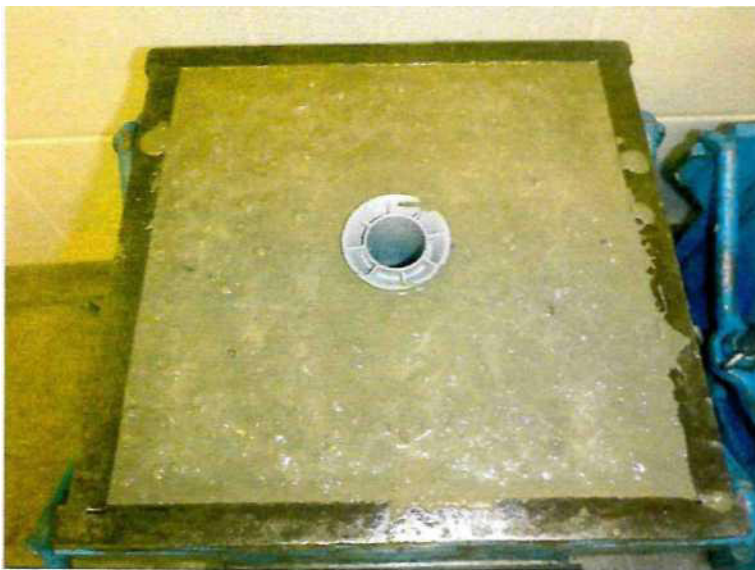
Figure 4:

Sample cube with encased  
"Oktagon-Plus" spacer

One “Oktagon-Plus” plastic spacer was embedded in the center of each of the sample cubes (see Figure 4 in the appendix).

Before mounting in the test apparatus, the spreader cones molded into the spacer by the client were broken on their predetermined breaking point and pulled out, and the encased plastic spacers were plugged on one side using sealing plugs (the sealing plugs were hammered in place).

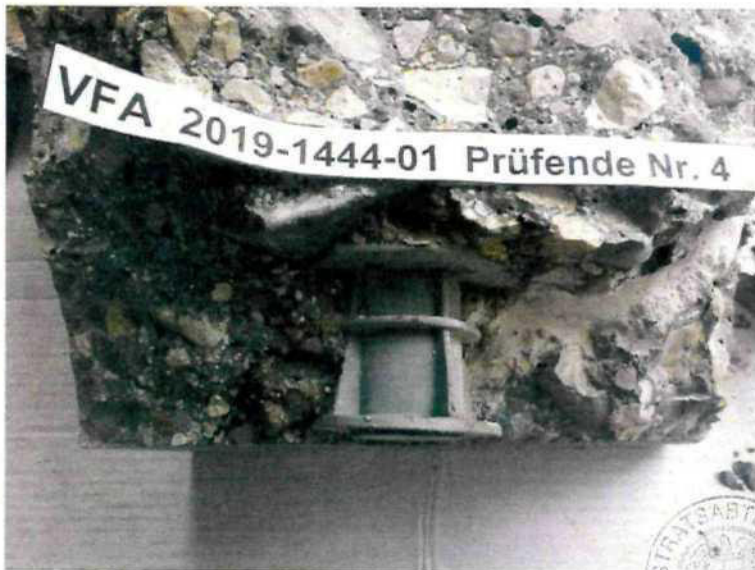
Figure 5:

Water penetration depth test

Sample No. 4 -  
"Oktagon"

Water penetration depth 20 mm

After splitting the test specimens, it was possible to see that water had penetrated into the concrete to depths between 8 mm and 20 mm on the 3 samples tested.

No moisture could be detected along the plastic pipe on any of the samples.

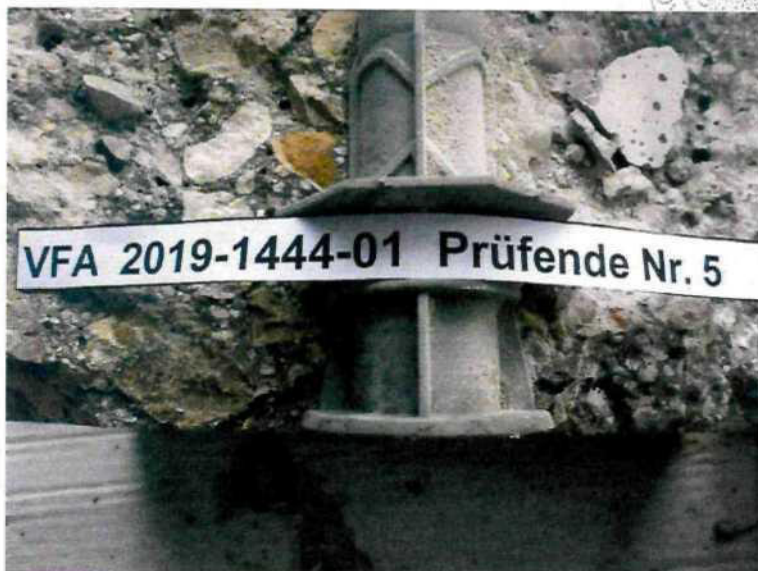
Figure 6:

Water penetration depth test

Sample No. 5 -  
"Oktagon"

Water penetration depth 8 mm

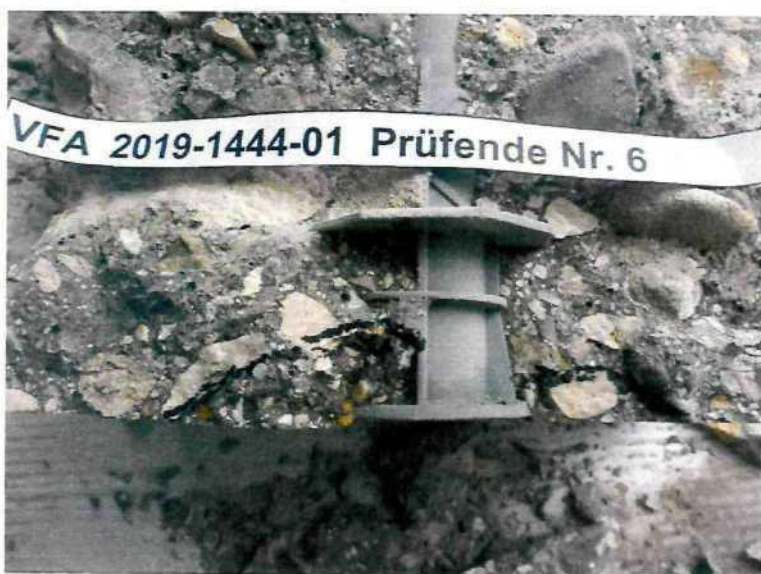
Figure 7:

Water penetration depth test

Sample No. 6 -  
"Oktagon"

Water penetration depth 20 mm

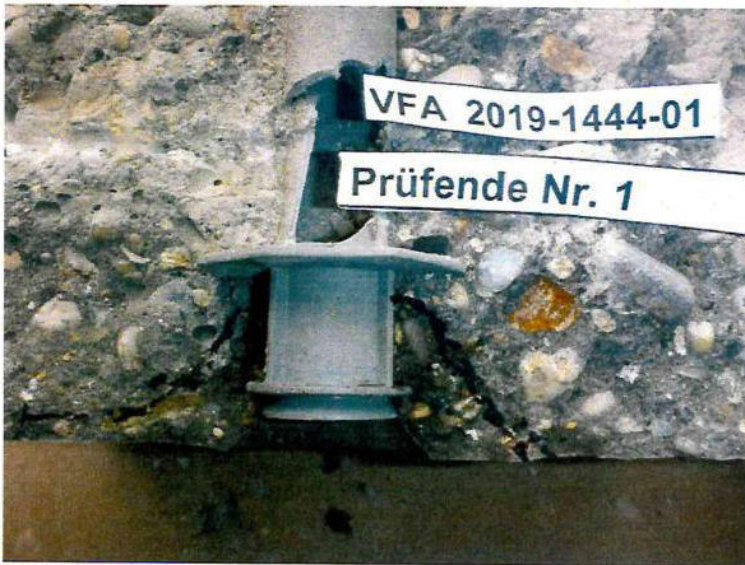
Figure 8:

Water penetration depth test

Sample No. 1 -  
"Oktagon-Plus"

Water penetration depth 30 mm

After splitting the test specimens, it was possible to see that water had penetrated into the concrete to depths between 30 mm and 50 mm on the 3 samples tested.

No moisture could be detected along the plastic pipe on any of the samples.

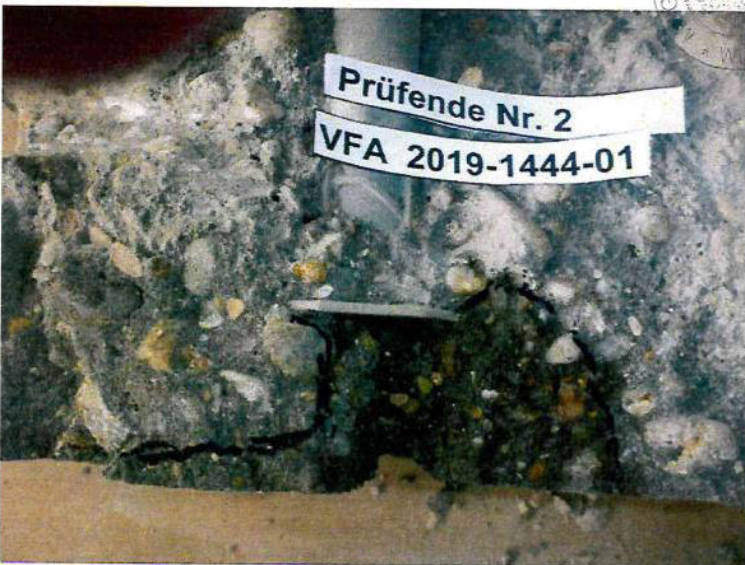
Figure 9:

Water penetration depth test

Sample No. 2 -  
"Oktagon-Plus"

Water penetration depth 50 mm

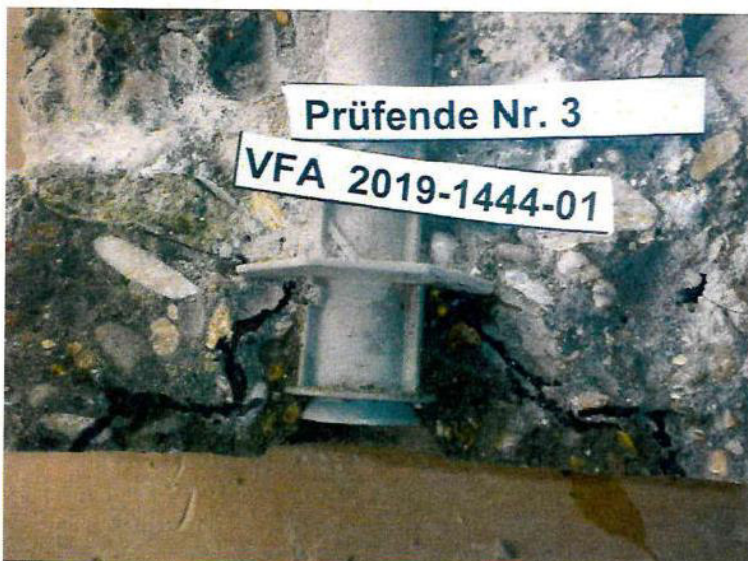
Figure 10:

Water penetration depth test

Sample No. 3 -  
"Oktagon-Plus"

Water penetration depth 38 mm
