NEW PRODUCT!

Announcement Number: S04091901

#JF015E-PISTON

JATCO/NISSAN JF015E/RE0F11A

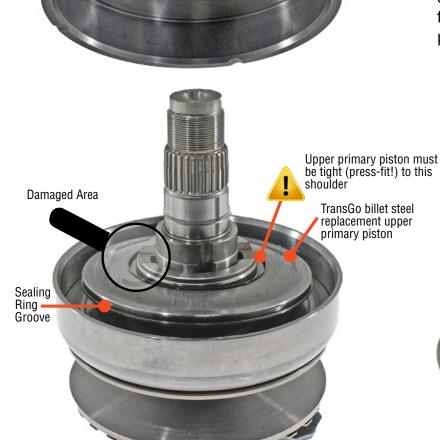
Primary pulley assembly

CNC machined billet steel
replacement upper primary piston

Slipping pulleys, with or without codes, get worse when hot. This is likely due to upper primary pulley ID piston damage. The upper primary piston's inner seal is press-fit onto the shoulder of the pulley sheave. A worn or loose fitting piston leaks primary pulley-pressure, causing the belt to slip.

Don't overlook this very common hidden failure. This piston **MUST BE PRESS-FIT** or it will leak.
