62TE-HP-A

High Pressure Tuneless™ Reprogramming™ Kit

An essential performance and durability upgrade for hard-working ProMaster and passenger vans to prevent 2-4 clutch failures, especially in shift busy delivery vehicles. A recalibrated pressure curve delivers increased clutch and TCC holding capacity with short, clean shifts at all throttle openings. A 26% overall increase in line pressure takes this unit from (stock OEM) 60-135 psi to (TransGo) 75-170 psi.

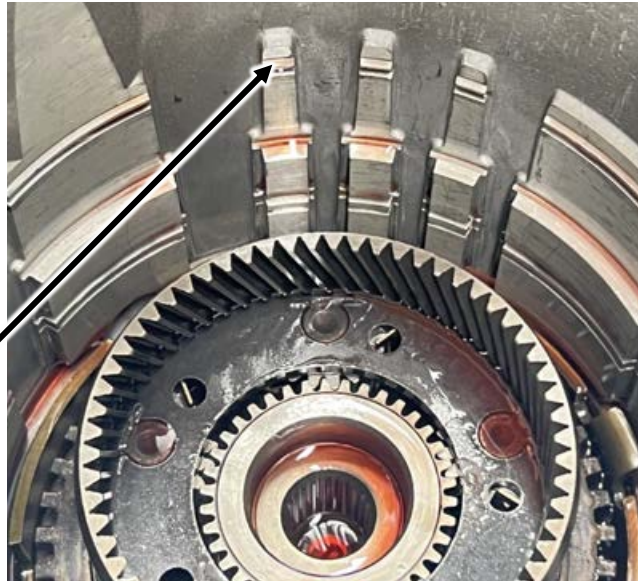
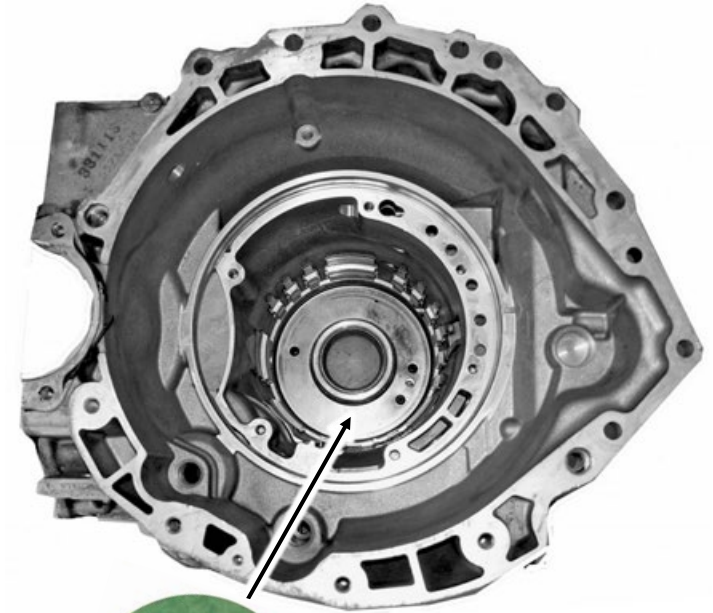
Step 2. After you've installed your clutches and piston housing, fit the new, wider 2-4 clutch piston retainer snap ring into the top groove.

This snap ring was re-engineered to significantly reduce deflection upon 2-4 clutch apply.

New, wider 2-4
clutch piston
retainer snap ring

Install **new non-shrinking gasket**

Step 1. Discard original L/R housing gasket. Install **new non-shrinking gasket** under piston housing. This gasket works great with all L/R piston housings.

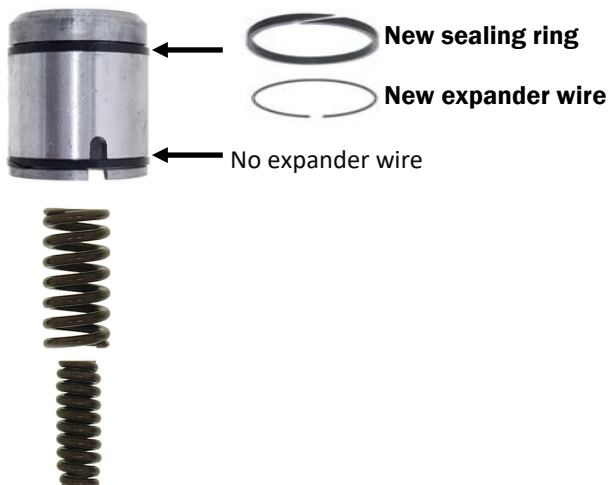
Step 3. Install the **3 new sealing rings** on the new 2/4 orange billet accumulator piston. Insert the **new plain 2/4 spring** into the piston. Do **NOT** use expander wires on the this piston.

(3) New sealing rings

New orange 2/4 billet accumulator
Redesigned to provide dual-sealing, closed end and middle ring seals in an unworn portion of the bore.

New plain outer spring

New Plain inner spring

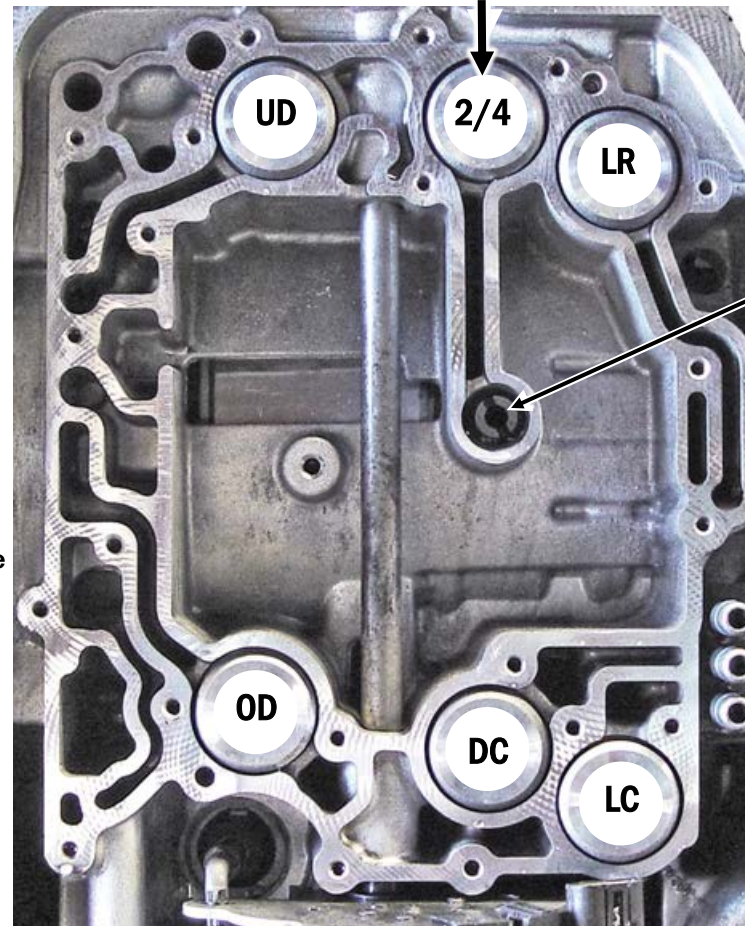
2-4 feed plug

Seal

O-Ring

Be sure to install the 2-4 feed plug exactly as shown.

Lube

Low clutch

Direct clutch

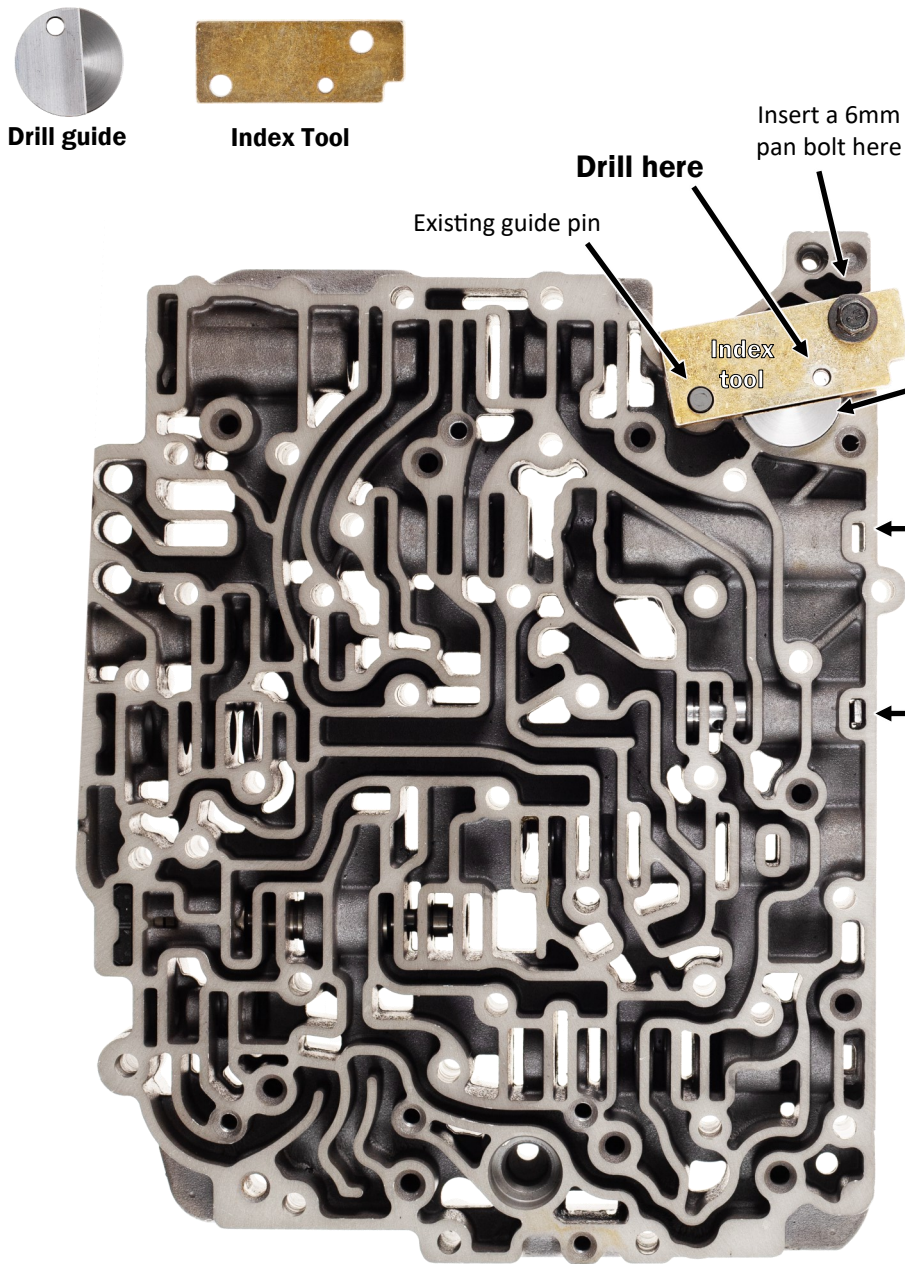
Step 5. Using the existing guide pin, drill jig, a pan bolt in the holes of **index tool** as shown. Next carefully and slowly drill through the casting with 0.156" drill bit provided **just enough to break through the pocket floor, then stop.**

Listen up! There must be **no air gap** between cup plug and hole. If for any reason the hole you drilled does not look perfectly round, use a little bit of Loctite® 518 flange sealant or alike on the cup plug. When done, clean any excess sealant, making sure none of it made it in the orifice.

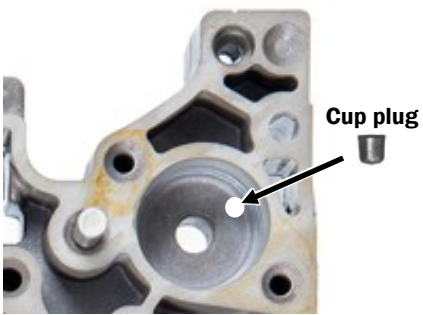
Step 6. Using a **flat punch**, insert **furnished cup plug** from the transducer side into the drilled hole until **flush** with the top of the casting.

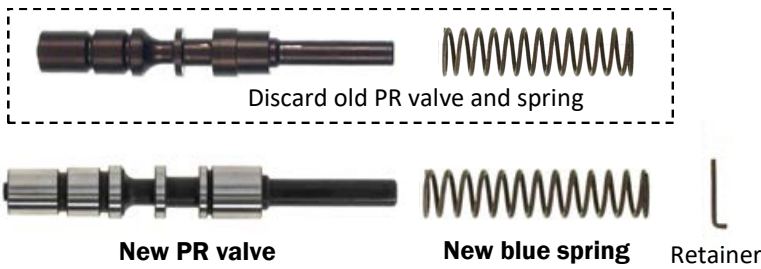
Step 7. Install **new PR valve**, ensuring it travels freely, then the **new blue PR spring**, and reuse the retainer.

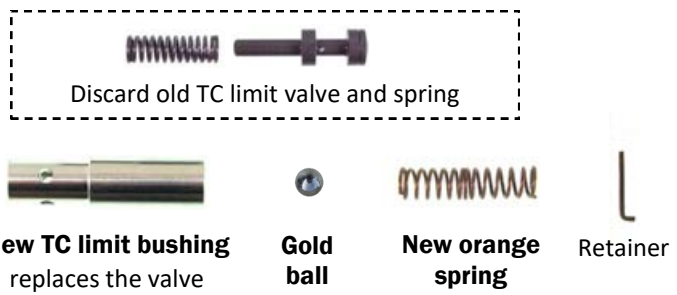
Step 8. Install **new TC limit bushing**, **gold ball**, **orange spring**, and reuse the retainer. **Regardless of the amount of bore wear this system works perfectly!**

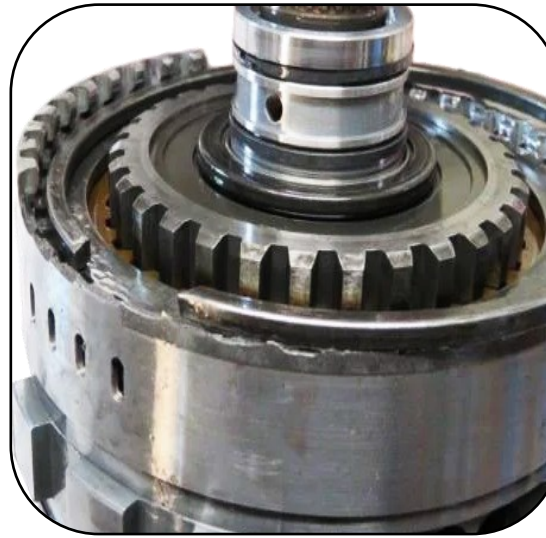
Figure 1

The low drum and case are prone to wear causing the snap ring to blow out the top of the drum. **(Figure 1 and 2)**

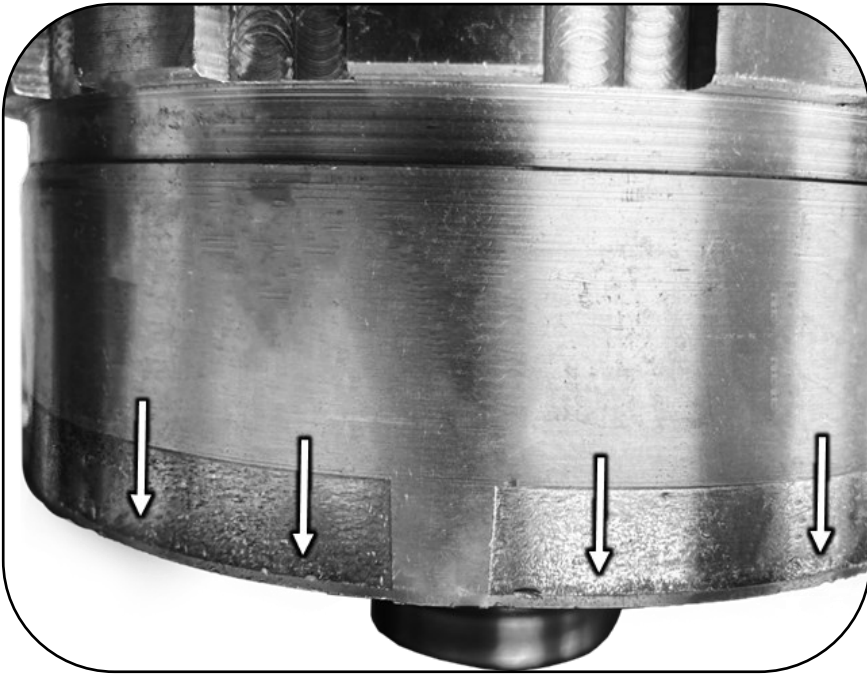
Figure 3

Always inspect the drum **(Figure 3)** and the case **(Figure 4)** closely for wear. The low drum should have an interference fit in the case. Removing the drum should be difficult and require the use of a slide hammer.

Look closely for low drum wear (as shown in the example above) where the arrows point on the side of the drum as well as where the drum sits against the lip in the case.

If the drum comes out easily without the need to use a slide hammer, the drum is bad, and must be replaced. Inspect the case for excessive wear as well.

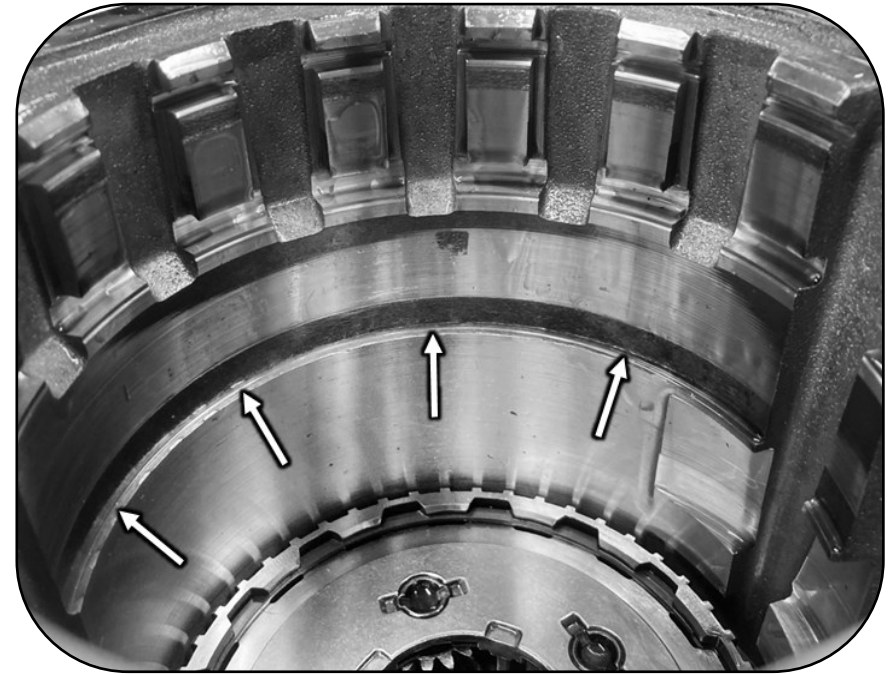
Figure 4

Look closely for case wear (as shown in the example above) where the arrows point at the lip where the low drum stops in the case as well as the area above it.

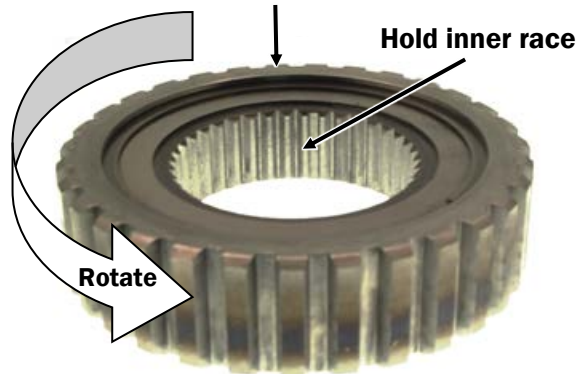
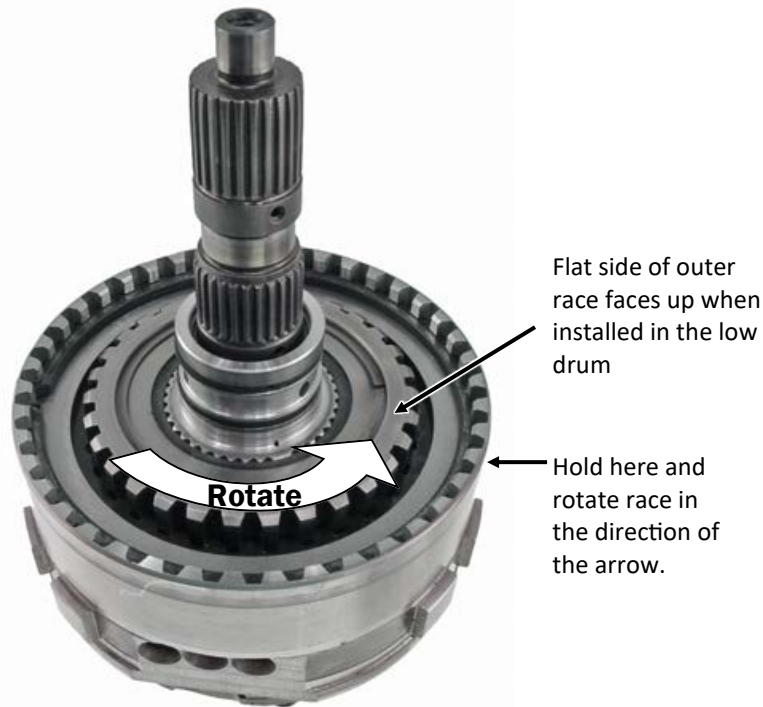
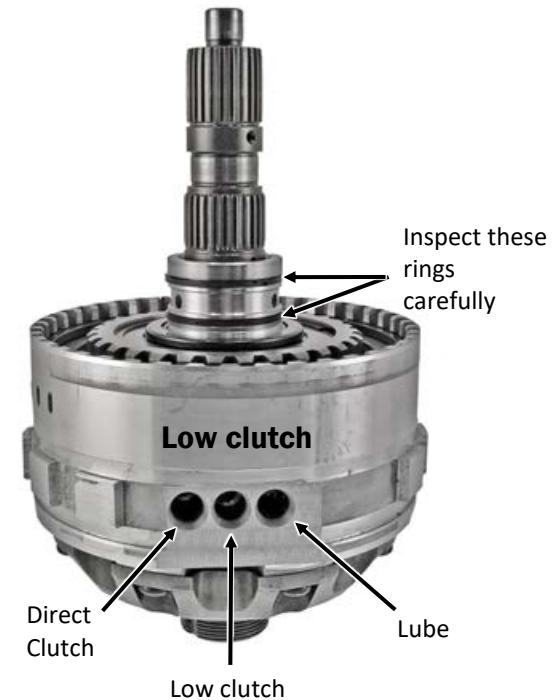
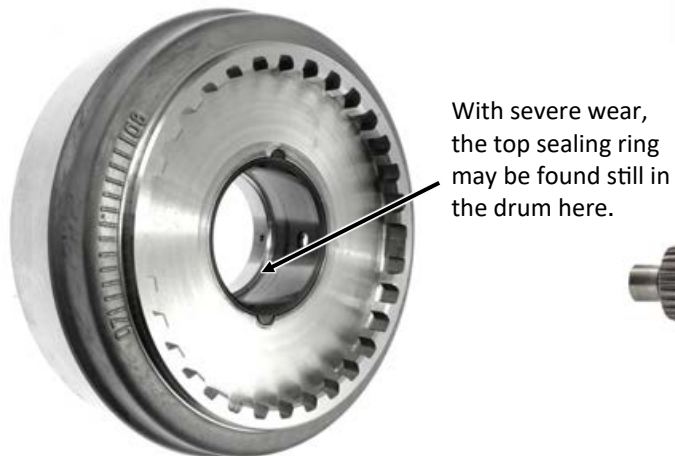
Compounder one-way clutch

The stepped side of the outer race faces into the low drum. When sprag assembly is installed in the low drum, the outer race must rotate counterclockwise while the drum held stationary.

Flat side of outer race faces up when installed in low drum

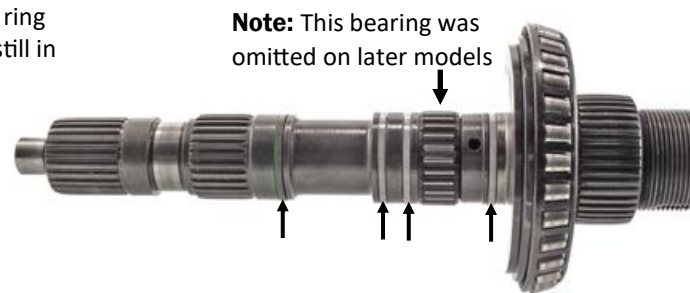
Direct Clutch

Loss of lube from shrunk sealing rings on the transfer shaft will accelerate wear on the ring tower causing direct drum rings to leak.

Transfer Shaft

These 4 rings like to shrink dumping lube oil that can lower main line and accelerate ring land wear on the low clutch housing. OE part # 68018615AA

Low Clutch Housing

Early rotating rings usually destroy the ring grooves on low clutch housing. Later housings are notched for non-rotating rings (OE part # 05078800AB) OE rings aircheck great and work excellent in these notched housings. **20-25 psi of regulated air must apply the direct clutches on the bench, don't assemble unit until they do!**

Updating the low clutch housing to the latest non-rotating ring type housing during overhaul is an great way to prevent rework due to ring groove damage. Even though it may not be damaged at time of overhaul, be warned, it does have a known high failure rate. Remember the customer pays for the parts now, you pay for them later.

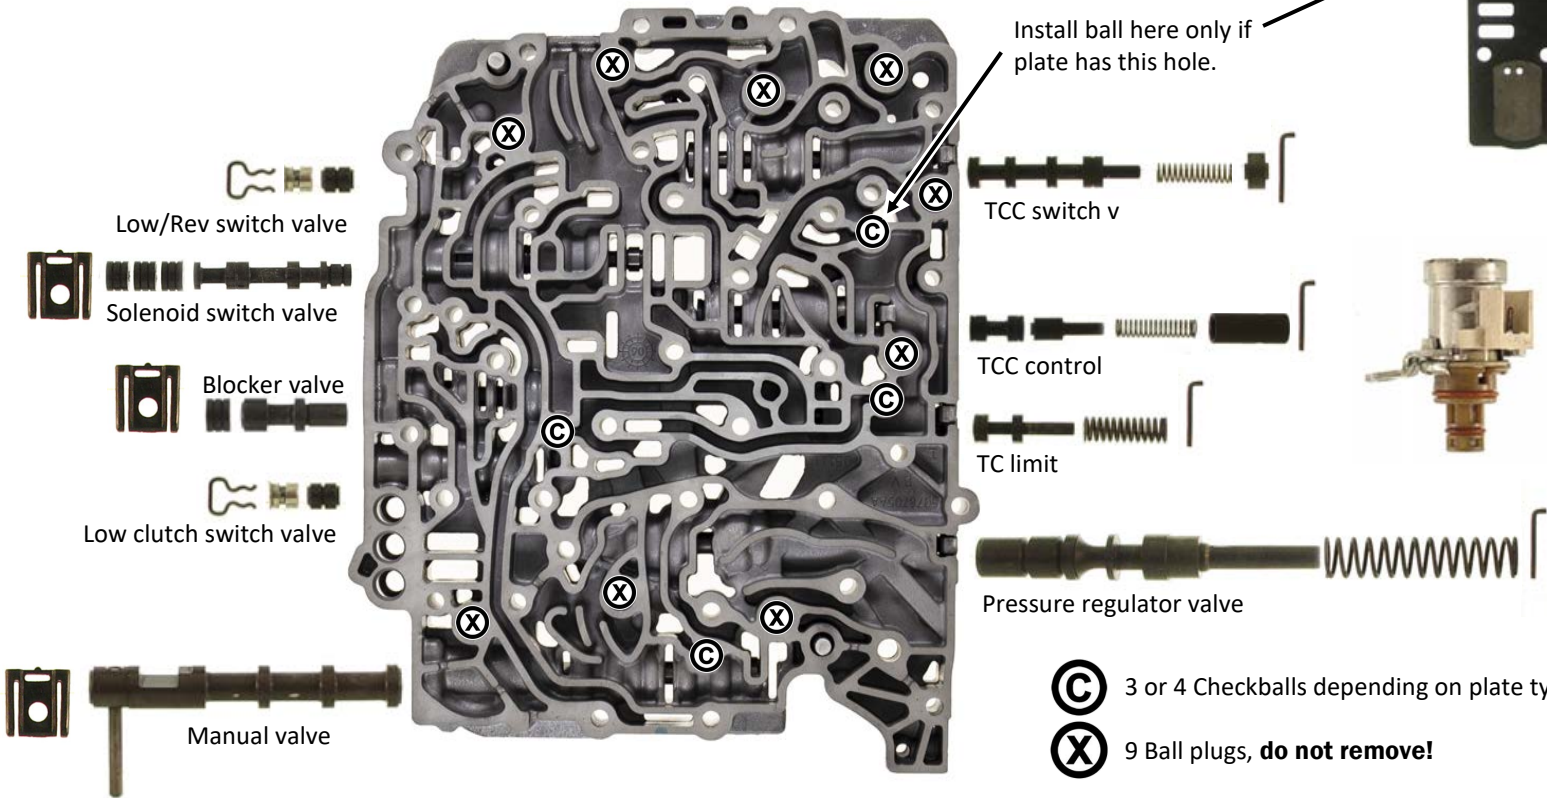
Install ball here only if plate has this hole.

TCC solenoid often fails causing “chugs” or “kills” engine at a stop. Replace it.

- Ⓒ 3 or 4 Checkballs depending on plate type.
- ⓧ 9 Ball plugs, **do not remove!**

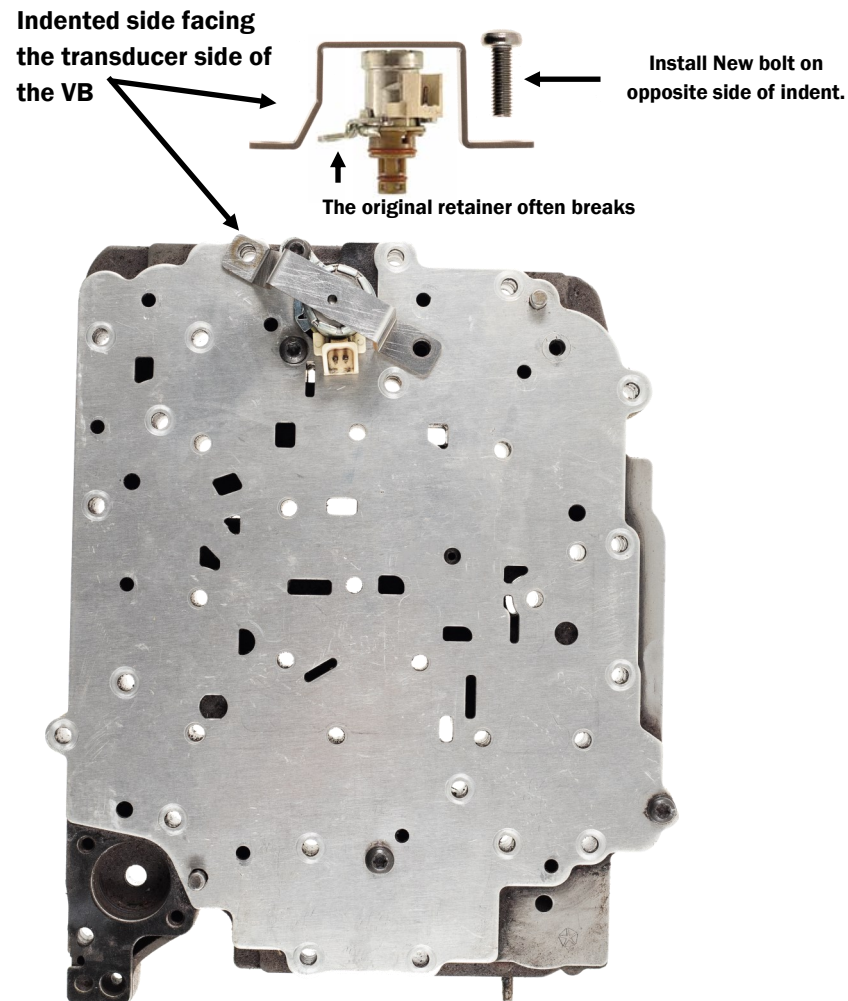
62TE-TCCSOL-BRKT

TCC solenoid often fails and breaks causing “chugs” or “kills” engine at a stop. Replace the solenoid and install our new retainer to prevent the solenoid from coming out when its original retainer breaks.

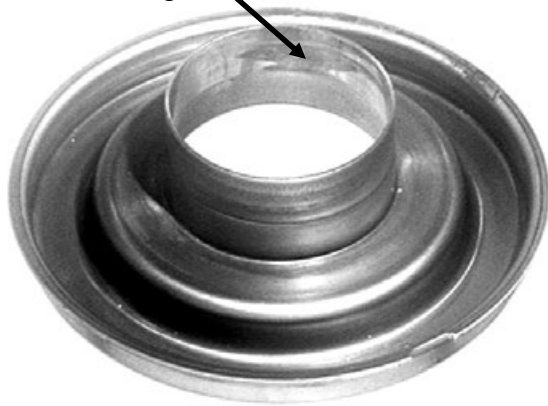
Close inspection of Underdrive piston bore will often show wear and a ridge where the piston has rubbed against the seal groove in the input hub. This ridge nibbles the seal and the wear causes a cold leak.

Inspect piston here
for wear and ridge.

PLEASE: Don't hone, sand, scrape, polish or try to fix the piston in anyway. Leave it as-is. If it's really bad, replace it and use the new expander & seal for a long term fix.

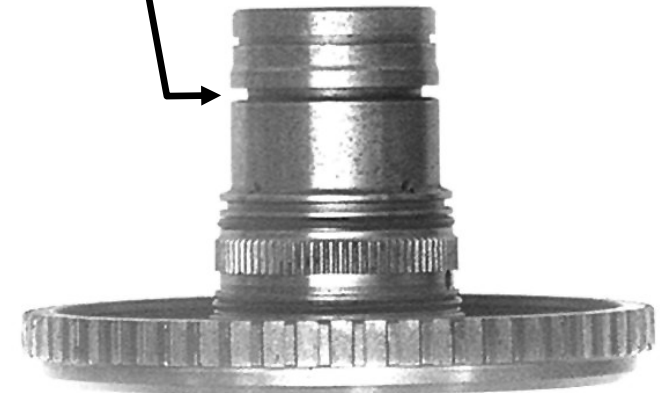
- A. Install wire expander into groove.
- B. Then install the seal.

Tough Seal

Expander Wire

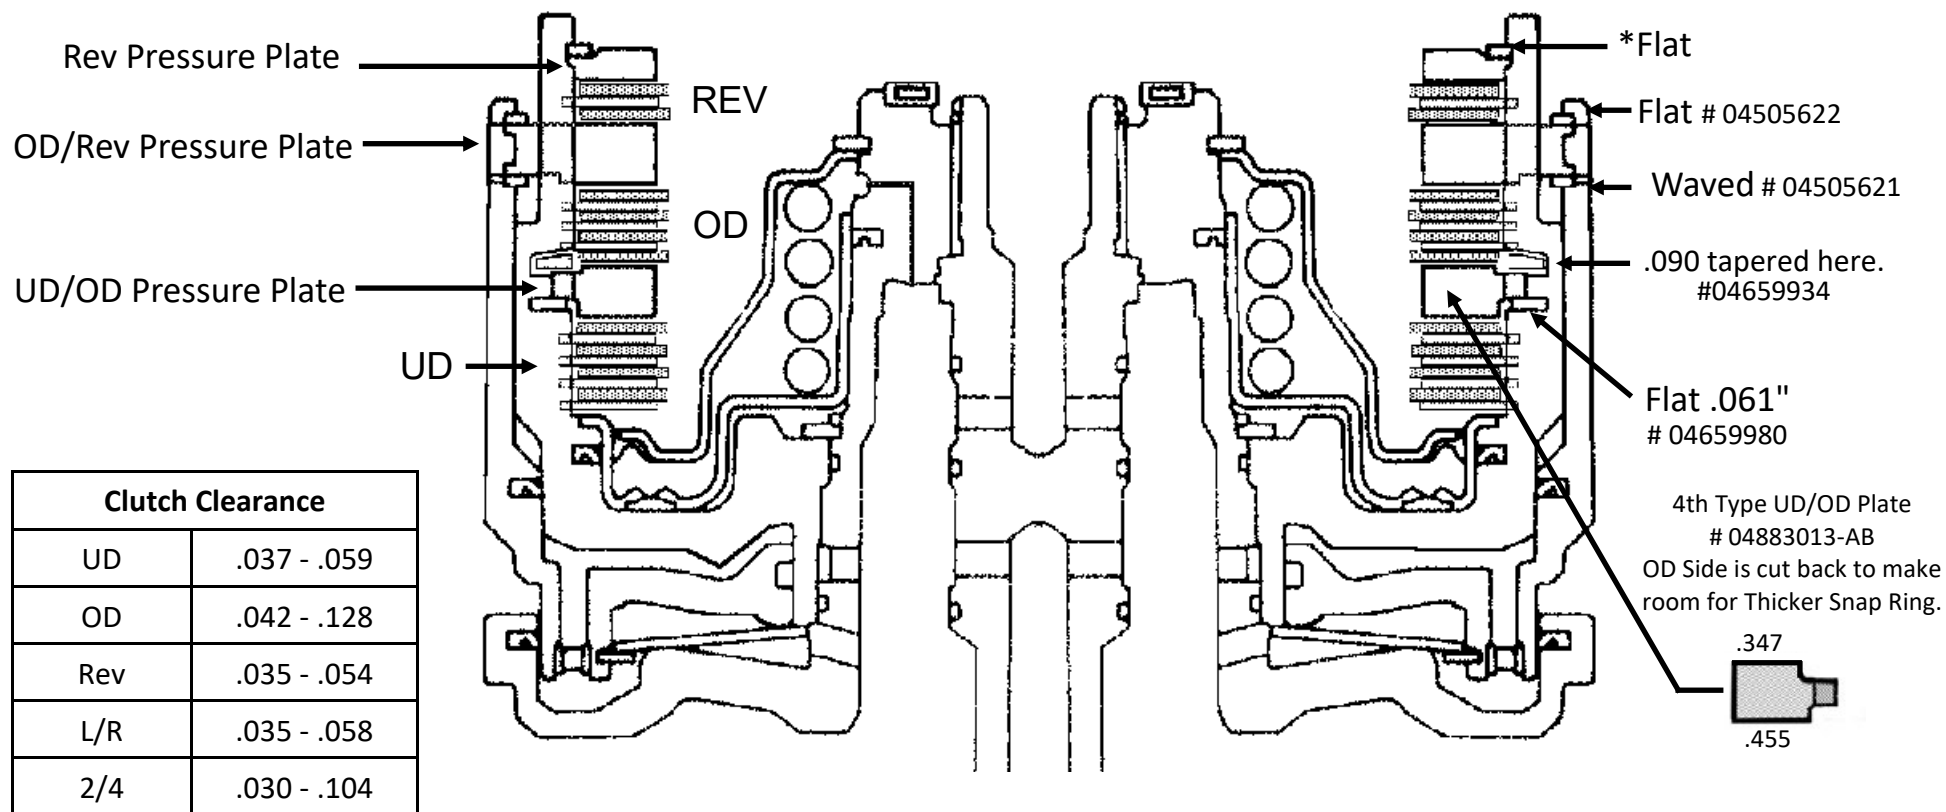
604/42RLE/62TE 4th Type** Stack-up

UD stack- Start with .068 steel plate, alternate .073 clutch plates, the stack will end with a friction. Install .061" flat snap-ring, 4th design UD/OD Pressure plate then tapered .090 snap-ring.

OD stack- Start with .073 friction plate, alternate with .068 steel plate. The stack will end with a friction plate. Install waved snap-ring, OD/Rev Pressure Plate then install flat snap-ring.

***Rev stack-** Start with .073 friction, .068 steel, .073 friction, Pressure Plate and flat selective snap-ring.

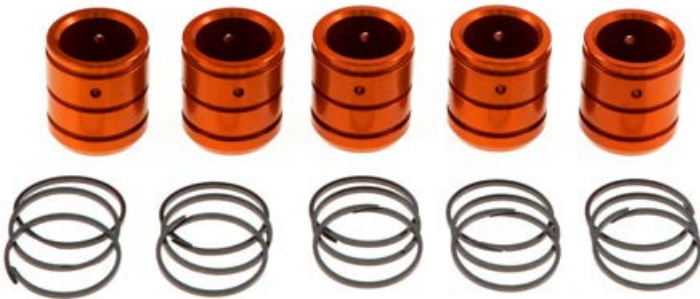
#RFE-ACMPST-KIT

Easy-to-install drop-in billet dual-sealing accumulator pistons. No time consuming special installation process or tooling required.

Billet Accumulator Piston Kit

- Two sealing rings double the sealing capacity over OE
- Our new additional center ring seals in a previously unused area of the bore allowing reuse of the valve body or case even when damaged by side-loading of the OE design accumulator piston

- The third ring, combined with a shallower groove in the piston, acts as a guide preventing damage from side loading the OE piston
 - Billet aluminum to avoid cracking
- Includes:**
- Five billet accumulator pistons
 - 15 scarf-cut PTFE rings

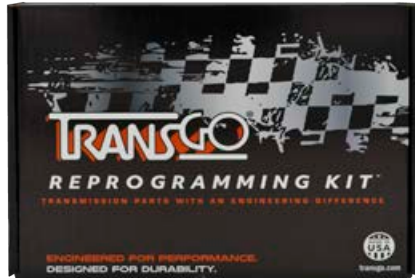
RFE: 1999-2018

High Pressure Tuneless™ Reprogramming Valve Body Kit™

- Internally balanced calibrations provide progressive, seamless clutch apply pressure increases to 210 psi max, a 30 percent increase over the OEM 160 psi max
- Re-engineered converter clutch charge system provides graduated TCC apply pressure increases with a built-in safety relief system to prevent converter ballooning
- No high RPM clutch failure often associated with aftermarket oversized drums

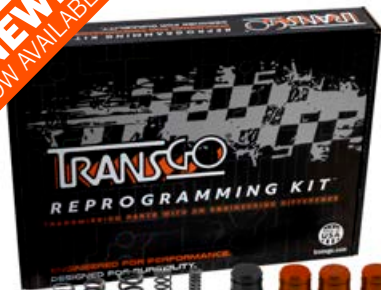
RFE: 2019-UP

High Pressure Tuneless™ Reprogramming Valve Body Kit™

- Essential fixes and major durability upgrades for the top complaints of repeat UD and/or OD clutch failure

- Stops repeat underdrive clutch failure after raising line pressure with turning and other internal modifications
- Adds 36% more line pressure at all throttle openings without the need of computer software

- Reduces OD clutch failure with added power
- Major performance and durability upgrades
- Perfect for performance and hard-working trucks
- Short, clean shifts that really hold the power
- Calibration that relearns quickly

- Stops rough lockup when using triple disc converters
- Prevents converter drain back
- Allows use of pump cover with worn TC limit bore
