48-Act-TL 4L80E Actuator Limit Valve Repair Kit

4L80E Saves Worn Valve Bodies

Actuator Limit Valve Repair Kit

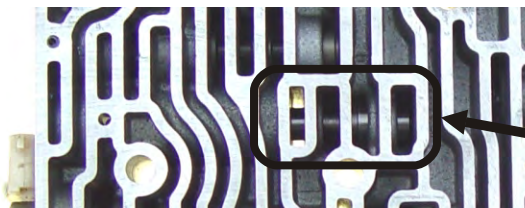
Look for wear: Move valve back and forth slightly while feeling for up and down or side to side wiggle.
