# 5R1-PMP-ALIGN

Fits: 5R110W 2003up

Severe Damage from Misaligned Pump

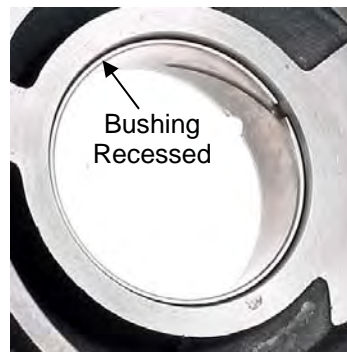
Bushing must be **recessed below** gear pocket surface or you'll bind the Drive Gear against the pump plate. The bushing must always have some clearance between it and the pump gear. Position the lube groove as shown.

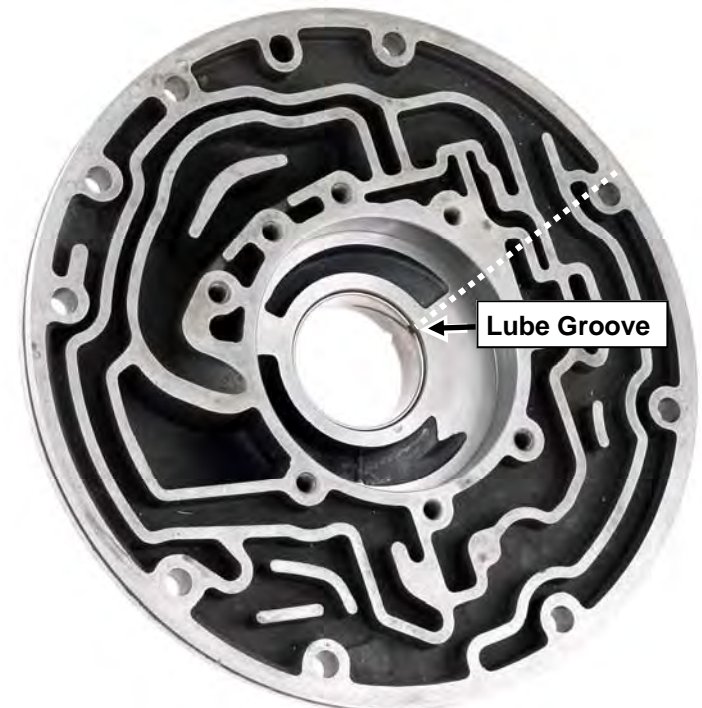
If you **can't re-use** the original pump bushing, then index the *Lube Groove* of the new bushing into the Pump Body using the factory position as shown and recess the bushing as shown on left.

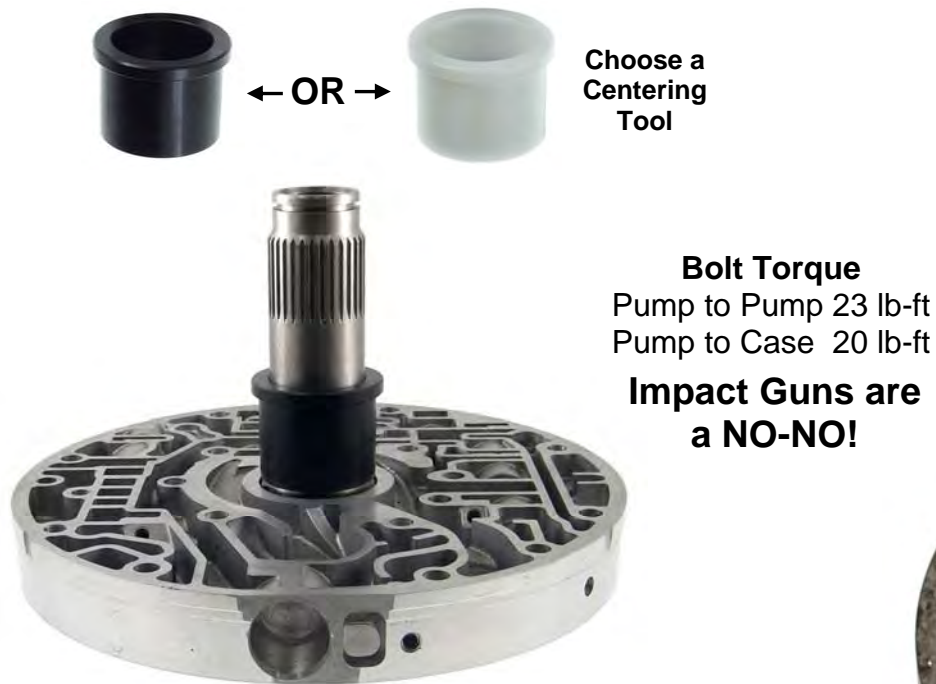
Choose the alignment tool that fits your stator tube the snuggest without forcing it. The white tool has a slightly larger inside diameter than the black, both tools have the same outside diameter under the shoulder.

Select the tool that fits the stator tube and set the other unused tool aside and out of the way.

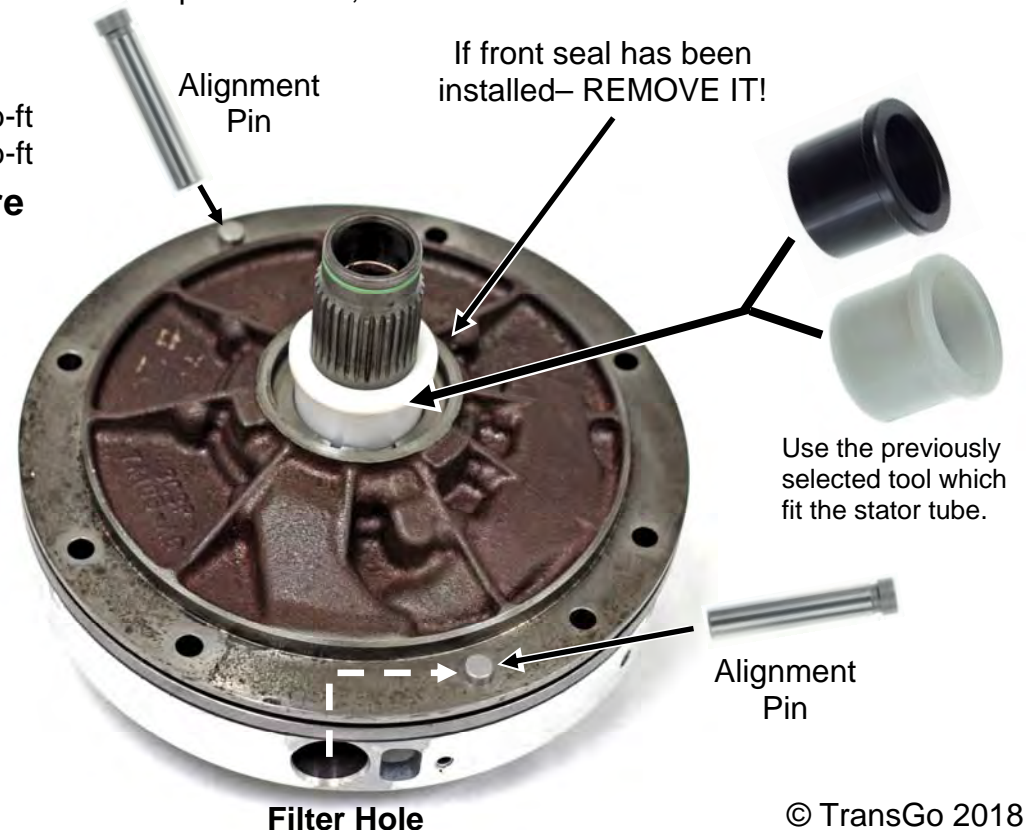
The idea here is, the tool fits snug to the stator tube and the taper on the tools outside diameter centers the Pump Bushing to the tube as you push the tool down. **Do not use force!** When taper seats into the bushing. **Stop!** You're done!

The stator & bushing are now perfectly centered to each other. Now just snug the outer band to center the wear plate. Torque the bolts, remove the tools & install the front seal.

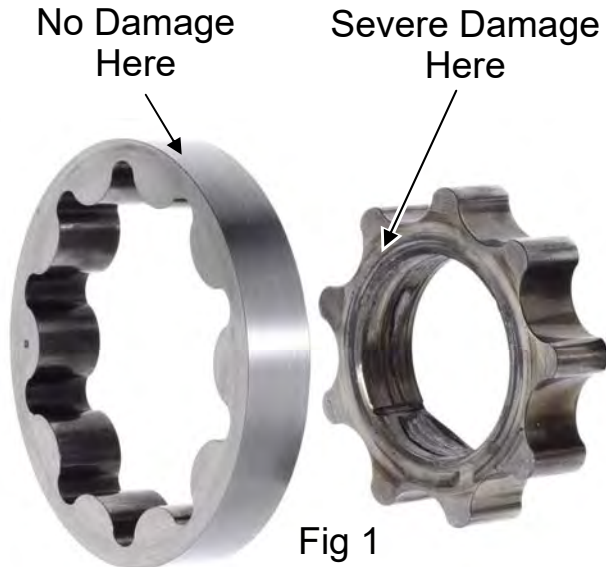
Electrical ground failure or a tight pump bushing clearance will weld the inner gear to the pump plate.

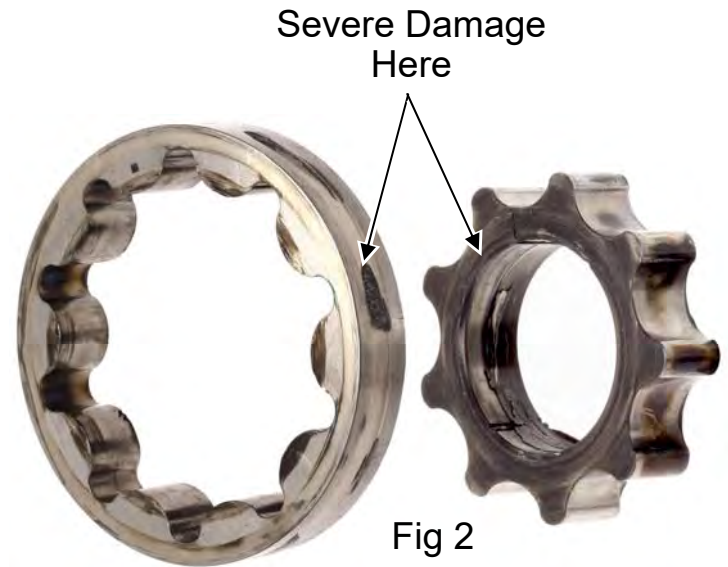
Lack of oil, restricted filter, dry start-up or aggressive TCM programming. Both gears are equally black & blued.

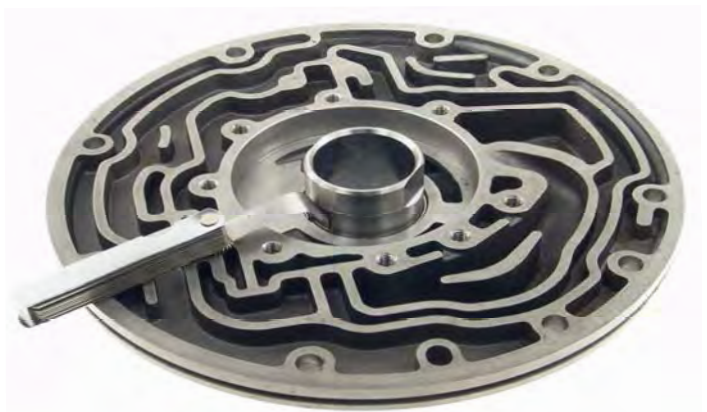
**Pump Bushing To Hub Clearance: If the pump bushing or the converter is changed the bushing to hub clearance must be checked.** Place the feeler gauge through the pump bushing bore then drop the pump body over the converter hub.

**Clearance, min .0025" max .0045".**

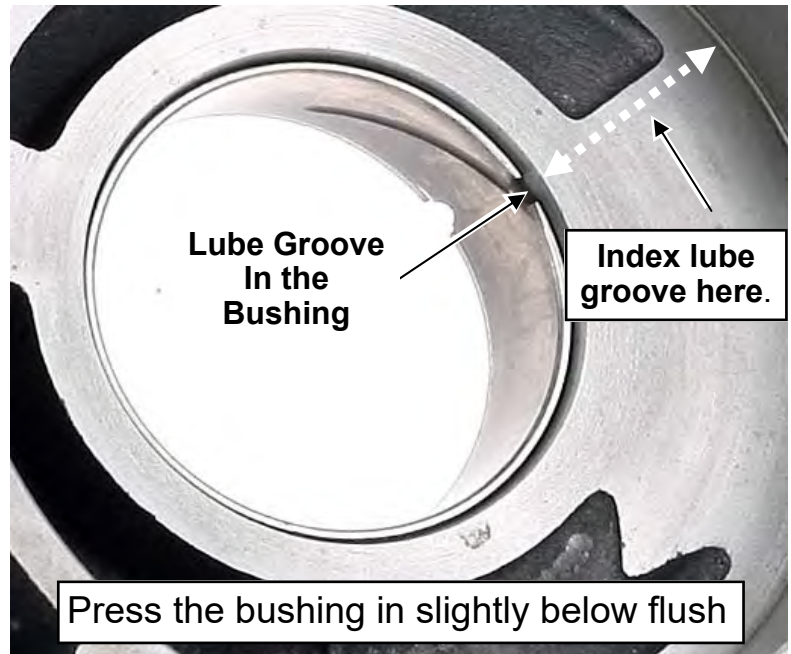
**Some 5R110 pumps have been found with an offset bushing bore. This required the factory to machine the bushing in place, another reason to leave the OE bushing alone. Always use a pump alignment tool that centers the bushing bore to the stator tube. See: TransGo 5R1-PMP-ALIGN.**

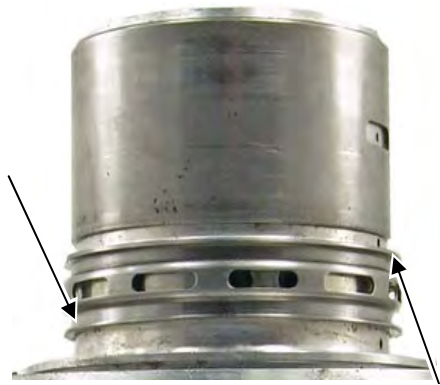
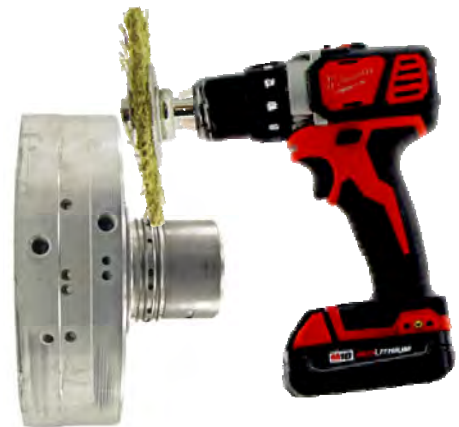
The arrows are pointing to the outside of the ring grooves where the rings need to seal. This is the area where the bronze particles accumulate and imbed into the support.

A common tech call that we receive is how poorly the direct drum air checks through the center support. Many of the center supports that we tested had bronze particles imbedded into the side of the ring grooves preventing the rings from sealing. The bronze material is coming from the drum bushings. Always replace the drum bushings. A wire wheel on a drill or a piece of green scotch-brite used with a small screwdriver on a lathe are effective tools to remove the bronze build up. Once the imbedded bronze was removed a majority of the “bad” supports would now air check with 35-45psi. If the drum still does not air check after a good cleaning with new Ford rings #3C3Z-7D025AA the support ring groove is cracked, scrap it.
