# SK® O9G

(Also Fits TF60SN)

## Reduces/Corrects/Prevents

Harsh Shifts, Cut-Loose, Rough Coasting  
Downshifts, Slow Pressure Rise, TCC slip.

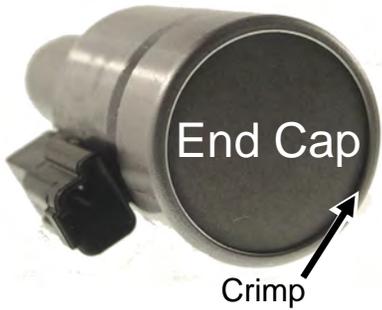
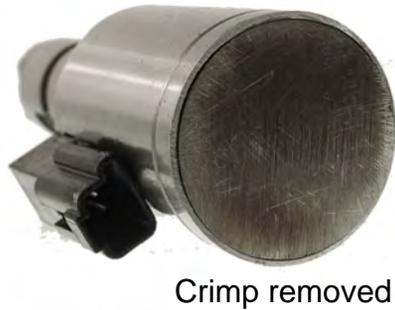
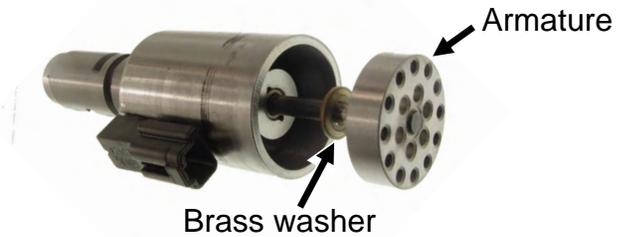
## Step 2

Grind crimp until end cap falls off.  
Use side of bench grinding Wheel.

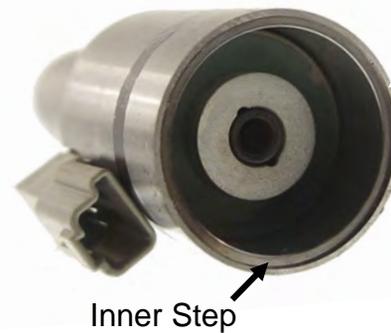
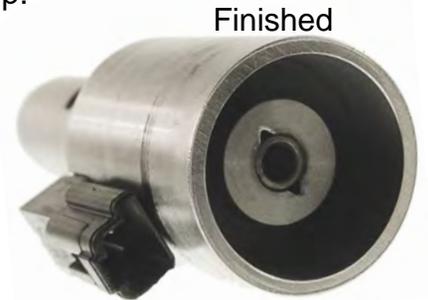
## Step 3

Remove Armature & washer. Grind Body flush with inner step.

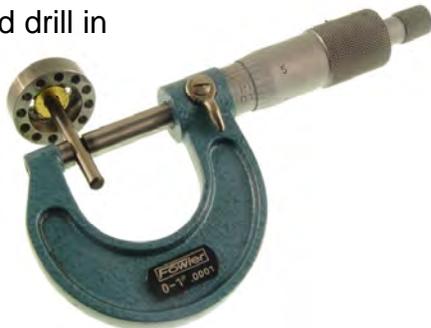
## Step 4

Measure the Shaft.  
.156-157 use long drill  
.154-155 use short drill  
Use selected drill in  
**Step 5.**

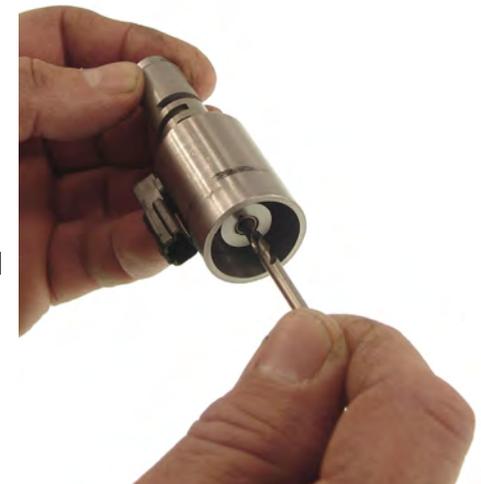
## Step 5

Turn Drill **counter clockwise by hand** insert it all the way into Solenoid. While holding the Drill turn the Solenoid both directions for 15 seconds. **Turn the drill counter clockwise & remove the drill.**

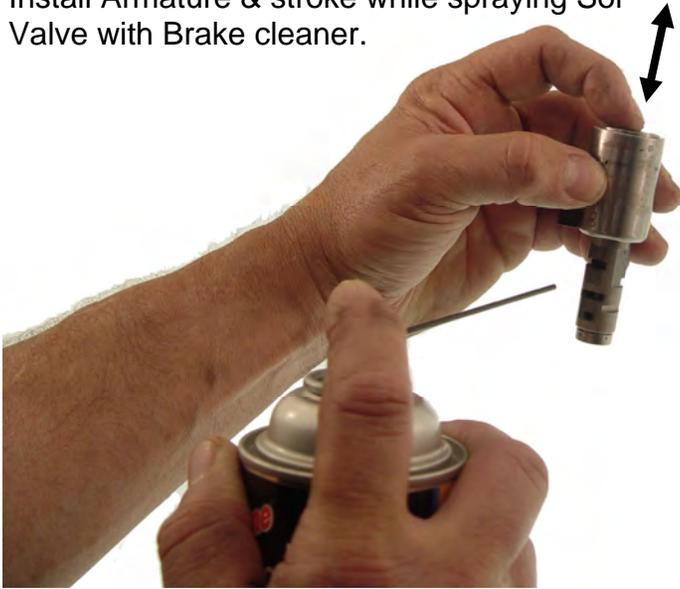
## Step 6

After resizing Solenoid Bushings clean out debris with brake clean & blow out with air. Install Armature & stroke while spraying Sol Valve with Brake cleaner.

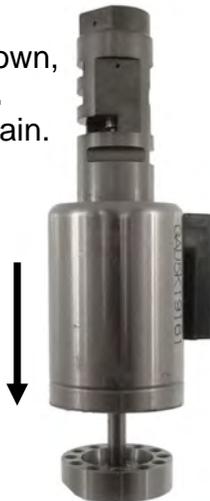
## Step 7

Hold Solenoid upside down, Armature **must fall out**. If not perform Step 5 again.

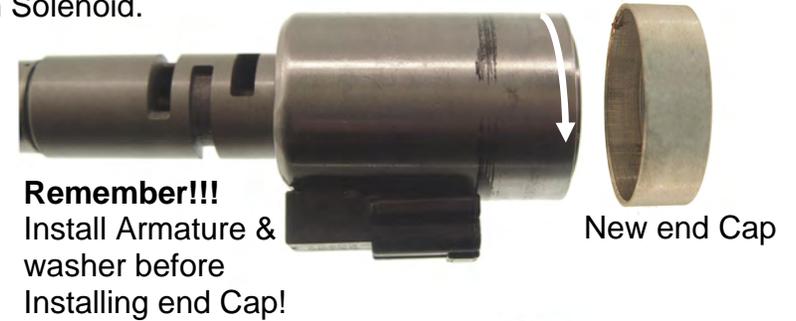
## Step 8

Lay a narrow bead of Red Thread locker around the end of Solenoid Body. Keep Thread locker away from inside of Solenoid. Position new end Cap on Solenoid.

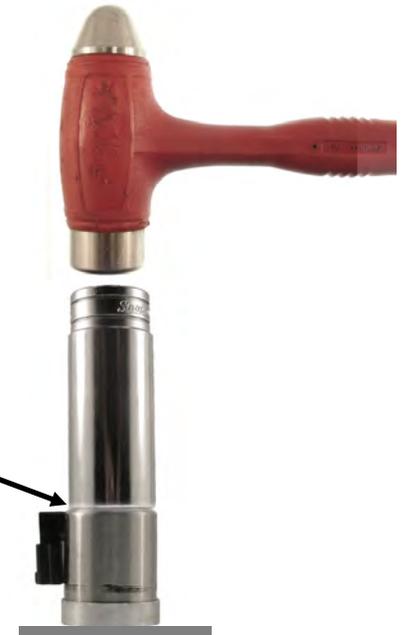
## Step 9

Stand Solenoid on end cap. Place deep 1/2" drive 3/4" socket over Solenoid Snout. *Lightly* tap the Socket to seat the Solenoid into the Cap.

**Socket needs to rest on Solenoid Body**

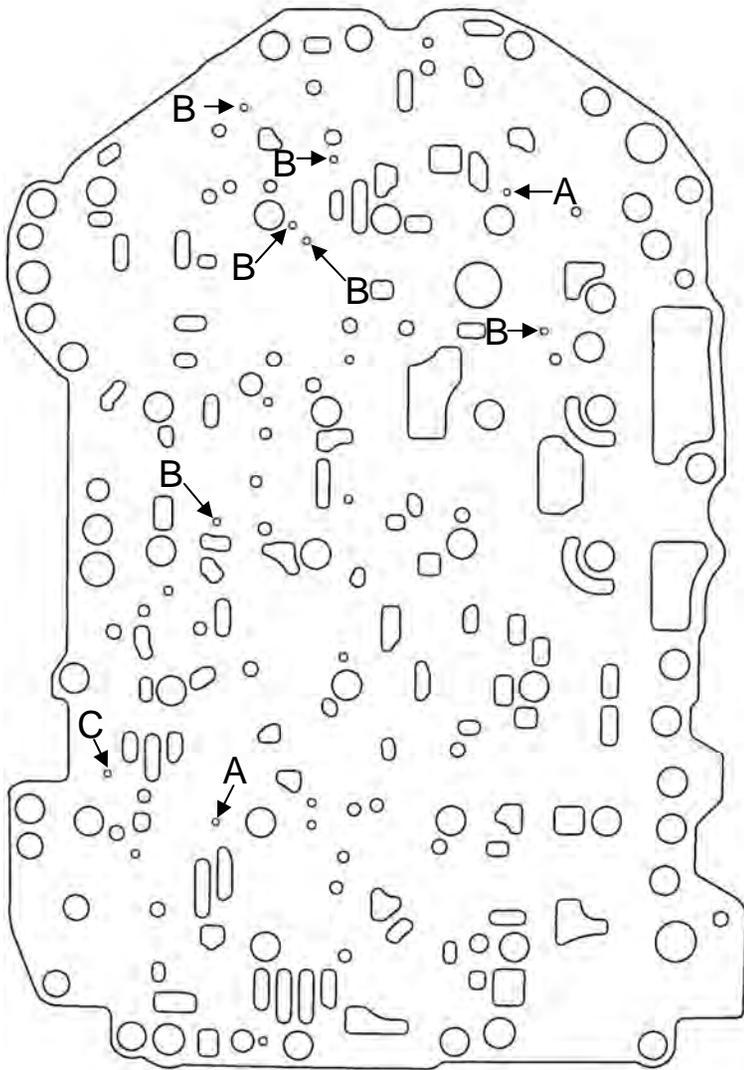
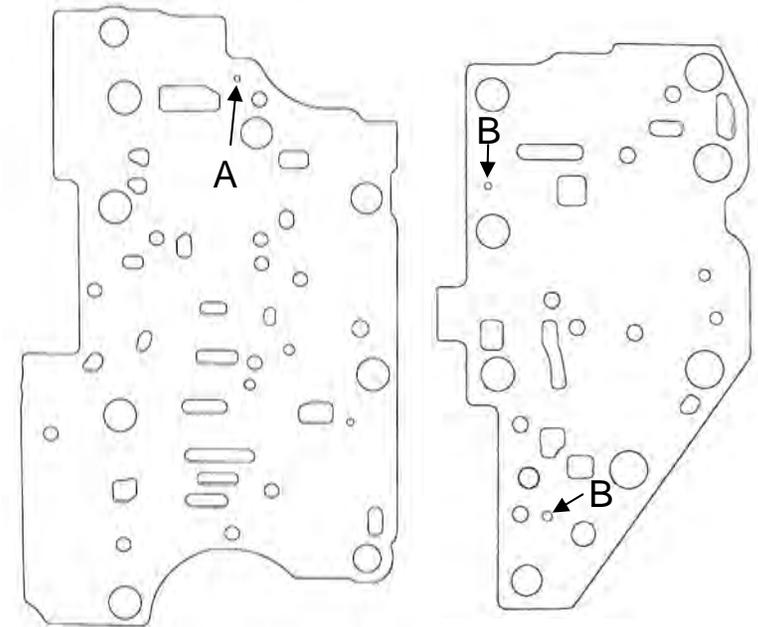
## Step 10 Separator Plates

Enlarge 3 holes A- .041  
Enlarge 8 holes B- .046  
Enlarge 1 hole C- .076

After drilling recheck by  
counting the holes drilled.

Use care when drilling!  
Look twice drill once!

**Note:** Enlarging these holes allows for the normal wear in solenoid to valve control circuits and creates a more positive signal between solenoids and valves. These are **NOT** clutch circuit feed holes to make firmer shifts!

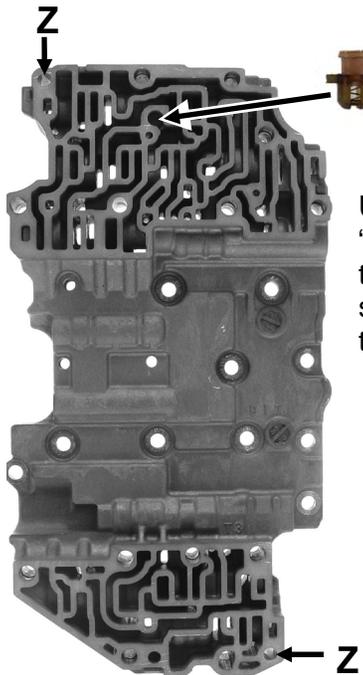
# Valve Body Reference Data

Use 2 Long bolts in "Z" locations as guides to align the main VB sections before tightening any bolts!

.610x.247x.025 6oz@.540

B2 control Valve  
.377x.162x.018  
6oz@.330

K2 clutch acc check valve.

Pressure regulator  
1.432x.518x.045 5-12@.737

Pay attention to Retainer position before removing! Re-install as found.

Secondary PR Valve  
1.500x.412x.048 7-5@.932

Sol regulator N88-90/N282-  
N283 .983x.314x.042 8-6@.616

Cooler bypass  
.555x.248x.042 9lb@.453

K3 Regulator  
.800x.325x.042 4-8@.590

B1 Regulator  
.746x.249x.037 4-8@.585

K2 Regulator  
.737x.257x.035 3-0@.585

K1 Regulator  
.804x.324x.035 4-4@.482

Lube limit valve- (Not all models)  
.620x.245x.037 5-6@.453
