SHIFT KIT[®] TURBO HYDRA-MATIC 400

Mechanic: We thought you might like to know what the kit does and how it does it.

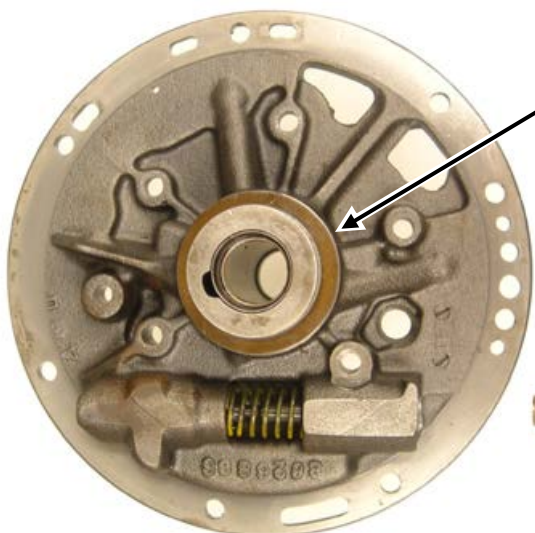
Don't reduce front end play by installing thicker washer here. Forward rings can miss locate in the drum, causing forward clutch failure. Shim drums forward to reduce front end play. Where to get shims?- TransGo 4L80 HTRK. Rear unit end play (behind support) must remain less than front end play so that rear unit thrust does not reach the pump washer. Push up on output shaft while checking for front endplay! Apply air to 2nd Clutch while checking for rear endplay.

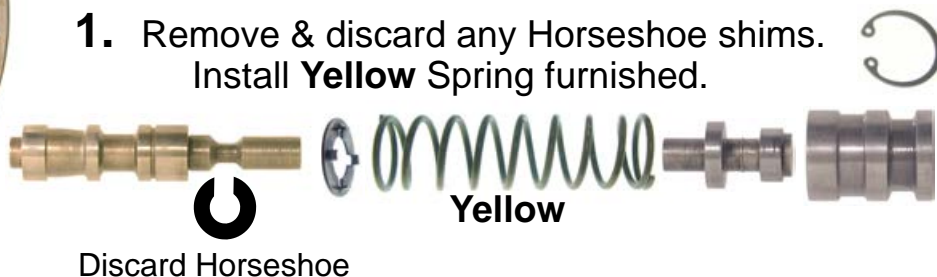
1. Remove & discard any Horseshoe shims. Install **Yellow** Spring furnished.

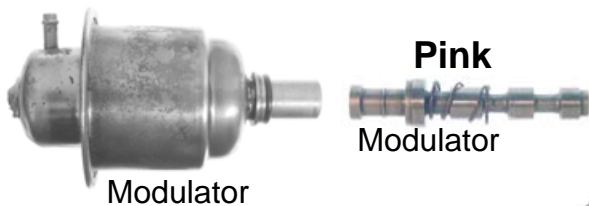
2. Modulator Valve Spring: Install **Pink** spring. After road test, if later/shorter 3/8 throttle shifts are needed, remove PINK spring.

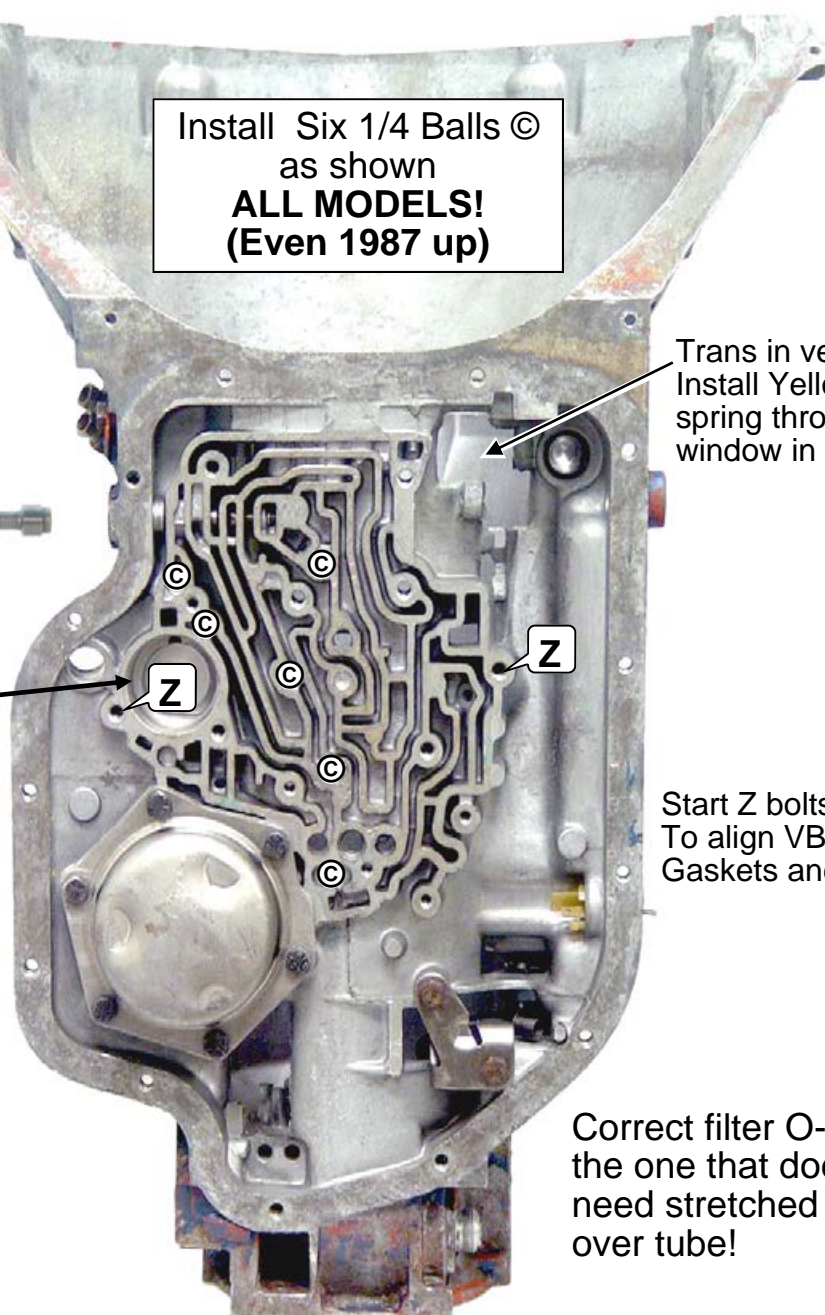
Don't forget to install the piston and pin here.

Install Six 1/4 Balls © as shown **ALL MODELS! (Even 1987 up)**

Trans in vehicle? Install Yellow spring through window in case.

Start Z bolts first. To align VB, Plate, Gaskets and Case.

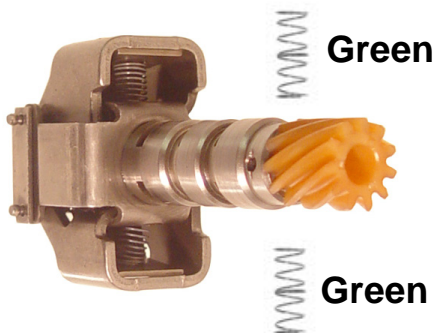
3. Want earlier shifts: Install new **Green** governor springs. Don't disassemble governor

Correct filter O-ring is the one that doesn't need stretched to go over tube!

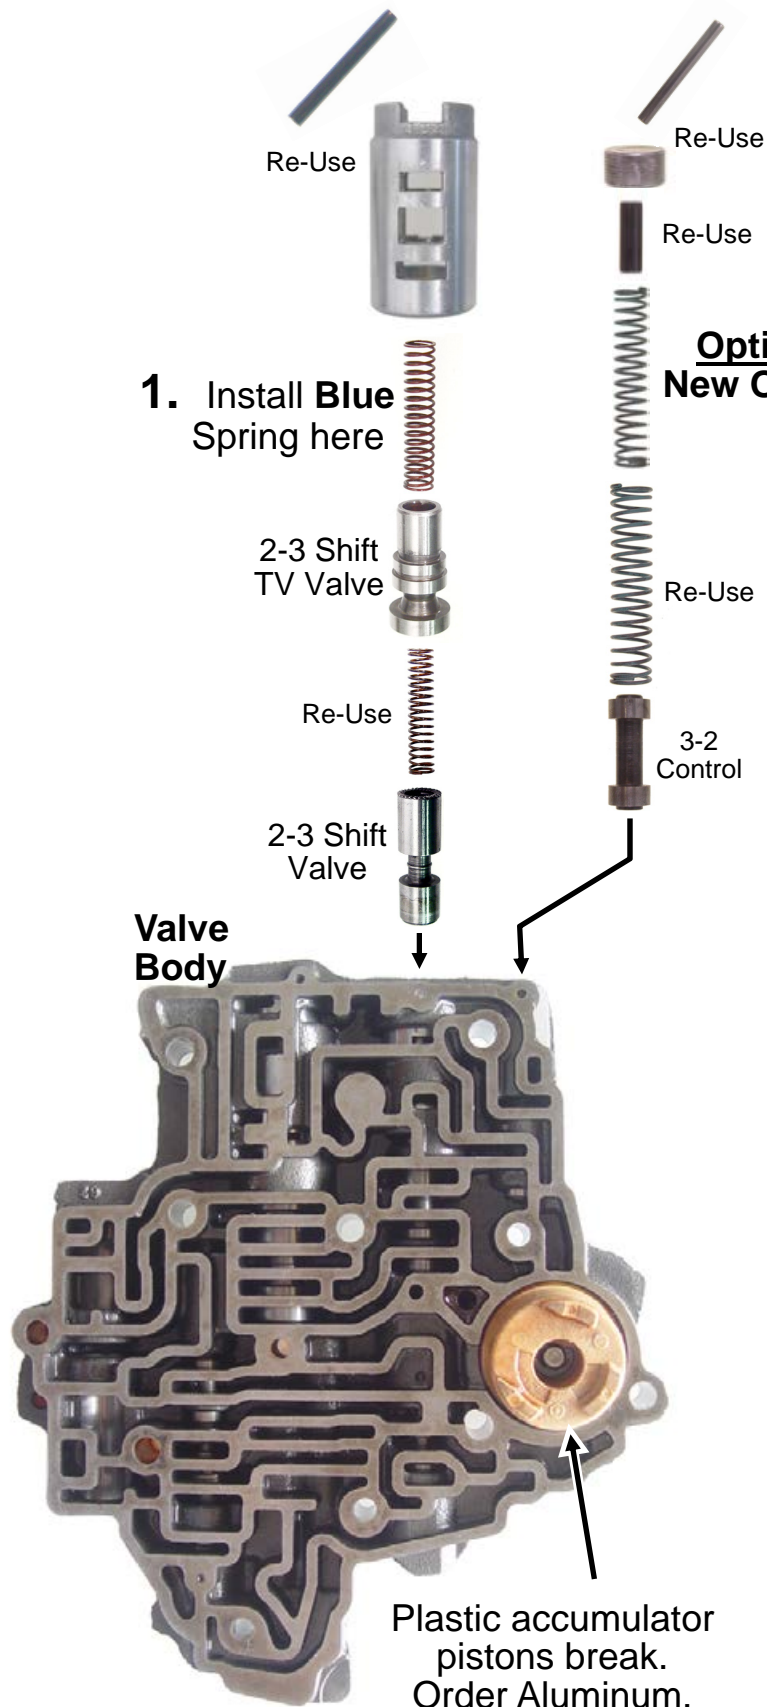
Valve Body & Plate

Optional:

For more low speed, 3-2 part throttle sensitivity, install **New ORANGE** spring *inside* the original 3-2 control spring. Re-use spacer & end plug.

Optional New Orange

Trans in vehicle:
Install Six 1/4" Checkballs
All Models!
(Even 1987up 7 ball models!)

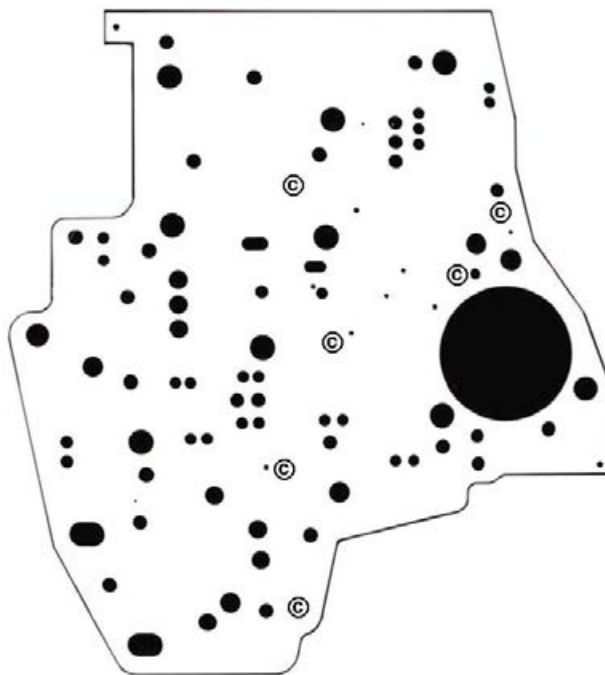
New SK[®] plate produces short smooth shifts. This product is not for making firm Hi-Perf type of shifts. If you want firm shifts and complete gear control order TransGo Reprogramming Kit.

The separator plate in this kit, working in coordination with the pressure regulator spring, furnishes more oil flow and pressure to the intermediate clutches allowing them to engage before the accumulator is compressed. If the clutches are of reasonable quality and condition, the result will be a quick and smooth 1-2 shift.

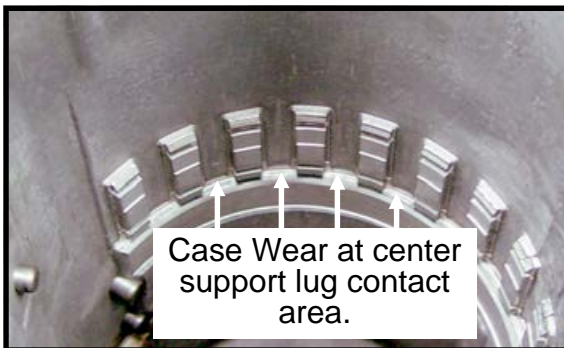
Case Wear: This case wear problem that has driven many a good man right up the wall. Wear at this point allows excessive center support movement and misalignment. This can cause high clutch failure, late or no 2-3 shift, falls out of high when hot; center support bushing wear, front planet wear and stator support failure. Only use center support that uses a steel shim in the case under the support.
