# SK<sup>®</sup> 5R110W-A

2003 Up

## Reduces/Corrects/Prevents

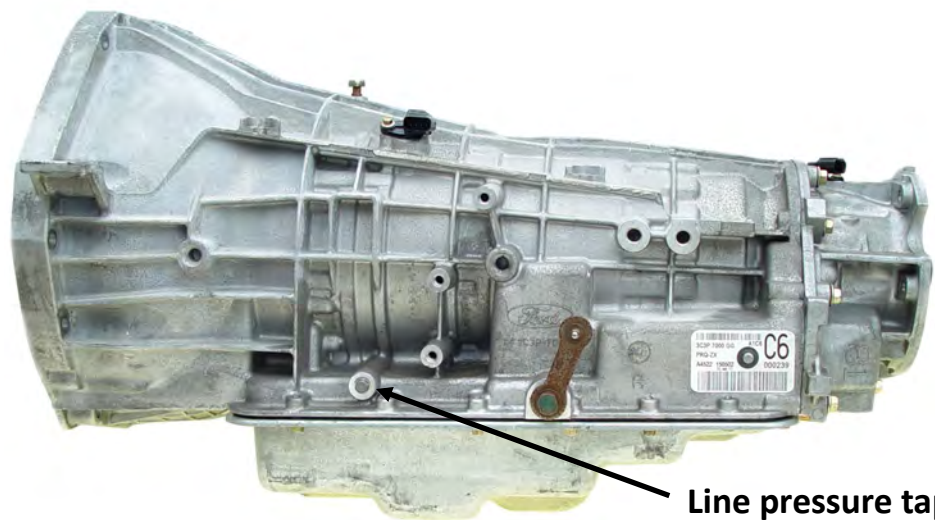
Line pressure tap

Very common for this trans to have a high line pressure error, up around 450 lbs, especially in reverse with throttle ON. Sooner or later this *will* blow off Low Reverse snap ring lugs, destroying the case. **OUCH!** 😞  
The Shift Kit<sup>®</sup> has upgrades that brings pressure to safe specs, plus a tougher L/R snap ring.

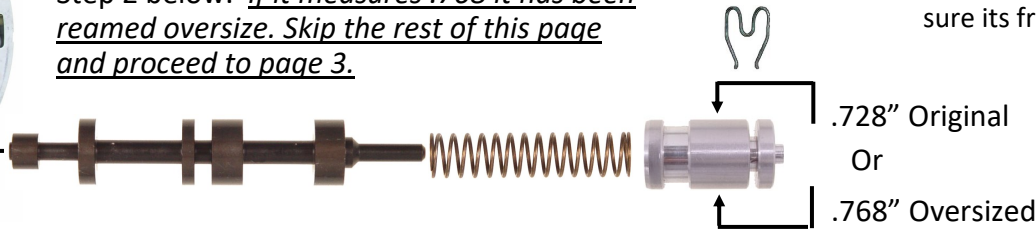
Assemble New PC Limit Bushing that measures .728"

New .728" bushing  
 Has No ID Groove here.

Ball  
 .187"

Orange  
 Spring

Cotter Pin

Assemble New .728" Diameter PC Limit Bushing: Insert .187 ball into bushing first, then insert and compress Orange Spring with the small end of the paper clip. Install cotter pin into bushing thru holes and spread legs of cotter pin. **Remove** paper clip with pliers.

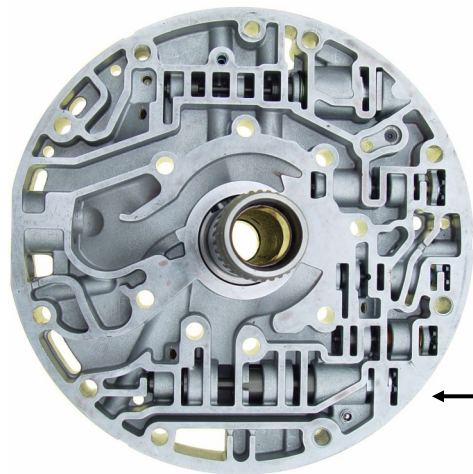
**New Steel PR Valve** replaces factory grooved or non-grooved PR Valves. Do not use in oversize bores.

New Plain

Retainer

.728"  
 PC Limit  
 Bushing

**New Steel 2 piece PR Valve Installation Check:** (Used with .728" size PC Limit Bushing only.)  
 Insert both **New Steel** PR Valves into the bore and check for smooth movement. Any ridge or burr that creates a tight spot **MUST** be flattened to prevent sticking. Here's how: **Move valve onto the tight spot.** Use a 11/16 open end wrench as a hammer and flat blade screwdriver on the valve, tap the screwdriver in the areas between the polished lands to loosen the tight spot. Re-check for smooth movement. **Do NOT tap on the polished Lands of the valve!** Assemble as shown below.

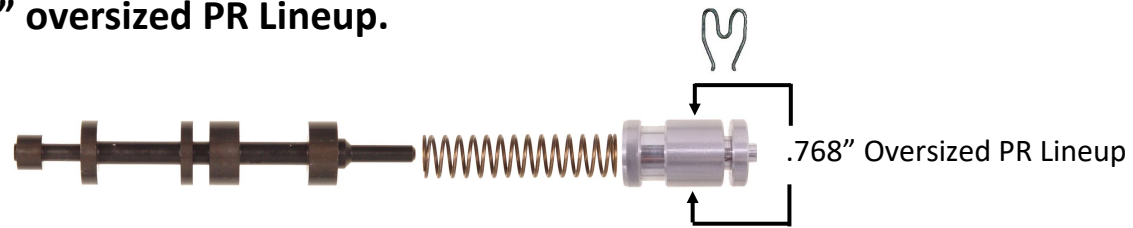
Assemble New PC Limit Bushing that measures .768"

Ball .187"

Cotter Pin

Assemble the New .768" Diameter PC Limit Bushing: Insert .187" ball into bushing first, then insert and compress Orange Spring with the small end of the paper clip. Install cotter pin into bushing thru holes and spread legs of cotter pin. **Remove** paper clip with pliers.

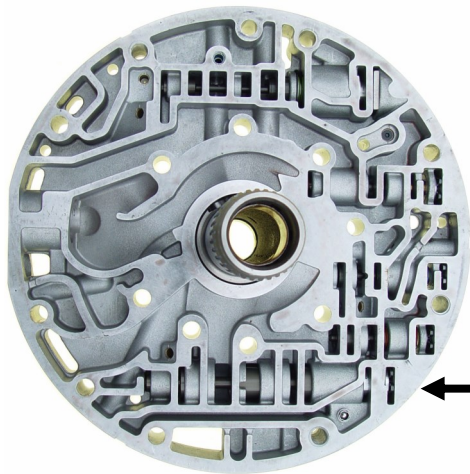
Re-Use **Original** PR Valve & Spring the Pump came in with. Install New Assembled .768" PC Limit Bushing & New Retainer.

Re-Use Original Oversized PR Valve

Re-Use Original

.768

Retainer

Oversize PC Limit Bushing

Do not Tap on or use Sandpaper on Aluminum Valves!  
If oversized PR is sticking or dragging **REPLACE** Pump!

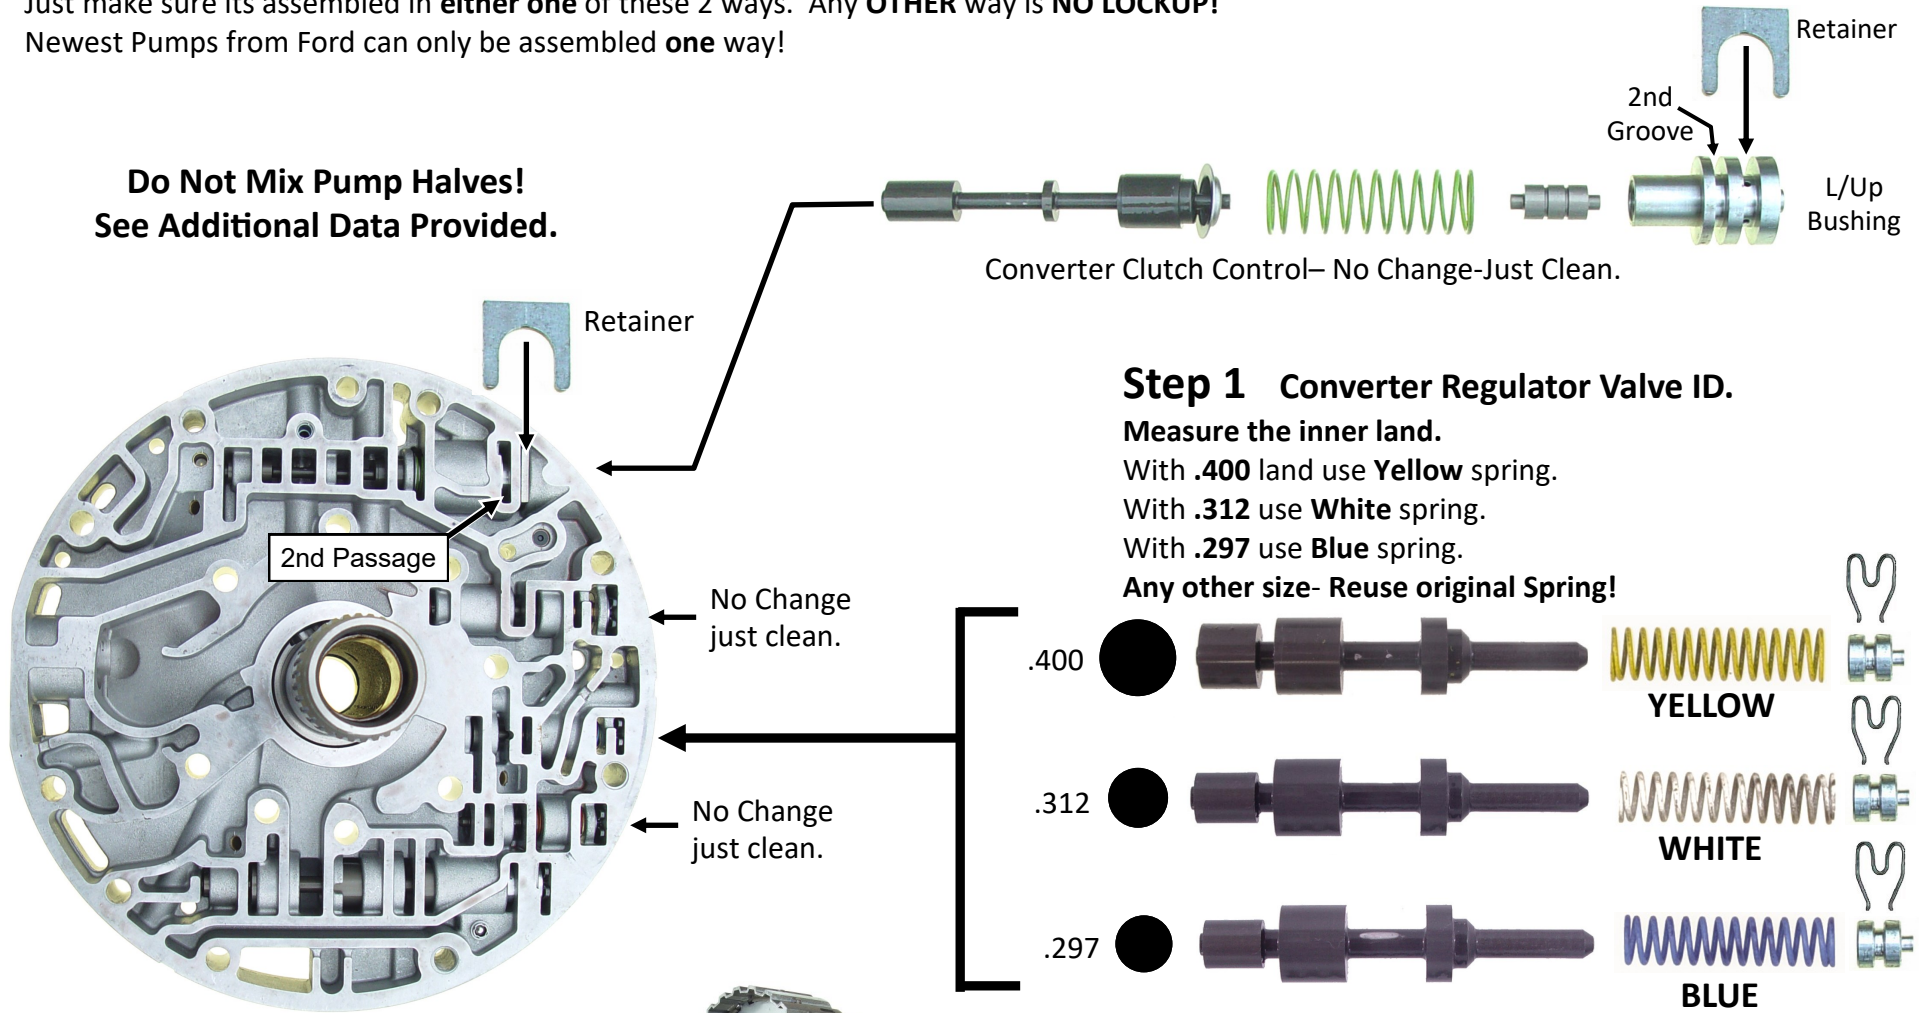
Installing Retainer in the **outer passage** of pump and **outer groove** on the bushing- **IS OK! REALLY! It's OK!**  
 Installing Retainer in the **2nd passage** of pump and **2nd groove** on bushing- **IS OK!** (Factory Location)  
 Just make sure its assembled in **either one** of these 2 ways. Any **OTHER** way is **NO LOCKUP!**  
 Newest Pumps from Ford can only be assembled **one** way!

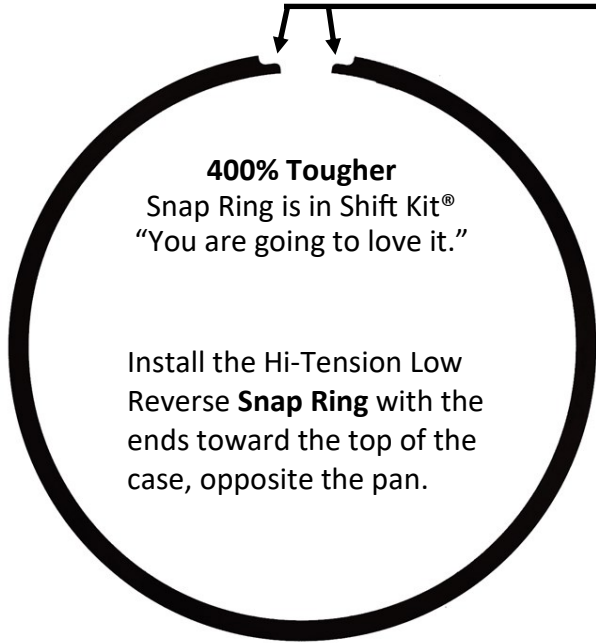
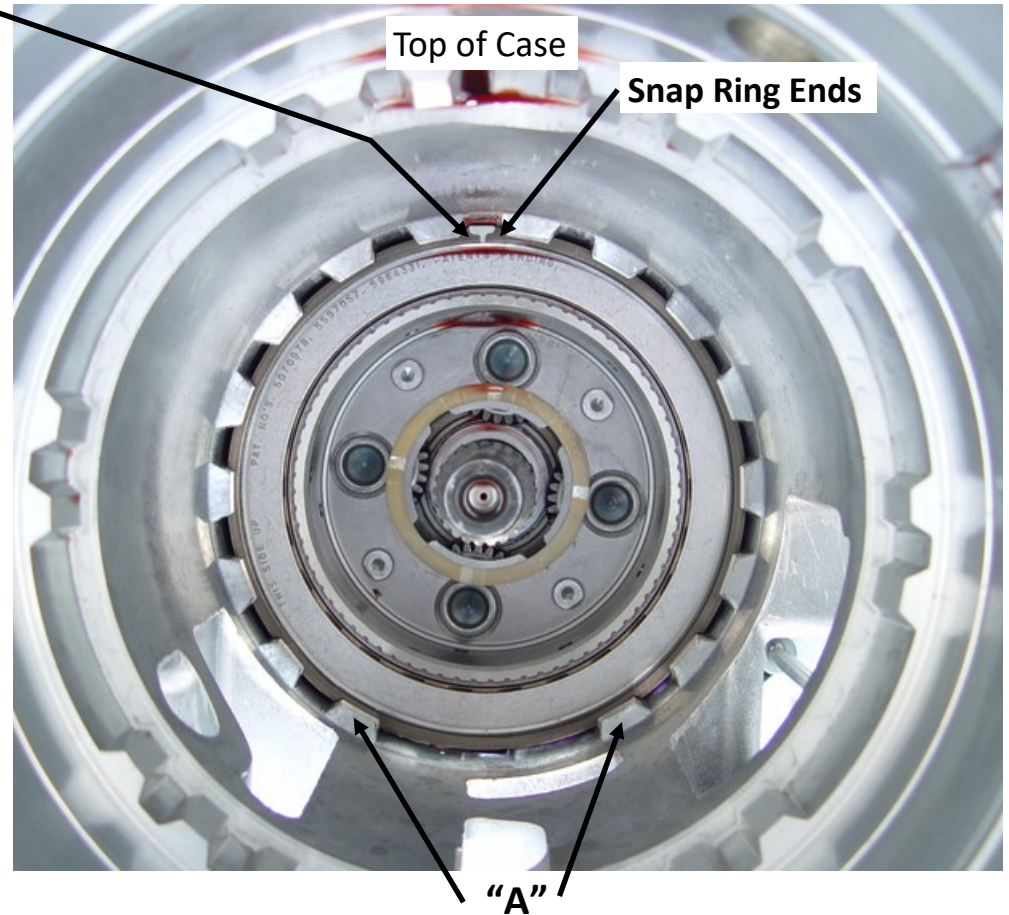
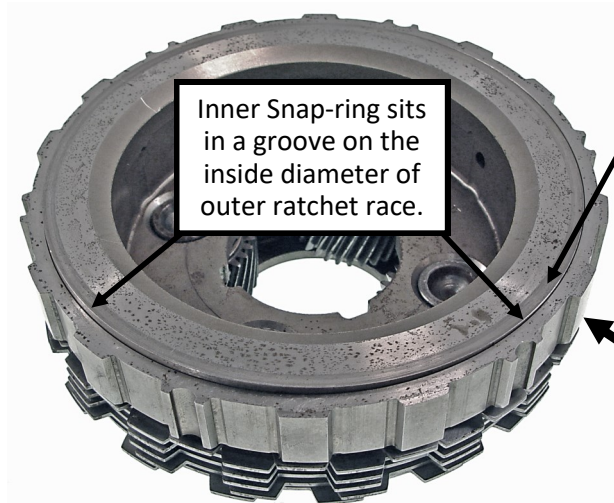
If the trans came in with no Reverse or Slip in Reverse, this is the first thing to look at to see if you will need a new case.

This is where the snap ring normally rubs on the planetary.

**"A"**: These are the two lugs that break off. If they're broken off, a new case is needed. If they are angle worn but still there, the tougher snap ring will save the case.

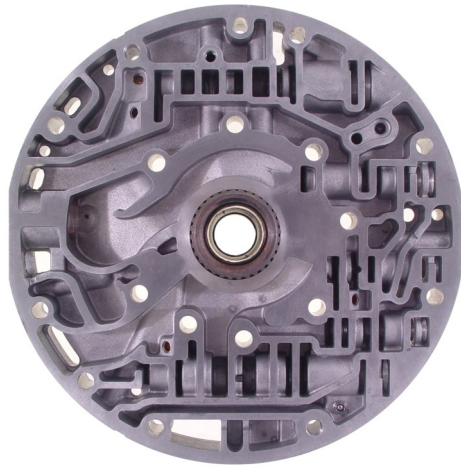
Casting # RF3C3P

Pump half's & wear plate **must** match. **2003-04 Type** Pump Body w/casting code 3C3P and Stator RF3C3P match a plate with two slots inside circle.

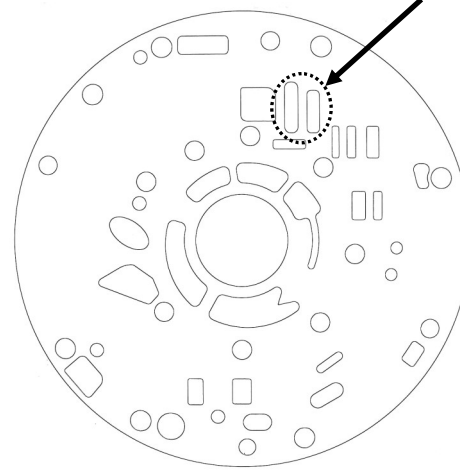
Two slots here for 03/04 Type

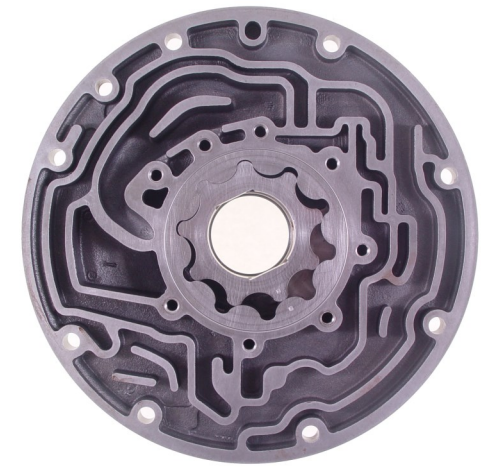
Casting # 3C3P

No Movement **after** repair can be **mismatch** of pump half's **or** wear plate. Pump was redesigned in **2005**. **Complete pumps** can be swapped for all years but mixing parts between pumps can create a no move condition.

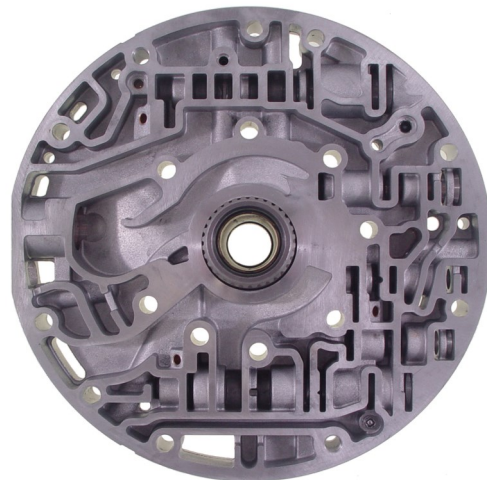
Casting # RF5C3P

Pump half's & wear plate **must** match. **2005 Type** Pump Body **and** Stator w/casting code RF5C3P match a plate with no slots inside circle.

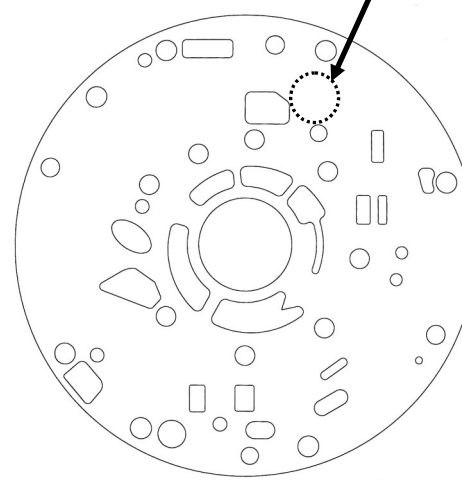
No slots here-- 2005-09

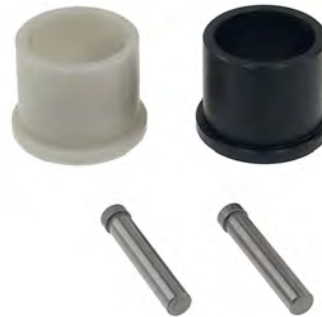
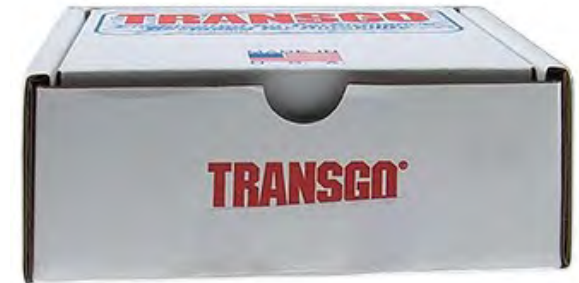
**Fits: 5R110W 2003up**

**Corrects/Prevents/Reduces**  
Severe Damage from Misaligned Pump

We have heard the reports of replacement bushings that will only provide .001" clearance to a properly sized hub. Running the bushing this tight will seize the bushing to the hub and spin the bushing in the pump body. The metal generated will get between the inner gear and pump plate welding them together, this will look like a ground failure, see fig 1. Tolerances and alignment are critical with this pump. See TransGo 5R1-PMP-Align.

**Some 5R110 pumps have been found with an offset bushing bore. This required the factory to machine the bushing in place, another reason to leave the OE bushing alone. Always use a pump alignment tool that centers the bushing bore to the stator tube. See: TransGo 5R1-PMP-ALIGN.**

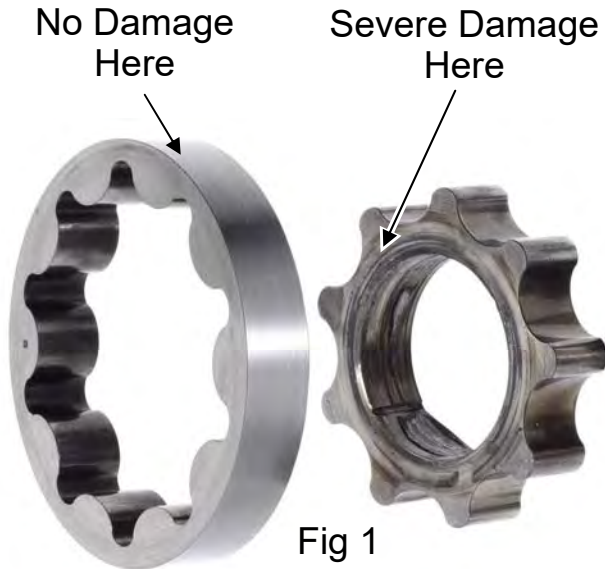
Electrical ground failure or a tight pump bushing clearance will weld the inner gear to the pump plate.

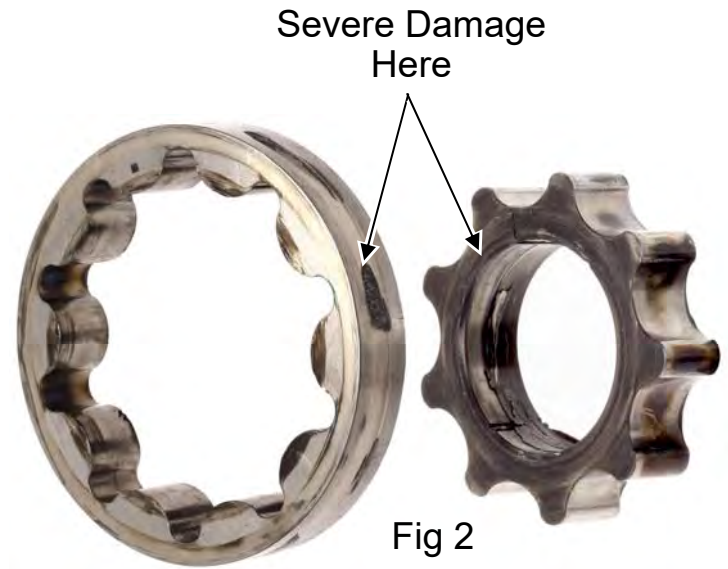
Lack of oil, restricted filter, dry start-up or aggressive TCM programming. Both gears are equally black & blued.

**Line Pressure and Pump Failure:** Aggressive computer programming can contribute to high line pressure and pump failure, see page 1 fig 2. Check with a pressure gauge during the road test. Stock Programming: Light-load cruising speed 150-170psi and very reactive to engine load. Hard throttle up-shifts 200-235psi. Full throttle starts can briefly spike to 280psi.

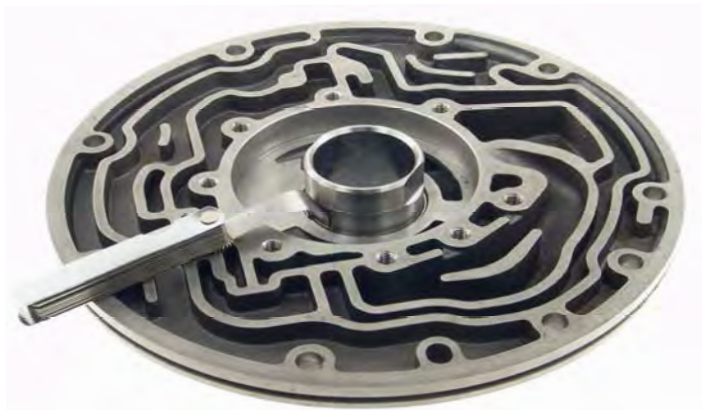
**Pump Bushing To Hub Clearance: If the pump bushing or the converter is changed the bushing to hub clearance must be checked.** Place the feeler gauge through the pump bushing bore then drop the pump body over the converter hub.

**Clearance, min .0025" max .0045".**

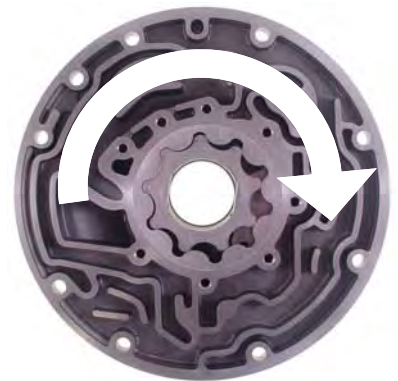
**Perform quick test:** With the pump bushing and gears installed into the pump body, place the pump body onto the converter hub so the inner gear indexes to the hub.

Now rotate the body 360 degrees and feel for tight spots or binding. It should rotate smooth as glass all the way around. Binding or tight spots indicates a problem with the gear pocket, gears, convertor hub or pump bushing.

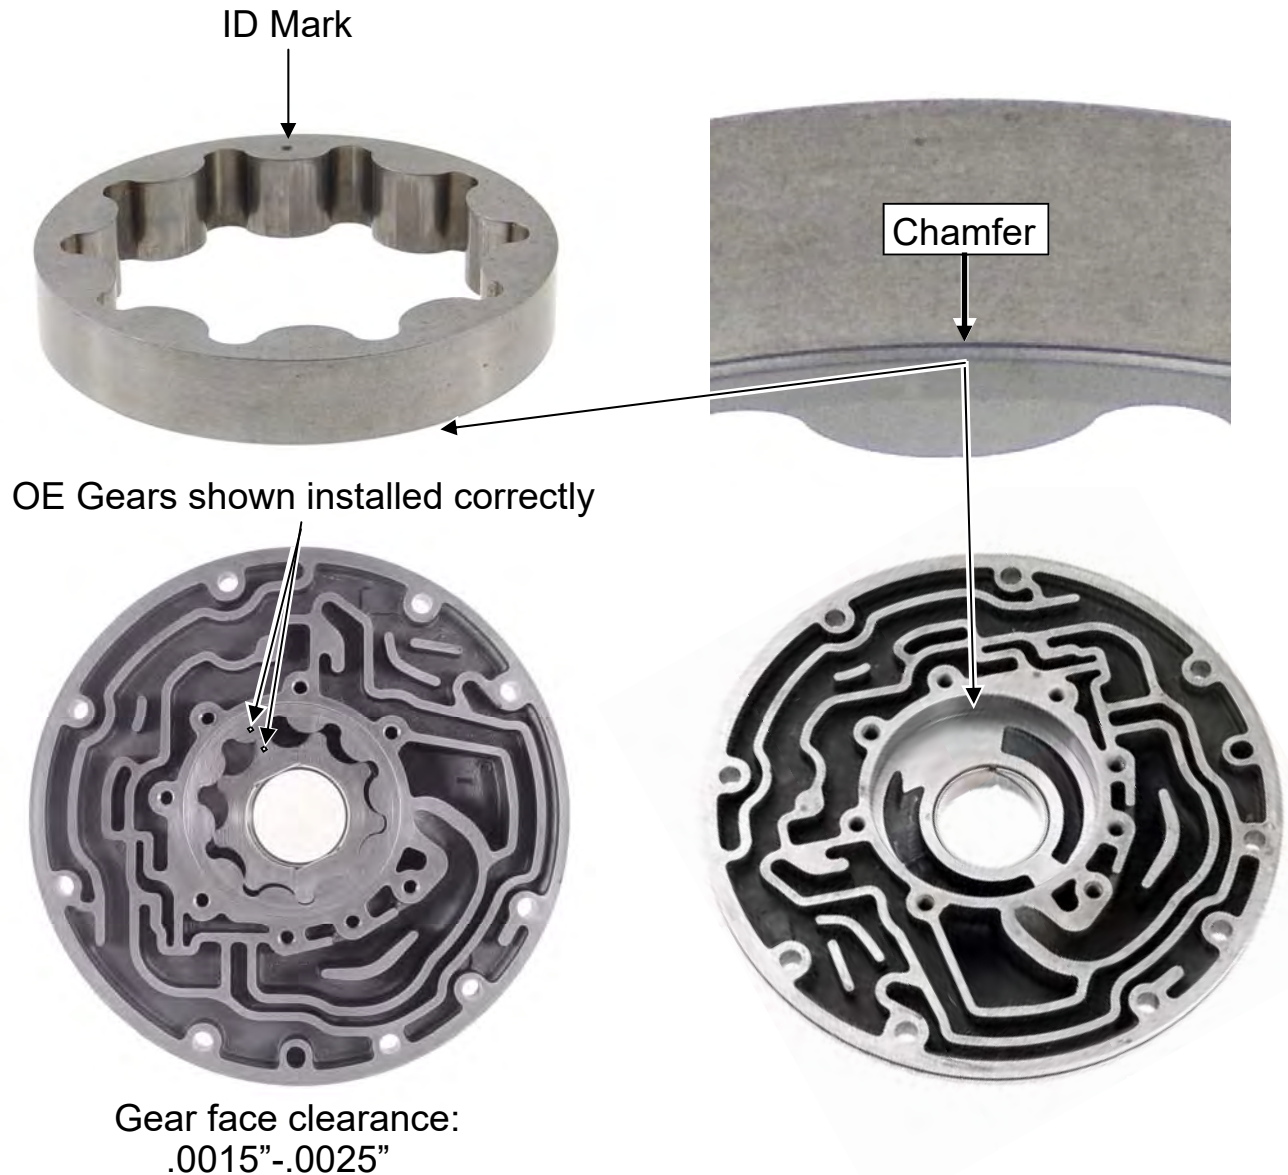
The **Original Equipment** pump gears have ID marks on the inner and outer gear. These ID marks **MUST be visible** when the gears are installed into the pump body. With original equipment gears this will ensure that the chamfered side of the outer gear is facing into the pump body. **Attention: If the outer gear ID mark is not visible when installed, the pump will seize on the road test or shortly after.**

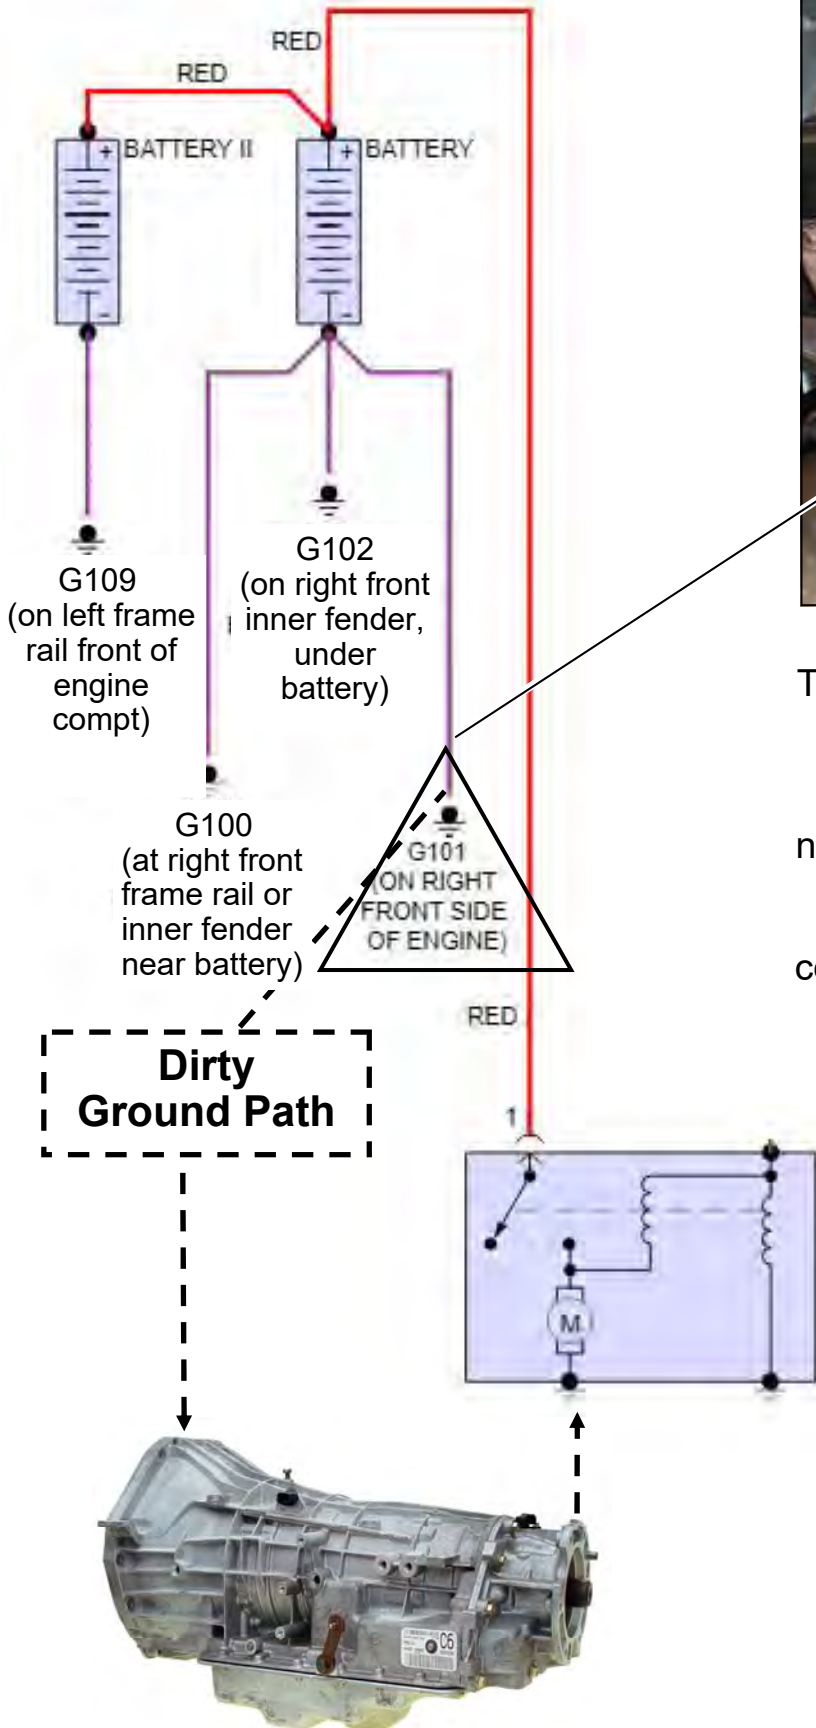
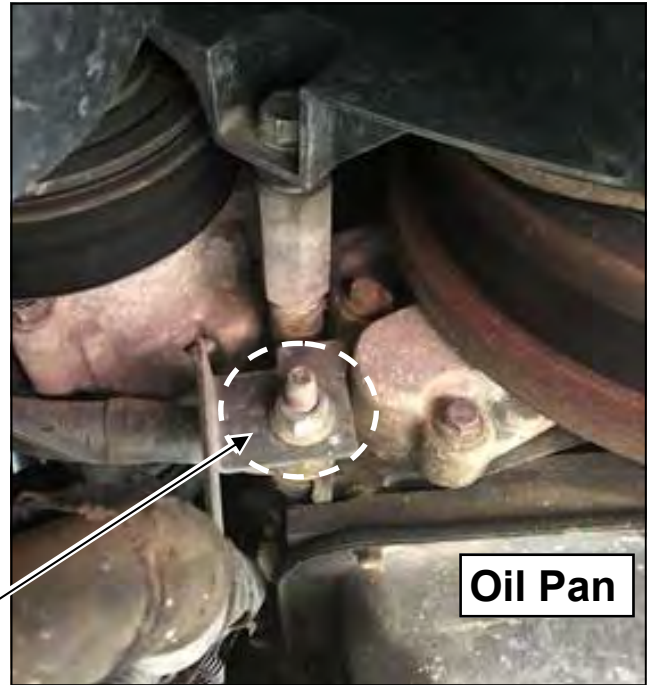
**Oil Pan**

This is the main battery ground on the passenger side front of the engine, #G101. This connection is the most critical one. To clean it correctly, the nut, cable and the stud that screws into the block **MUST** be removed and cleaned, **NO** exceptions. If this connection is dirty the current will take an alternate path through the transmission and damage the pump.

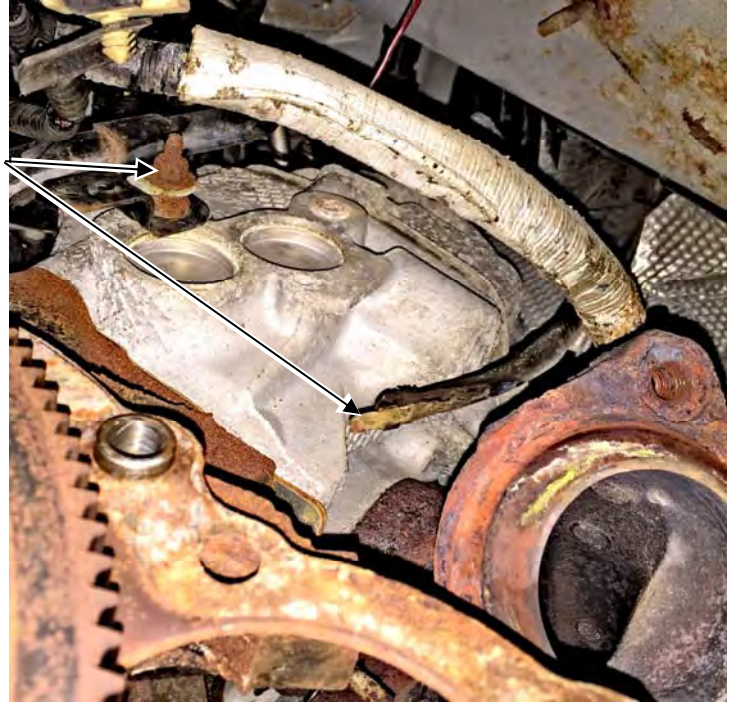
If corrosion is observed between the back of the engine block and the trans adapter housing, it may be easier to add a **heavy** ground cable from the adapter housing to the block rather than removing the adaptor housing to clean it.

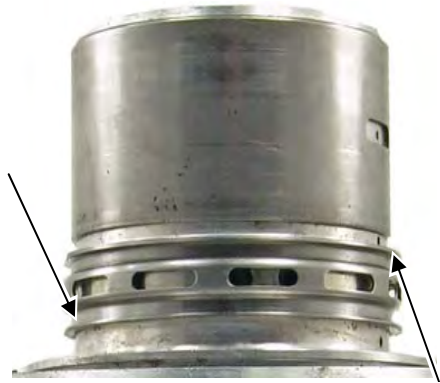
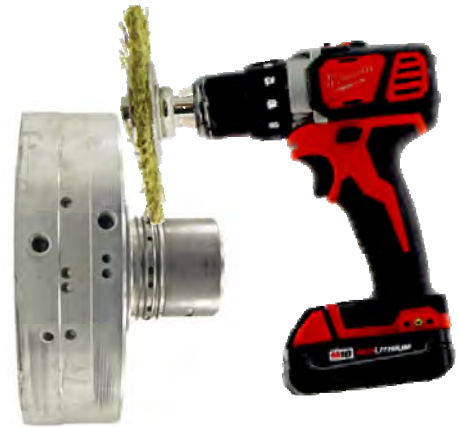
A common tech call that we receive is how poorly the direct drum air checks through the center support. Many of the center supports that we tested had bronze particles imbedded into the side of the ring grooves preventing the rings from sealing. The bronze material is coming from the drum bushings. Always replace the drum bushings. A wire wheel on a drill or a piece of green scotch-brite used with a small screwdriver on a lathe are effective tools to remove the bronze build up. Once the imbedded bronze was removed a majority of the “bad” supports would now air check with 35-45psi. If the drum still does not air check after a good cleaning with new Ford rings #3C3Z-7D025AA the support ring groove is cracked, scrap it.

The arrows are pointing to the outside of the ring grooves where the rings need to seal. This is the area where the bronze particles accumulate and imbed into the support.

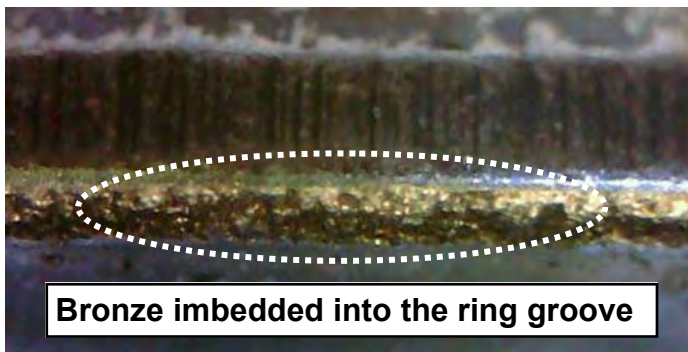
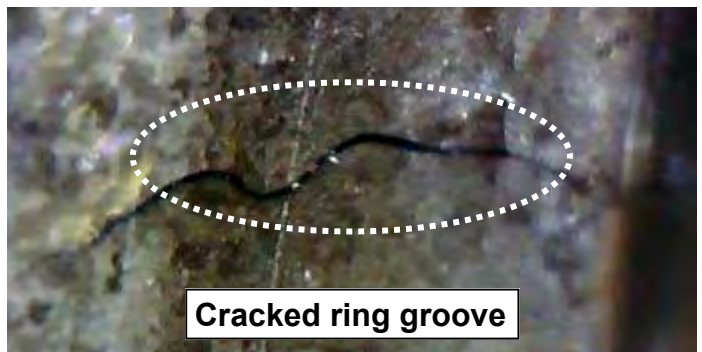
Here are some examples at 400x magnification:

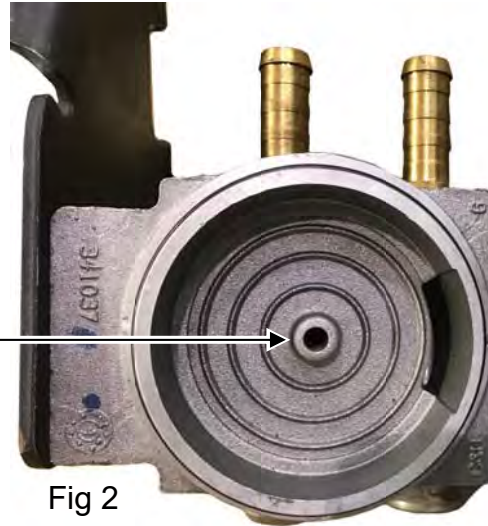
Fig 2

Tap the filter feed hole enough to install a 6mm bolt 2-3 threads.

(If the hole is a different size, use the appropriate size tap and bolt).

**Proper Cooler Flushing:** Remove and discard the filter cartridge and temporarily plug the filter feed hole. See fig 2. Most housings have a .204" feed hole. Use a 6mm tap to carefully add enough threads to install a 6mm bolt 2-3 threads, hand tighten the bolt so it will not fall out. Reinstall the filter bowl (leave cartridge out) and flush the system. After flushing remove the filter bowl and bolt, clean out the housing and install a new filter cartridge and bowl.

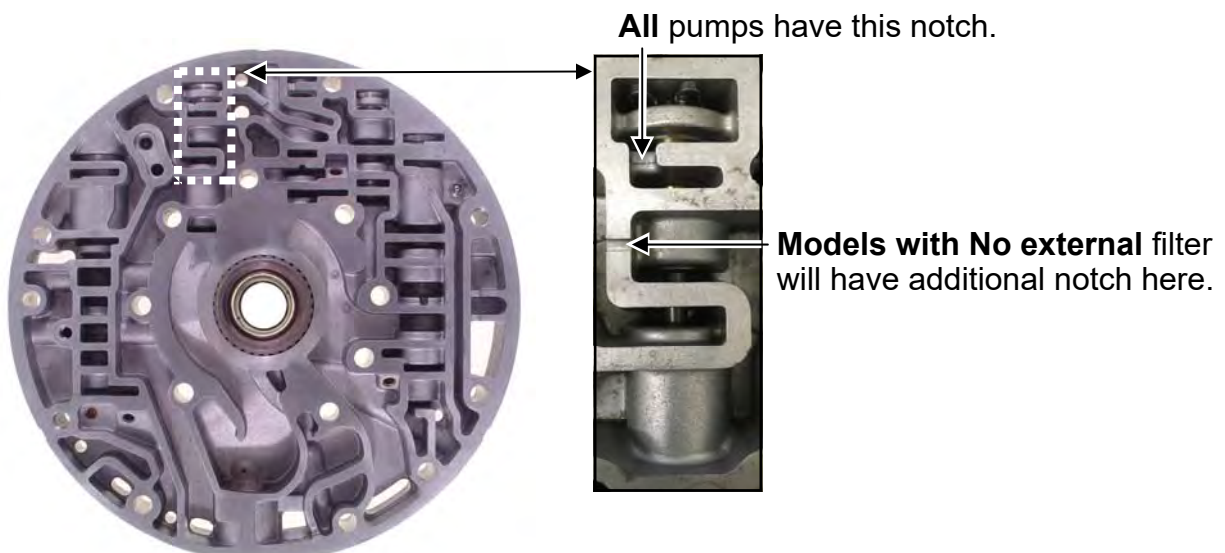
**Pump Interchange:** 2008 and later trucks no longer have the in-line cooler filter. These models use a different oil pump. In a pinch you can use a 2008 type pump (2 notch) on the external filter models by permanently plugging the external filter feed hole. The in line filter type pump (1 notch) should not be used in place of a 2 notch pump. If the 1 notch pump is installed on a truck with **NO external filter** you run the risk of starving the gear train for lube if the oil cooler becomes restricted or plugged.
