**SK® 6L80** Patent Pending Fits: 2006-2020 6L45 thru 6L90

Extreme Pressure Damage Due to Worn PR Bore, **New PR Valve** Restores Proper Pressure Regulator Function, **New Boost Valve** Adds Over-Boost protection. **No special tools required to install!** Includes parts to repair **blown pressure switches**, **PLUS** our **New Design** sealing rings for **steel pump towers that use** rotating rings. Fixes the ring leaks that can cause 3rd & 5th ratio codes, delay or delay-bang forward or reverse engagements.

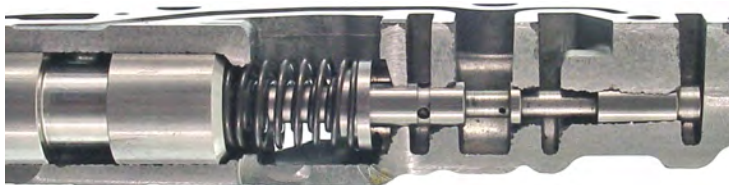
**Great News! New TransGo® PR Valve** design increases support to **restore** proper valve function **EVEN IN A WORN BORE!**

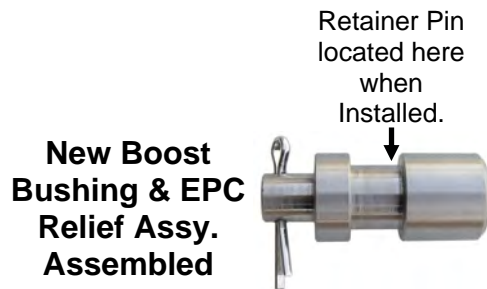
**Step 1**  
Assemble EPC Relief 3/16" ball & Plain Spring into New Bushing & Spread the Cotter Pin legs.

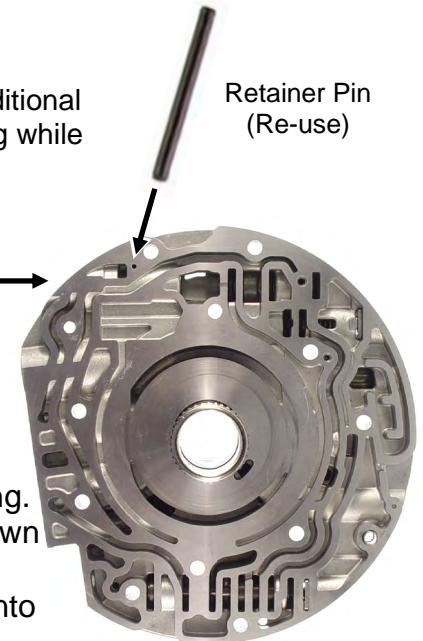
**Step 2**

Retainer Pin located here when installed.

**New Boost Valve**

**New Spring Seat**

This land is purposely undersized for additional lube flow. This helps prevent engine chug while coasting to a stop, when hot.

Retainer Pin (Re-use)

Remove & discard original Retainer, PR Valve & **LARGE** PR Spring. Assemble **New Spring Seat** on **New TransGo® PR Valve** as shown above and insert into Pump. Re-use original bumper Spring with **New RED PR Spring**, then install **New Boost Valve** into **New Boost Bushing Assy** & re-use original retainer pin.

The Original Bumper Spring & The **NEW RED PR SPRING** **MUST BE USED WITH THE NEW TransGo® PR VALVE.**

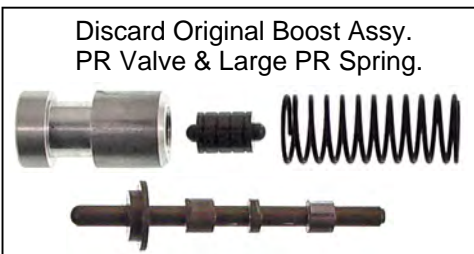
Discard Original Boost Assy. PR Valve & Large PR Spring.

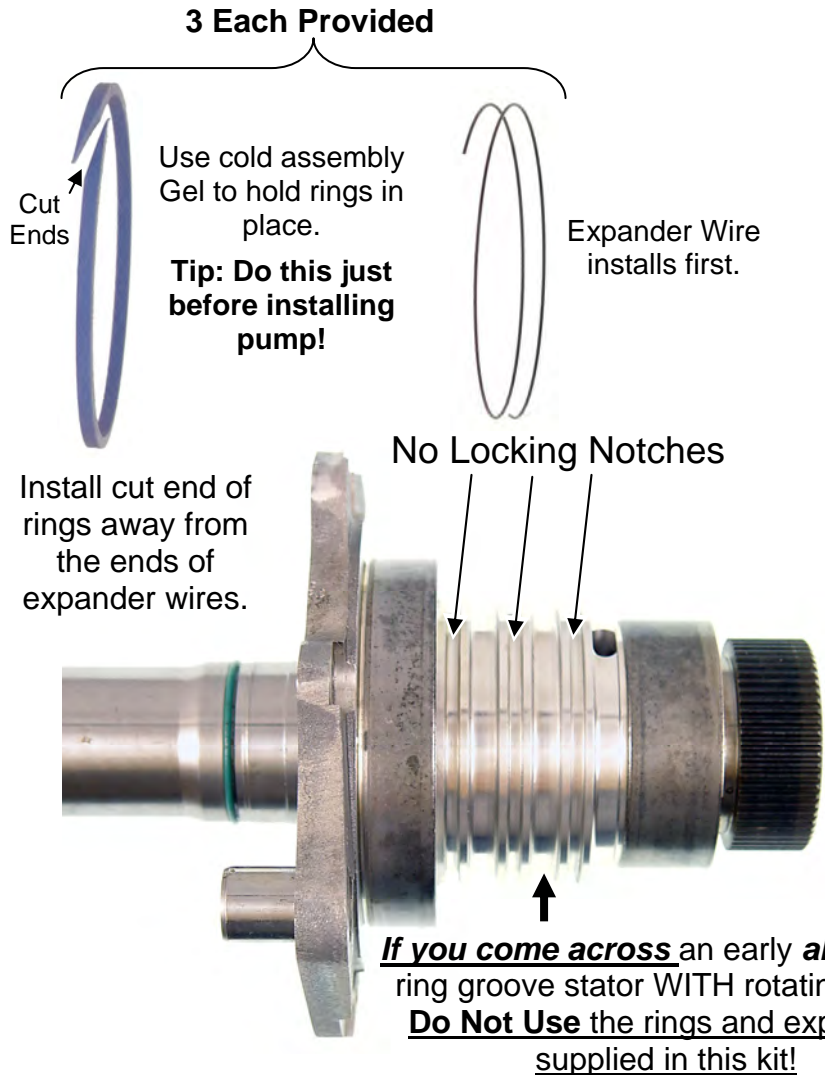
**Read this:** If your pump stator's ring groove area is made of **steel and uses rotating rings**, then installing our **NEW** design sealing rings and expander wires will fix the leaky ring issue with those stators and therefore updating the stator to the non rotating ring type stator is not required.

Do not use the new rings on **aluminum ring grooves!**

## New Rings only FIT Stator's WITHOUT Locking Notches!

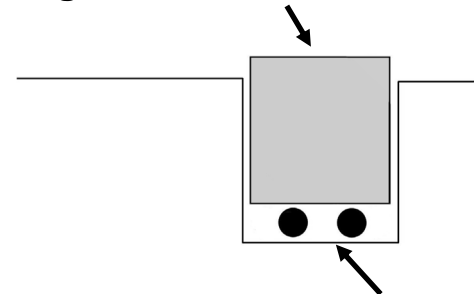
**1.** Install **Expander Wire** in bottom of ring groove **FIRST!** Make **SURE** wire ends do not cross over each other. They should lay side by side.

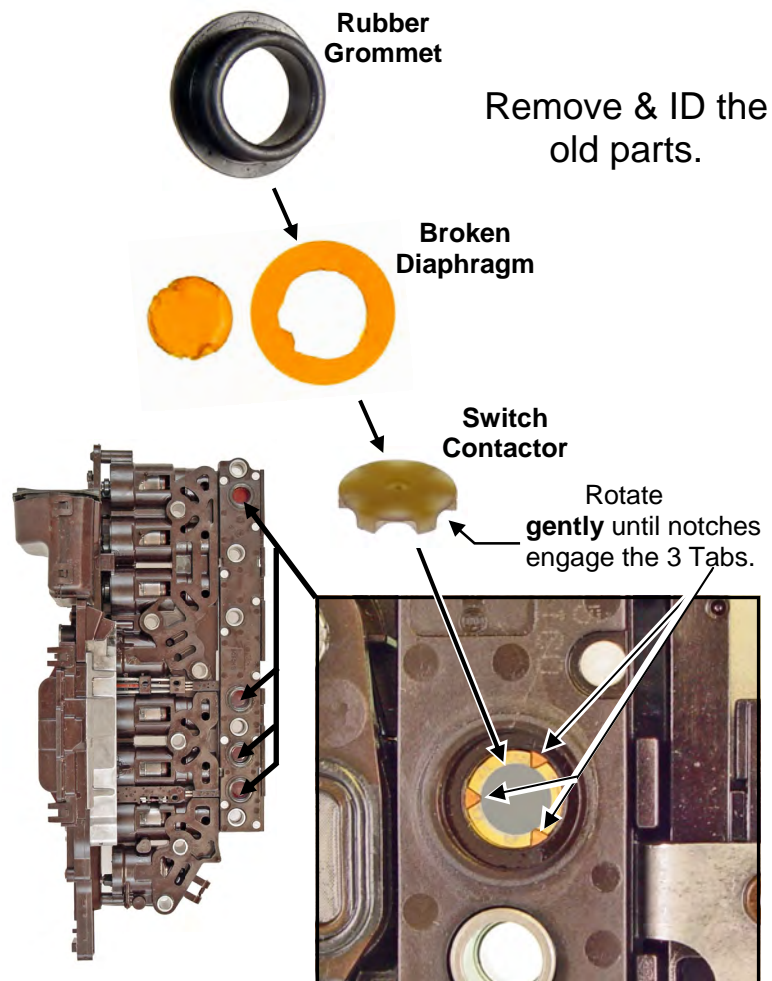
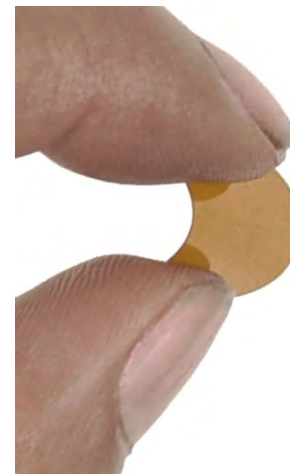
Often this trans experiences a drum or clutch piston failure often due to a Pressure malfunction. Typically, at least 2 of the 4 pressure switches in the assembly **will also be blown out** as shown below. **Your choice** is to **repair the TEHCM** with this kit or **replace it** with a new **TEHCM** from the dealer & have it programmed. **\$\$\$!**

Pinching Diaphragm for installation.

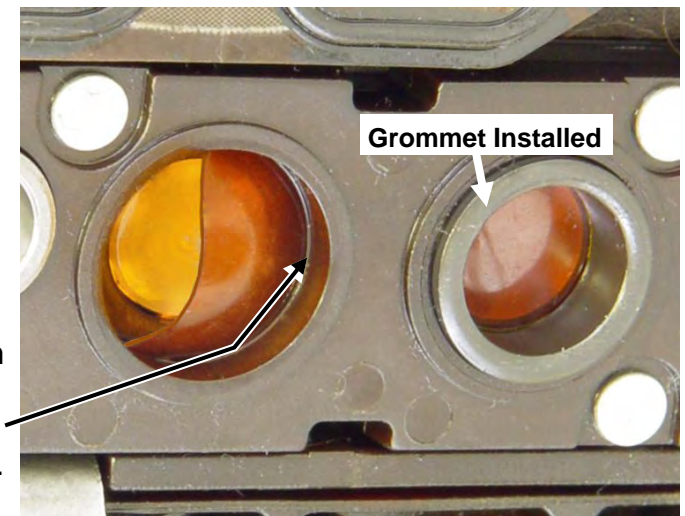
Take one of the new diaphragms, gently pinch the diaphragm into the shape of an upside down taco shell. Insert it as shown below into the switch hole making sure you guide it under the lip of the plastic. Using a small **flat-blade** screwdriver, work the rest of the diaphragm into the hole until it lays flat on the switch contactor. You may use a pencil eraser to move it left or right till it drops in place. **Continue on next page.**

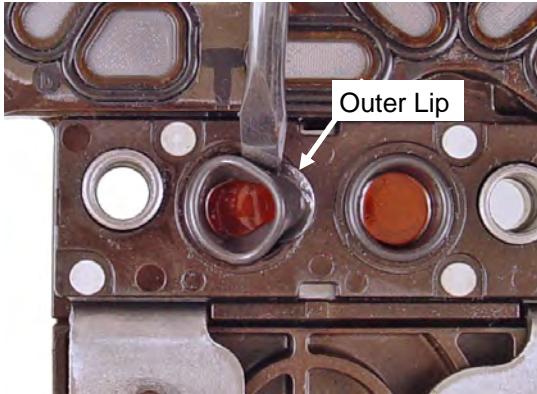
A **Small Flat Blade** screwdriver works best for doing this!

Pinch the Grommet to start the outer lip under the plastic. Work the outer lip under plastic with a small screwdriver.

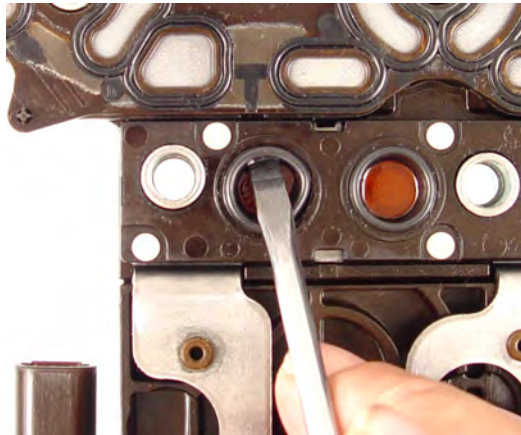
Use the small screwdriver to push behind the outer lip (from the inside) to wedge it under the plastic.

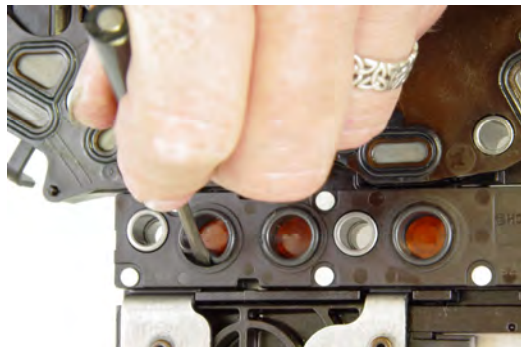
You may have to pull the top of the grommet back slightly to make sure the lip is going under the plastic.

Installing the grommet is done by **patiently coaxing** it into position. You **must** get the **outer lip** of the grommet to go **under** the plastic housing. This is what seals the switch. Lube the grommet & diaphragm with 90w gear oil or something equally as slippery. Treat this just like you would a small child– with patience! The first one is always about getting the knack of doing it. Be successful and you'll be putting cash in your pocket for each TEHCM you didn't have to buy new & then program.

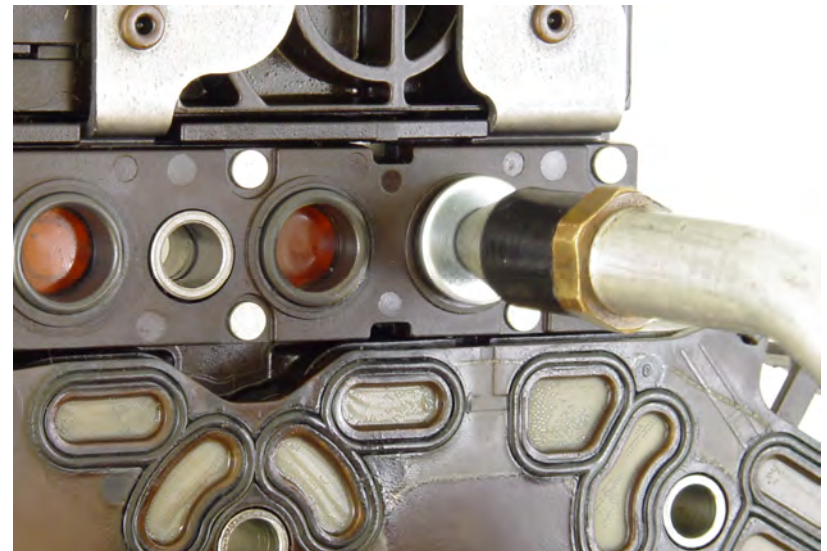
Using a flat washer on the rubber tip of a good blow-gun, make sure the switch does not leak. It should seal tight. Do the air test with 30 psi. If it holds, it's ok. It will be too hard to hold the blow gun in place to use full shop air.

**Final test:** Use a pencil eraser to gently push into the center of the switch to feel the switch click as you let up on it. Use one of the other switches to compare. The new grommets **will** be taller than old ones. It's OK!

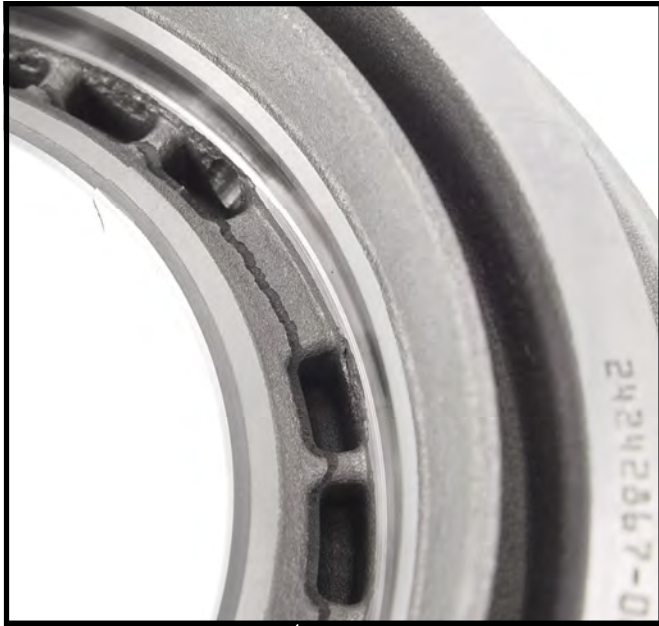
The blowouts are easy to see.

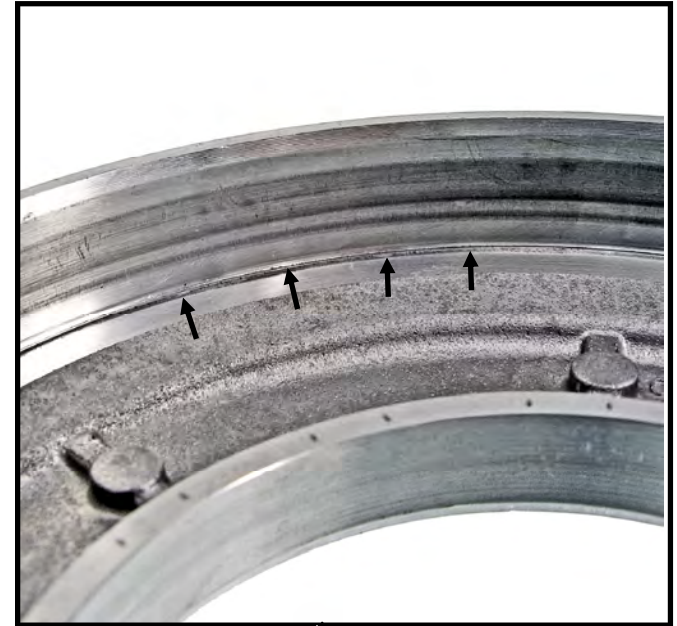
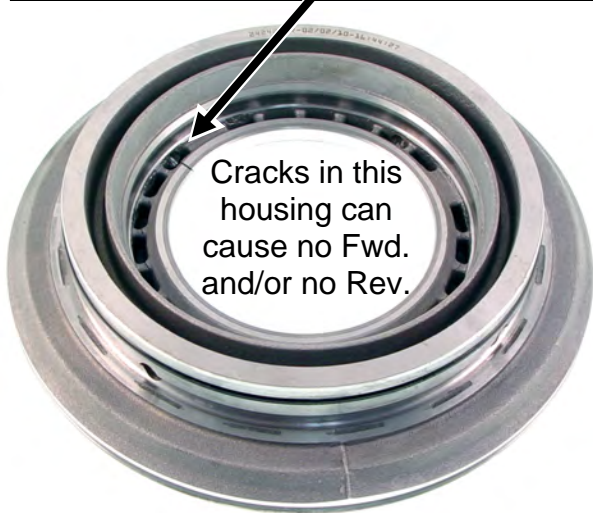
1-2-3-4 Clutch Housing

What breaks depends on what gear the trans was in when the extreme pressure malfunction occurs. The 1-2-3-4 clutch area shown is one of the more common areas to fail due to extreme pressure.

However, the Hairline Cracks are not!

Cracks in this housing can cause no Fwd. and/or no Rev.

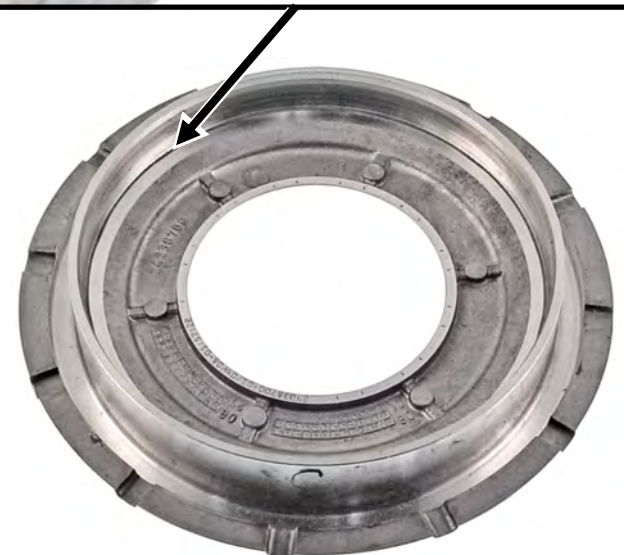
1-2-3-4 Clutch Piston

**When replacing pistons and related parts, MAKE SURE they are the same diameter as parts your replacing. Differences can be as little as .045"!**

**LOOK CAREFULLY!**

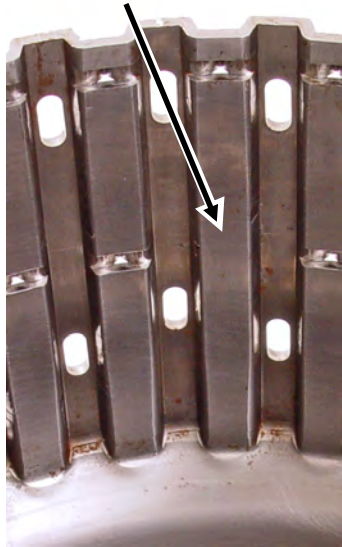
Lower Stop Lug

Pay attention to the location of the Lower & Upper Snap-ring **Stop Lug** in the Drum. The **open ends** of each snap-ring **MUST** be located on either side of the lug.

The lower and upper stops are located 180° opposite of each other in the drum. (Lug has no groove for snap-ring!)

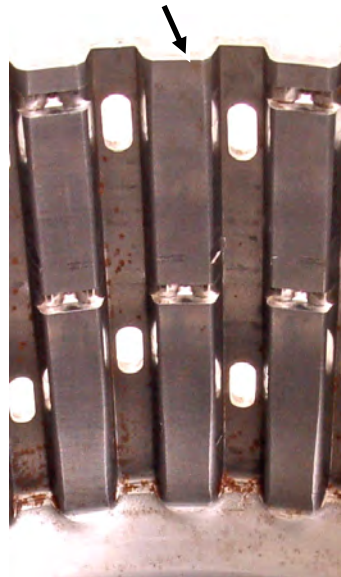
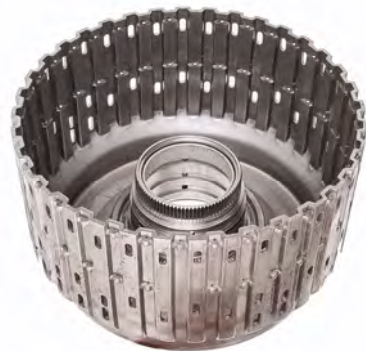
Upper Stop Lug

If mis-located, it may take as much as 3 weeks for the snap-ring to become dislodged & set solenoid performance codes. This is usually but not limited to complaints of no forward and or no reverse **after overhaul**.

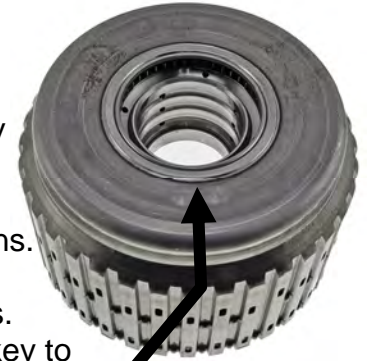
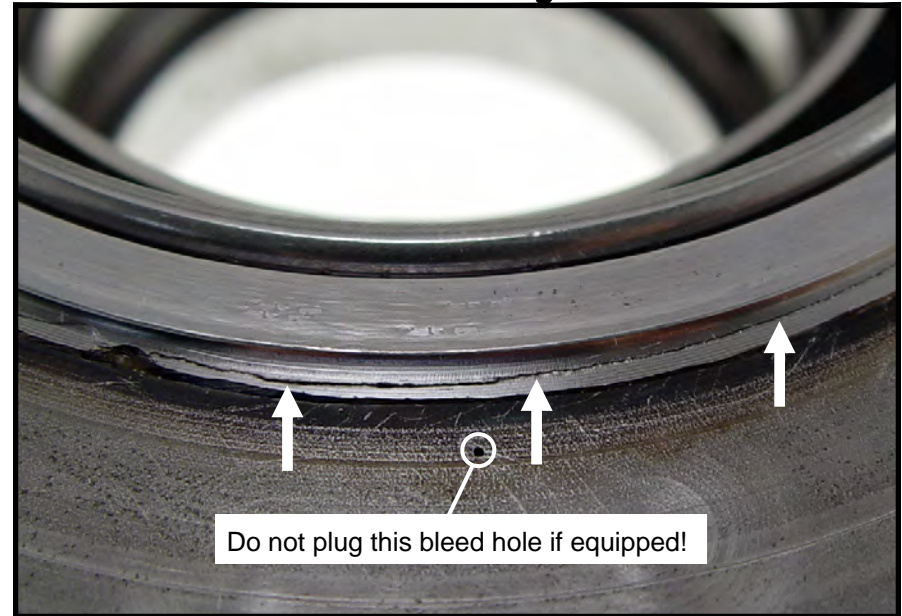
1,2,3,4 / 3-5-Rev Drum

Look carefully for hairline cracks on the front of the drum! You may need a magnifying glass to see the crack. In our opinion if the clutches were damaged or the vehicle had a Forward, 3rd, 5th or Reverse complaint, it's far safer to replace the drum as an assembly then risk the re-work.

High torque transfer or shift shock can damage the drum but not crack the pistons. However, It's the high pressure that can damage both the drum and or the pistons. Fixing the extreme runaway pressure is key to keeping the parts alive and that's what this product is all about.
