# SK® 6T70-G2 Fits 2013-on

## Corrects/Prevents/Reduces

Pressure Regulator and Actuator Feed System Malfunctions that lead to broken parts.  
Adds over boost protection, improves TCC stability.

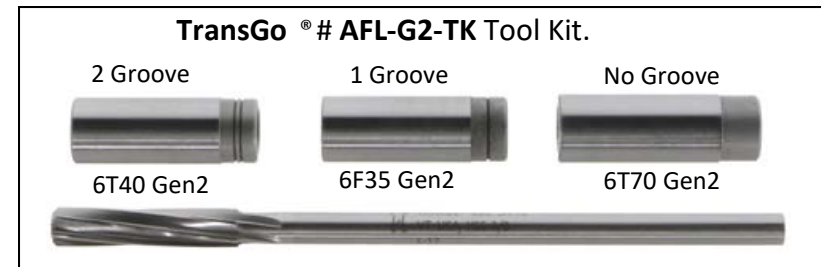
**AFL-G2-TK** Tool kit, works on 3 **different** transmissions  
Fits All **Gen 2 Vb's** 6F35's, 6T40's and 6T70's.

Due to the new vent location in a Gen 2 Rear body and the amount of bore wear seen, the AFL leak can not be fixed with a “drop-In” solution for the Gen 2 Actuator Feed Limit Valve. To repair the AFL Valve bore a tool kit is also required: TransGo # **AFL-G2-TK** Tool kit

Tool Kit fits 3 **different** transmissions, just use the correct reamer guide.  
Fits All **Gen 2 Vb's** 6F35's, 6T40's and 6T70's.

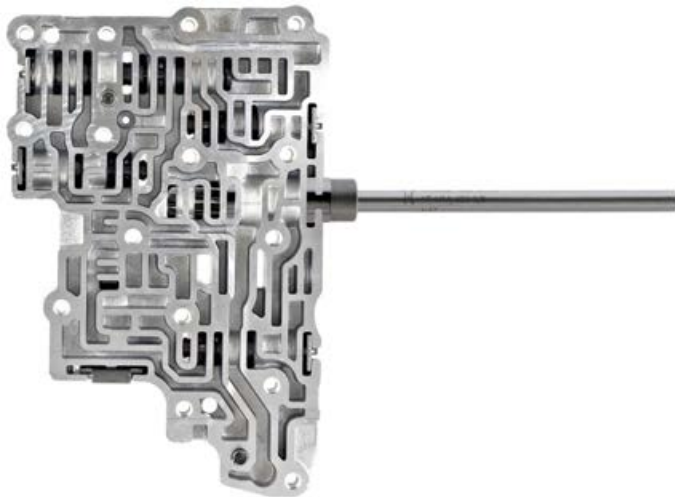
**Step 1.** The **6T70 Gen 2** uses the “**No Groove**” reamer guide. Place the no groove guide into the bore till it stops, with the stepped end out as shown. Use lots of WD-40 and **low speed** on your favorite portable drill, let the reamer do the cutting until it bottoms in the bore. Don't force the reamer, bore finish and Reamer life require a slow inward movement and lots of WD 40.
