## SK<sup>®</sup> 722.6 Corrects/Prevents/Reduces

Insufficient Pressure Rise, 2-3 Flair, TCC Slip or shudder, Soft Shifts, Shudder on Hard Throttle Acceleration from a stop.

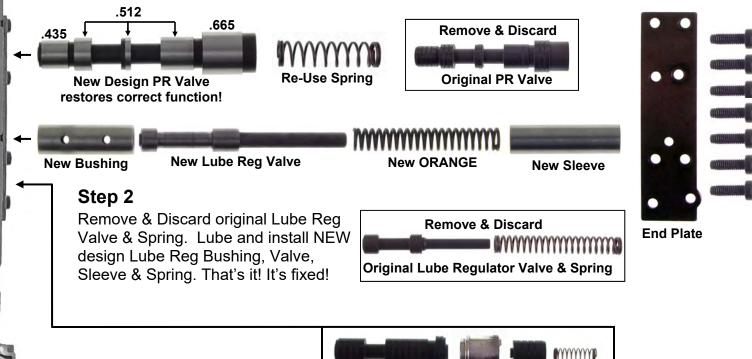
Remove this plate to do repair work.

2-3 O-lap Reg –No Changes

Clean & re-install 2-3 O-lap Reg and End Plate.
