SK[®] AWF21

(Also Fits TF-81SC & AW6A-EL)

**05-06 Ford Fusion & 500, 05-06 Mazda 6
06 Lincoln Zephyr, 06 Mercury Milan,
05-06 Mercury Montego**

Linear Solenoid Disassembly and Correction

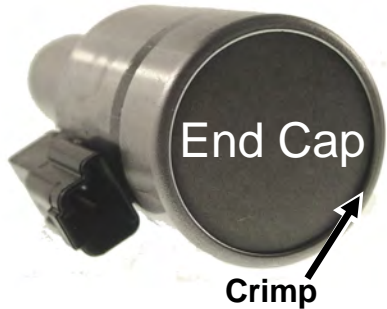
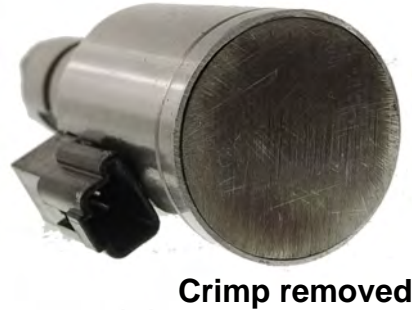
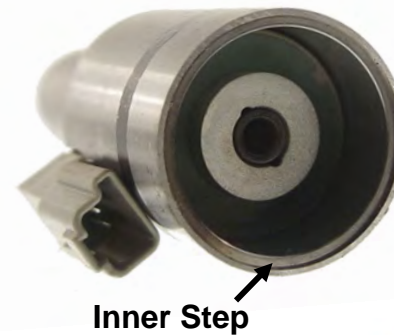
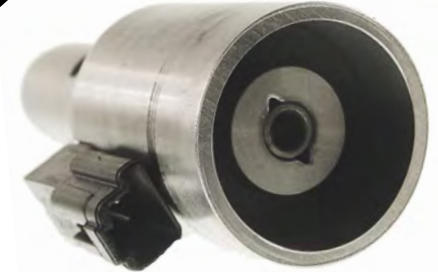
Step 2

Grind crimp until end cap falls off. Use side of bench grinding Wheel.

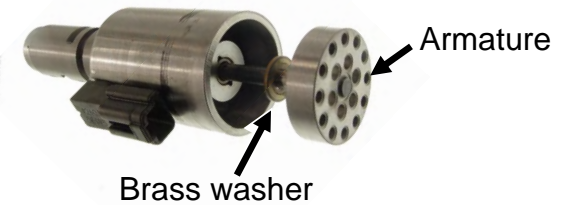
Step 3

Remove Armature & washer. Grind Body flush with inner step.

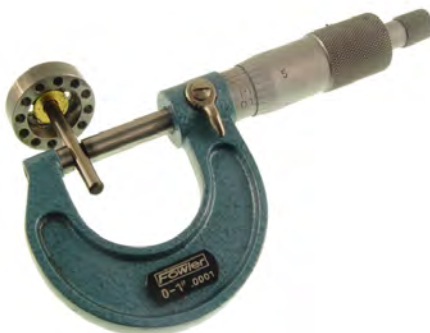
Step 4

Measure the Shaft.
.156-157 use long drill.
.154-155 use short drill.
Use selected drill in **Step 5**.

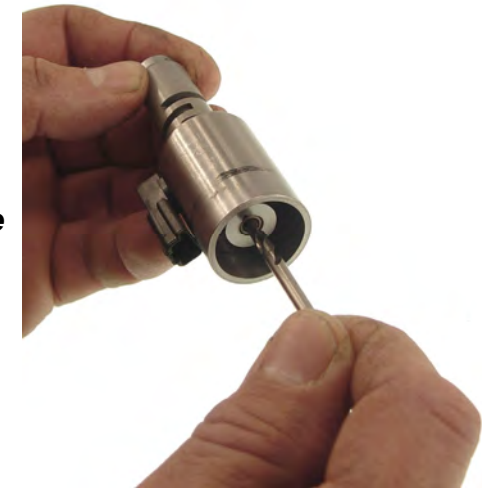
Step 5

Turn Drill **counter clockwise by hand** insert it all the way into Solenoid while holding the Drill turn the Solenoid both directions for 15 seconds. **Turn the drill counter clockwise & remove the drill.**

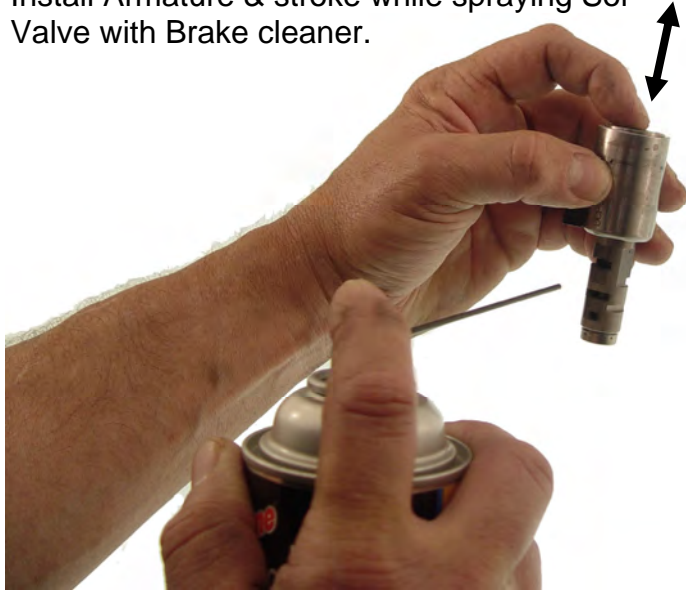
Step 6

After resizing Solenoid Bushings clean out debris with brake clean & blow out with air. Install Armature & stroke while spraying Sol Valve with Brake cleaner.

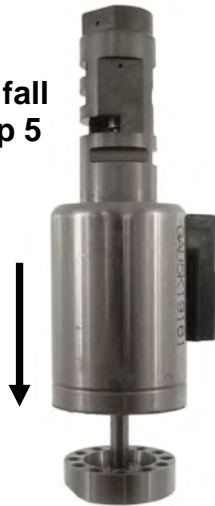
Step 7

Hold Solenoid upside down, Armature must fall out. If not perform step 5 again.

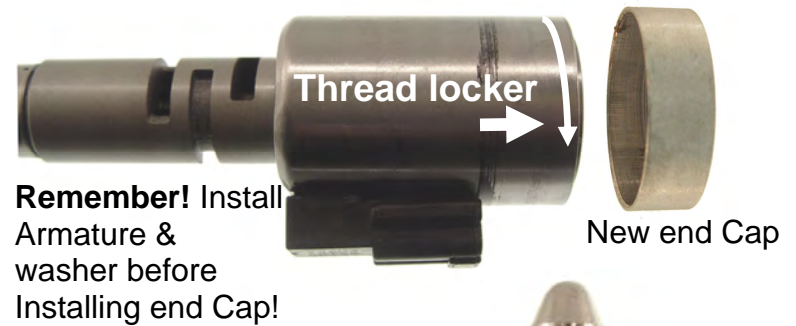
Step 8

Lay a narrow bead of Red Thread locker around the end of Solenoid Body. Keep Thread locker way from inside of Solenoid. Position new end Cap on Solenoid.

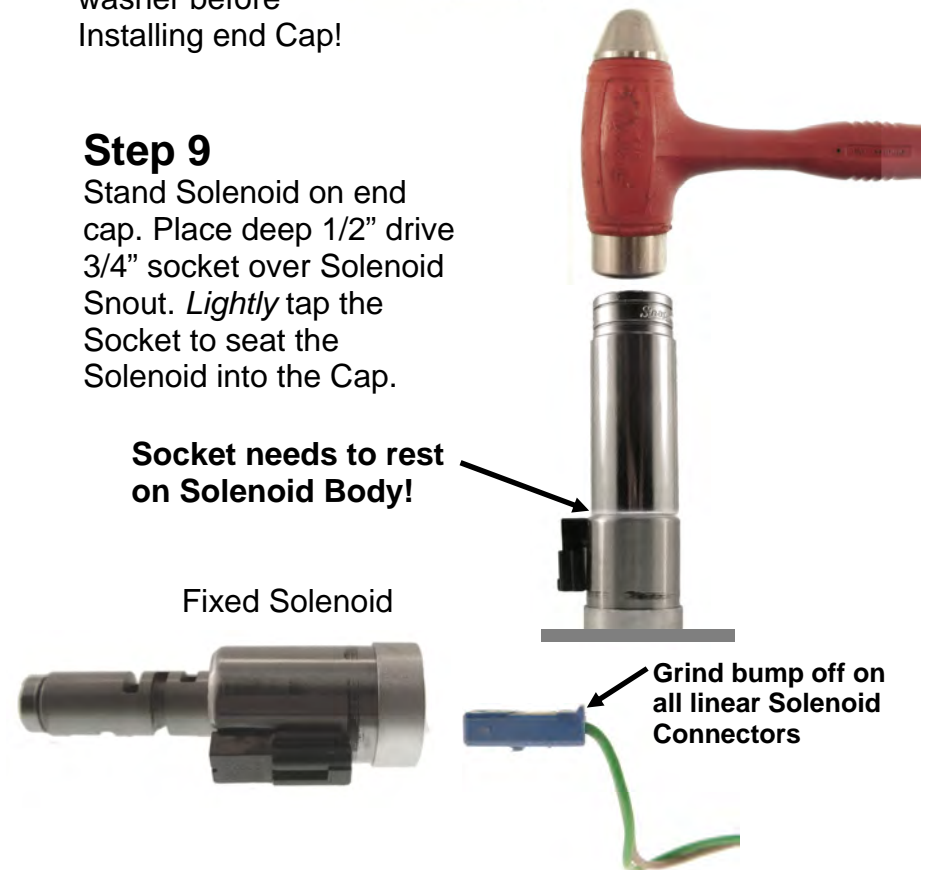
Step 9

Stand Solenoid on end cap. Place deep 1/2" drive 3/4" socket over Solenoid Snout. *Lightly* tap the Socket to seat the Solenoid into the Cap.

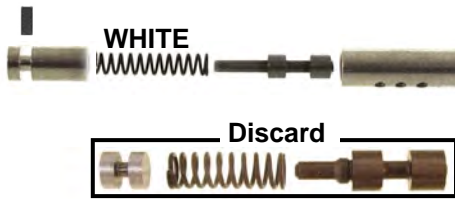
Step 1

Discard OE Valve, Spring & end Plug.
Install new Bushing, Valve, **WHITE** Spring & new end Plug.

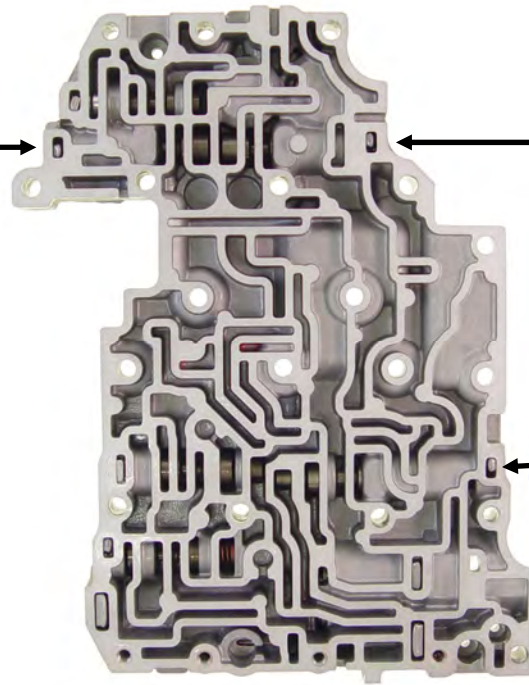
Step 3

Install new Bushing & Valve

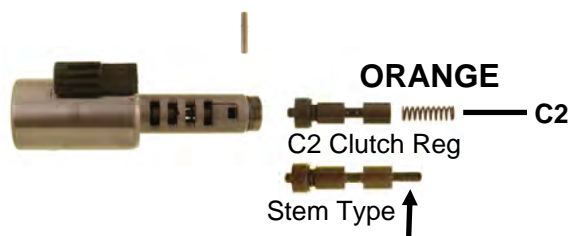
Step 1

Look at C2 & C3 Clutch Reg Valve springs (they break).
If your valve **has a stem** that the spring slides over, **re-use your original springs!** **No stem type valves:** Use **NEW Orange** springs provided.

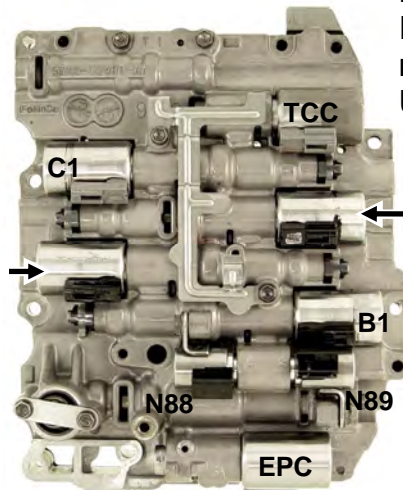
Do not use new orange springs on C2 or C3 Clutch Reg if **your valve has a stem** located here.

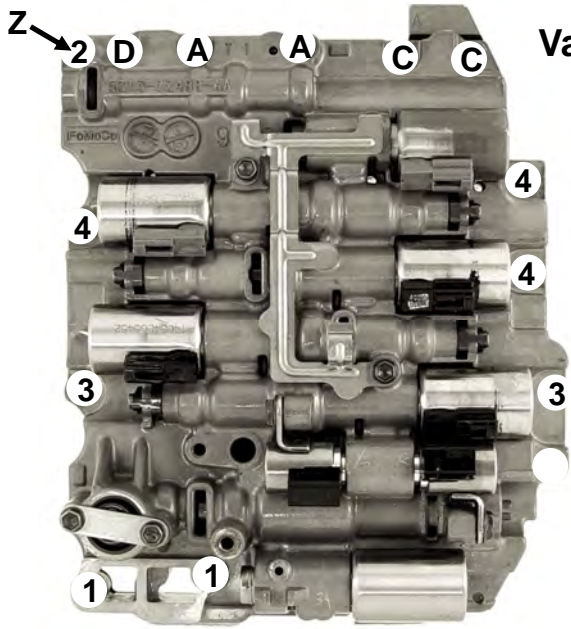
Valve Body Bolts

Z bolts are alignment Bolts, start them first. Tighten VB Bolts from center outward. Bolts are not actual size.

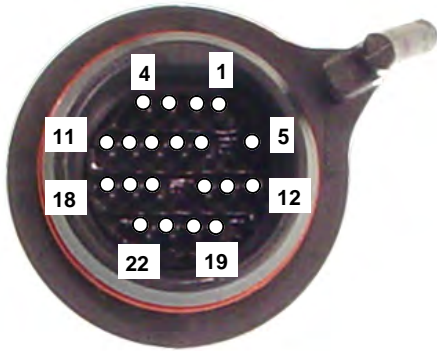
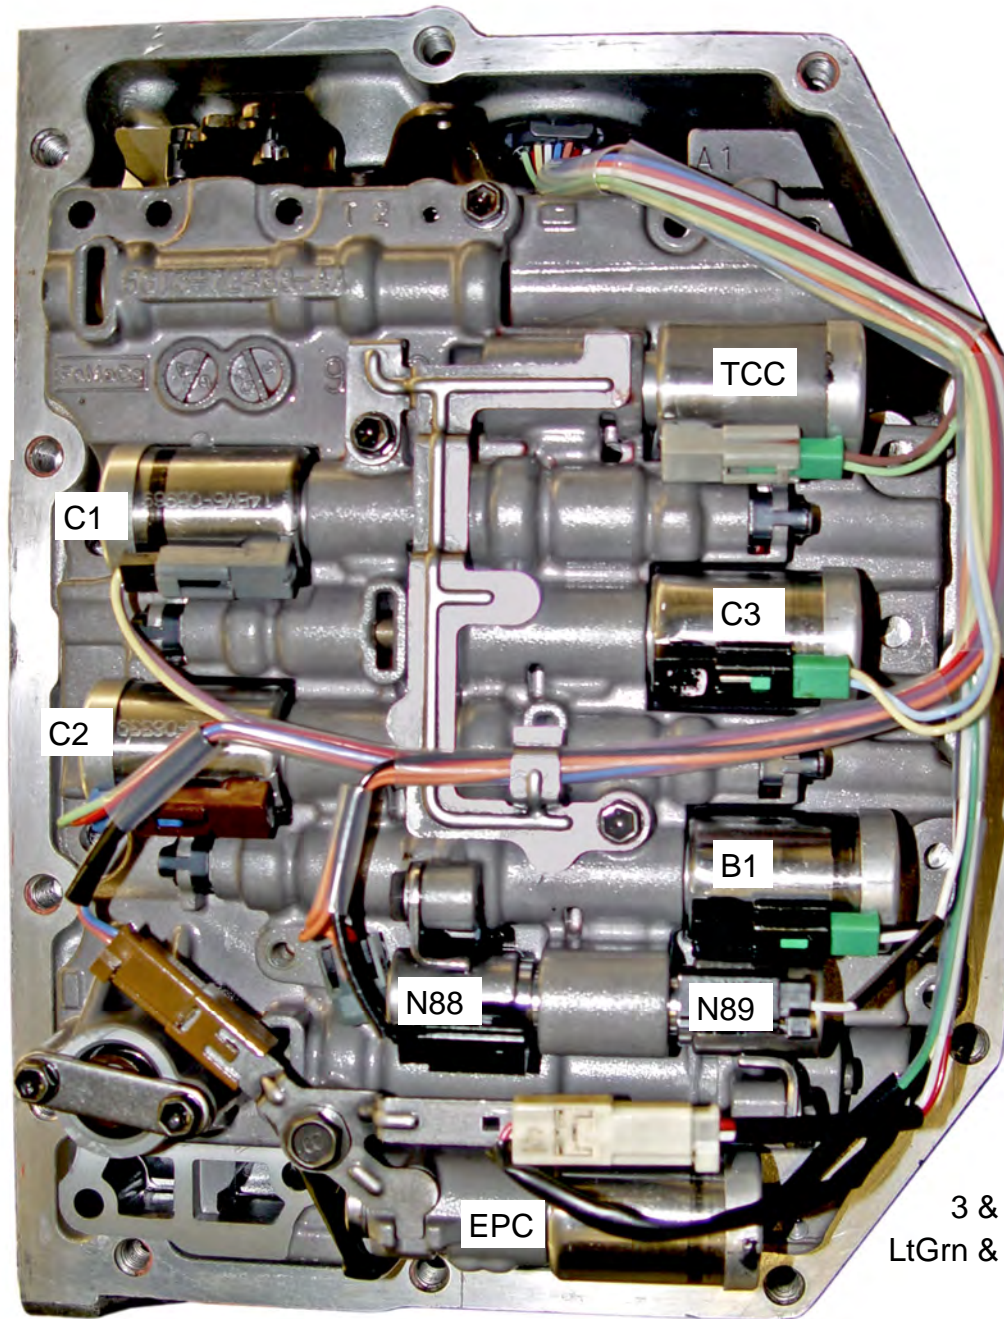
AWF-21 Internal Wiring

Case Conn View
Pins 6 & 15 not used.

Linear Sol Resistance 5-7Ω
N88 & N89 12.5Ω

New Internal wiring harness from
Ford P/N 5G1Z-7G276-A
2005-2011 prox \$95.00
