SK® U151

Corrects/Prevents/Reduces

Shuttle, bind-up or flare on 2-3 shift, slips with throttle in 3rd and/or 4th, TCC slip codes.

Tech Notes: If shuttle, bind-up or flare on the 2-3 shift is the only complaint, it may be possible to correct the complaint just by installing this repair package. However, if the clutches are already damaged, an overhaul will be necessary.

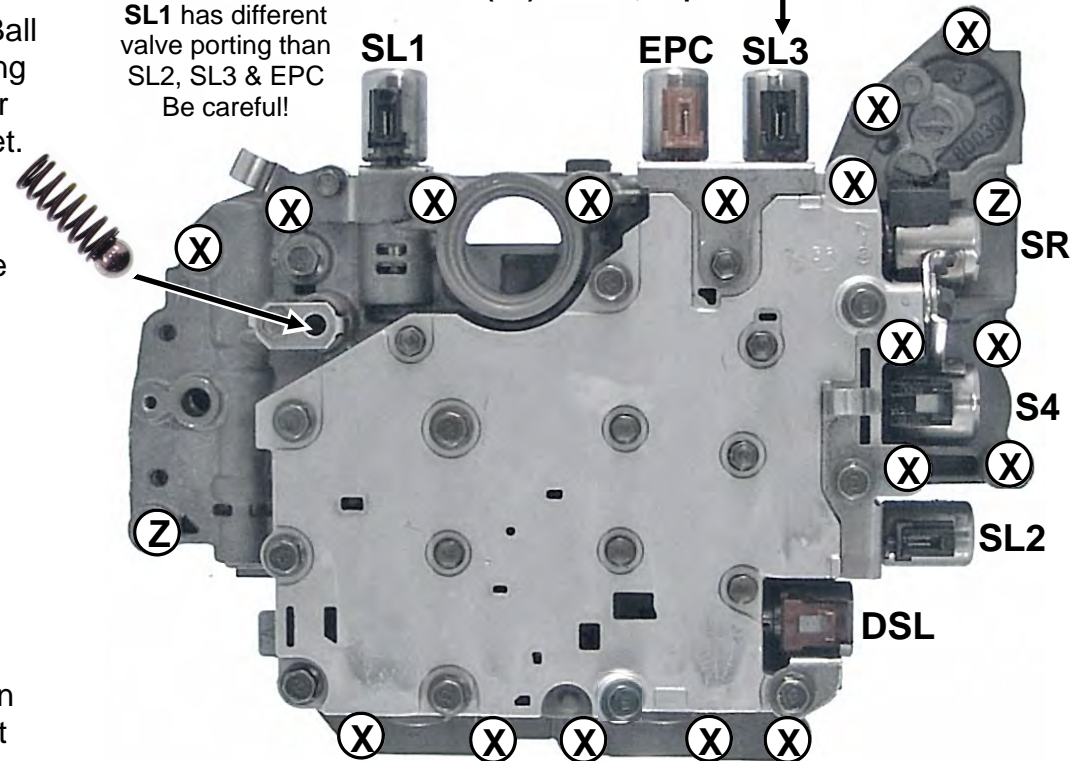
Step 1

Remove the "X" & "Z" bolts that hold the VB to the case. When reinstalling VB, install "Z" bolts first. They align the VB to the case. Disconnect wiring. Keep bolts separate from the rest of the VB bolts.

Relief Ball & Spring Under Bracket.

SL1 has different valve porting than SL2, SL3 & EPC
Be careful!

SL1,2,3 & EPC 4-6.6 Ohms between pins
SR,S4 & DSL 11-15 Ohms between pins
From Either Pin to Body of Solenoid must be open!

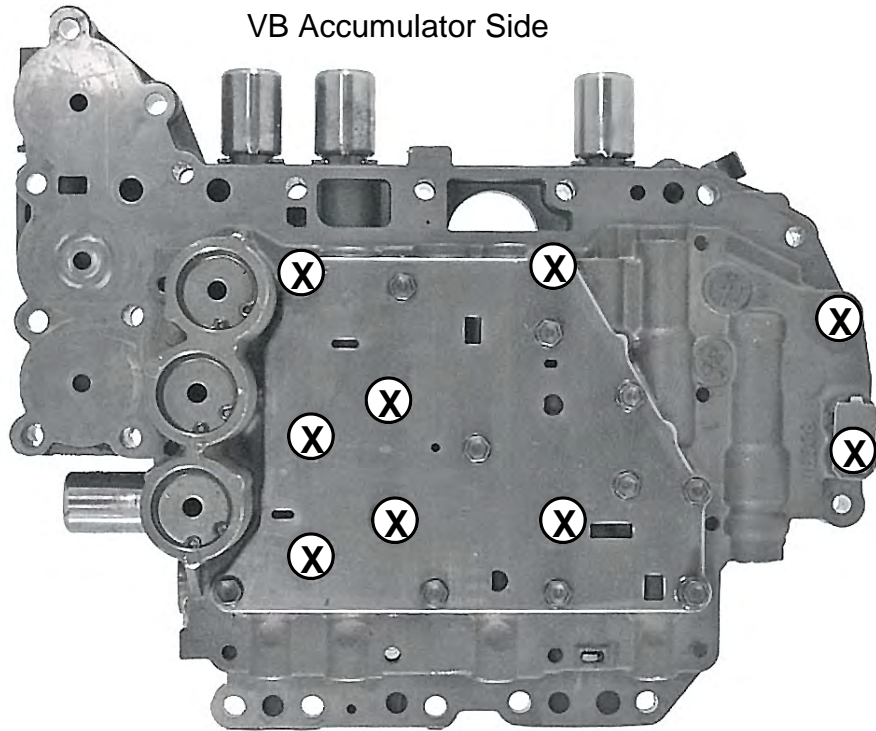
Separating Valve Body Halves.

Flip the VB over so the accumulator side is facing up as shown at left. Remove the bolts marked with an "X". Keep bolts from each side separated to make it easier to reinstall them later.

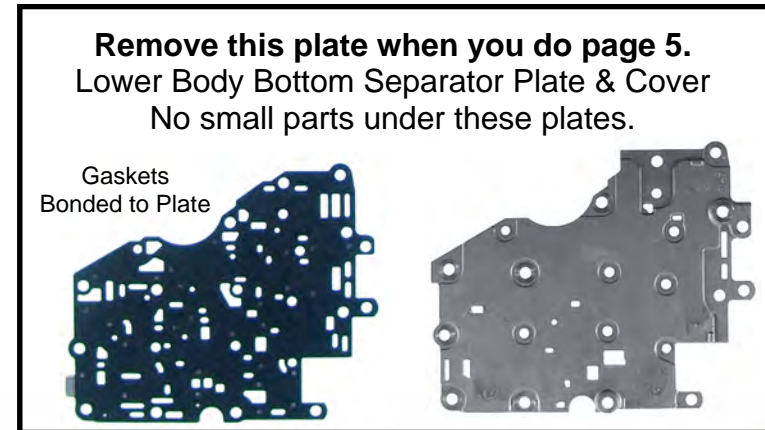
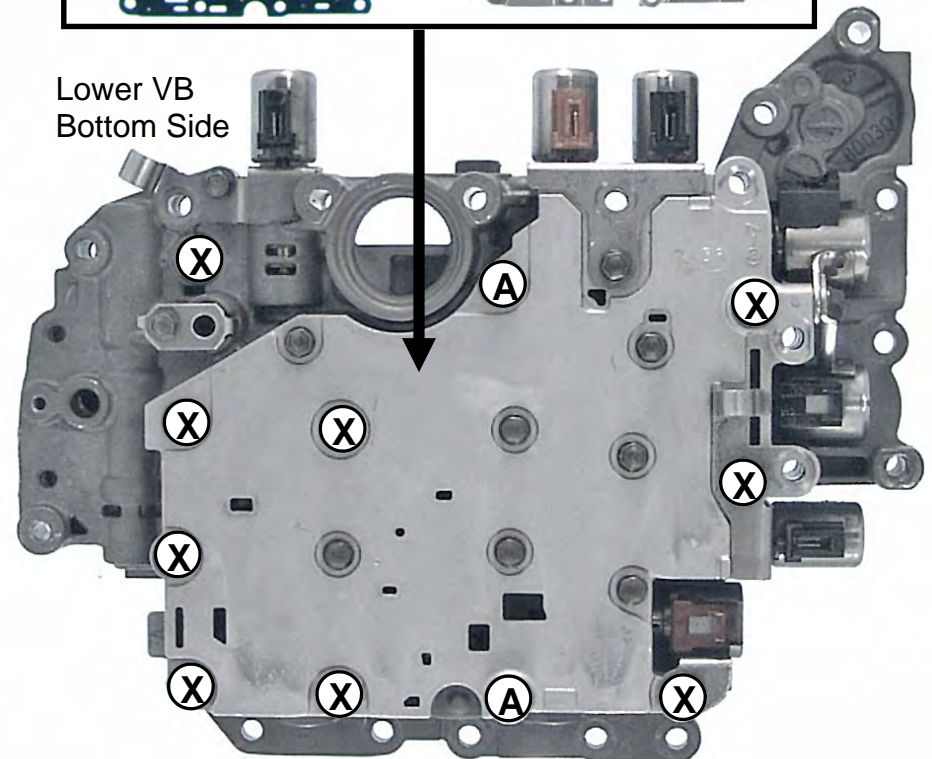
Step 2

After removing the Accumulator body "X" bolts shown above, flip the VB over again and remove the "X" bolts shown at right. Finally, remove the 2 "A" bolts and lift the lower body AND the separator plate together as an assembly off the accumulator body. Flip Lower VB assembly over with separator plate facing up at you. Remove plate and mark the locations of any small parts on both VB halves such as check balls, filters, retainers etc. just in case they differ from what is shown in this instruction. Always reinstall them back in their original locations.

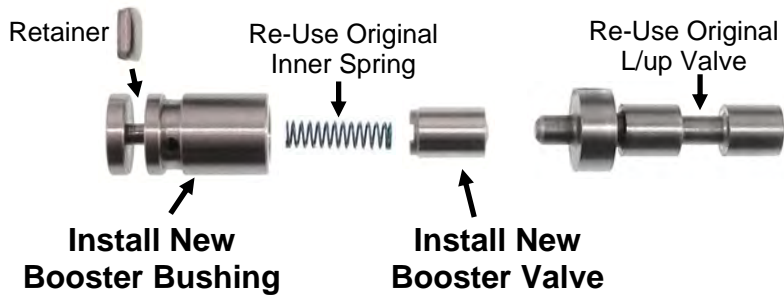
Accumulator Body Repair (Upper Body)

Step 1. Remove and discard original Booster Bushing and Booster valve but **SAVE** the small inner spring! Clean & install original Lockup Valve, New Booster Bushing, original inner spring, New Booster Valve & retainer as shown.

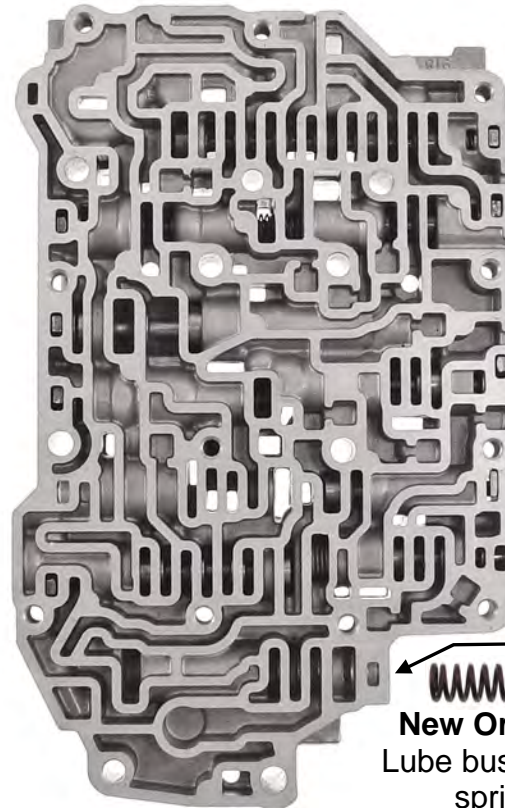
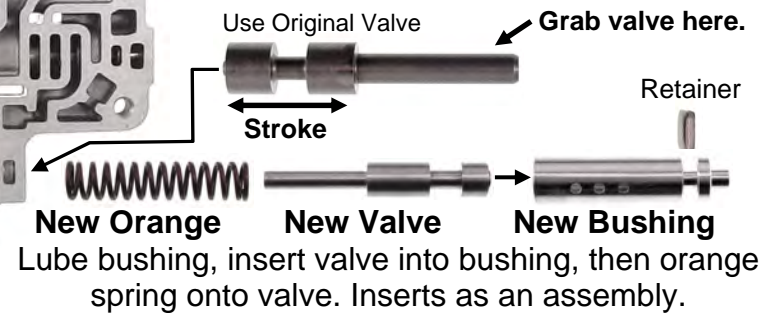
Step 2 Remove Solenoid Reg. Valve & Spring. **The bore needs to be cleaned of any ridge** that will cause the New Bushing to bind during installation. Prepare the bore for the New Bushing by taking the original valve and inserting it into the bore backwards. (Stem end outward.) Using the stem end as a handle, stroke the valve back and forth until any ridge or burr that you feel is gone.

IF BUSHING BINDS— STOP!
Bore **still** has a ridge or burr!

Preassembly Check— Clean new valve and bushing. Insert new valve into bushing and look for chips in the drilled holes. Clean as necessary. We have gone to great lengths to remove them but occasionally one sneaks by.

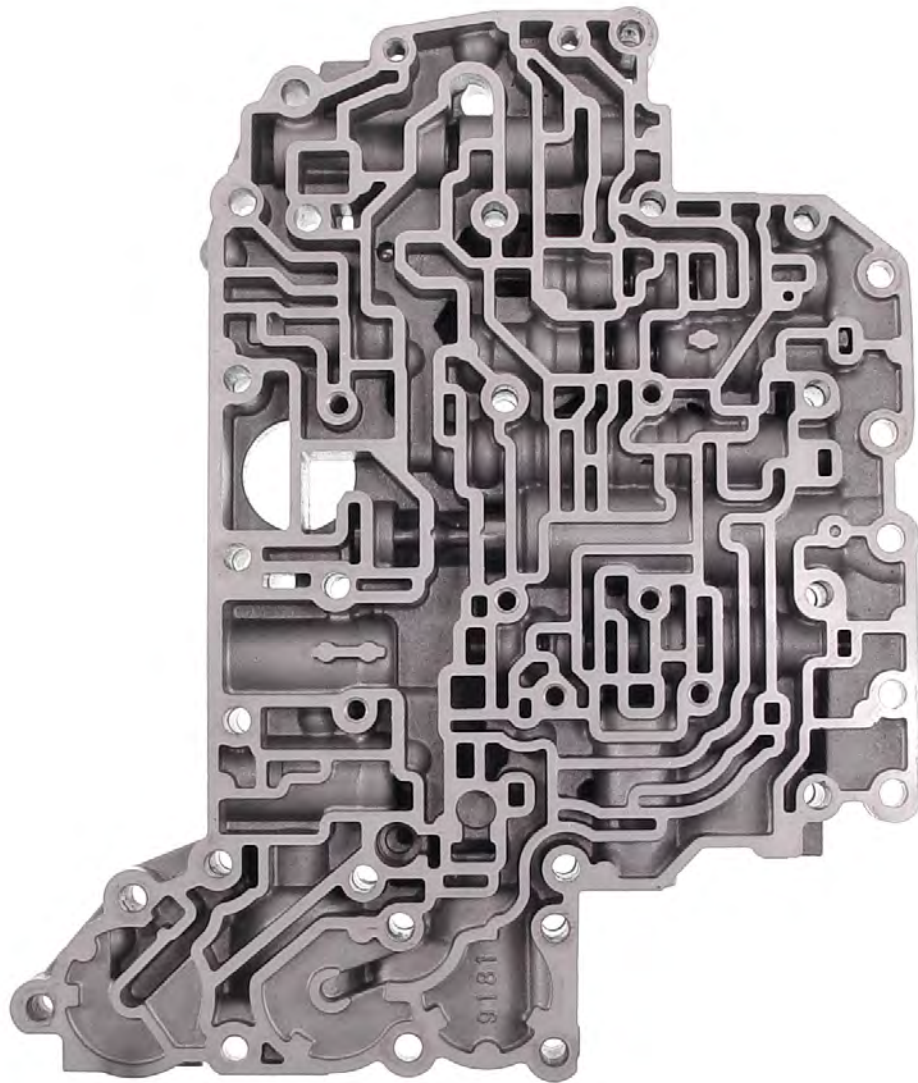
Top view of Lower Valve body.

Step 1. Remove and discard original Direct Clutch Control Valve.

Use Screwdriver on Grooved Areas ONLY!

New Direct Clutch Control Valve

1.10x.780x.026

Reuse Spring,
End Plug & Retainer

Insert **NEW** Steel Direct Clutch Control Valve. The valve must **freely** slide back and forth in the bore.

A tight spot may be fixed by locating valve onto a tight spot and tapping on the side of the valve in the grooved area using a small flat blade screwdriver and 9/16 wrench. (Do Not tap on the polished lands!) Once free, **RE-Use** original spring, end plug and retainer. Clean and reassemble the valve body.

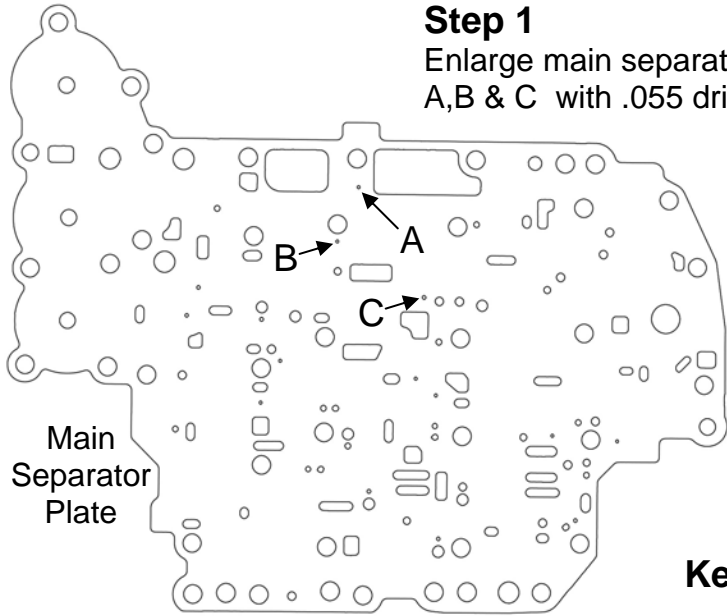
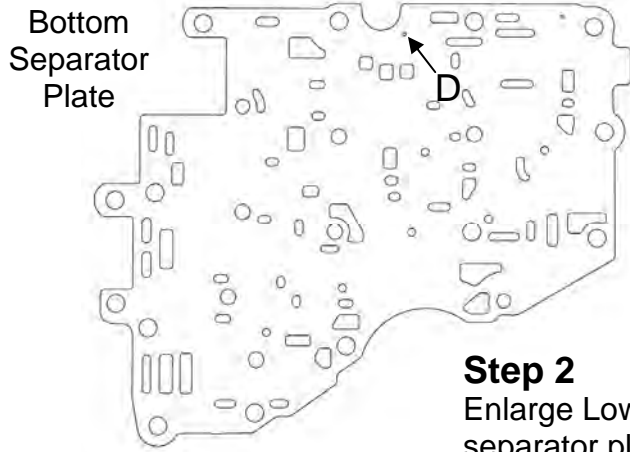
Lube Corrections

Enlarge main separator plate holes A, B & C with .055 drill provided.

Enlarge Lower Body bottom separator plate hole "D" with .055 drill provided.

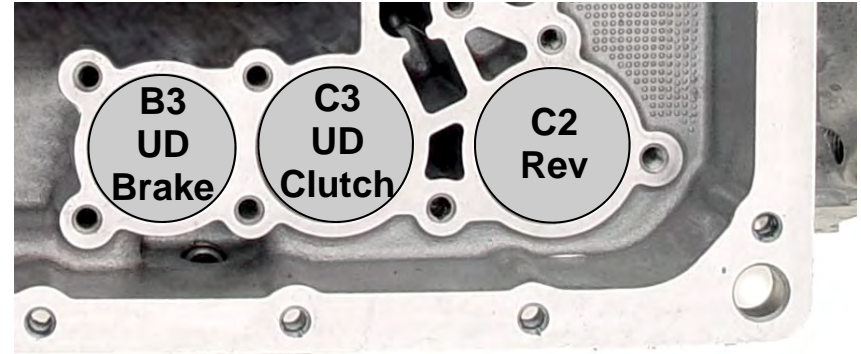
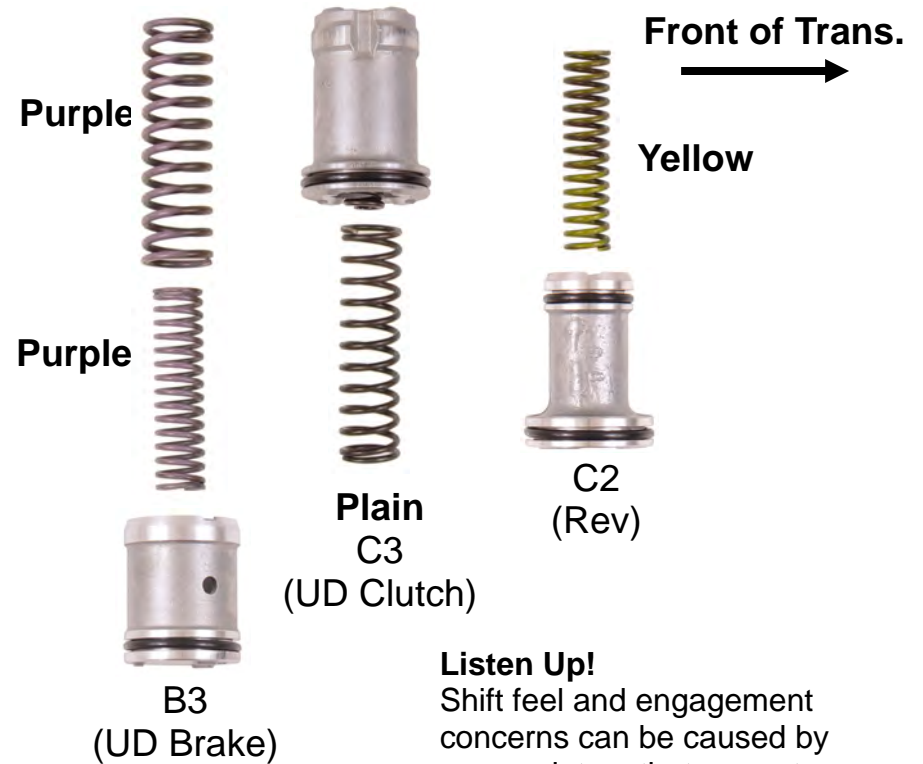
Typical Layout of Case Accumulators (No Changes)

Listen Up!
Shift feel and engagement concerns can be caused by accumulators that are not assembled correctly.

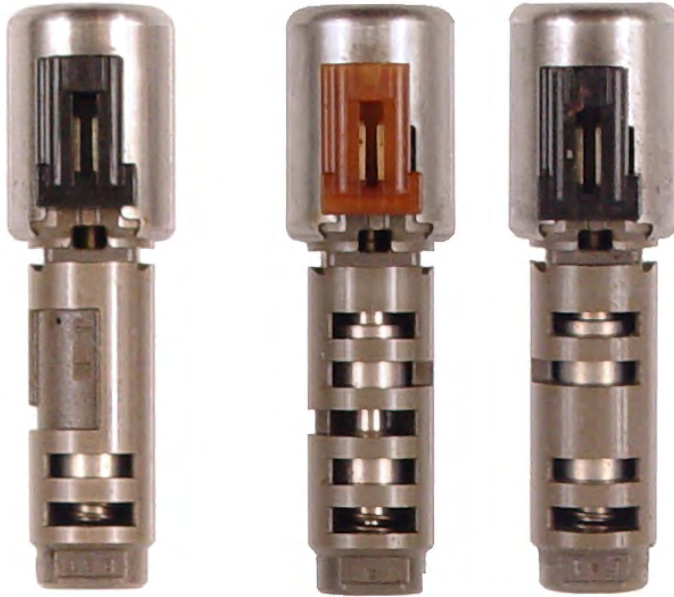
U151 Linear Solenoid ID and Placement

Linear Solenoids
Use the PORTING for ID!
NOT the color of the
electrical connector!
All are 5-5.6Ω

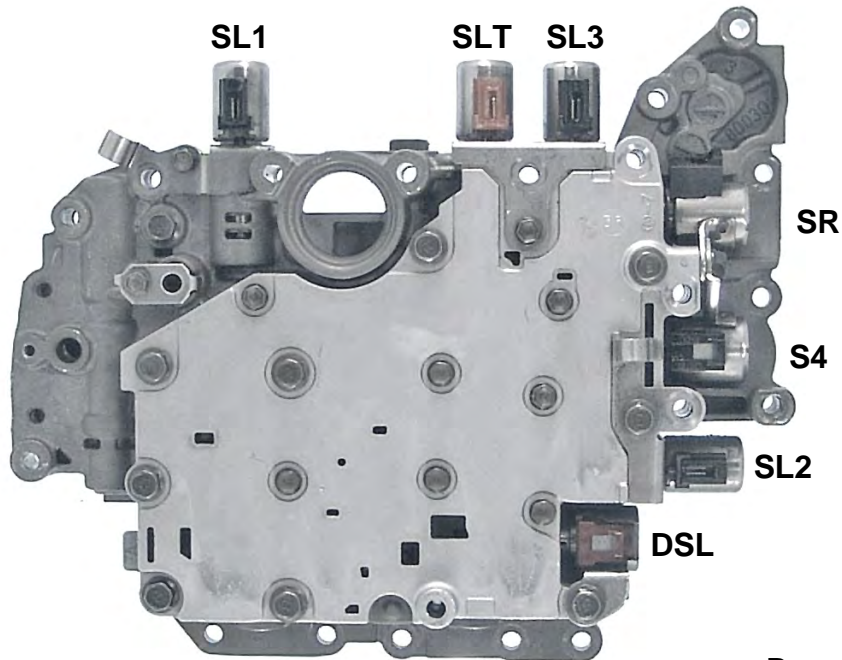
Small On/Off Solenoids.
SR, S4, DSL
All are 11-15Ω
