Item #13811335 - 2019 JCB 9304 6500 lb 4x4 Rough Terrain Forklift

Inspection Report

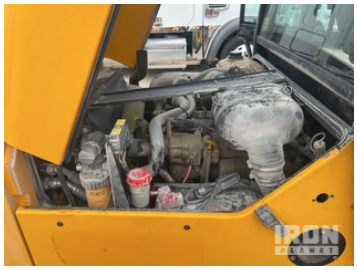
Item	Assessment	Photo
Emission Label	Not present.	
A/C Compressor	Operational Covered	
Starter	Operational	
Exhaust System	No visible damage or missing components	
Radiator	★★★☆	
Oil Leaks	No dripping leaks	
Fuel Leaks	No dripping leaks	
Cooling System Leaks	No dripping leaks	
Engine - Left Side

Limited Function Check	The engine started and ran.	
Engine #1

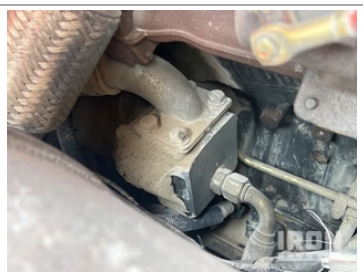
Item	Assessment	Photo
Pumps (Hydraulics)	★★★☆

Valves	★★★☆ Covered	
Hydraulic Tank	★★★☆	
Hoses (Hydraulics)	★★★☆	
Steering Cylinders	★★★☆	
Mast Lift Cylinders	★★★☆	
Mast Tilt Cylinders	★★★☆

Side Shift Cylinder	★★★☆	
Limited Function Check	The hydraulic system was operational.	
Hydraulics #1		
Hydraulics #2

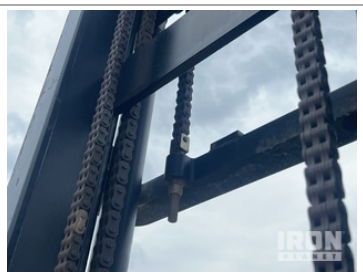
Item	Assessment	Photo
Mast/Boom Condition	★★★☆	
Chain / Tensioners	★★★☆

Carriage Rollers and Guides	★★★☆	
Load Back Rest	★★★☆	
Side Shift	★★★☆	
Forks	★★★☆
