## Item #13810722 - 2019 Skyjack SJ6832 RT Dual Fuel 4x4 Scissor Lift

- Features: 32 ft Max Platform Height, 1000 lb Max Weight Capacity, Platform Extension, Power to Platform, Stabilizers, Solid Non-Marking Tires, Upper Control Box, 2018 US EPA Label, CARB Compliant, Kubota 3 Cylinder Dual Fuel Engine
- Meter Reading: 1,193 Miles
- Serial # : 37014715
- Inspection Completed: 8/27/25

## Inspection Report

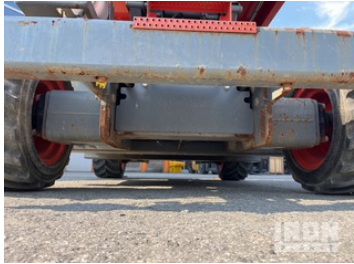
| Item | Assessment | Photo |
|---|---|---|
| Rear Drive Axle | ★★★★☆ | A photograph of the rear drive axle assembly, showing the axle, suspension, and the red-painted wheel hub. The IronPlanet logo is visible in the bottom right corner. |

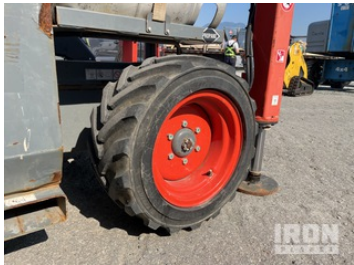
| Left Rear Tire | Screws | |
