## Item #13811404 - 2018 JLG 4069LE Electric Scissor Lift

# Inspection Report

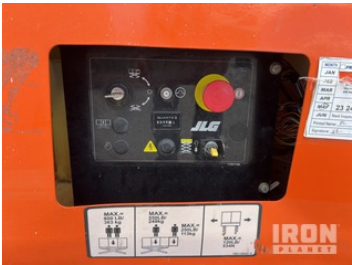
| Control Station Ground | | |
|---|---|---|
| Function Controls | ☆☆☆☆ | |

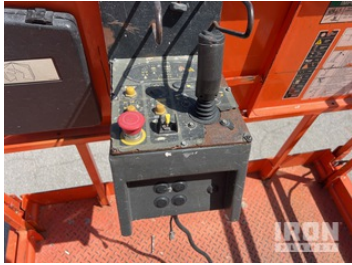
| Item | Assessment | Photo |
|---|---|---|
| Emergency Shut Off Switch | Operational | |

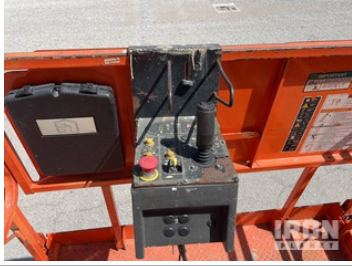
| Item | Assessment | Photo |
|---|---|---|
| Upper Function Controls | ★★★★☆ | |

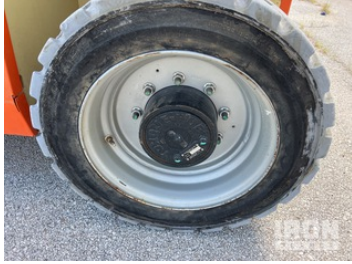
| Item | Assessment | Photo |
|---|---|---|
| Final Drives | ☆☆☆☆ | |

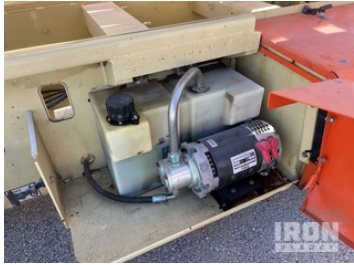
| Hydraulics | | |
|---|---|---|
| Pumps (Hydraulics) | ★★★★☆ | A close-up photograph of the hydraulic pump assembly, showing a black electric motor connected to a pump unit with various hoses and fittings. The assembly is mounted on a yellow metal frame. |

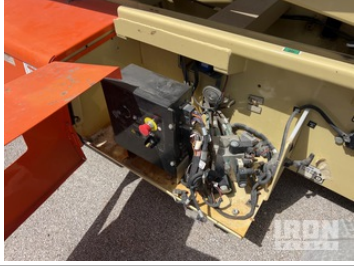
| Hydraulics | | |
|---|---|---|
| Valves | ★★★★☆ | A photograph of the hydraulic valve assembly, featuring a black control valve with multiple ports and hoses, mounted on a yellow metal frame. |

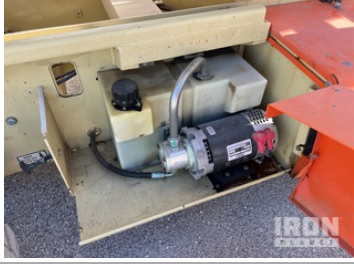
| Hydraulics | | |
|---|---|---|
| Hydraulic Tank | ★★★★☆ | A photograph showing the hydraulic tank and pump assembly, with a black electric motor and pump unit mounted on a yellow metal frame. |

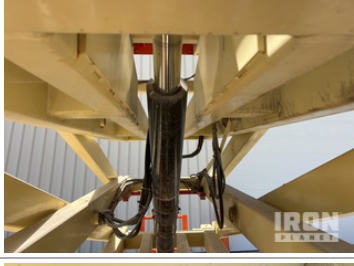
| Hydraulics | | |
|---|---|---|
| Lift Cylinders | ★★★★☆ | A photograph of the lift cylinder, showing a black hydraulic cylinder mounted on a yellow metal frame. |

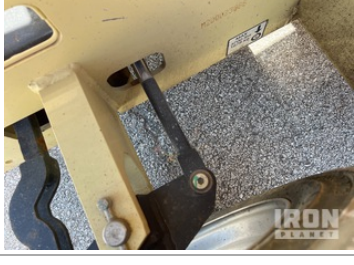
| Hydraulics | | |
|---|---|---|
| Steering Cylinder | ★★★★☆ | A photograph of the steering cylinder, showing a black hydraulic cylinder mounted on a yellow metal frame. |
