Item #13810768 - 2017 JLG 4069LE Electric Scissor Lift

Inspection Report

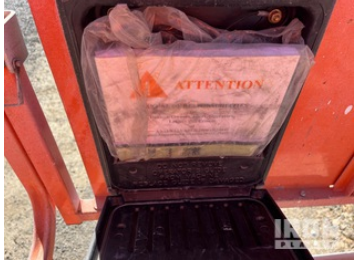
Safety		
Item	Assessment	Photo
Travel Alarm	Operational	
Horn	Operational	
Current Safety Manual	Yes	
Current Operator/Maintenance Manual	Yes	
ANSI Guidelines	Yes

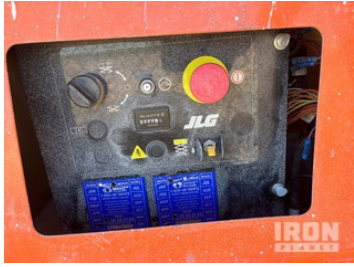
Limited Function Check	The main components are in place and operational as noted.	
Control Station Ground #1

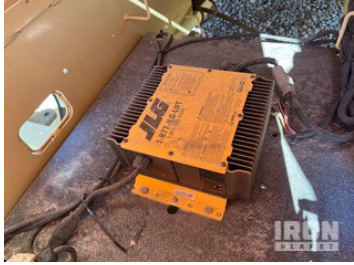
Electrical Operating System		
Item	Assessment	Photo
Operating Voltage	48 Volts	
Battery Condition	Functioned during the inspection	
Cables and Connections	No visible damage or missing components

Limited Function Check	The electrical system was operational in a limited check.

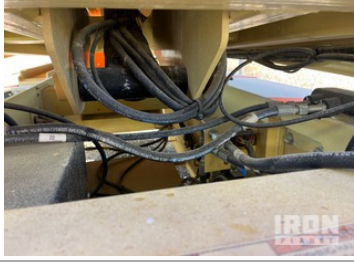
Hoses

Limited Function Check	The hydraulic system was operational.
