## Item #14340468 - 2015 Skyjack SJ7135RT Diesel 4x4 Scissor Lift

# Inspection Report

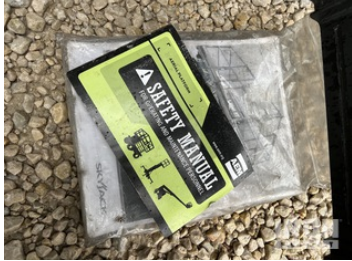
| Safety | | |
|---|---|---|
| ANSI Guidelines | Yes | |

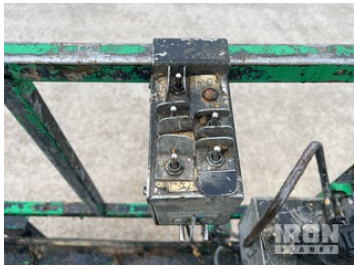
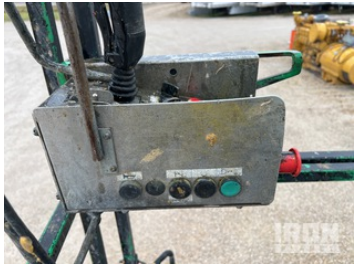
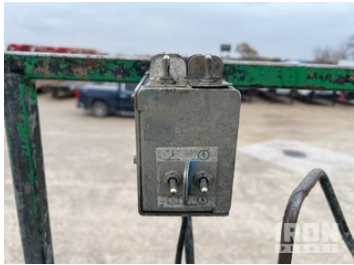
| Item | Assessment | Photo |
|---|---|---|
| Upper Function Controls | ★★☆☆☆<br>Outrigger controls do not respond; Lift speed does not run on high | |
