## Item #14340554 - 2016 Skyjack SJ4632 Electric Scissor Lift

# Inspection Report

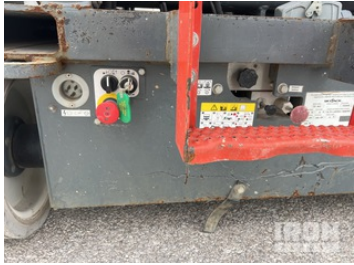
| Control Station Ground | | |
|---|---|---|
| Function Controls | ☆☆☆☆ | |
| Limited Function Check | The main components are in place and operational as noted. | |

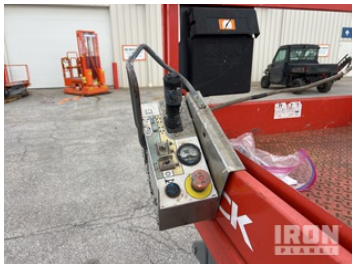
| Item | Assessment | Photo |
|---|---|---|
| Upper Function Controls | ★★★★☆ | |
| Limited Function Check | The main components are in place and operational as noted. | |

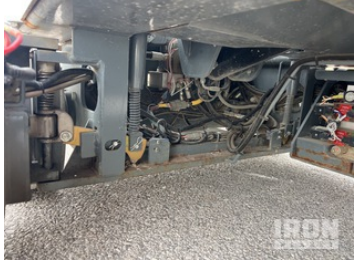
| Item | Assessment | Photo |
|---|---|---|
| Drive Motors | ☆☆☆☆ | |
| Limited Function Check | The drivetrain was operational. | |

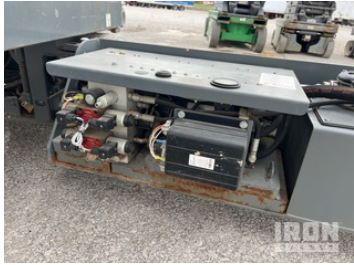
| Hydraulics | | |
|---|---|---|
| Pumps (Hydraulics) | ★★★★☆ | A close-up photograph of the hydraulic pump assembly, showing the pump motor, control valve, and associated hoses. The unit is mounted on a metal frame. |

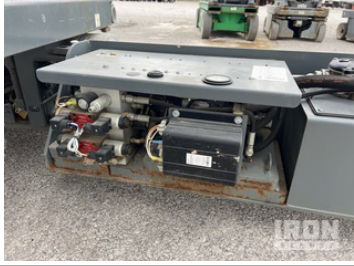
| Hydraulics | | |
|---|---|---|
| Valves | ★★★★☆ | A close-up photograph of the hydraulic valve assembly, showing the control valve and associated hoses. The unit is mounted on a metal frame. |

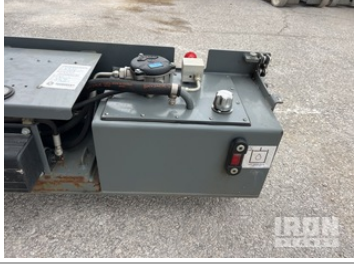
| Hydraulics | | |
|---|---|---|
| Hydraulic Tank | ★★★★☆ | A close-up photograph of the hydraulic tank, showing the tank body, filler cap, and associated hoses. The unit is mounted on a metal frame. |

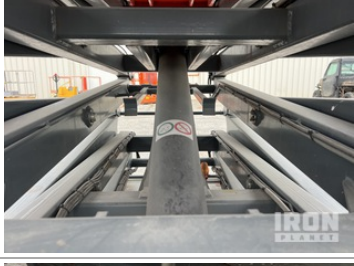
| Hydraulics | | |
|---|---|---|
| Lift Cylinders | ★★★★☆ | A close-up photograph of the lift cylinders, showing the cylinders mounted on the lift arms. The cylinders are black and have yellow and red markings. |

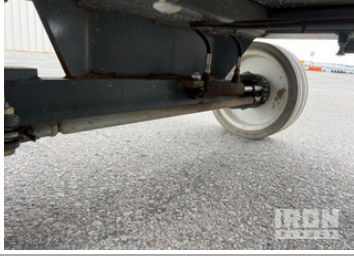
| Hydraulics | | |
|---|---|---|
| Steering Cylinder | ★★★★☆ | A close-up photograph of the steering cylinder, showing the cylinder mounted on the steering arm. The cylinder is black and has yellow and red markings. |
