## Item #13811276 - 2017 JLG 4069LE Electric Scissor Lift

## Inspection Report

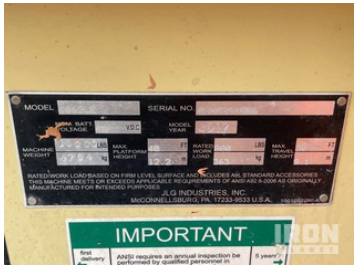
| Serial Number / VIN | 0200261006 | |

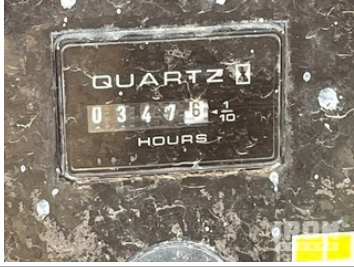
| Hour Meter / Odometer | 347 mi | |

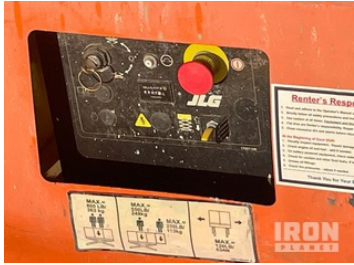
| Control Station Ground | | |
|---|---|---|
| Function Controls | ☆☆☆☆ | |
| Limited Function Check | The main components are in place and operational as noted. | |

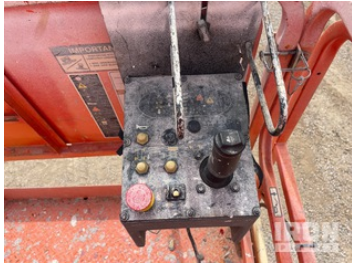
| Item | Assessment | Photo |
|---|---|---|
| Upper Function Controls | ☆☆☆☆ | |
| Limited Function Check | The main components are in place and operational as noted. | |
