## Item #13811480 - 2016 JLG 4069LE Electric Scissor Lift

# Inspection Report

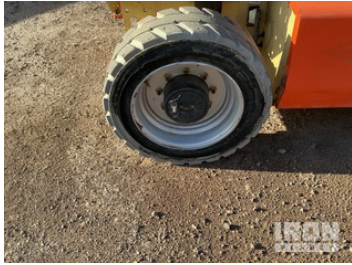
| Item | Assessment | Photo |
|---|---|---|
| Drivetrain #1 | | |

| Item | Assessment | Photo |
|---|---|---|
| Limited Function Check | The drivetrain was operational. | |
