## Item #14577210 - 2015 Skyjack SJ6832 RT Dual Fuel 4x4 Scissor Lift

# Inspection Report

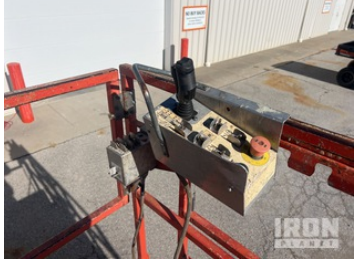
| <b>Control Station Upper</b> | | |
|---|--|--|
| Control Console | No visible damage or missing components | |

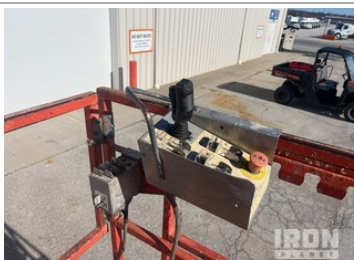
| <b>Control Station Upper</b> | | |
|---|--|--|
| Upper Function Controls | ★★★★☆ | |
| Limited Function Check | The main components are in place and operational as noted. | |

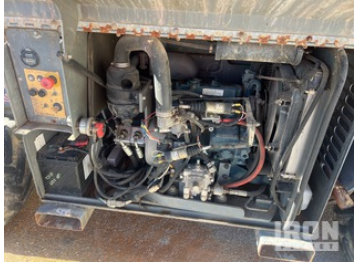
| <b>Engine</b> | | |
|---|---|--|
| Fuel System | Operational | |

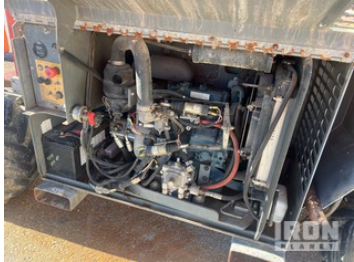
| <b>Engine</b> | | |
|---|---|--|
| Engine - Left Side | | |

| Limited Function Check | After jump starting, the engine ran. The engine would not re-start after shutting down without jump starting. | |

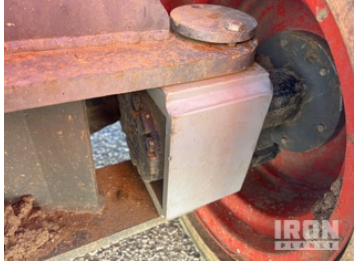
| <b>Drivetrain</b> | | |
|--|---|--|
| Drivetrain #1 | | |

| <b>Drivetrain</b> | | |
|--|---|--|
| Limited Function Check | The drivetrain was operational. | |

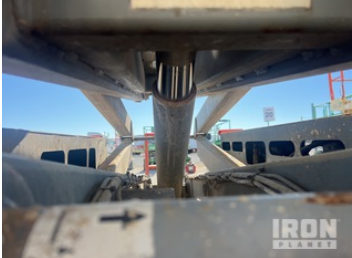
| Hydraulics #1 | | |

| Limited Function Check | The hydraulic system was operational. | |

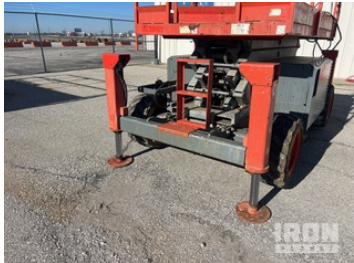
| Chassis #1 | | |

| Limited Function Check (Scissor-lift) | The main components appear to be in place and operational. | |
