Item #14577193 - 2016 Skyjack SJ6832 RTE Electric 4x4 Scissor Lift

Inspection Report

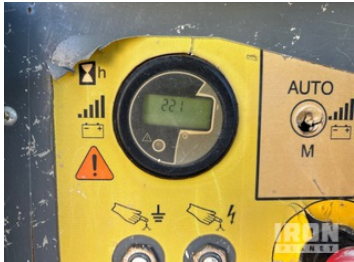
CE Mark	No CE mark found	
Hour Meter / Odometer	221 hrs

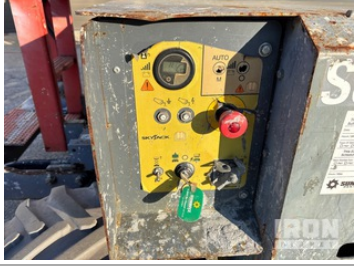
Function Controls	★★★★☆

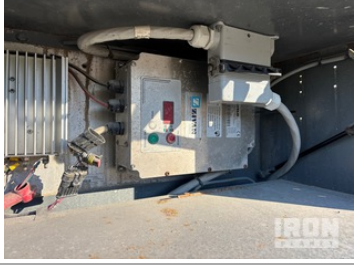
Electrical Operating System		
Item	Assessment	Photo
Operating Voltage	48 Volts	
Battery Condition	Functioned during the inspection, Weak or under-charged, Unit was charged at one point to finish inspection	
Cables and Connections	No visible damage or missing components

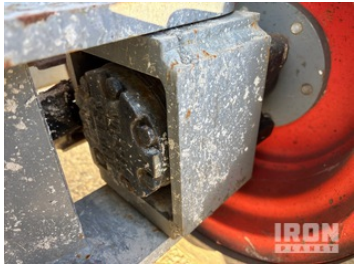
Drivetrain		
Operational test is limited to low speed in a confined flat area without load. Differential interlocks, full transmission shifting and functionality of all drive axles cannot be fully verified. Inspector listens for abnormal noises, observes leaks and notes physical damage.		
Item	Assessment	Photo
Drive Motors	★★★☆☆

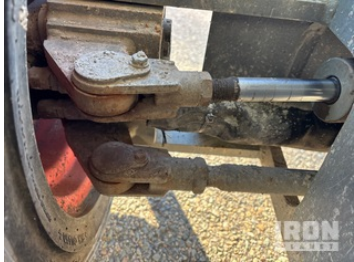
Chassis		
IronPlanet pin connection pivot point wear inspections are limited to sound, sight and feel observations. Dial indicator testing is not performed.		
Item	Assessment	Photo
Brake System	★★☆☆ The brake system functioned, stopping and holding the machine.	
Steering Linkage	★★☆☆

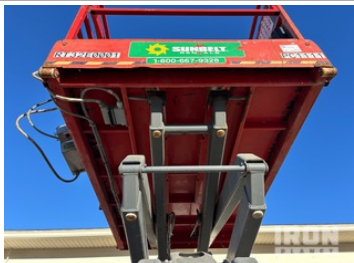
Platform Condition	★★☆☆

Platform Extension	★☆☆☆☆ Would not slide
