Inspection Report (Boom Lift)

Year	2013
Make	Skyjack
Model	SJ45T
Serial Number	98001112
Hour Meter Reading	3896
Previous Application (e.g., earth moving, mining, demolition, etc)	Rental

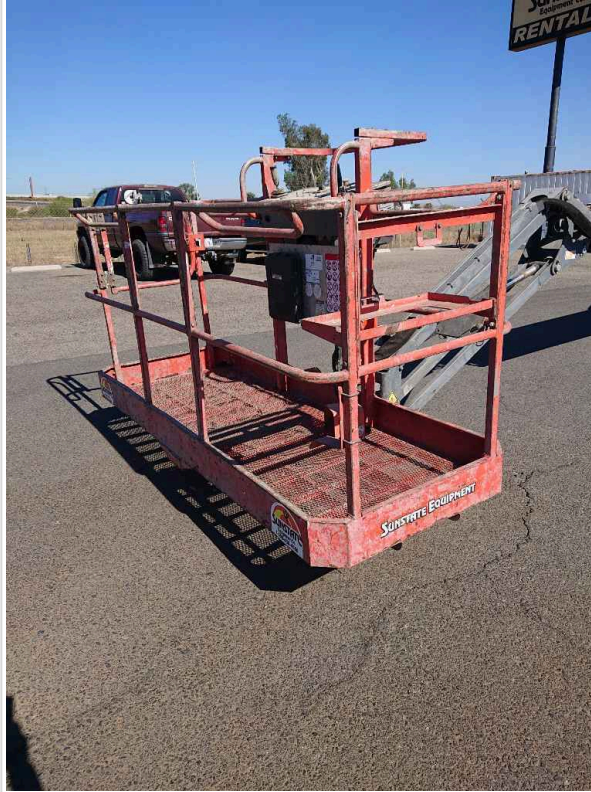
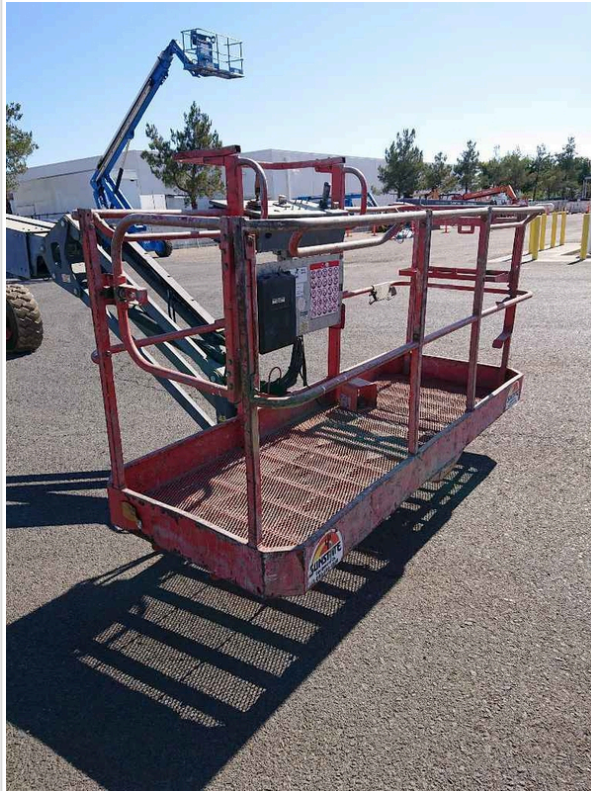
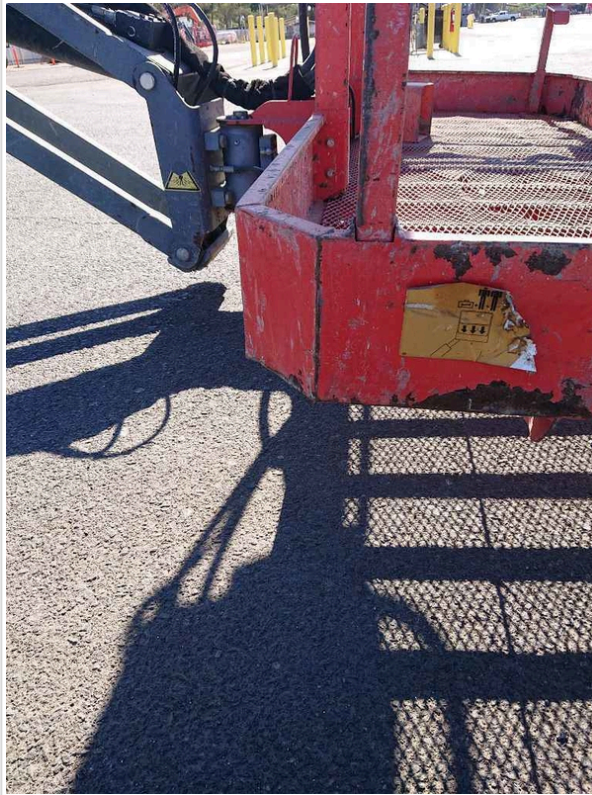
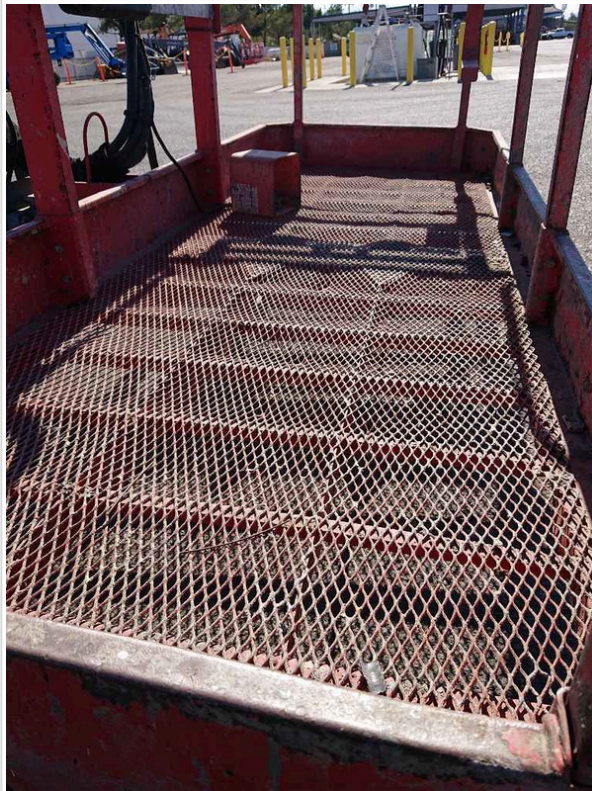
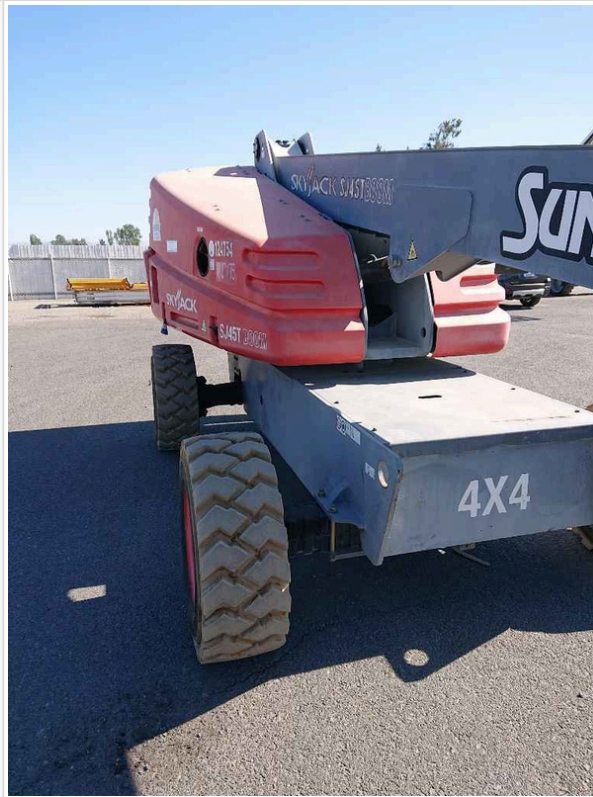
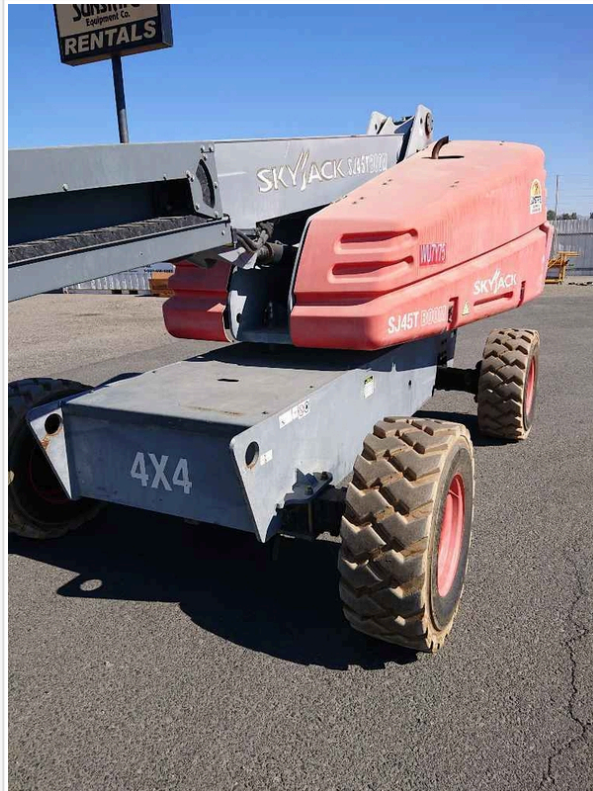
Front Photos

Instructions	<p>Evaluate the following on a 4 point scale (leave comments where an explanation is appropriate):</p> <p>4 = Like New, Recently Replaced 3 = Normal Wear & Tear 2 = Above Average Wear 1 = Service Required</p> <p>Things to look for:</p> <ul style="list-style-type: none"> - cosmetic damage - minor surface rust - repaint (and overspray) - cracked or damaged glass - major rust (cancer) - cracks / visible welds
Front	3 - Normal Wear & Tear

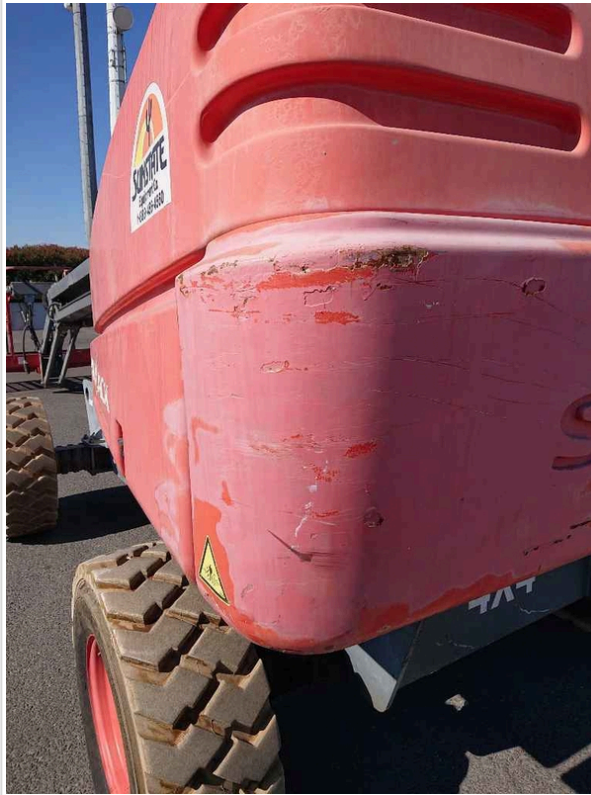
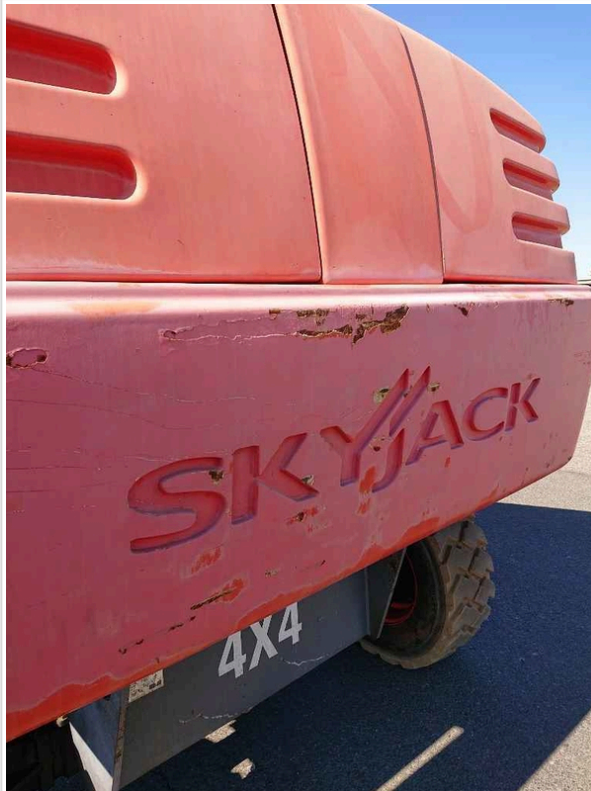
Rear Photos

3 - Normal Wear & Tear

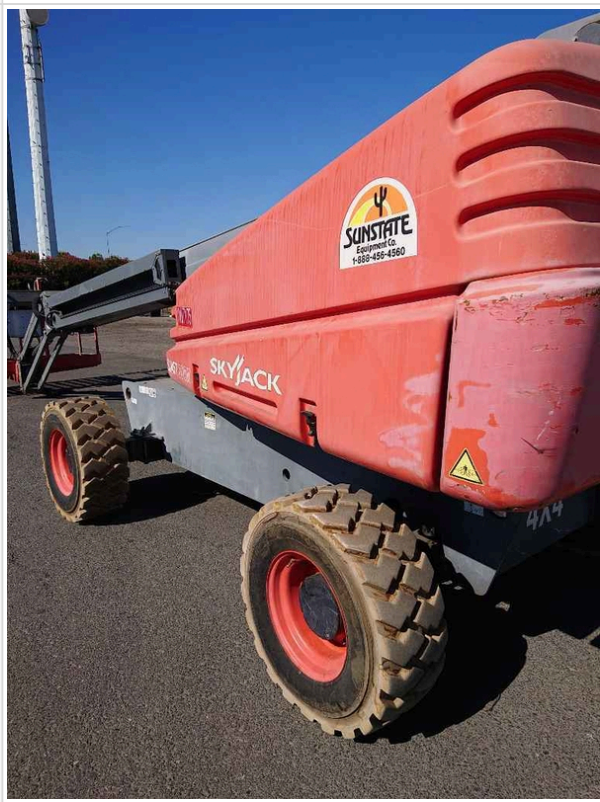
<p>Left</p>	<p>3 - Normal Wear & Tear</p>
<p>Left Photos</p>

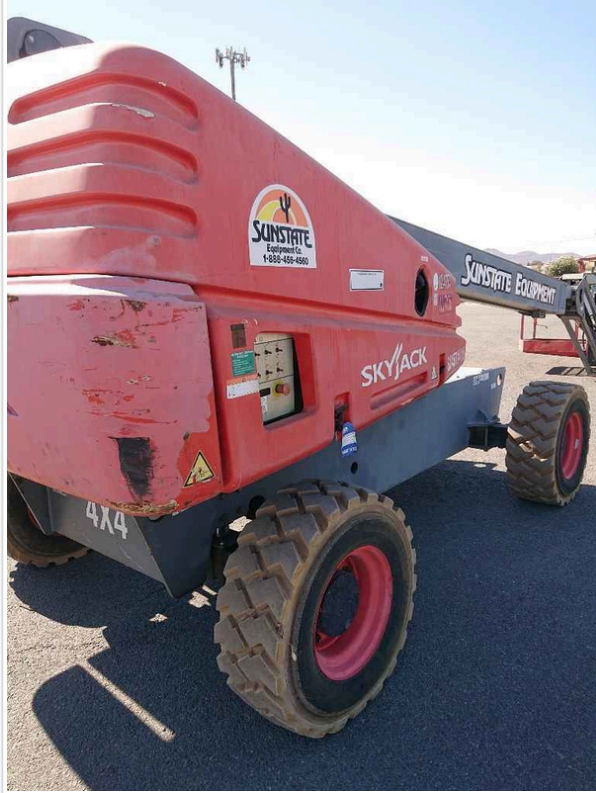
<p>Right Photos</p>

<p>Right</p>	<p>3 - Normal Wear & Tear</p>

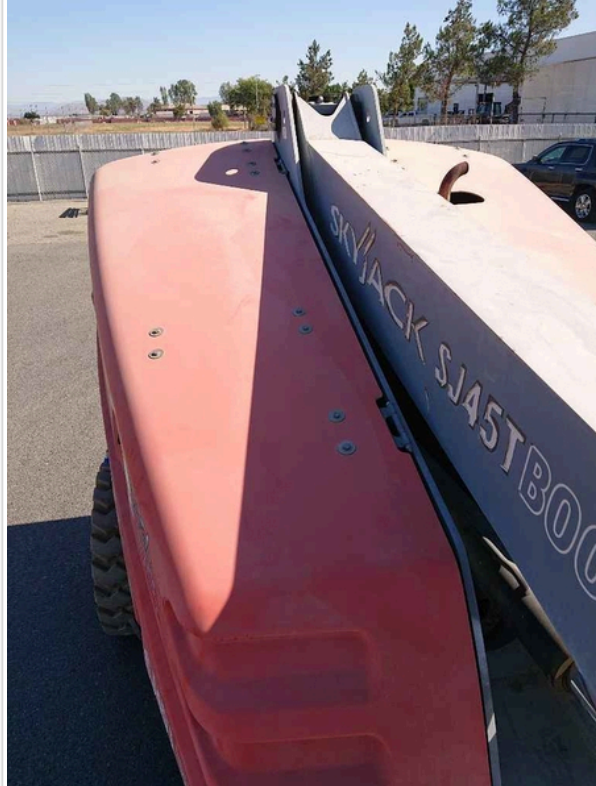
<p>Upper</p>	<p>3 - Normal Wear & Tear</p>
<p>Upper Photos</p>

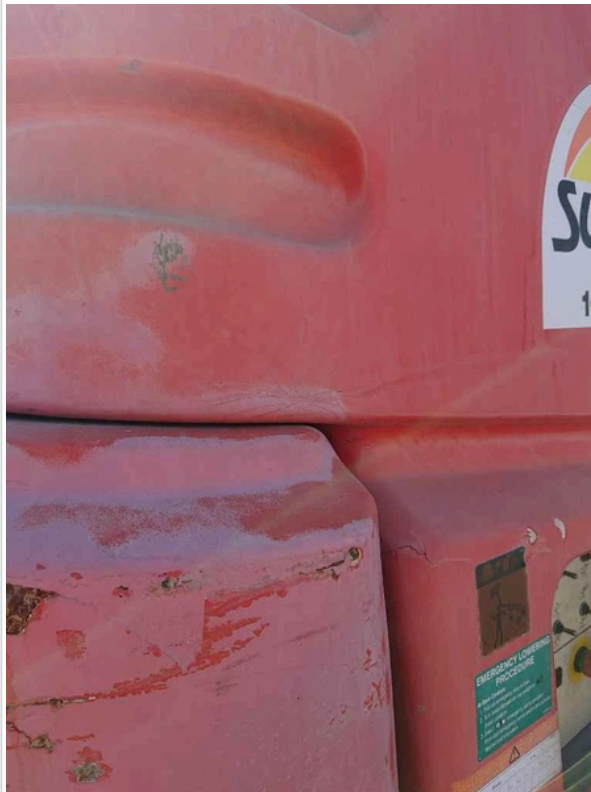
Body Panels Photos

3 - Normal Wear & Tear

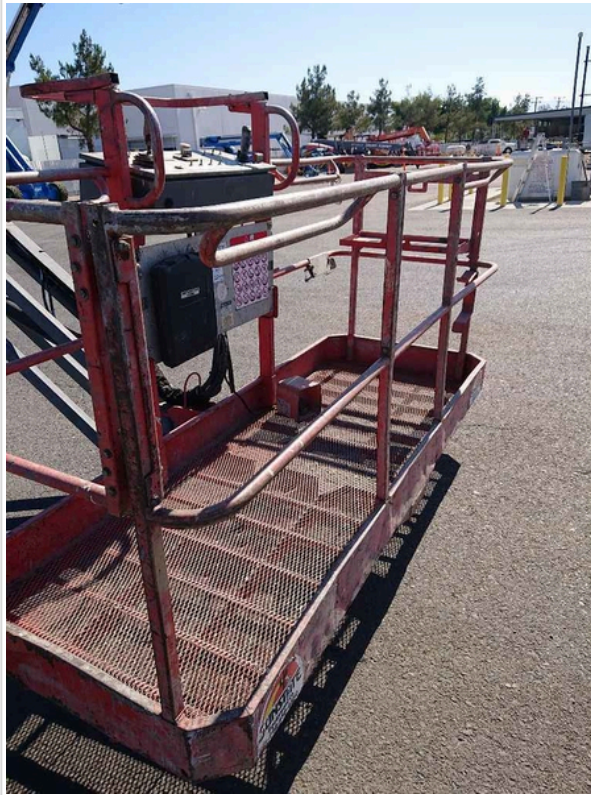
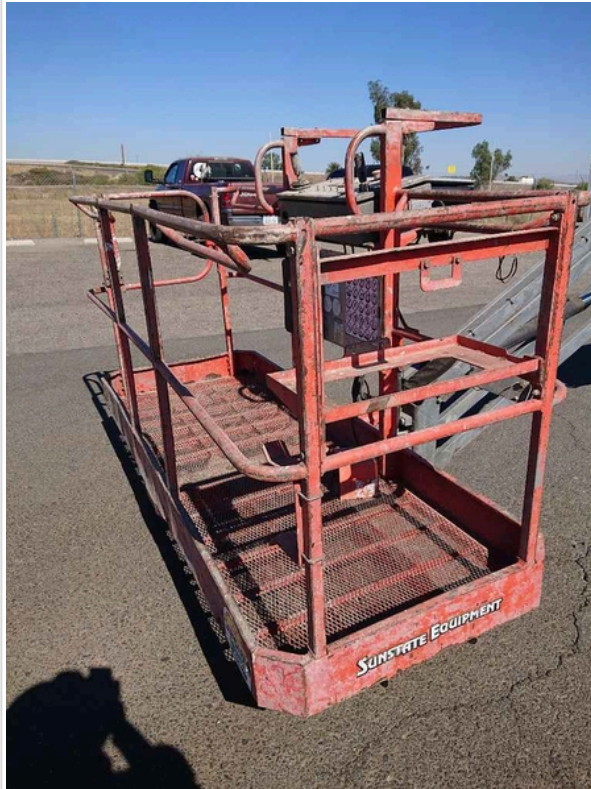
Platform Safety Rails & Appearance	3 - Normal Wear & Tear
Comments	Aged but no compromising damage noted
Platform Safety Rails & Appearance Photos

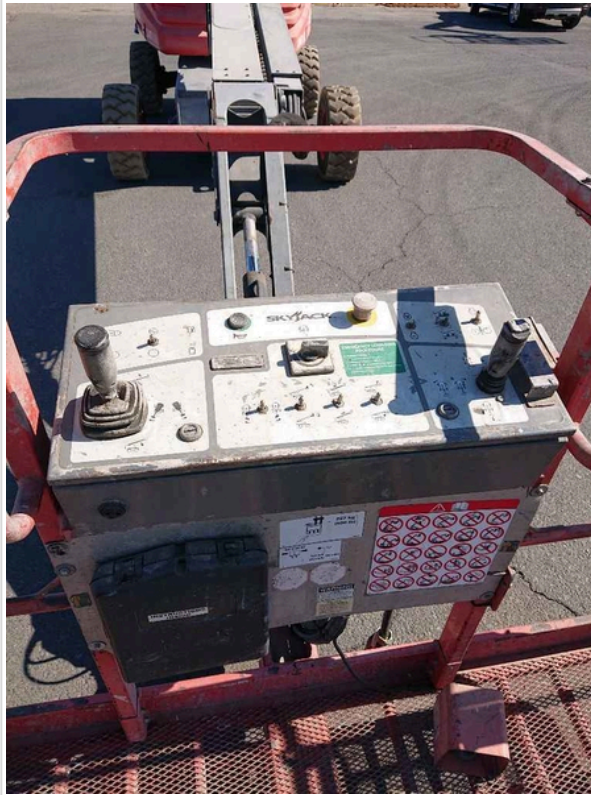
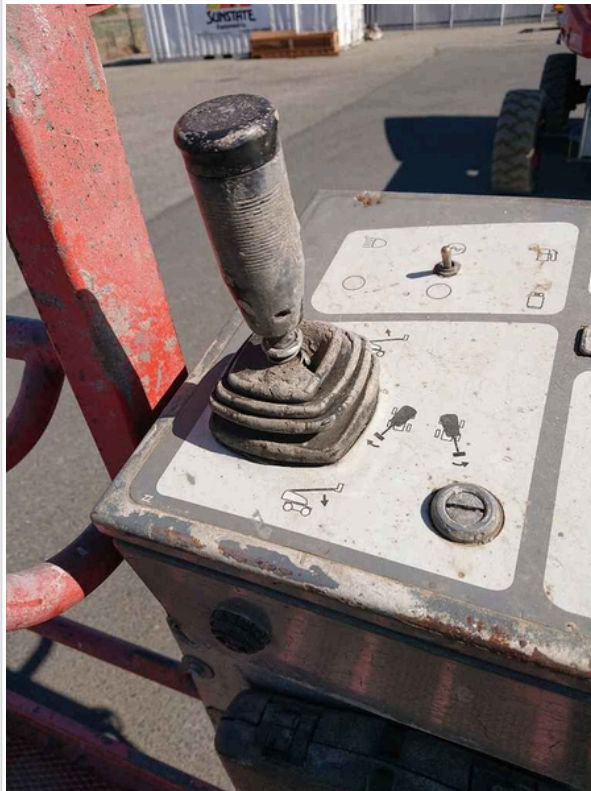
Platform Controls Photos

Platform Controls	3 - Normal Wear & Tear

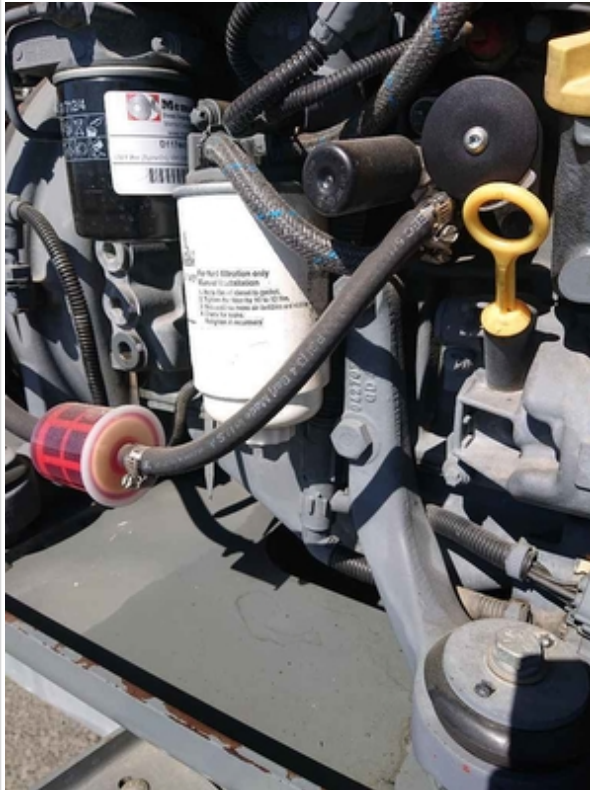
Hose Photos

3 - Normal Wear & Tear

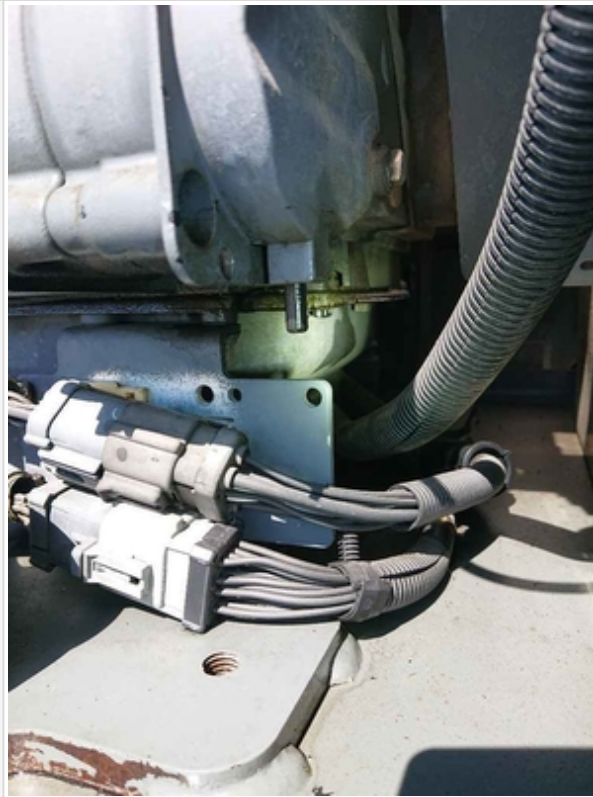
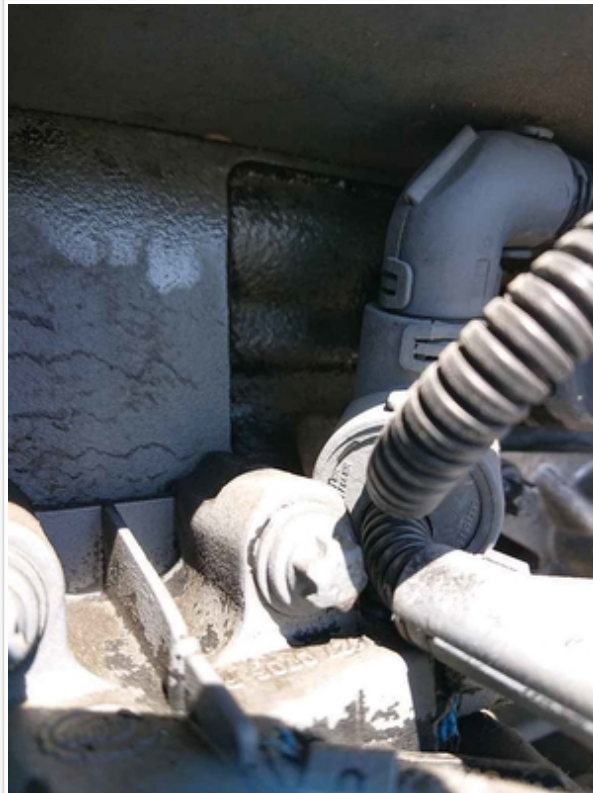
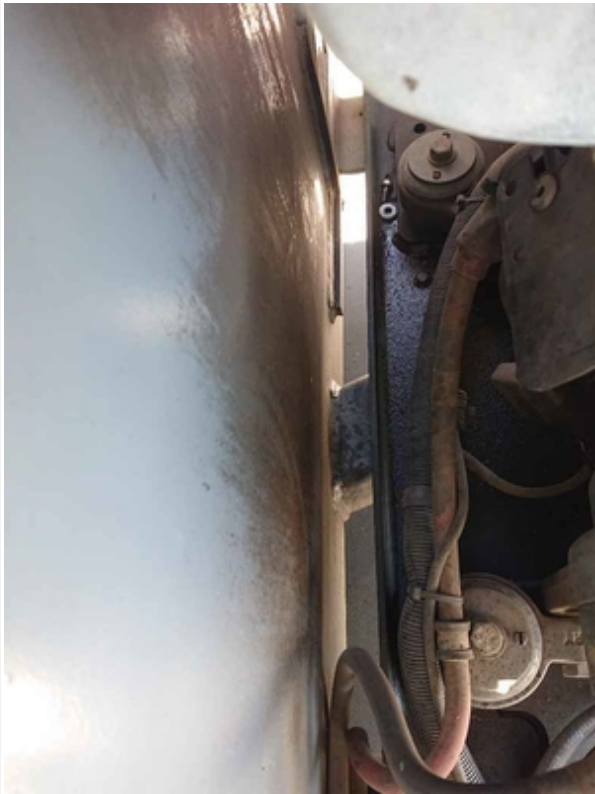
Water Pump	2 - Above Average Wear
Water Pump Condition	Other (see comments)
Comments	Inaccessible
Cooling System Leaks	No
Coolant Color / Appearance	0
Oil Leaks	Yes
Oil Leak Notes	Wet areas with drops forming due to oil leakage, Other (see comments)
Comments	Wet/leaking at oil pan; difficult/inaccessible to pinpoint exact source

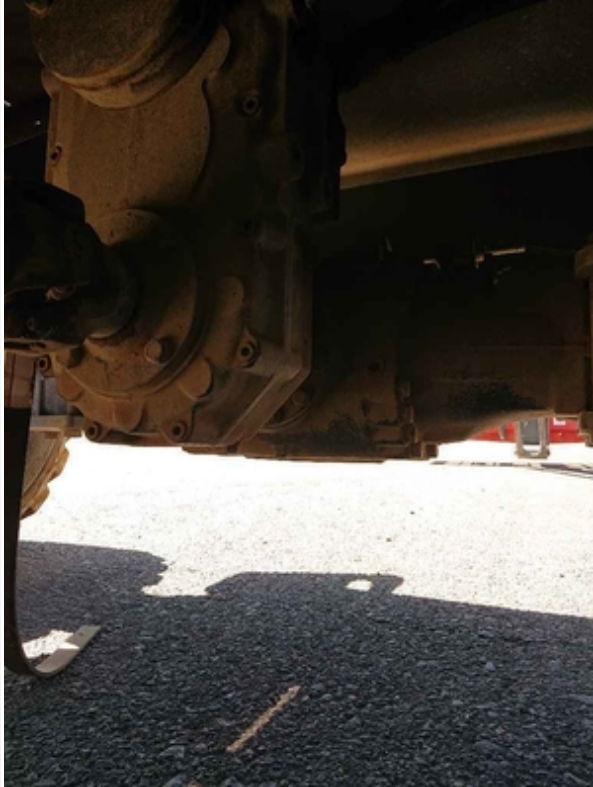
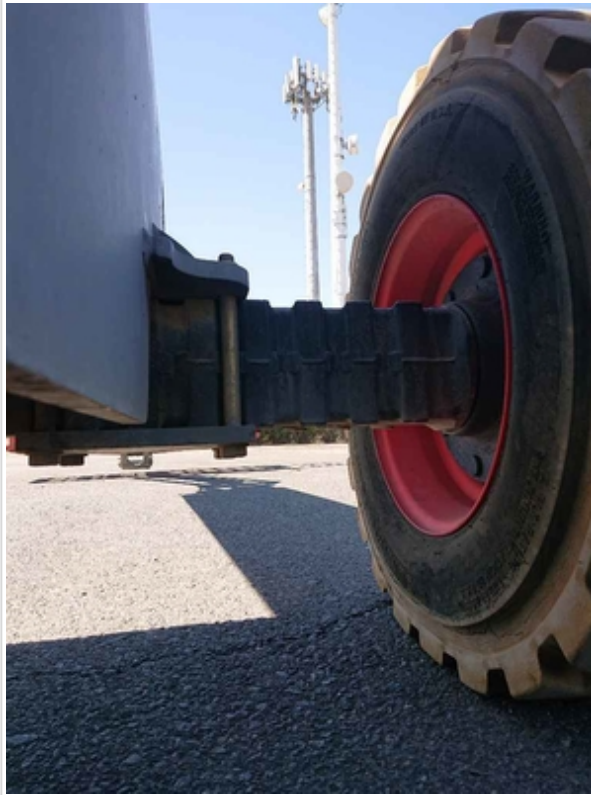
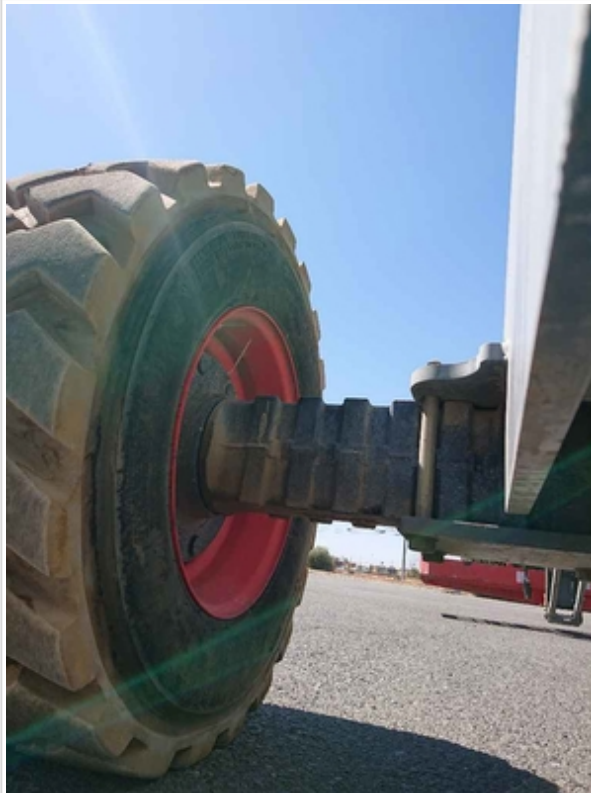
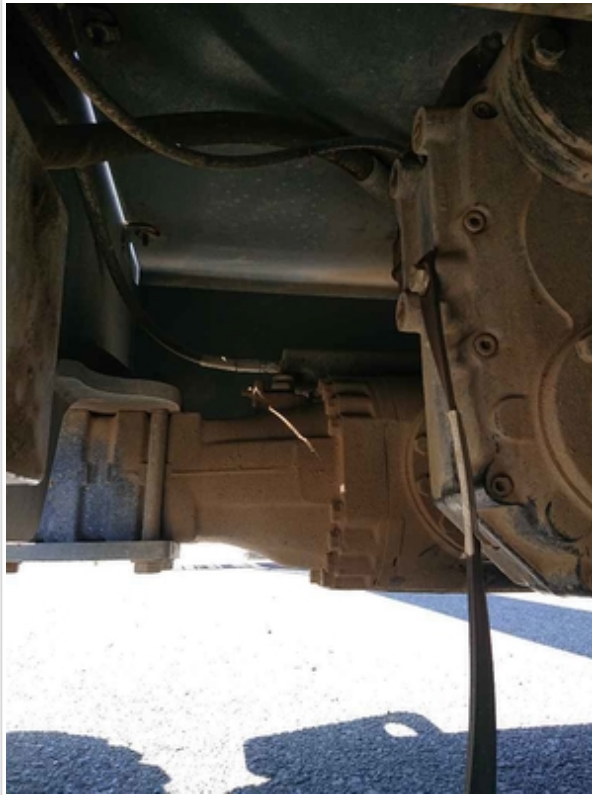
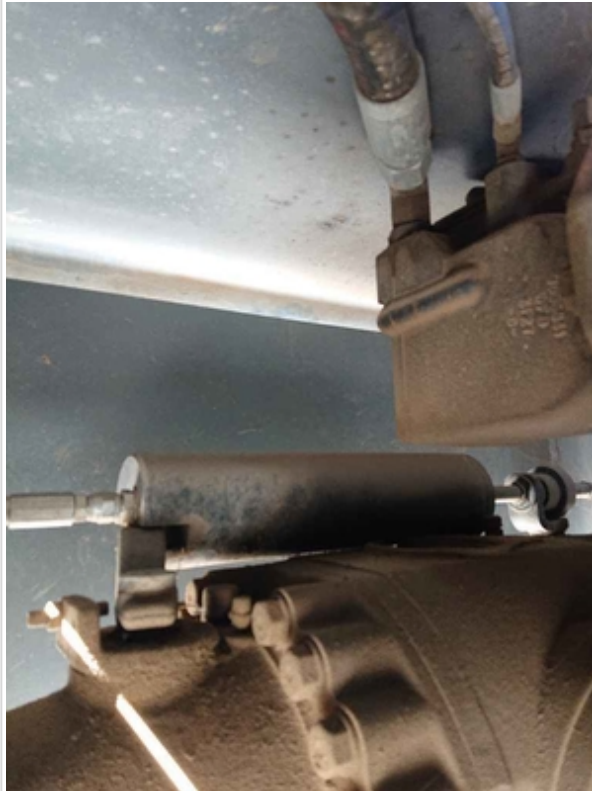
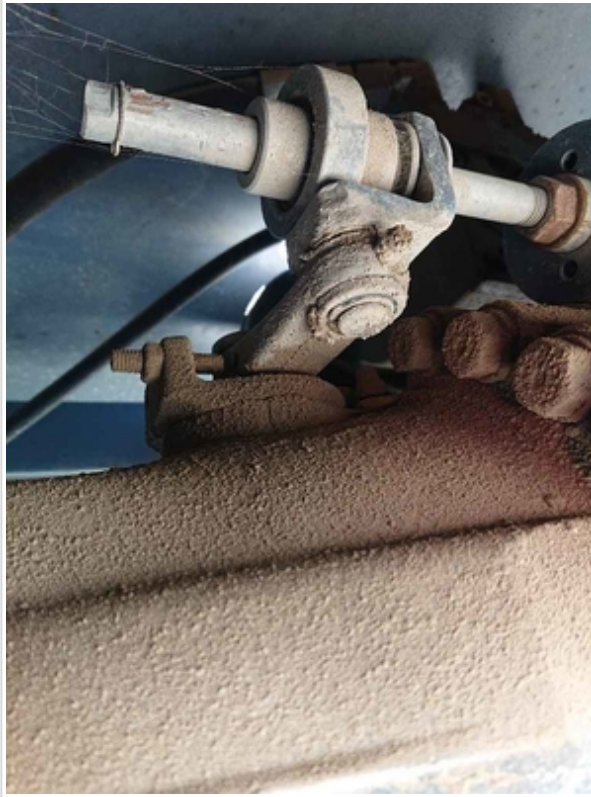
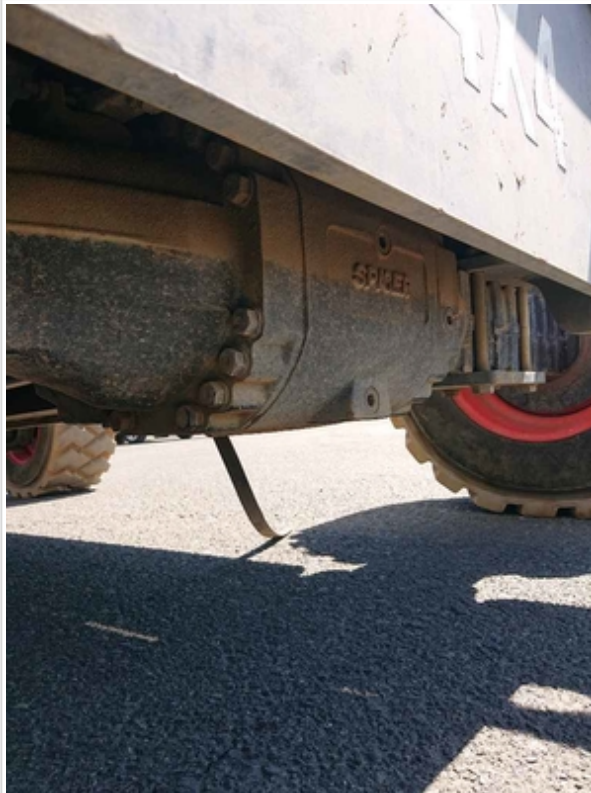
Instructions	<p>Evaluate the following on a 4 point scale (leave comments where an explanation is appropriate):</p> <p>4 = Like New, Recently Replaced 3 = Normal Wear & Tear 2 = Above Average Wear 1 = Service Required</p>
Frame	3 - Normal Wear & Tear
Comments	See 360 photos/all other profile pictures
Stance	3 - Normal Wear & Tear
Front Axle Appearance	3 - Normal Wear & Tear
Front Axle Appearance Photos

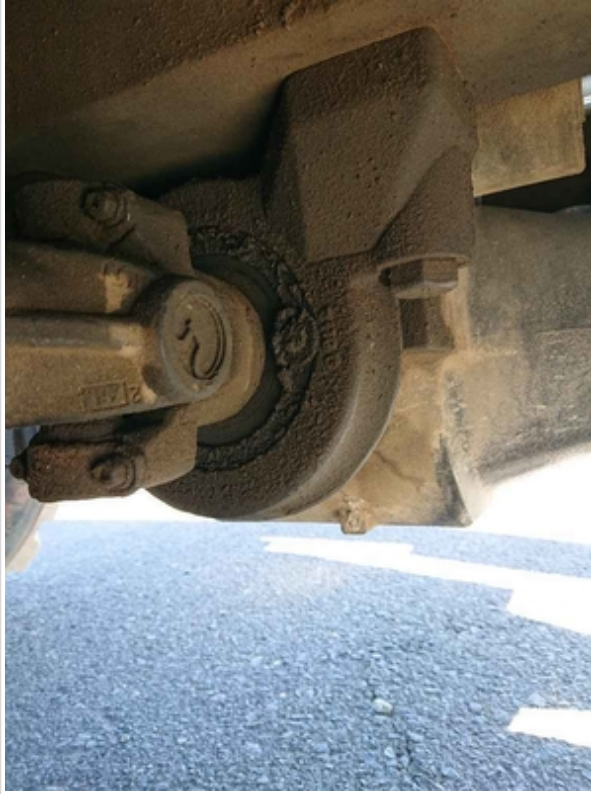
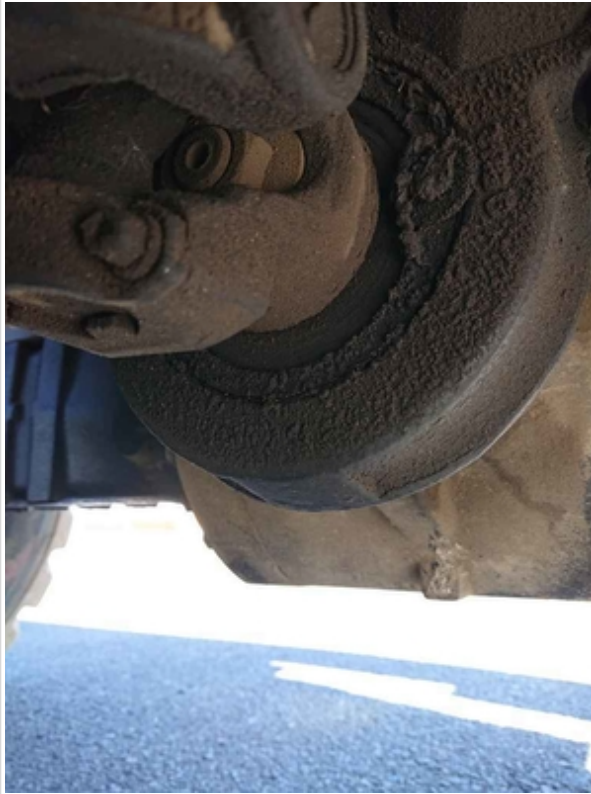
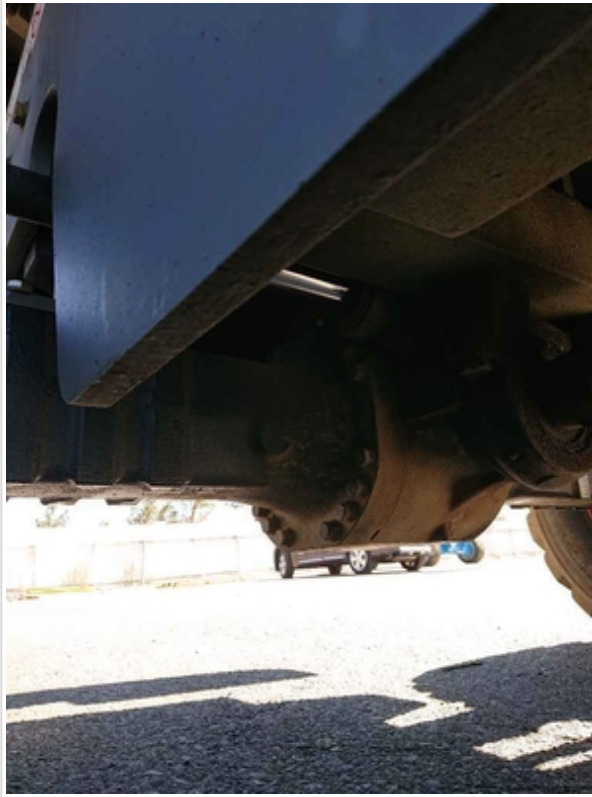
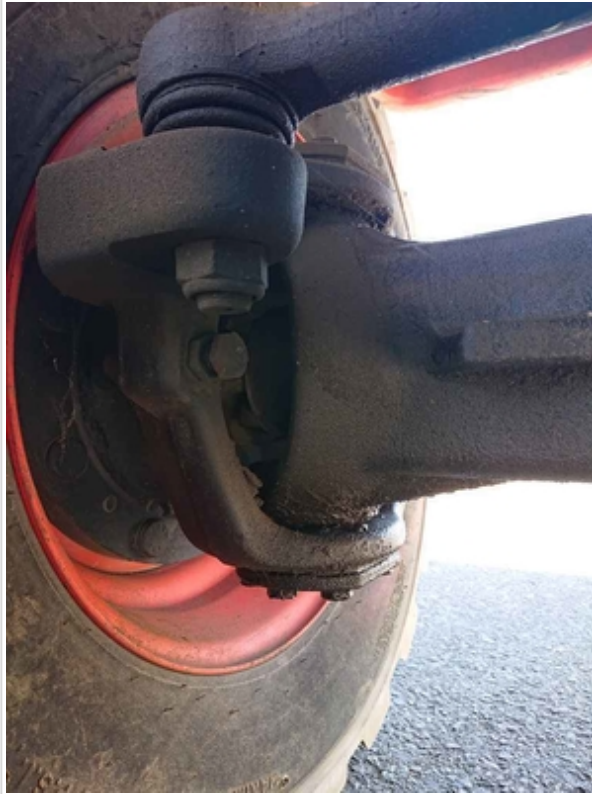
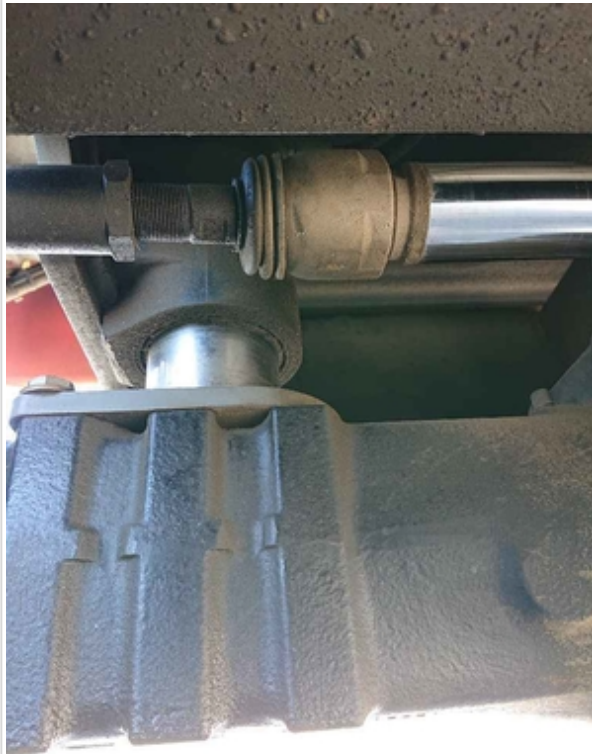
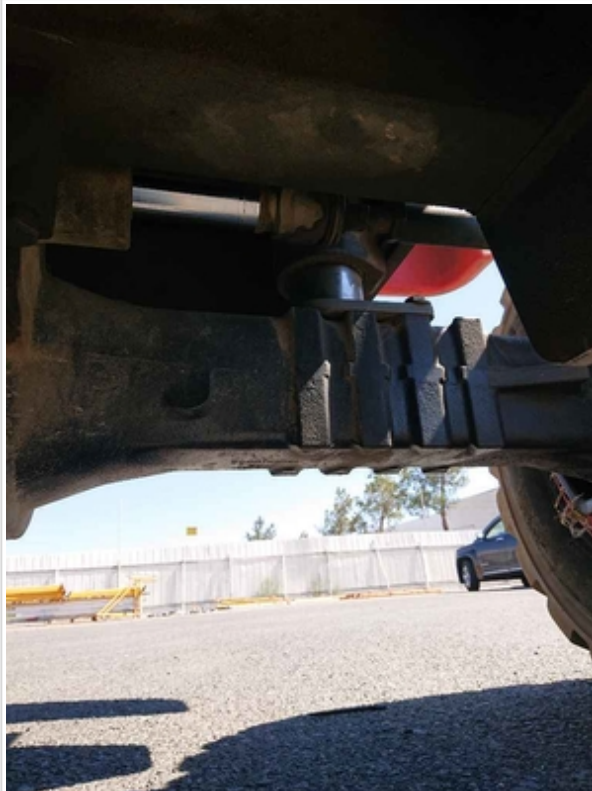
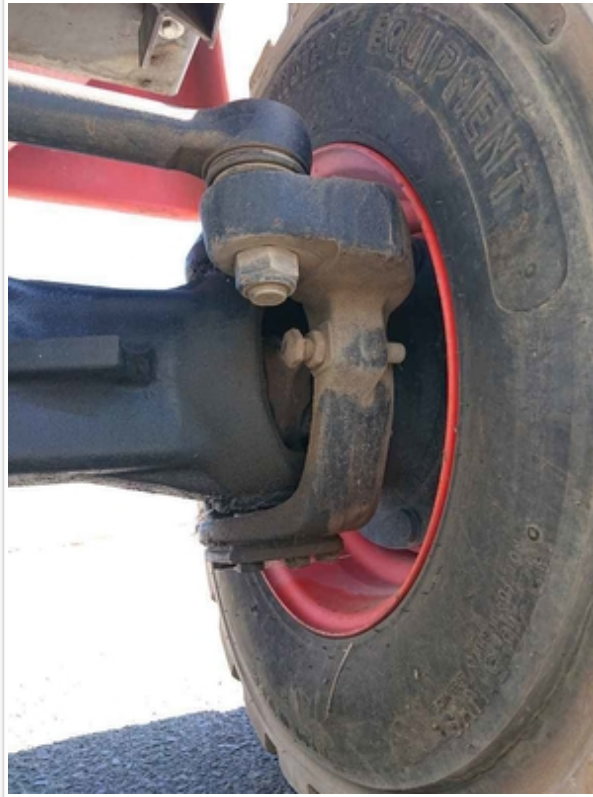
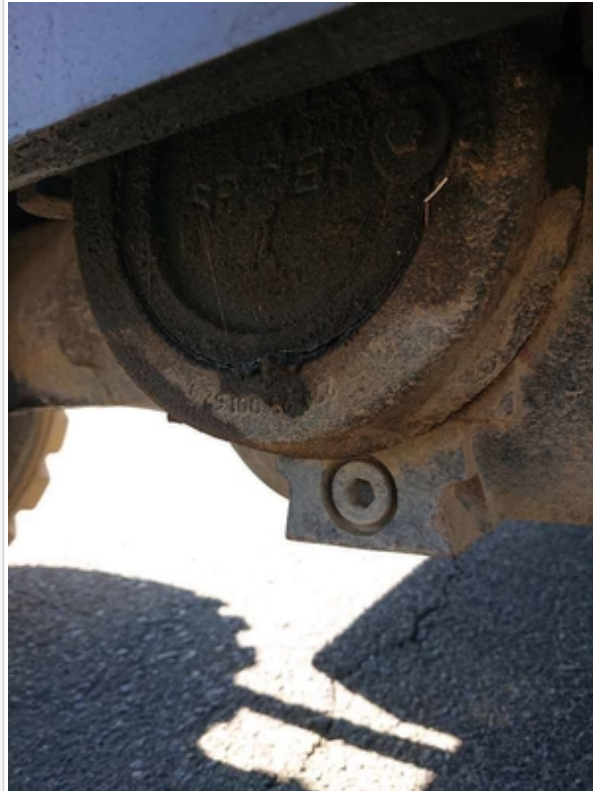
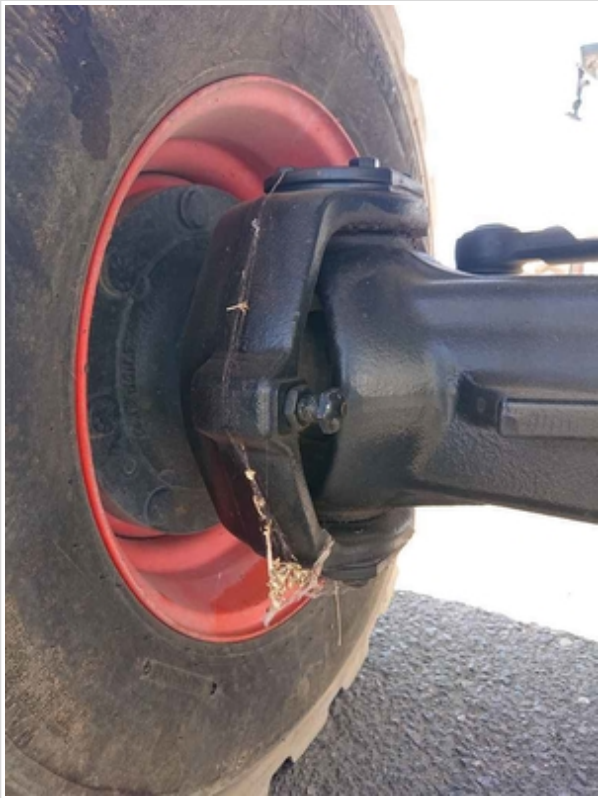
Rear Axle Appearance Photos

Rear Axle Appearance	3 - Normal Wear & Tear
Comments	Front and rear pivot bearing seals have seepage possibly from over lubrication

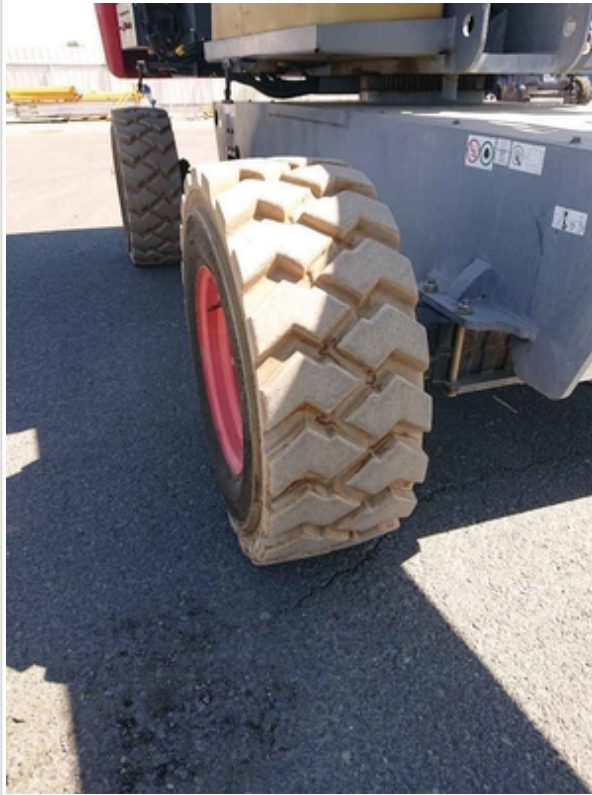
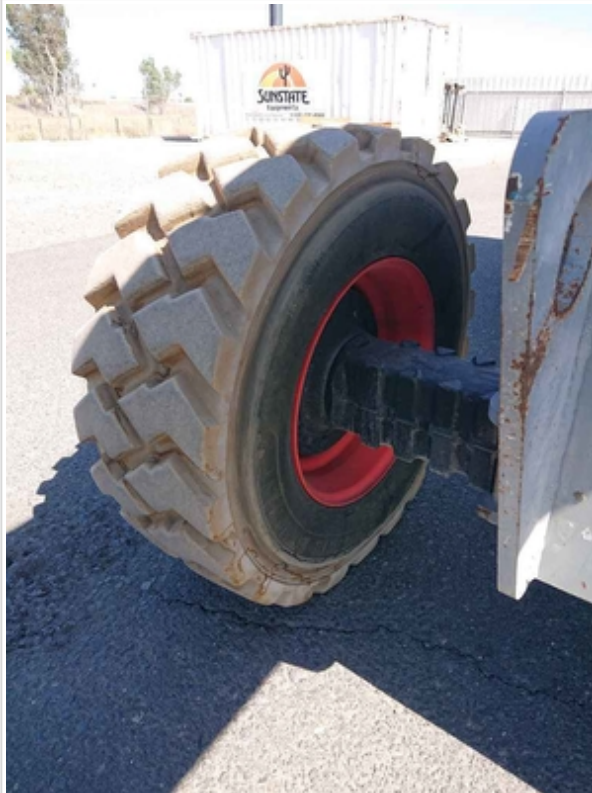
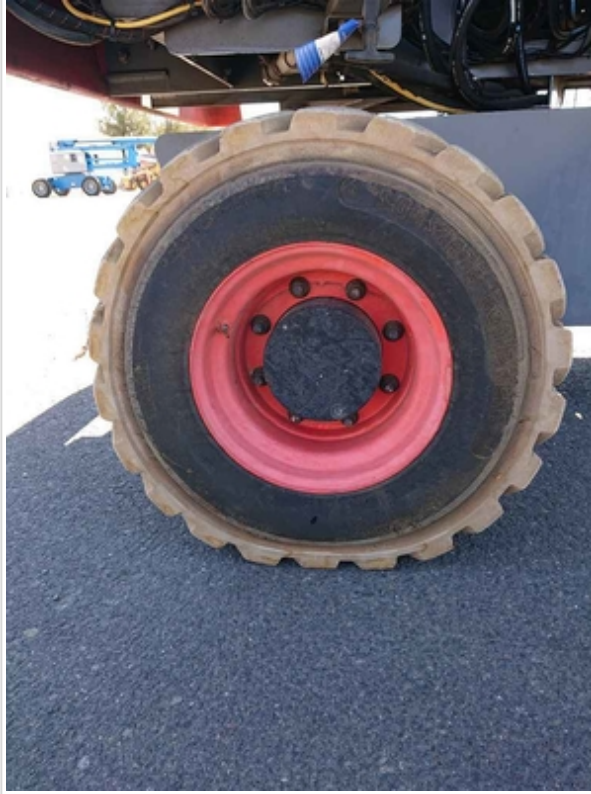
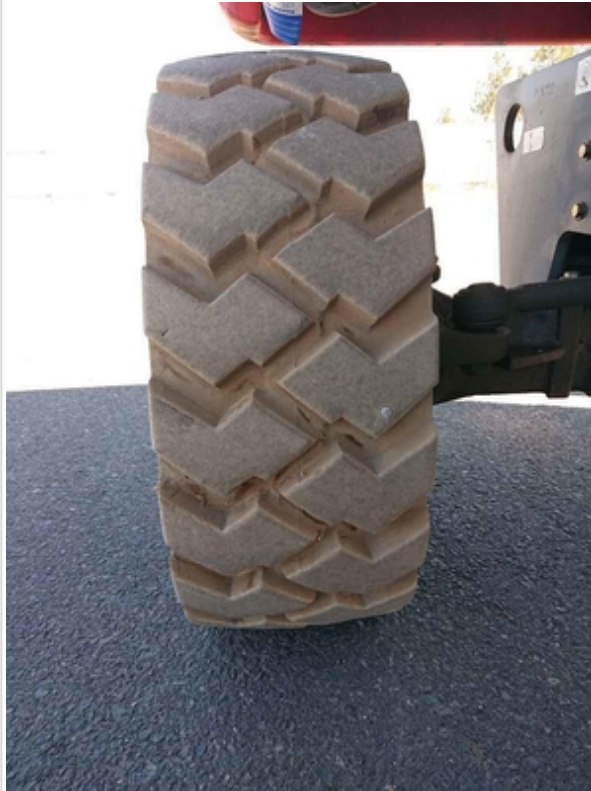
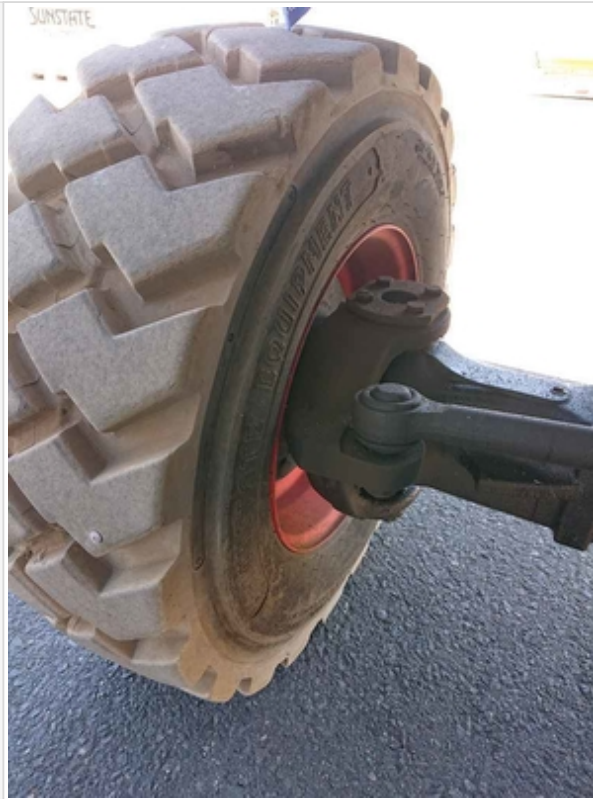
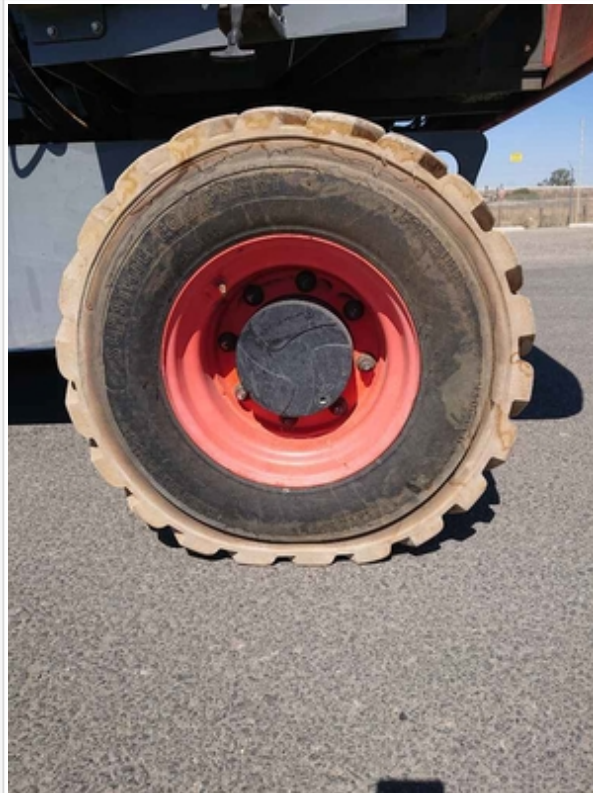
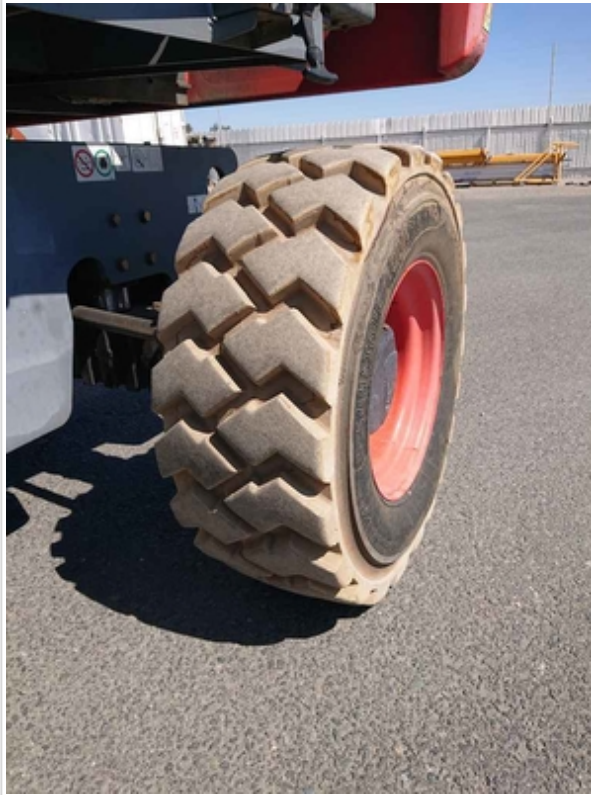
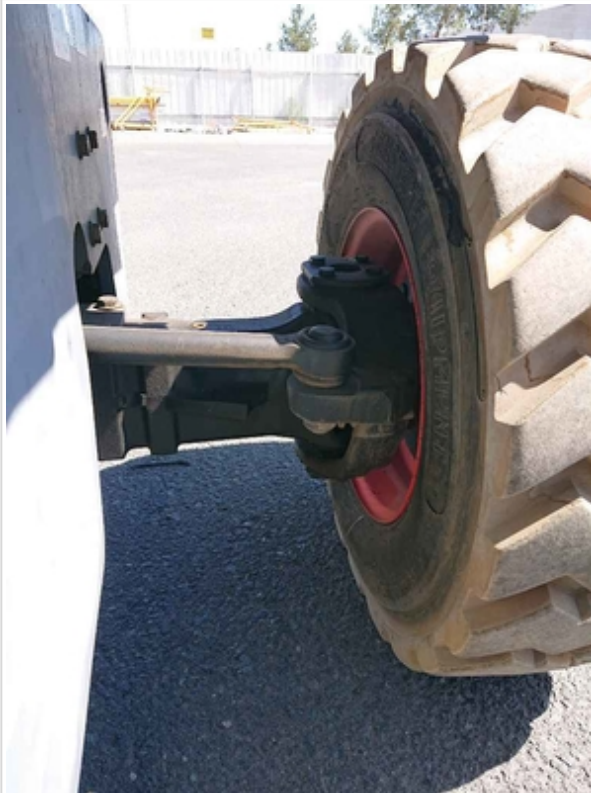
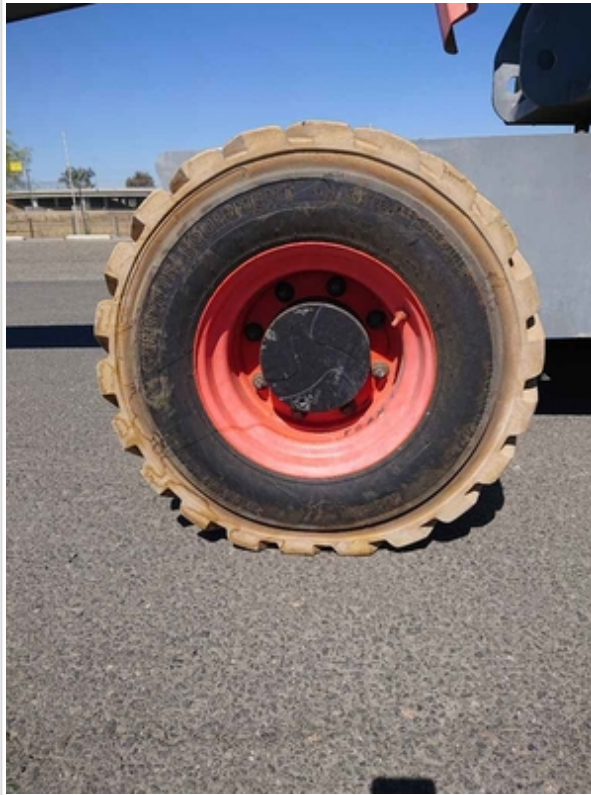
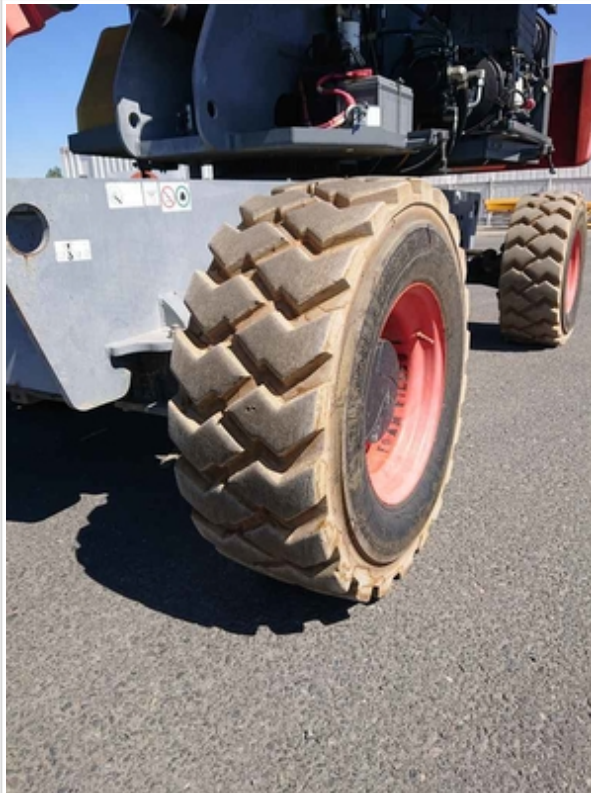
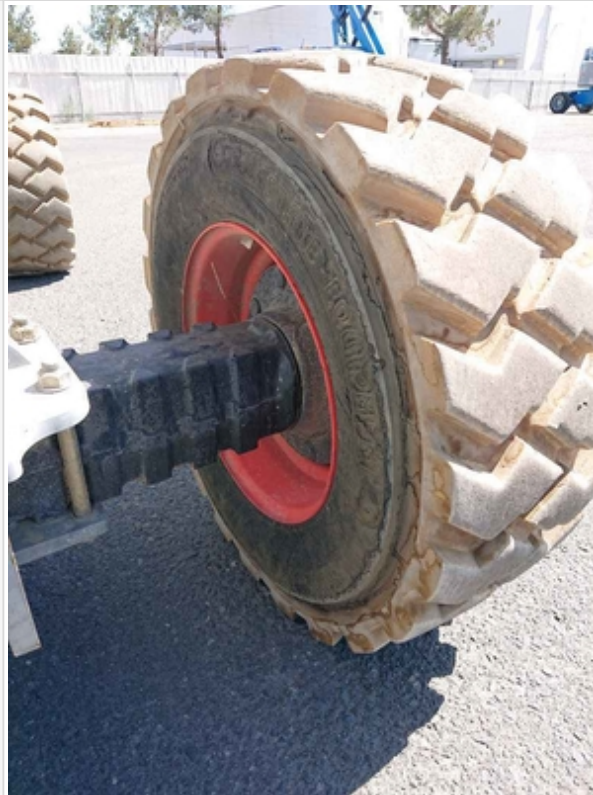
Wheels & Tires	3 - Normal Wear & Tear
Comments	Date stamps illegible, rear right has screw in tread (no leak observed)
Wheels & Tires Photos
