Inspection Report (Boom Lift)

Year	2013
Make	Skyjack
Model	SJ45T
Serial Number	98001112
Hour Meter Reading	3896
Previous Application (e.g., earth moving, mining, demolition, etc)	Rental

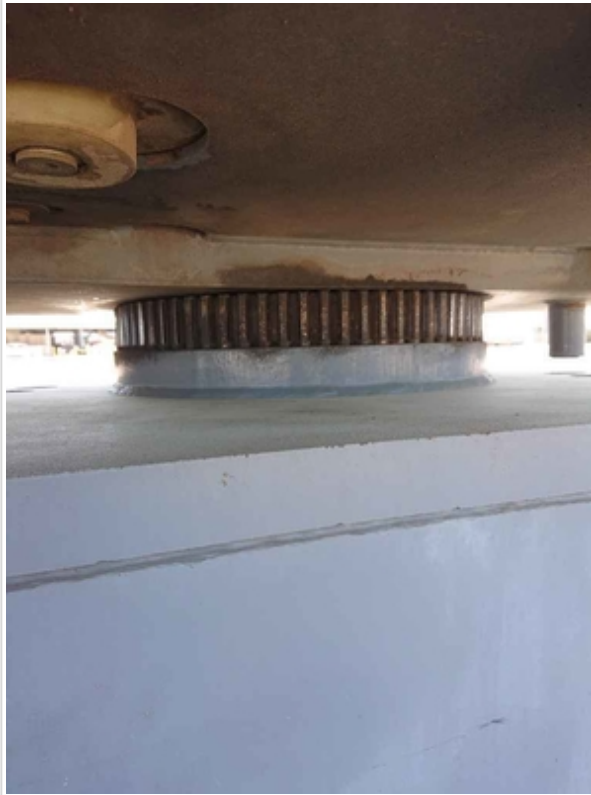
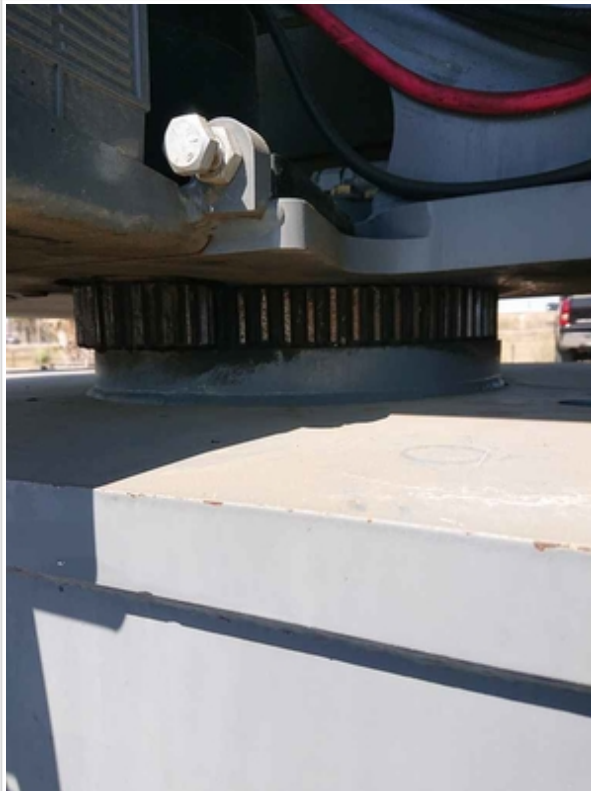
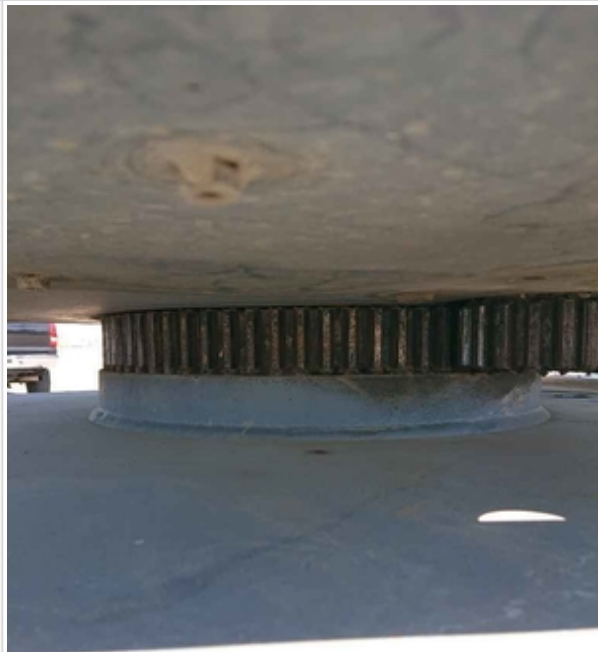
Swivel Bearing Photos

Tire Brand	Sunstate
Tire Size	12-16.5
Front Left Tire - Ratio Remaining	70%
Rear Left Tire - Ratio Remaining	70%
Front Right Tire - Ratio Remaining	70%
Rear Right Tire - Ratio Remaining	70%
Swivel Bearing	3 - Normal Wear & Tear
Comments	Normal operation, no damage noted

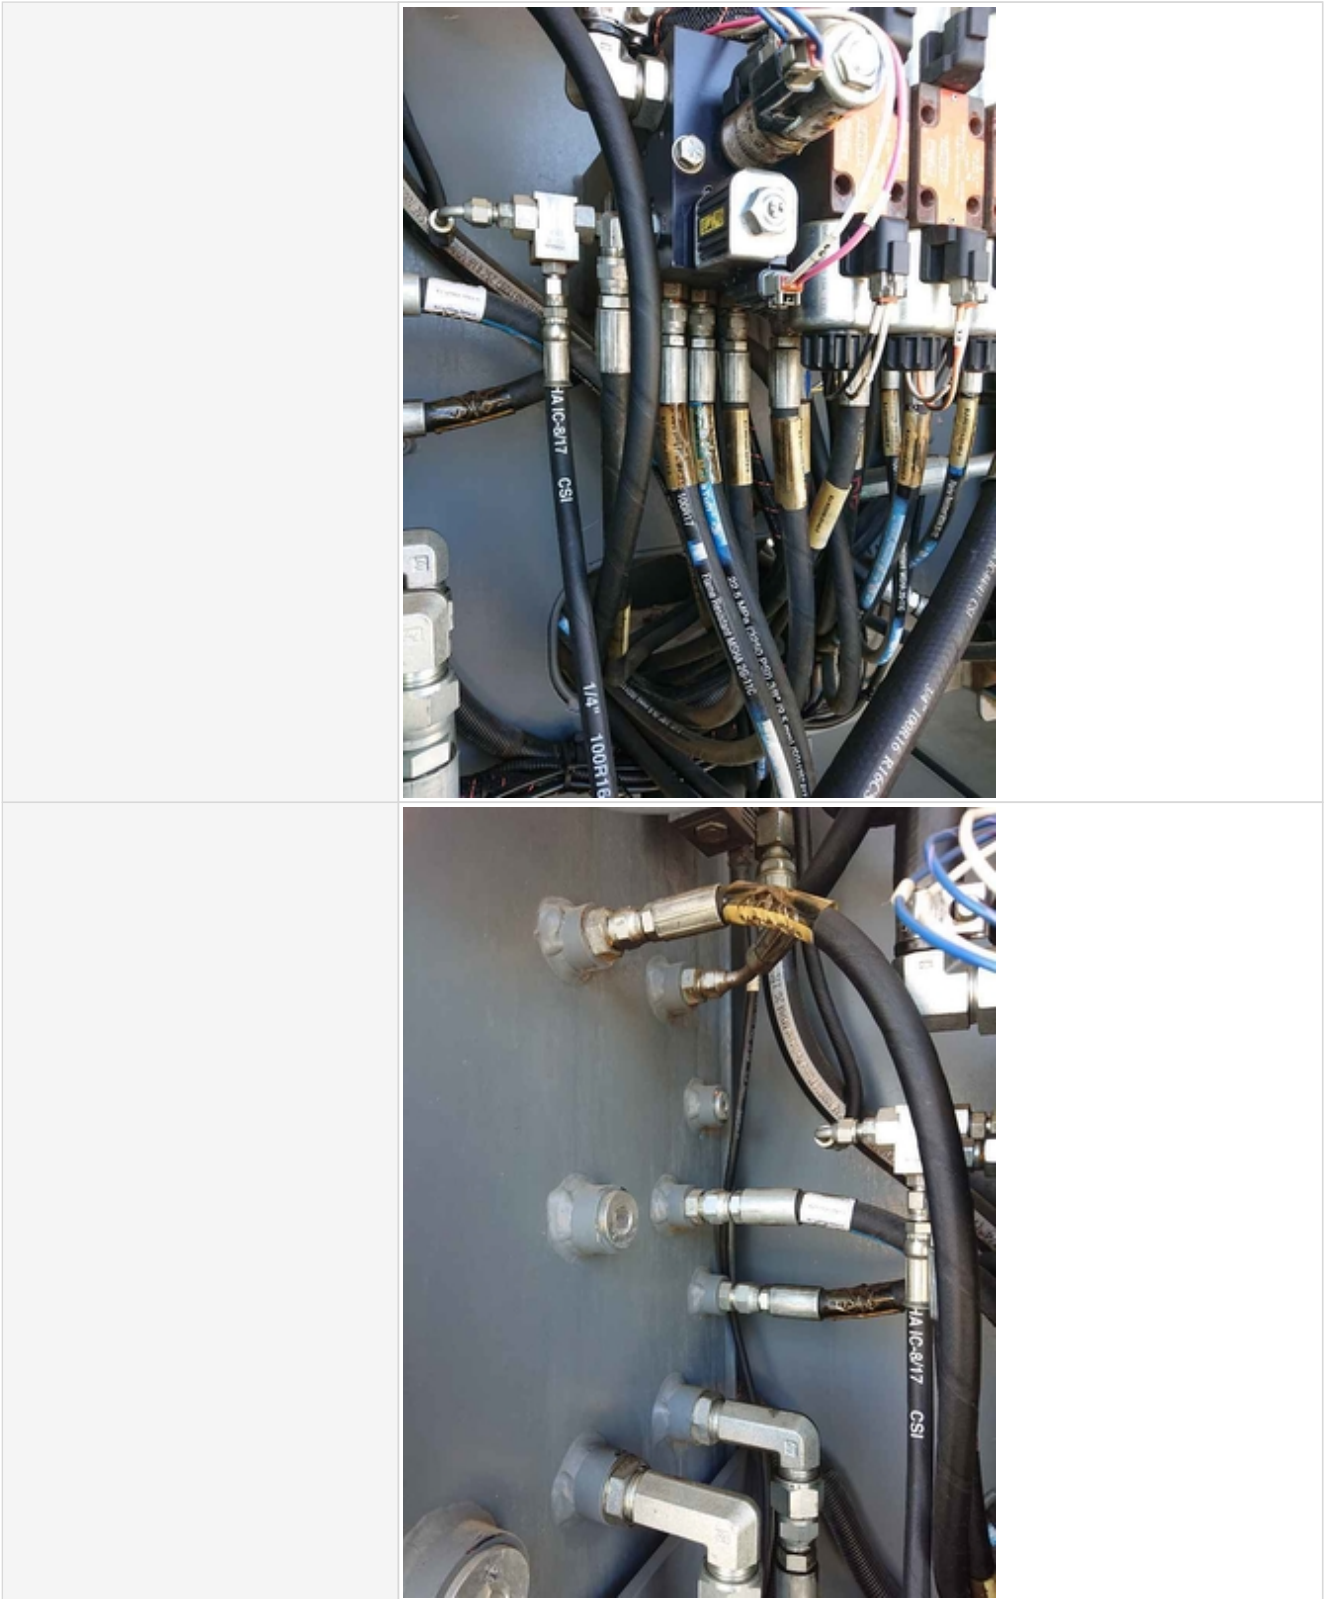
Wet or Damp Hydraulic Lines / Fittings	Yes
Appearance of Hydraulic Lines / Fittings	3
Hydraulic Lines / Fittings Condition	Active leaks in hoses or fittings observed
Comments	Cooler wet with active leak, filter leaking, reservoir drain plug leaking
Appearance of Hydraulic Lines / Fittings Photos

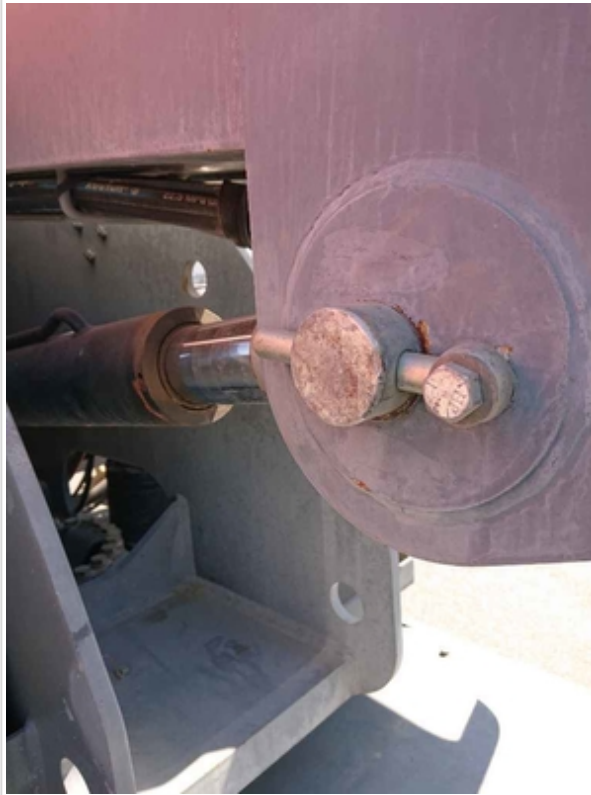
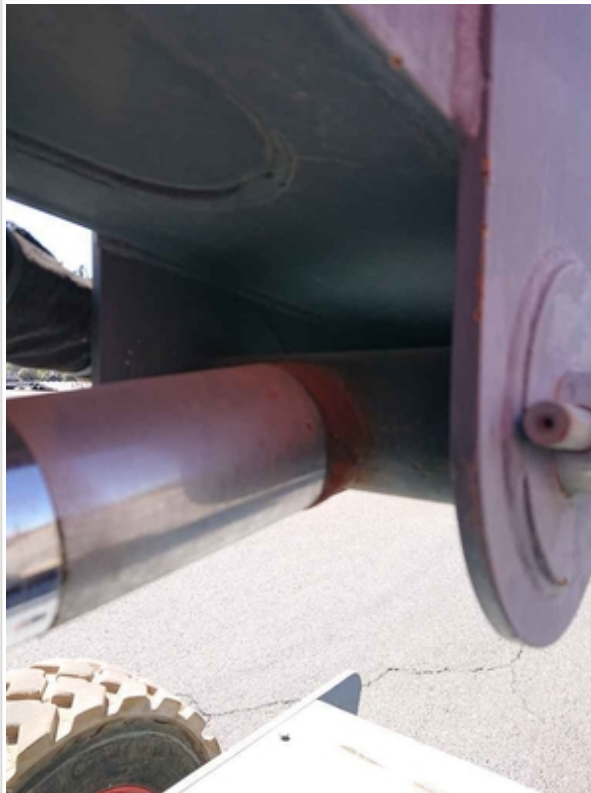
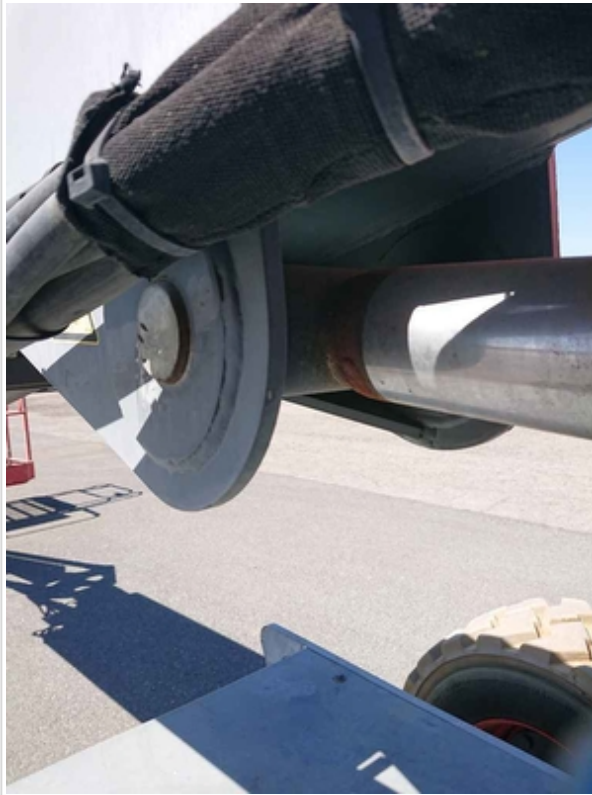
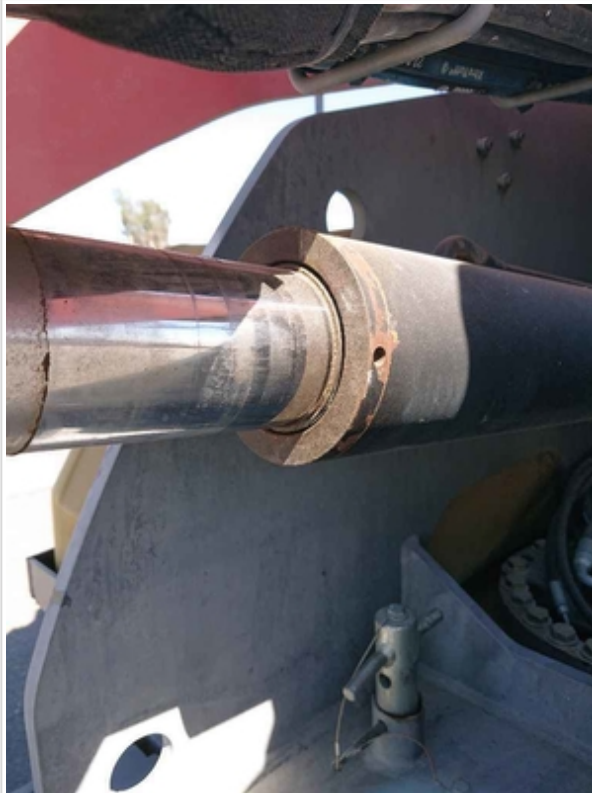
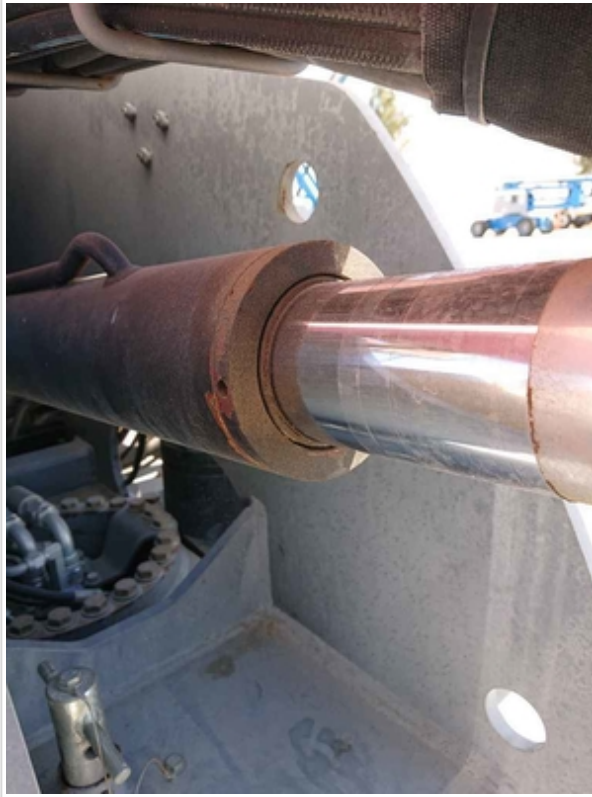
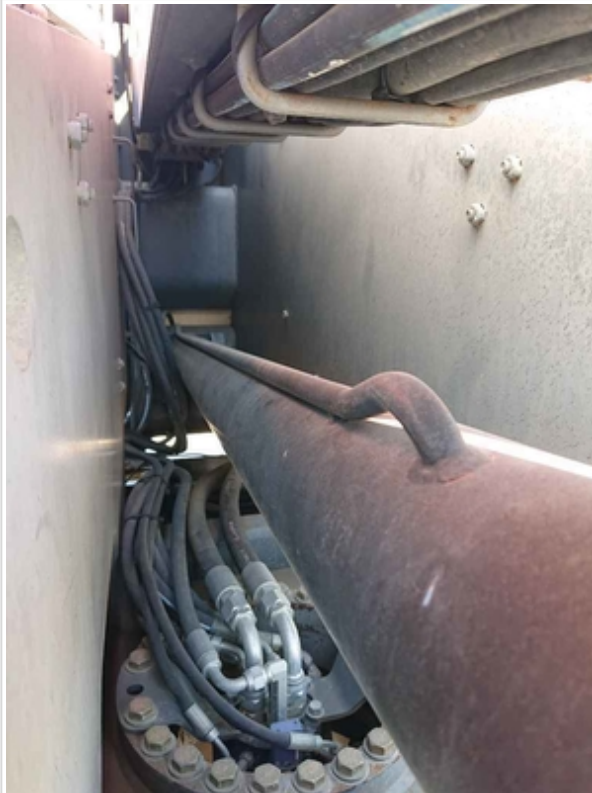
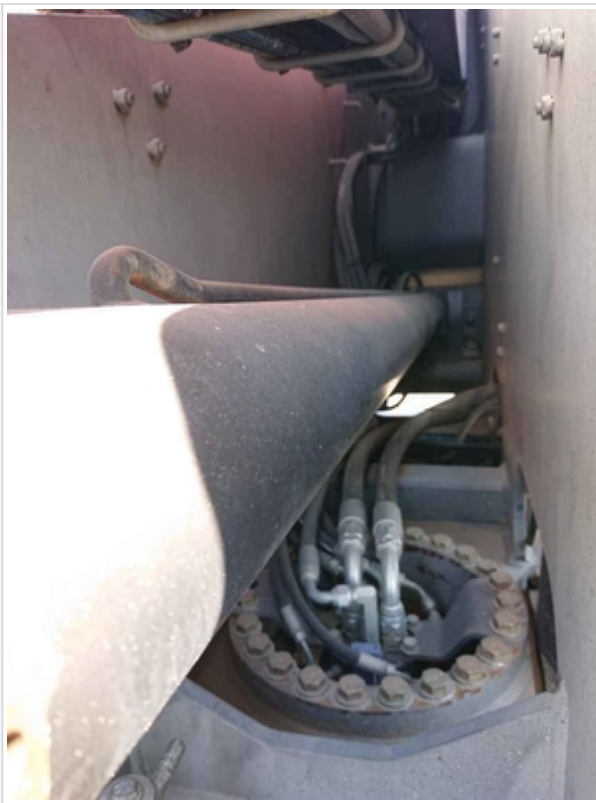
Boom Lift Cylinders Photos

Boom Lift Cylinders	Check the boom lift cylinders. Note any wear, pitting, discoloration, etc. Take photos.
Boom Lift Cylinders: Mounting Pin	3
Boom Lift Cylinders: Oil Leaks	No

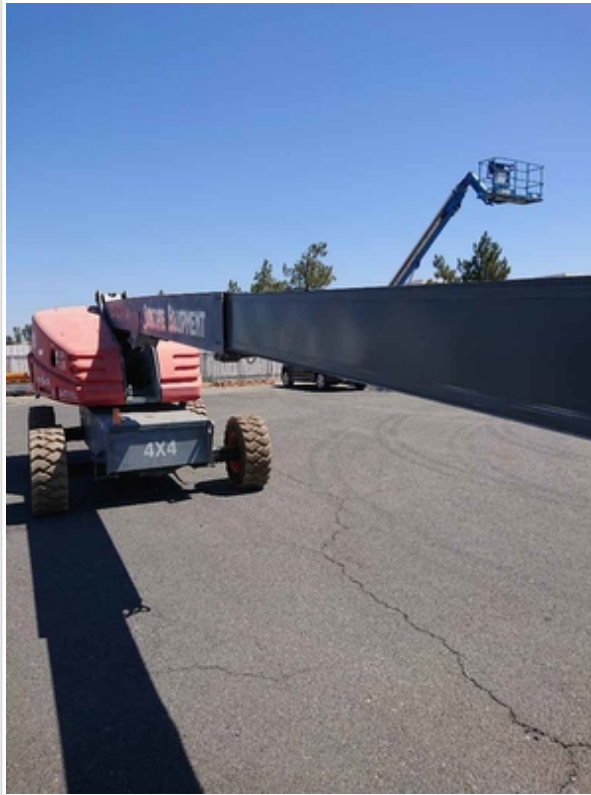
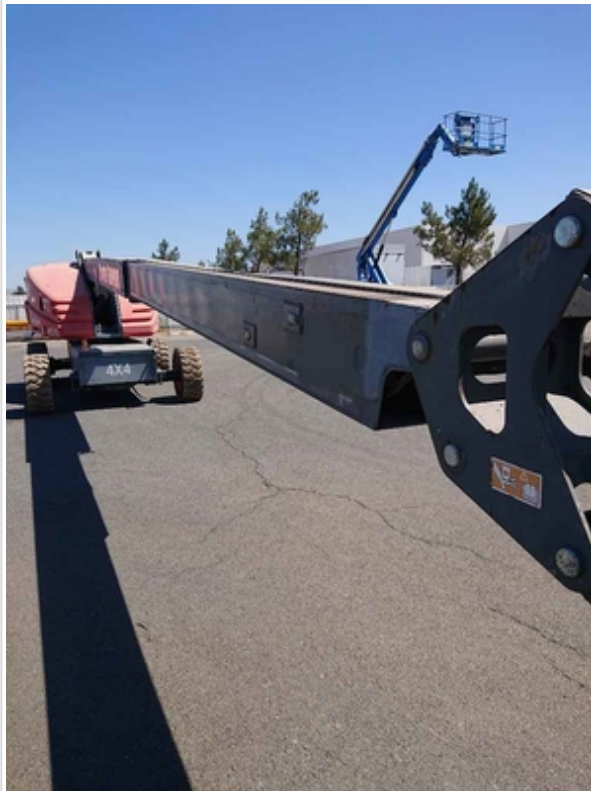
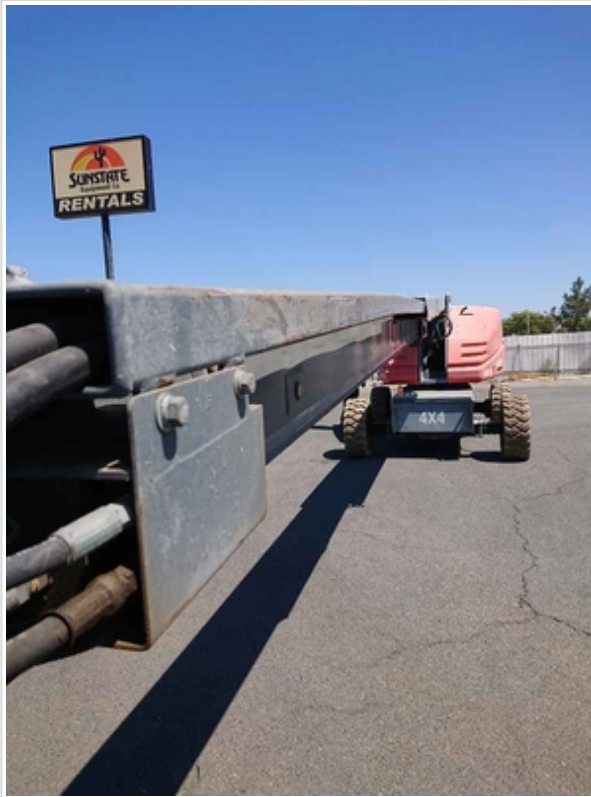
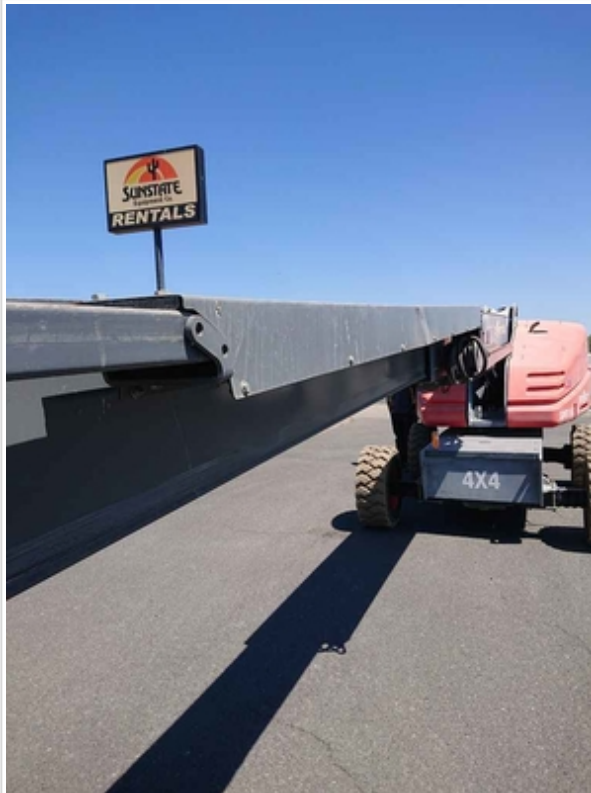
Boom Extension Cylinder Photos

Boom Extension Cylinder	Check the boom extension cylinder. Note any wear, pitting, discoloration, etc. Take photos.
Boom Extension Cylinder: Mounting Pin	3
Boom Extension Cylinder: Oil Leaks	No
Comments	Not accesible

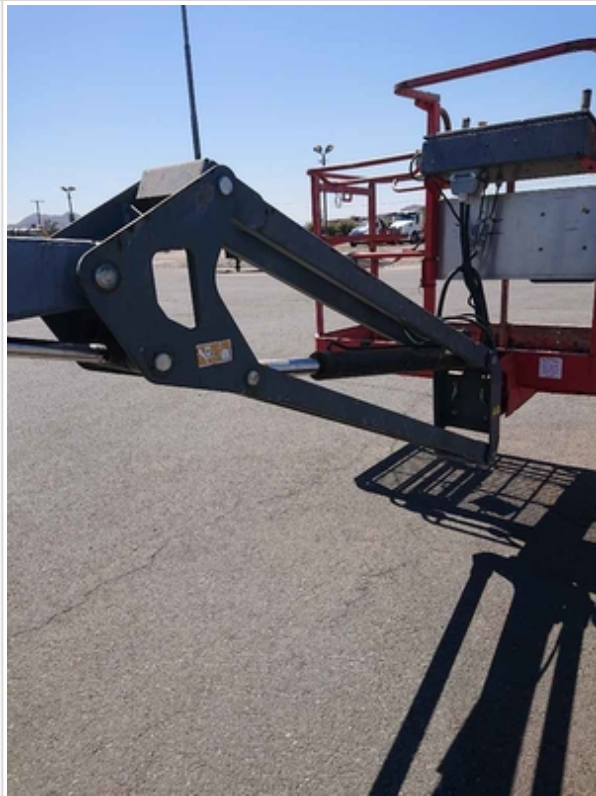
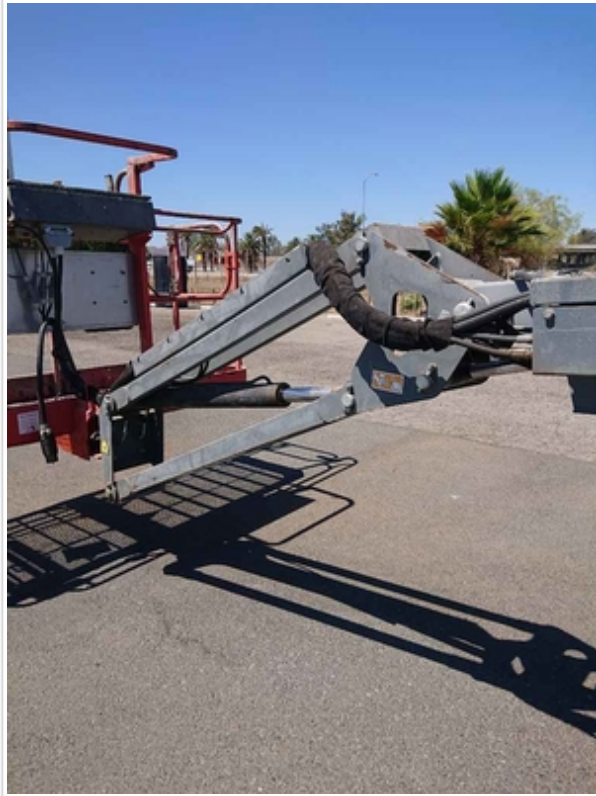
<p>Jib Cylinder Photos</p>

Jib Cylinder	Check the jib cylinder. Note any wear, pitting, discoloration, etc. Take photos.
Jib Cylinder: Oil Leaks	No
Jib Cylinder: Mounting Pin	3

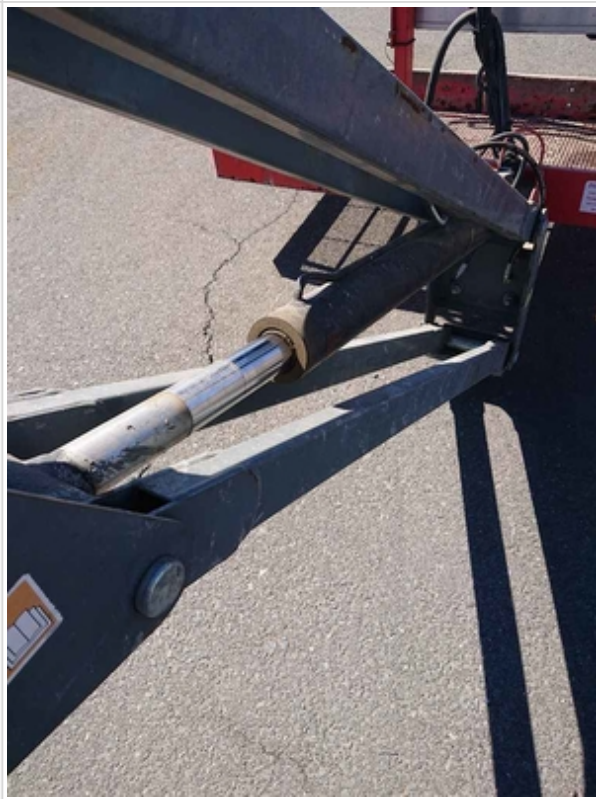
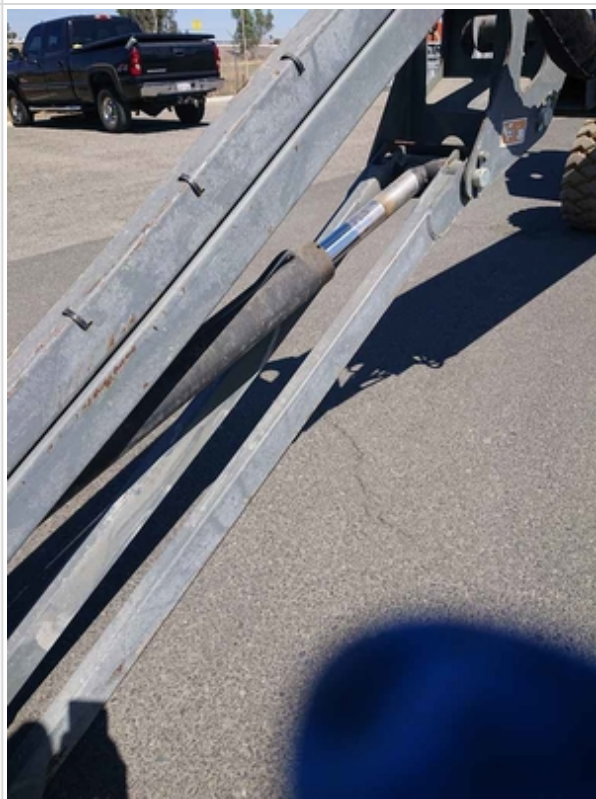
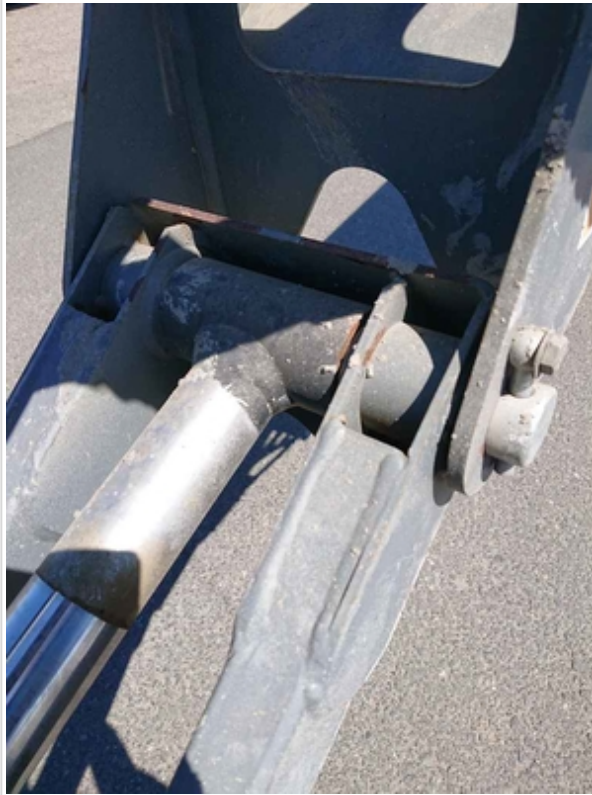
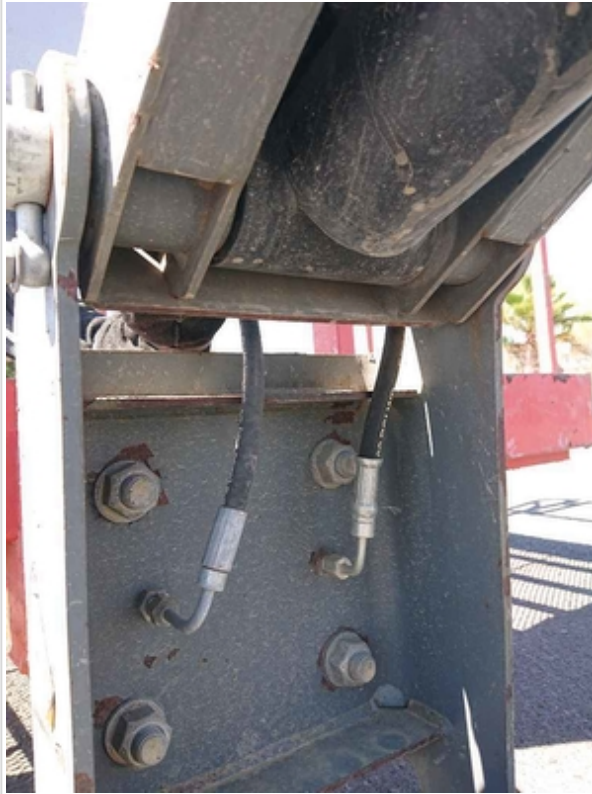
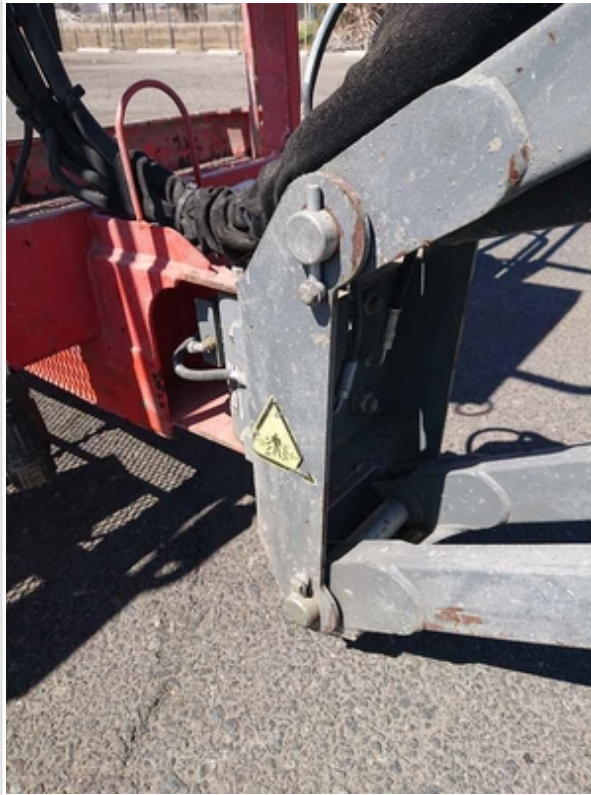
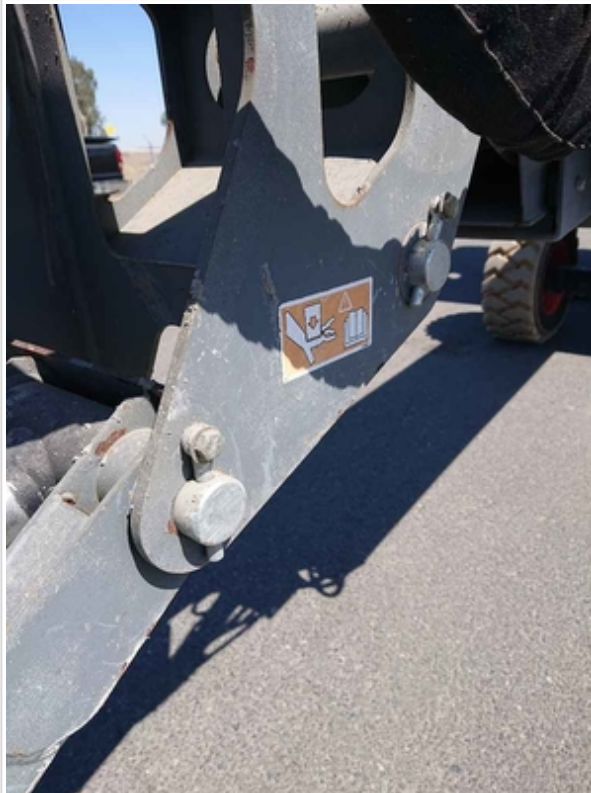
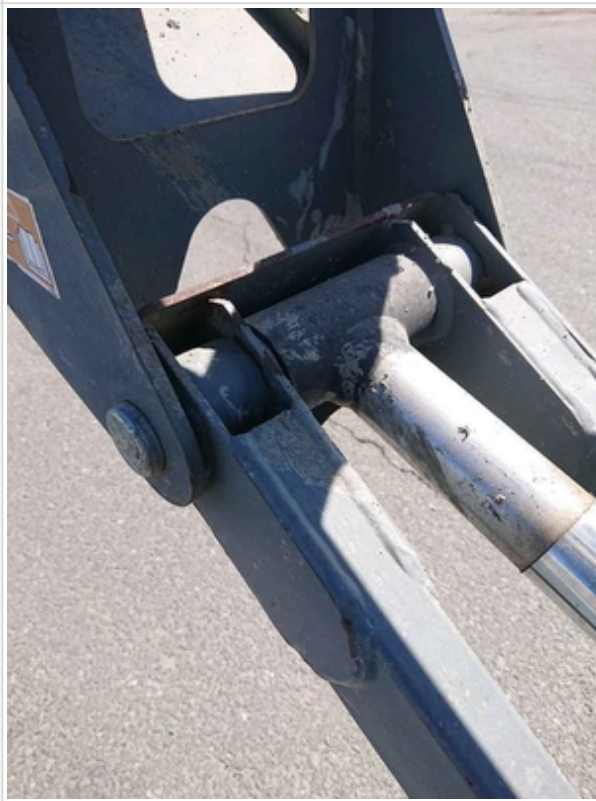
<p>Basket Tilt Cylinder</p>	<p>Check the basket tilt cylinders. Note any wear, pitting, discoloration, etc. Take photos.</p>
<p>Basket Tilt Cylinder: Mounting Pin</p>	<p>3</p>

Basket Tilt Cylinder: Oil Leaks	No
Basket Tilt Cylinder Photos

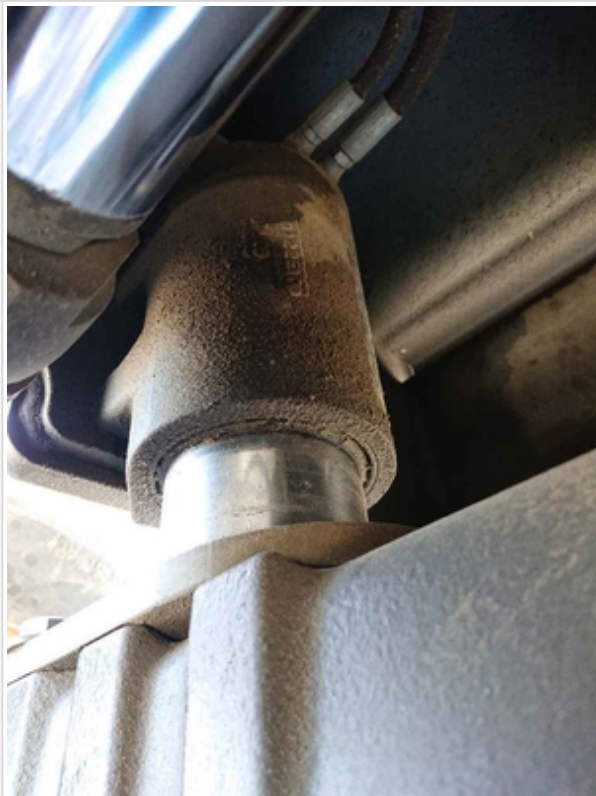
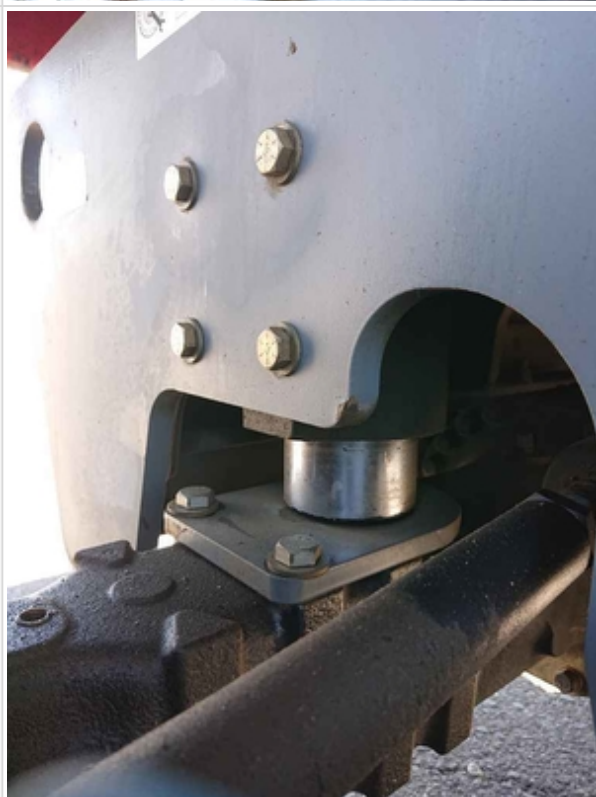
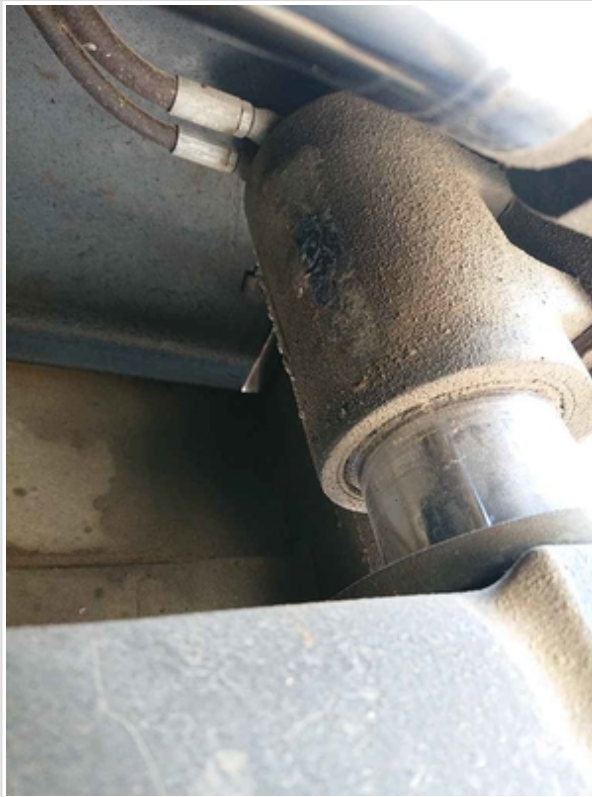
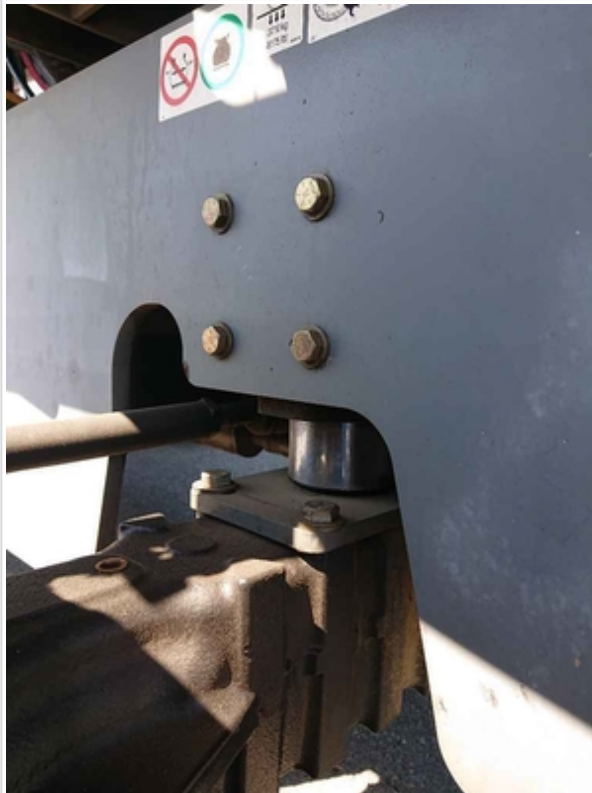
Frame Leveling Cylinders	Check the frame leveling cylinders. Note any wear, pitting, discoloration, etc. Take photos.
Frame Leveling Cylinders: Mounting Pin	3

Frame Leveling Cylinders: Oil Leaks	No
Frame Leveling Cylinders Photos
