Inspection Report (Mini Excavator)

Year	2015
Make	Bobcat
Model	E26
Serial Number	B33212850
Hour Meter Reading	2565

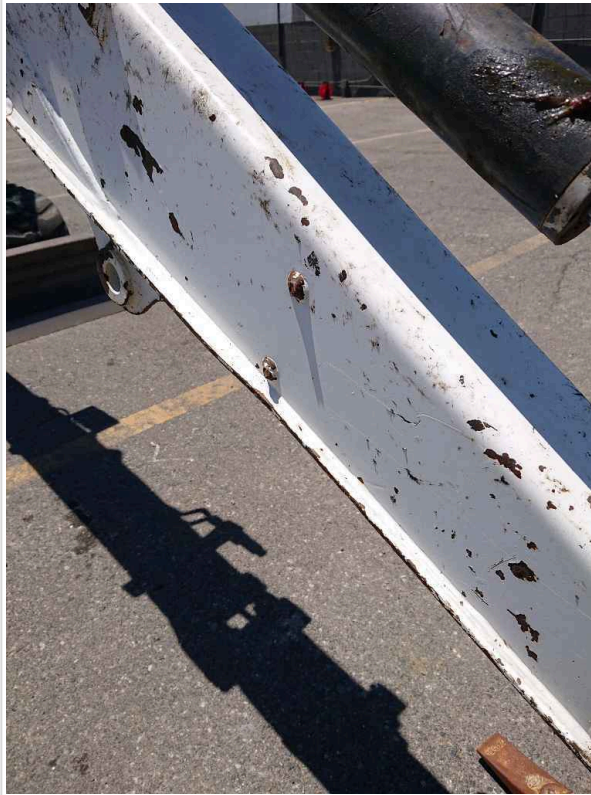
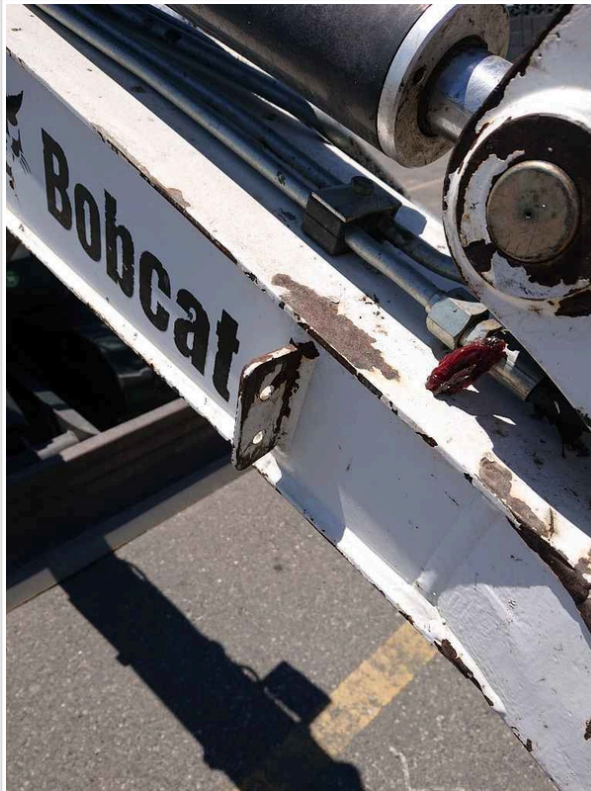
Front Photos

Front	3 - Normal Wear & Tear
Front Condition	Visible chipped paint or dents, Areas of surface rust observed, Other (see comments)
Comments	Broken/missing boom right hose guide

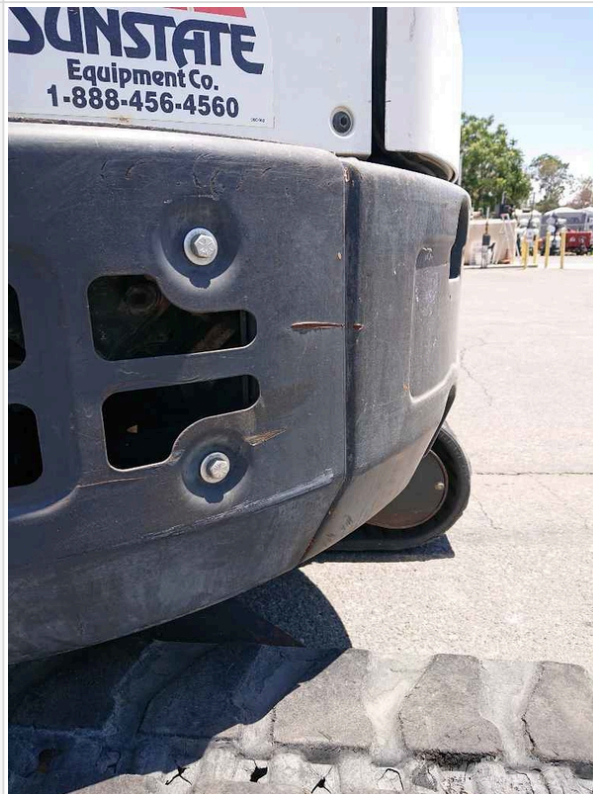
Left Photos

<p>Left</p>	<p>3 - Normal Wear & Tear</p>
<p>Left Condition</p>	<p>Visible chipped paint or dents</p>
<p>Comments</p>	<p>Normal wear, paint scuffs/deep scratches</p>

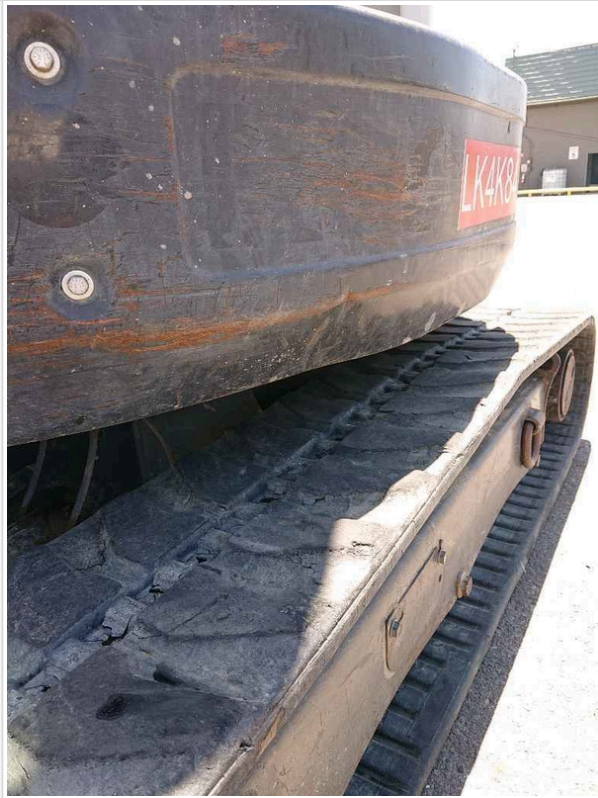
Right	3 - Normal Wear & Tear
Right Condition	Visible chipped paint or dents
Comments	Normal wear, paint scuffs/deep scratches
Right Photos

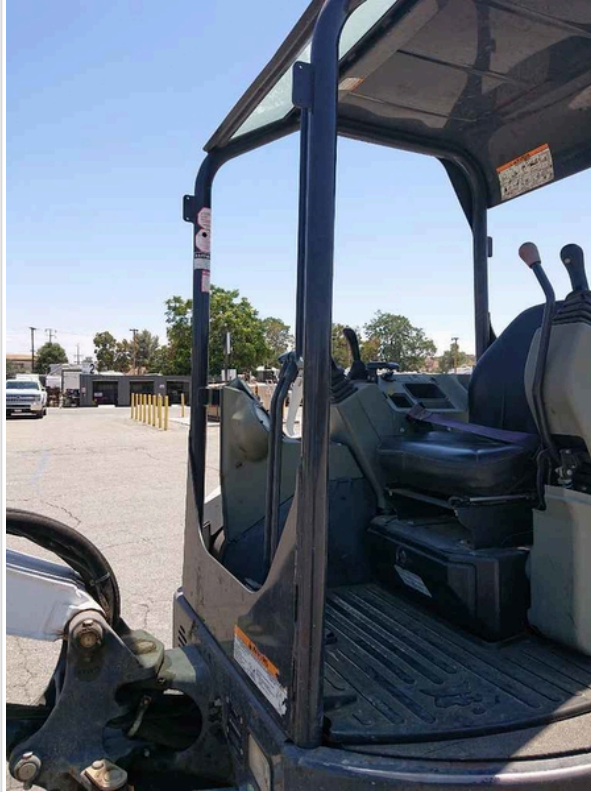
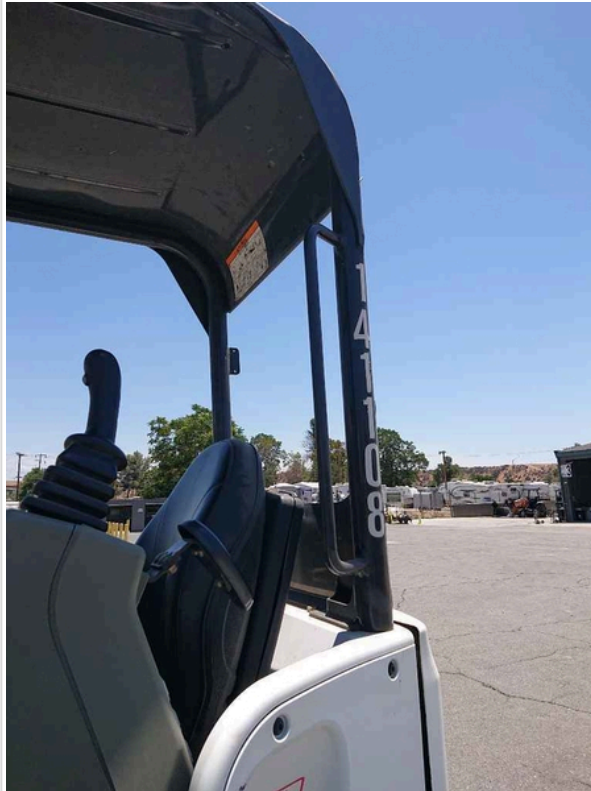
Doors / Canopy Latches Photos

Doors / Canopy Latches	3 - Normal Wear & Tear
Doors / Canopy Latches Condition	No visible damage

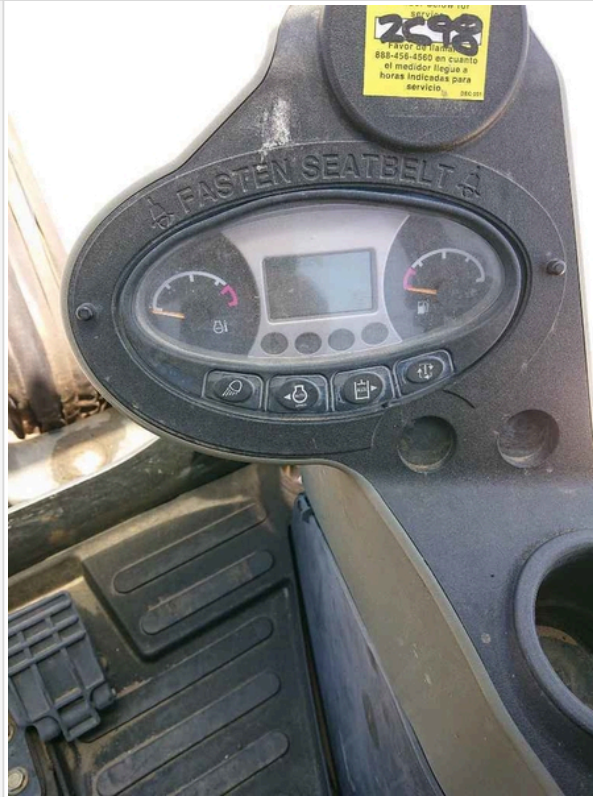
Controls & Switches Condition	All switches are installed and functional, Switches have good functionality, minor cosmetic damage observed
Comments	Normal wear
Controls & Switches Photos

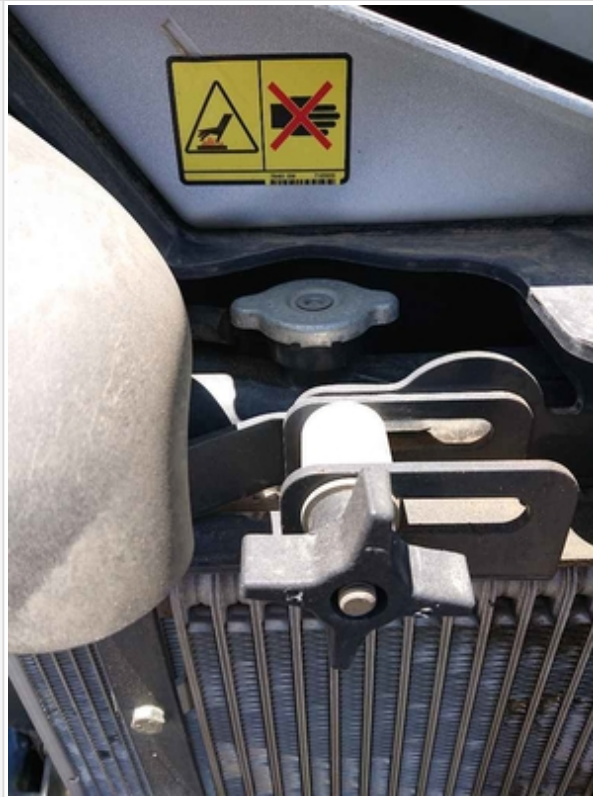
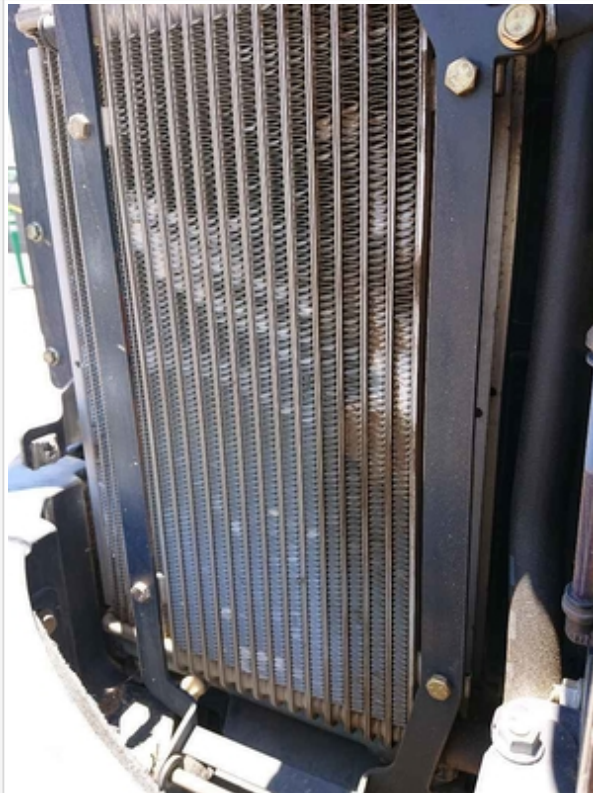
Radiator	3 - Normal Wear & Tear
Radiator Condition	Radiator fins & components appear to be in good working order, no signs of damage or leaks, Other (see comments)
Comments	Coolers are dirty, recommend cleaning out, slight fin bending
Radiator Photos

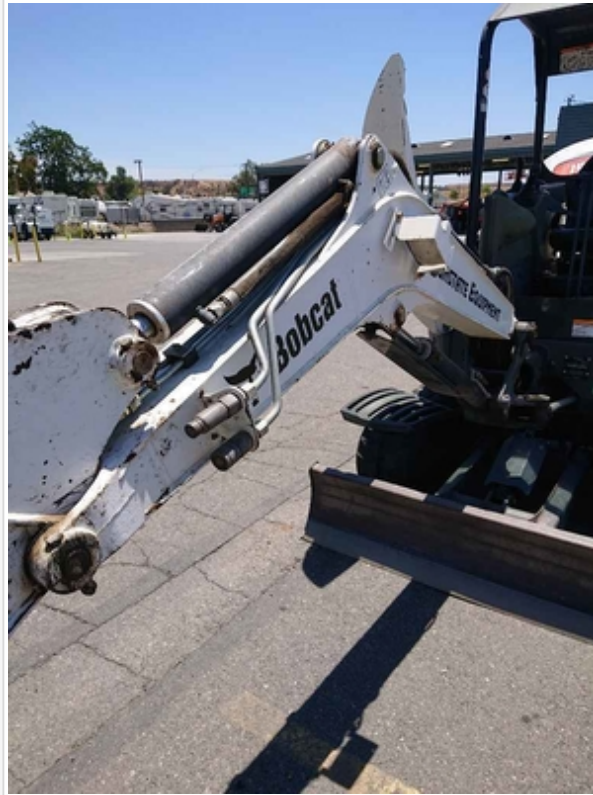
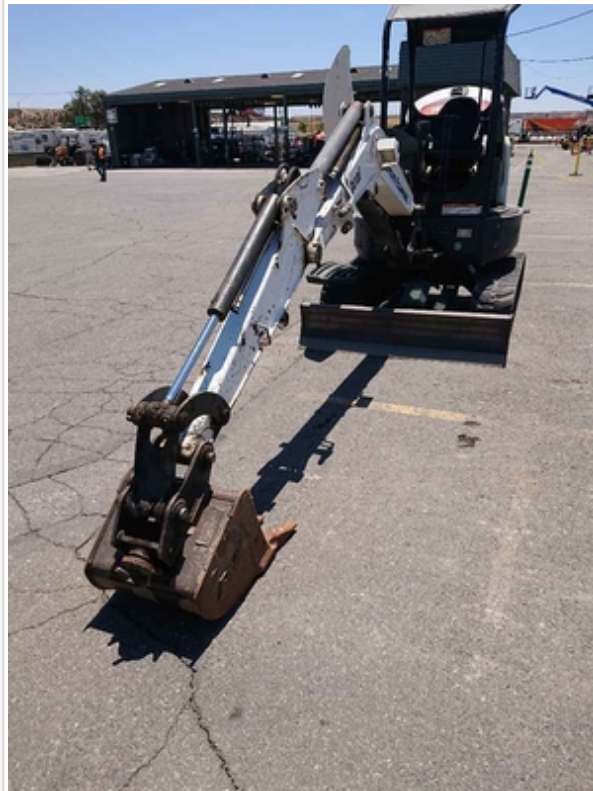
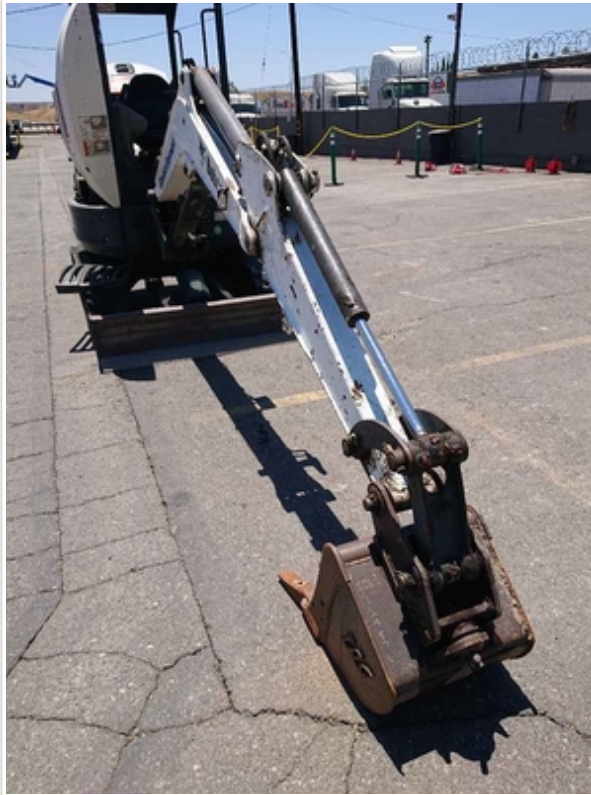
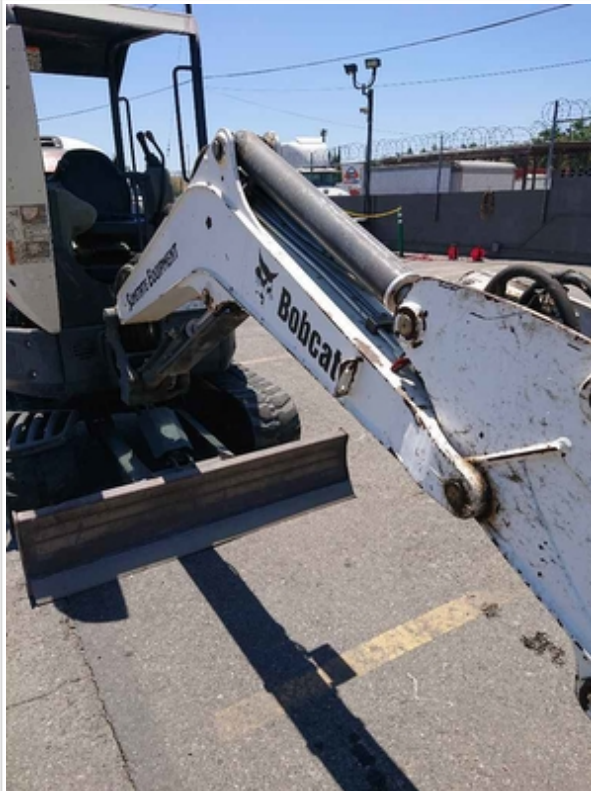
Instructions	<p>Evaluate the following on a 4 point scale (leave comments where an explanation is appropriate):</p> <p>4 = Like New, Recently Replaced 3 = Normal Wear & Tear 2 = Above Average Wear 1 = Service Required</p>
Boom Condition	<p>3 - Normal Wear & Tear</p>
Comments	<p>Normal wear</p>
Boom Photos

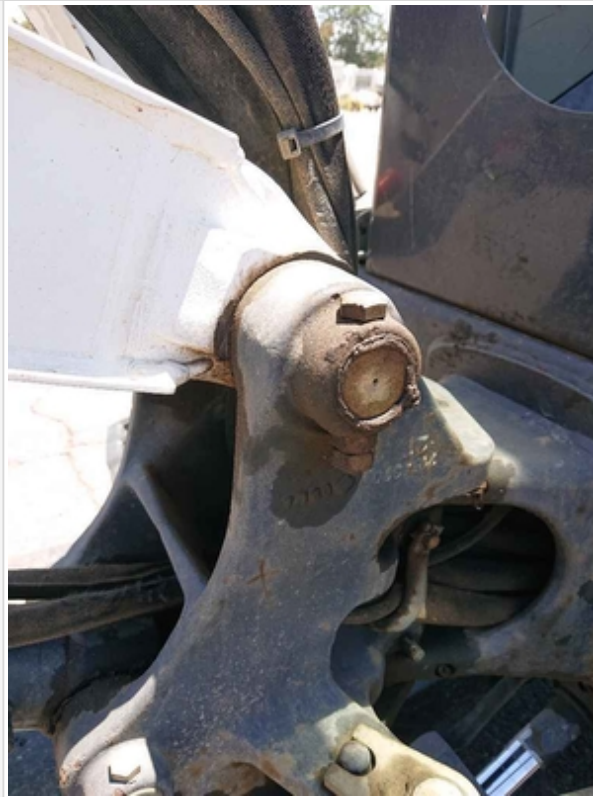
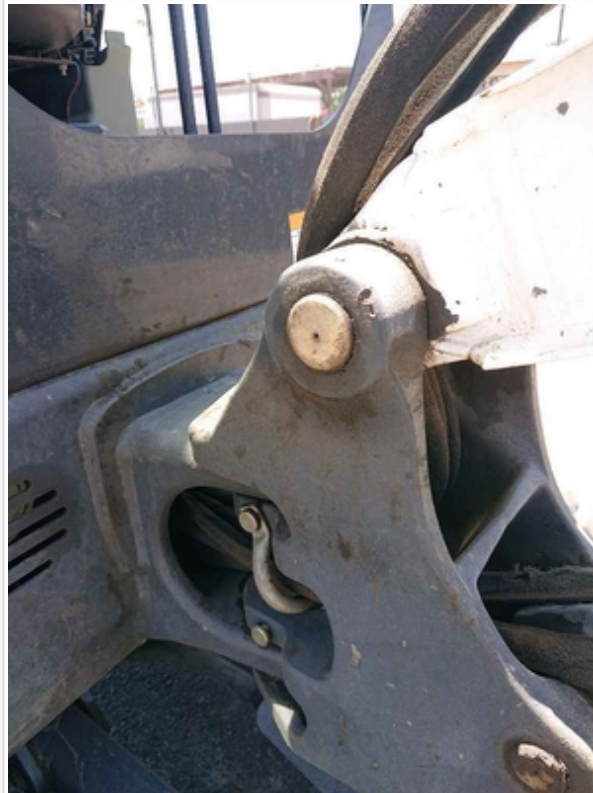
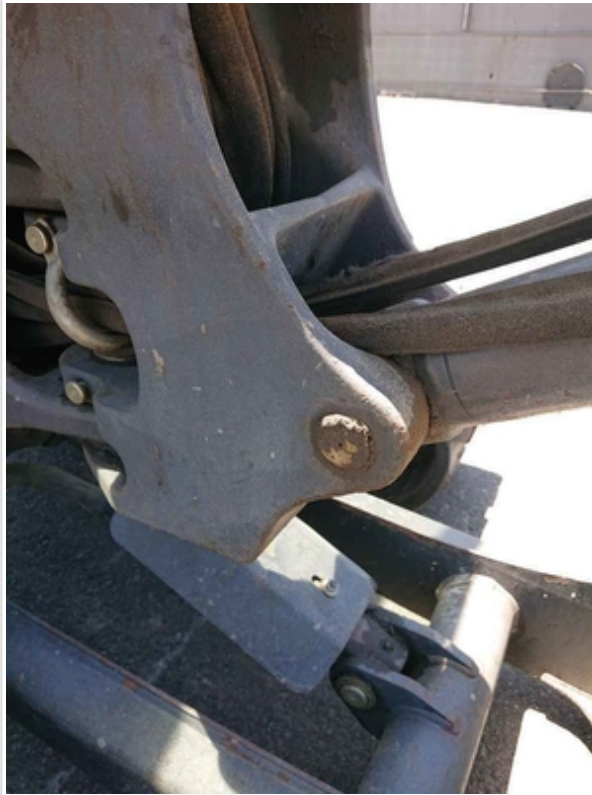
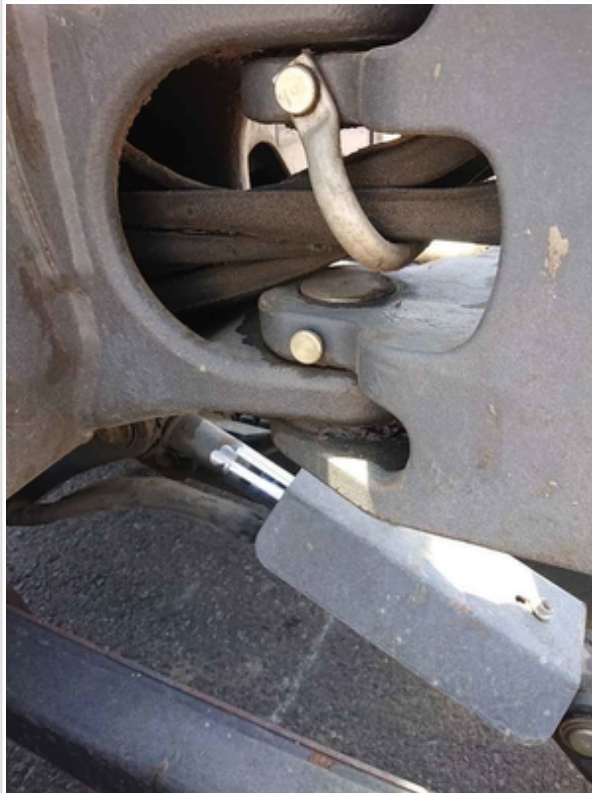
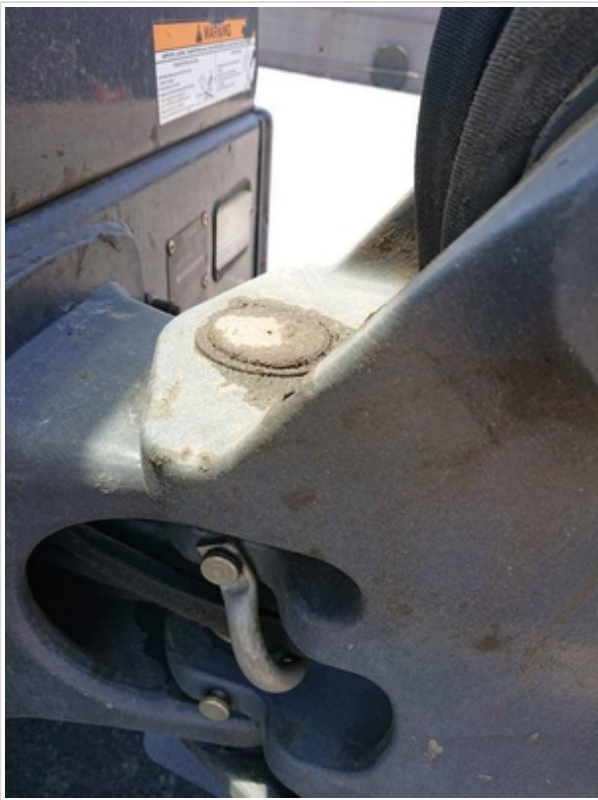
Stick Condition	3 - Normal Wear & Tear
Comments	Normal wear
Boom Base Pin & Bushings	3 - Normal Wear & Tear

Comments	Good condition
Boom Base Pin & Bushings Photos

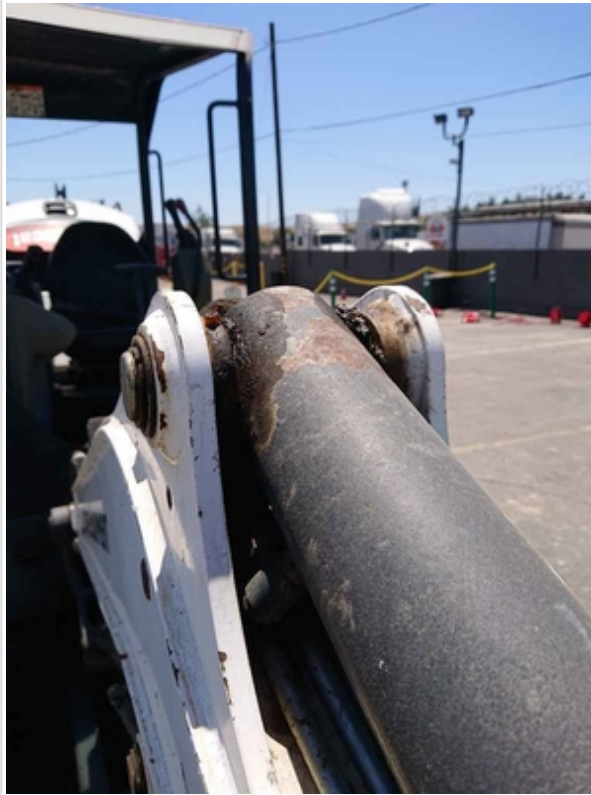
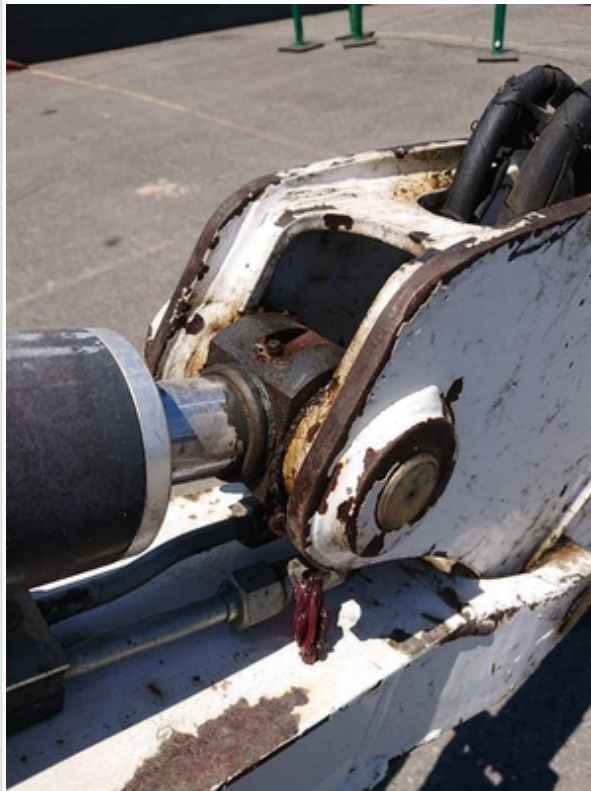
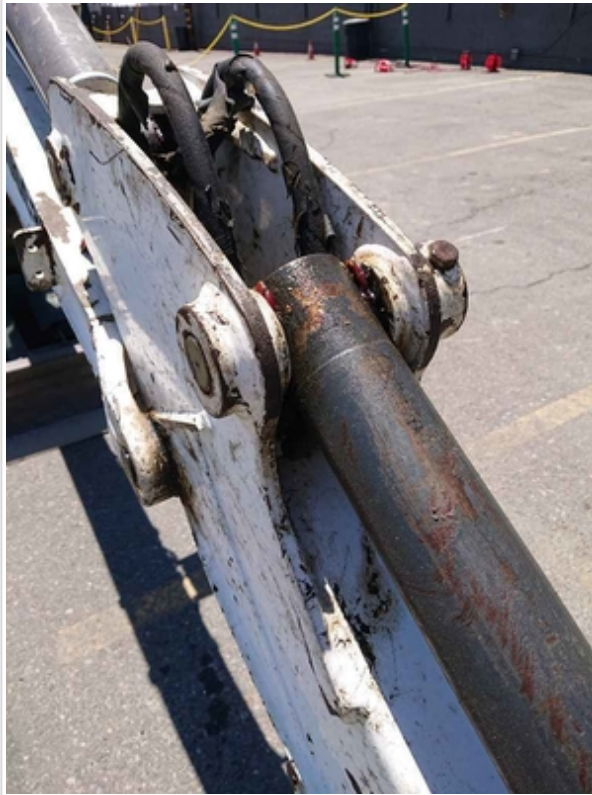
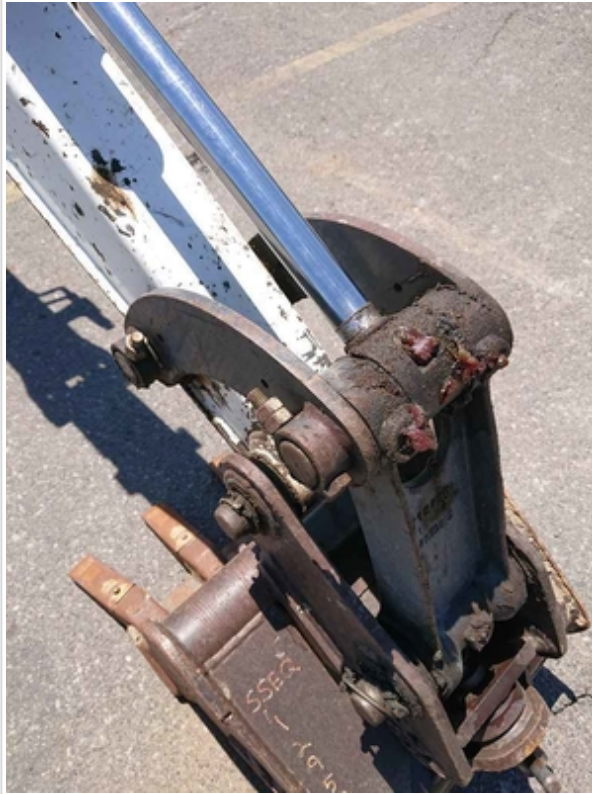
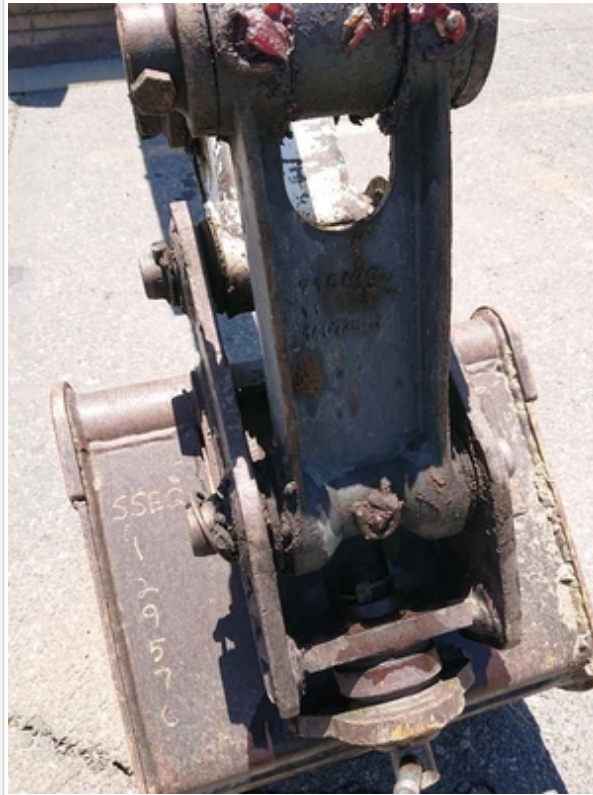
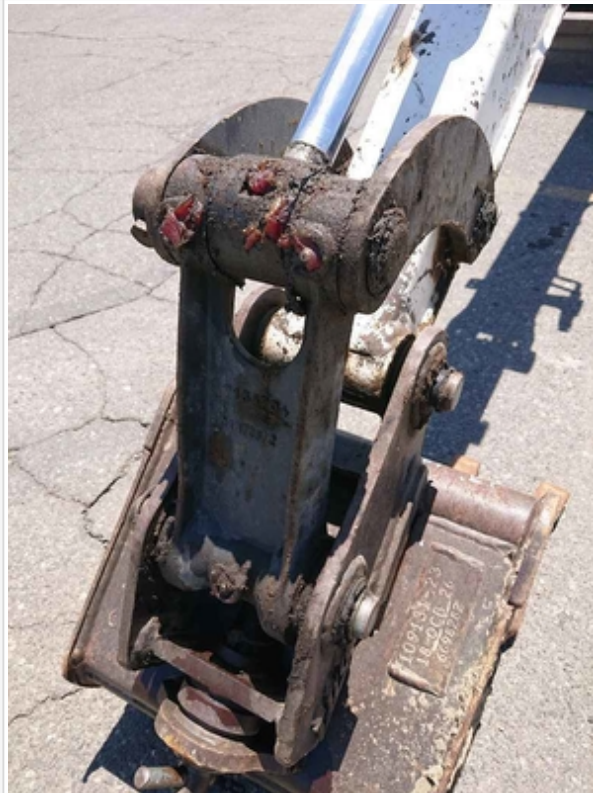
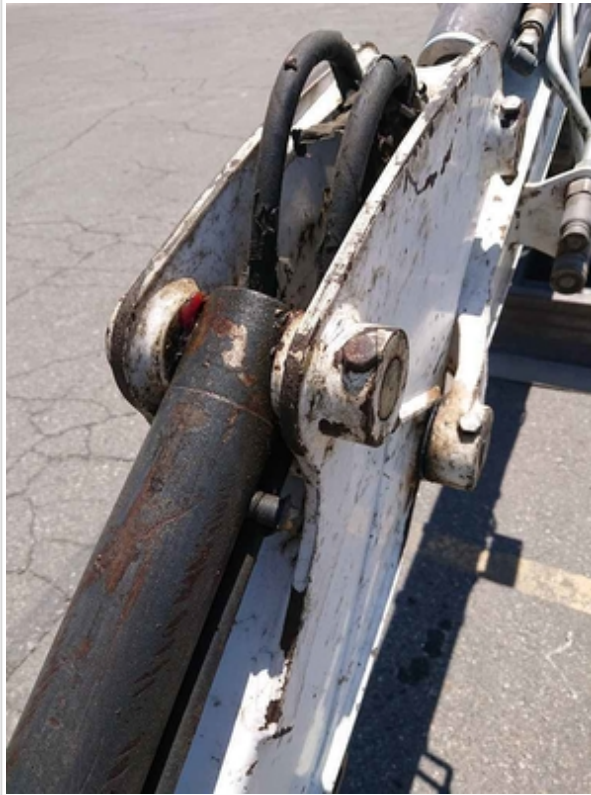
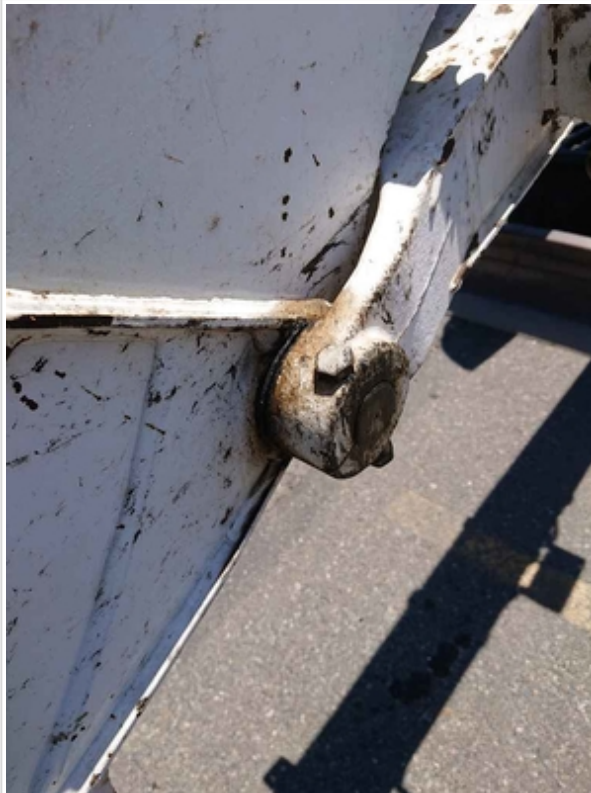
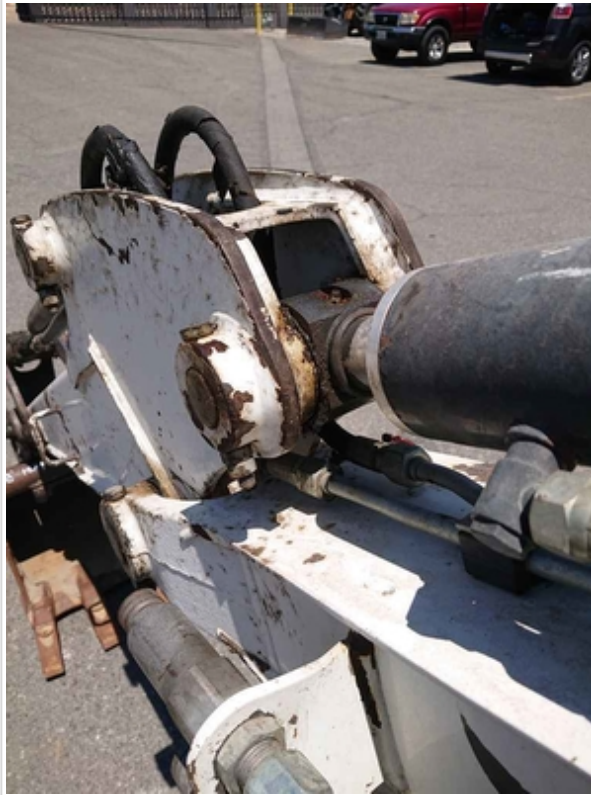
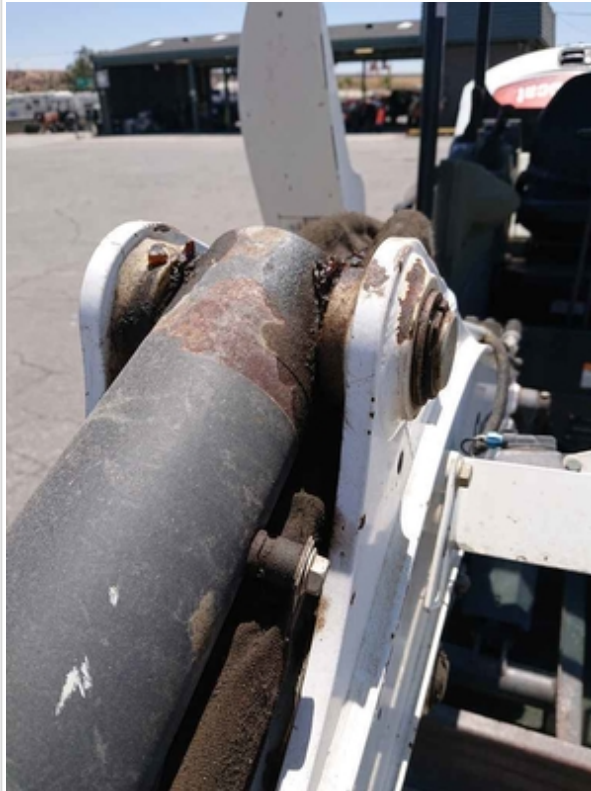
<p>Boom to Stick Pin & Bushings</p>	<p>3 - Normal Wear & Tear</p>	
<p>Comments</p>	<p>Good condition</p>	
<p>Boom to Stick Pin & Bushings Photos</p>

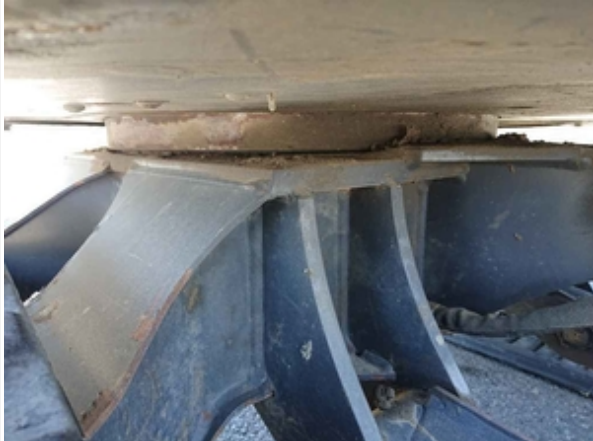
Comments	No issues noted
Turntable Bearing Photos

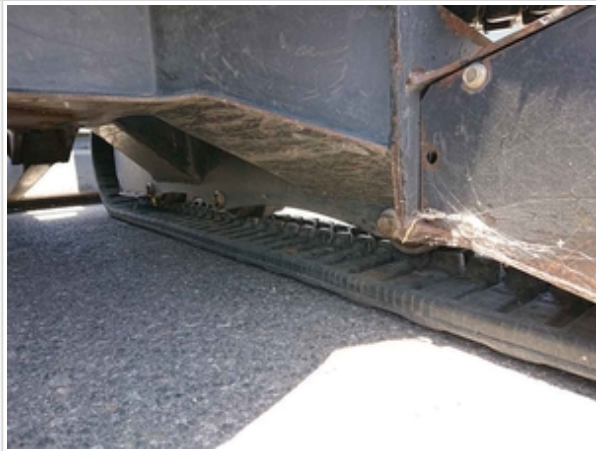
Instructions	<p>Evaluate the following on a 4 point scale (leave comments where an explanation is appropriate):</p> <p>4 = Like New, Recently Replaced 3 = Normal Wear & Tear 2 = Above Average Wear 1 = Service Required</p>
Roller Frames	<p>3 - Normal Wear & Tear</p>
Roller Frames Photos

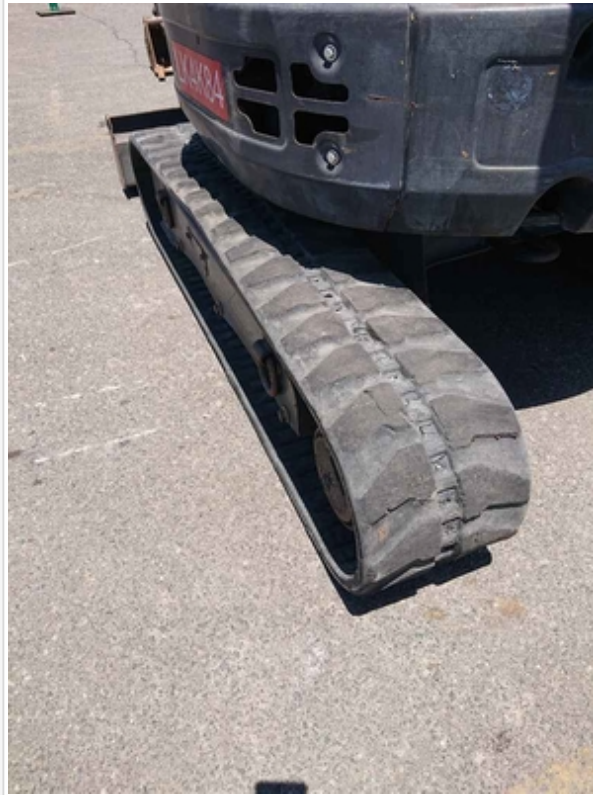
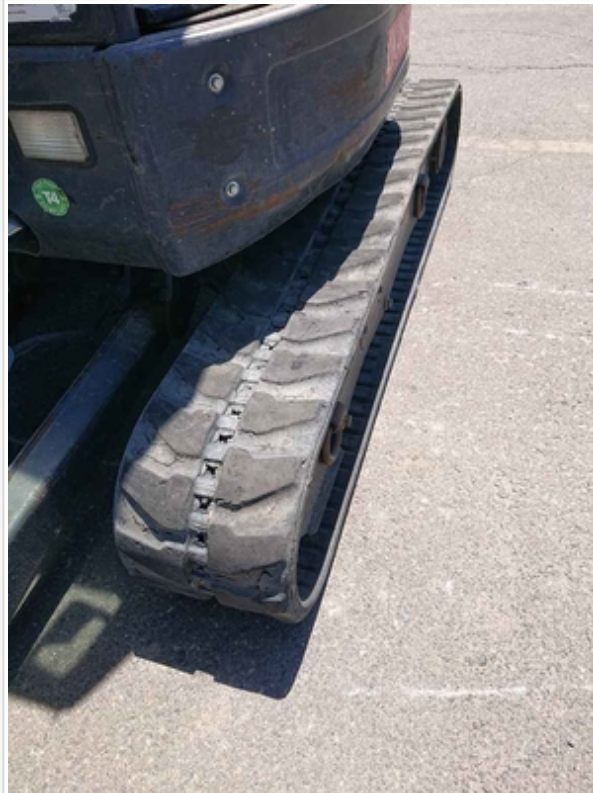
Track Belt Photos

<p>Track Belt</p>	<p>1 - Service Required</p>
<p>Comments</p>	<p>Slits/cracks in track belts observed</p>

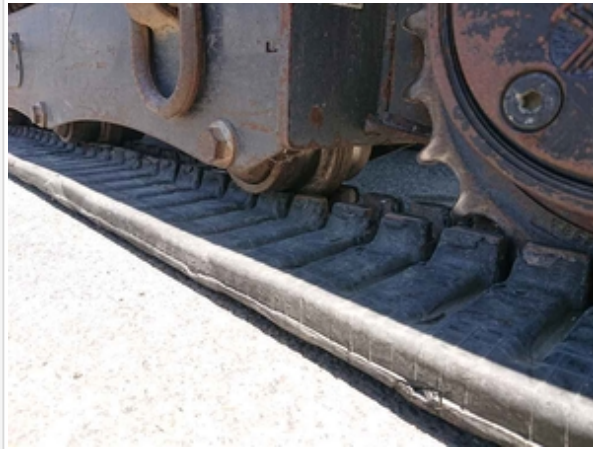
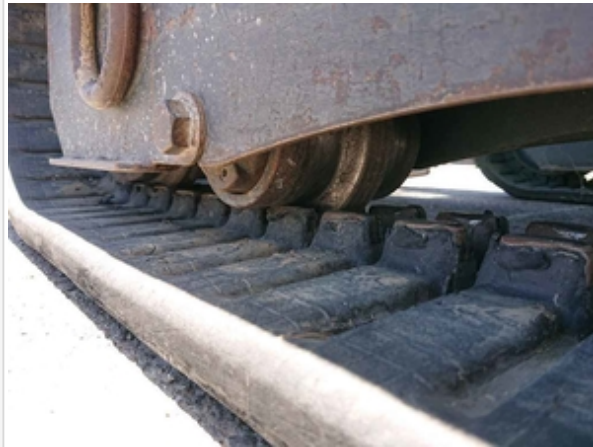
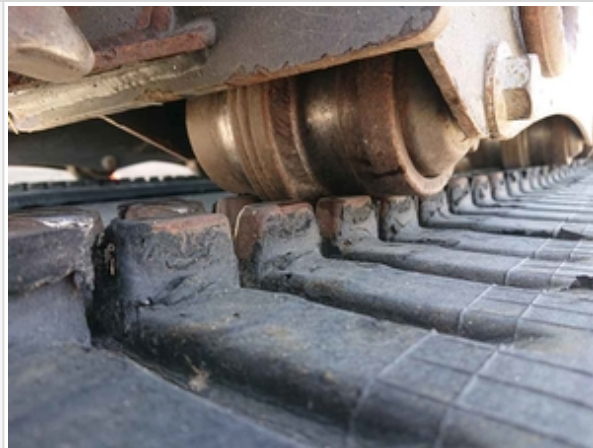
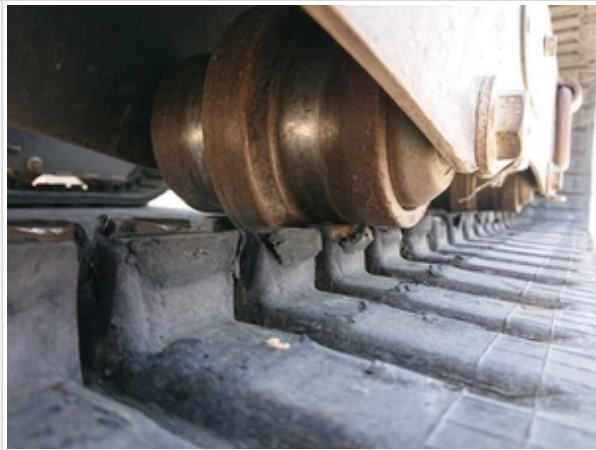
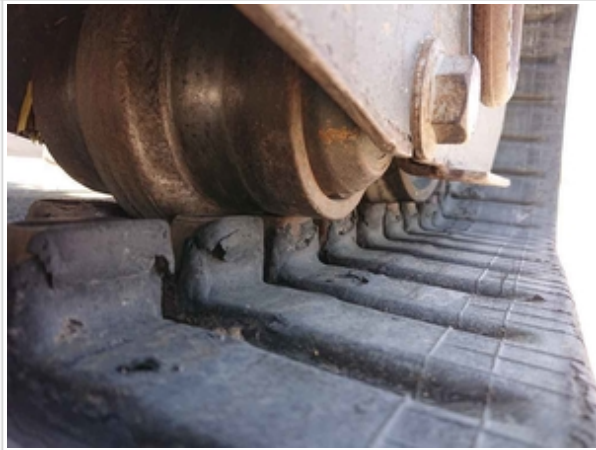
Rear Idlers	3 - Normal Wear & Tear
Comments	see rollers photos
Track Rollers	3 - Normal Wear & Tear
Track Rollers Photos

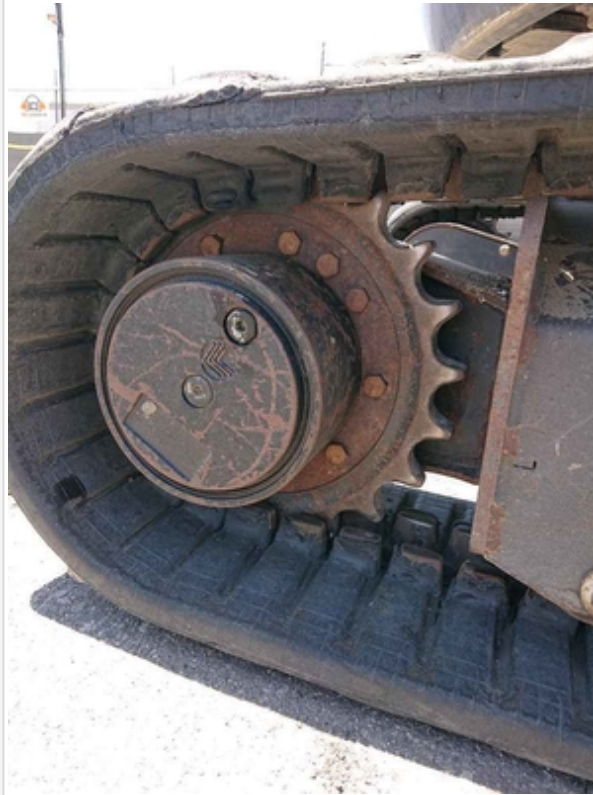
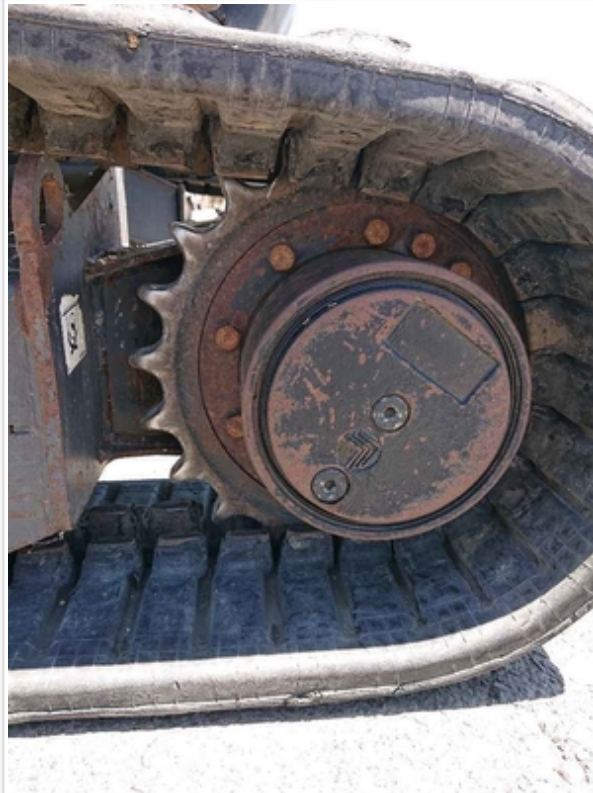
Sprockets Photos

Sprockets	3 - Normal Wear & Tear

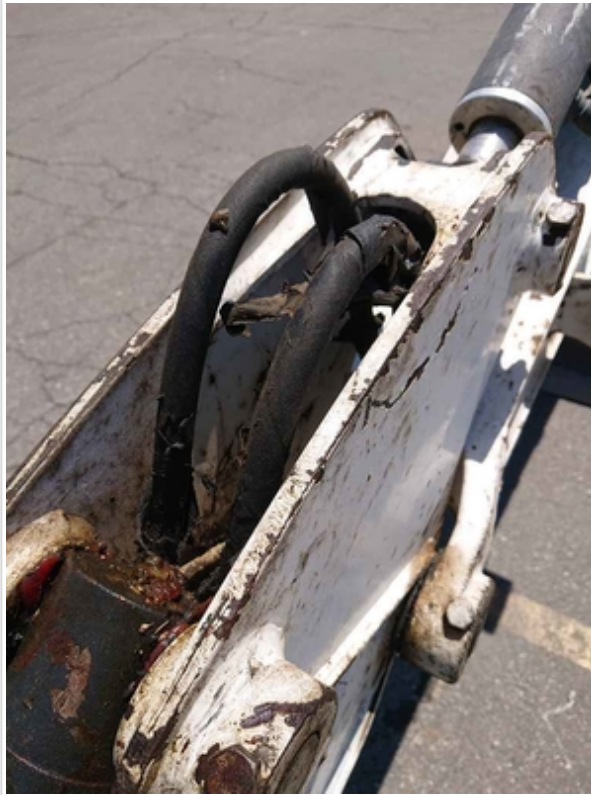
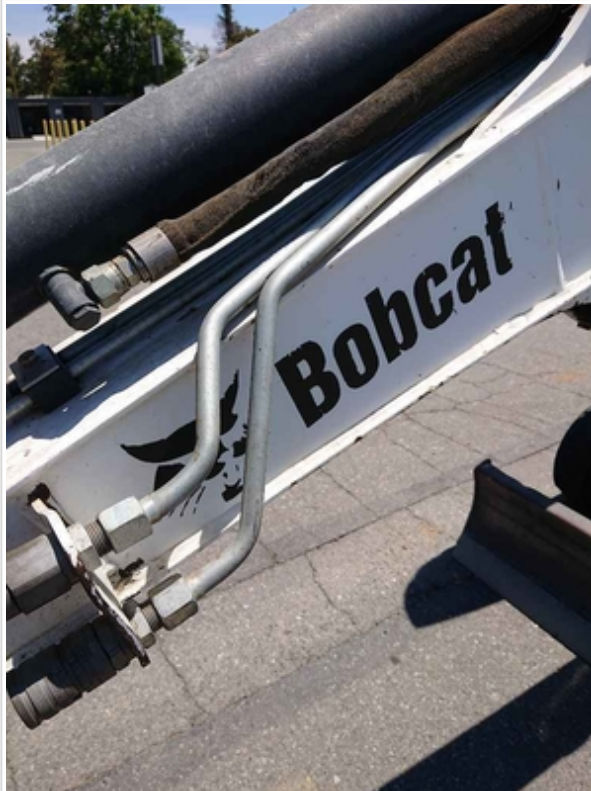
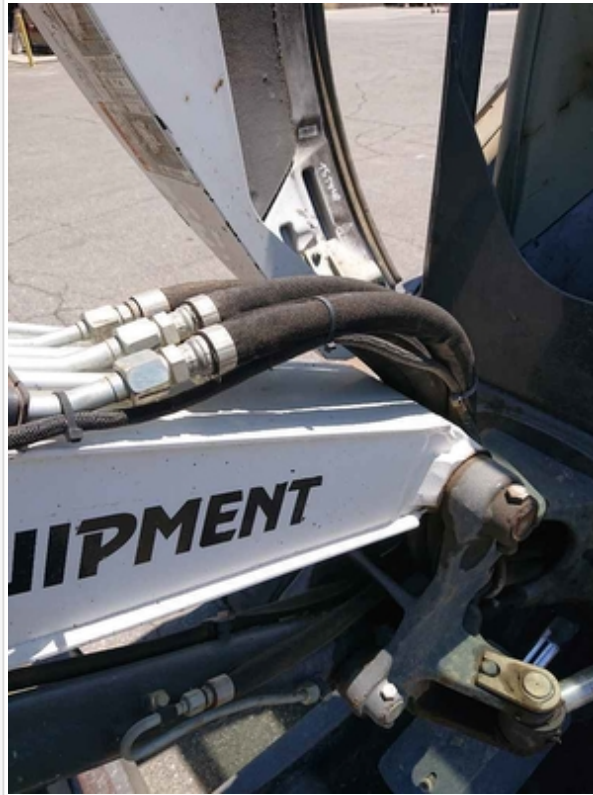
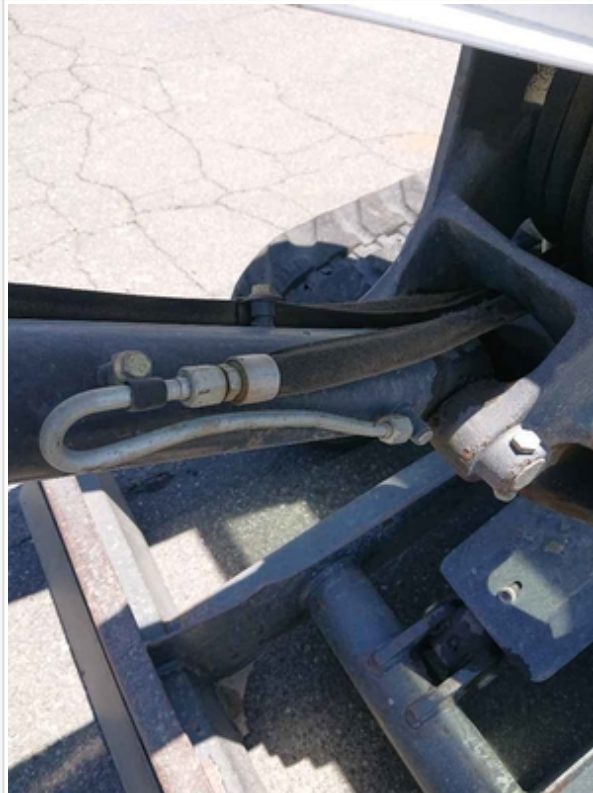
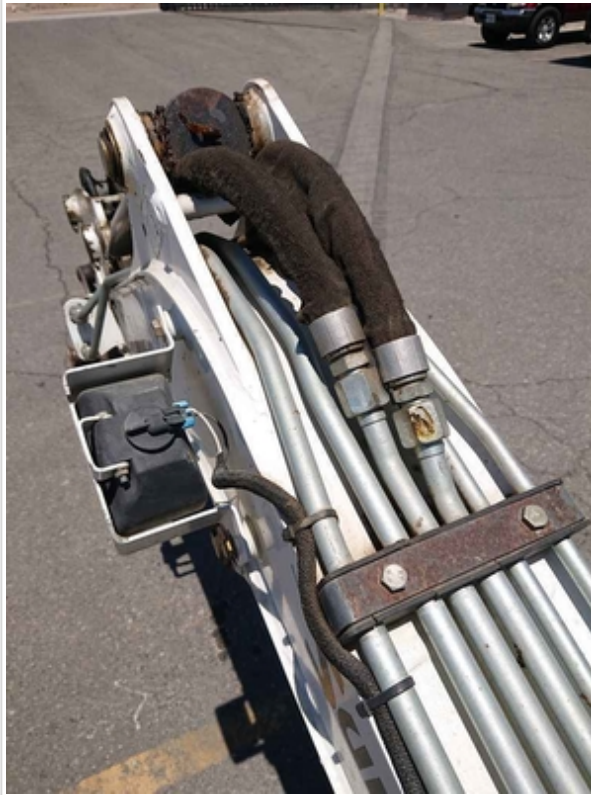
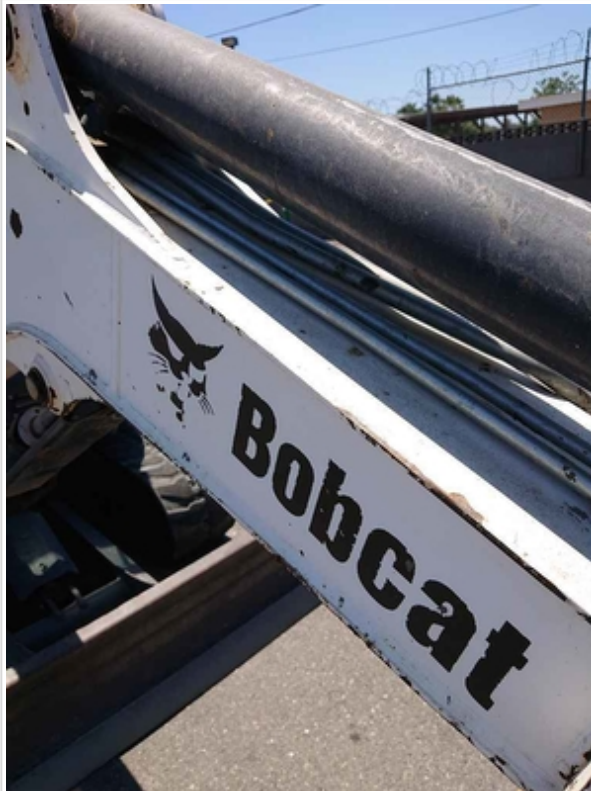
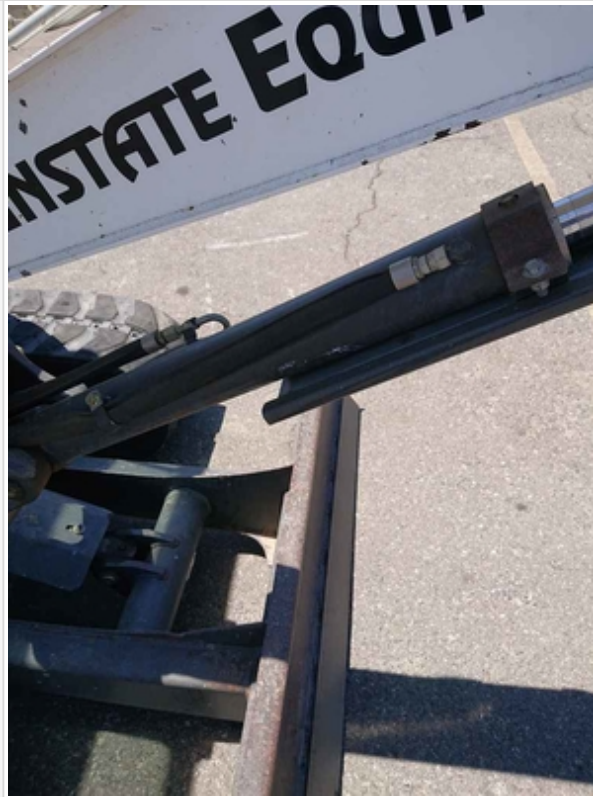
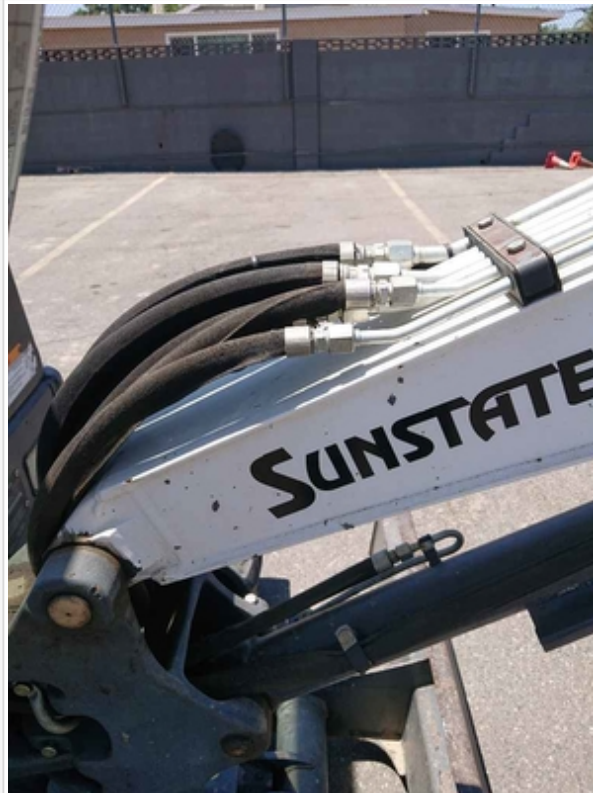
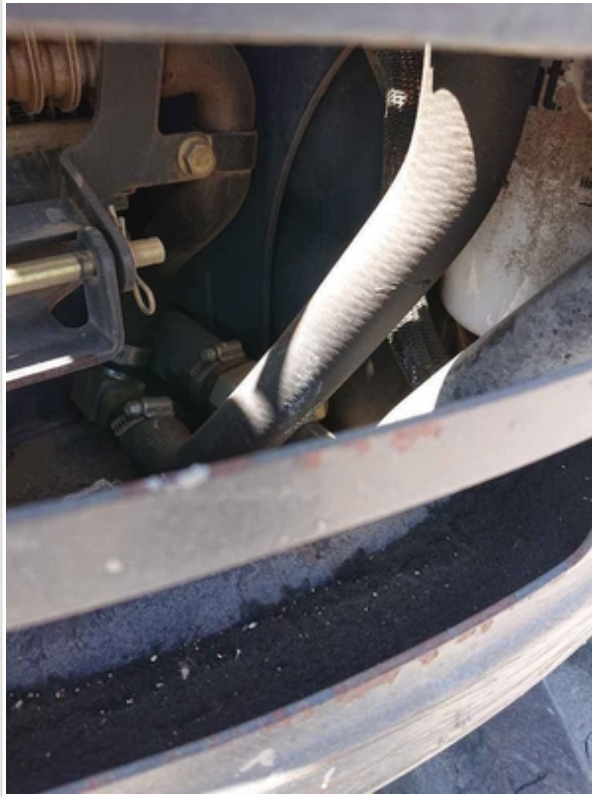
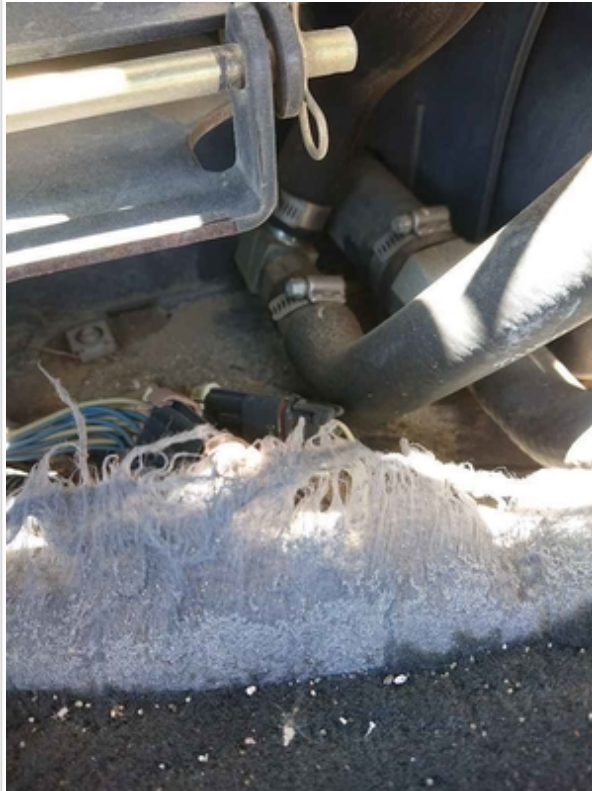
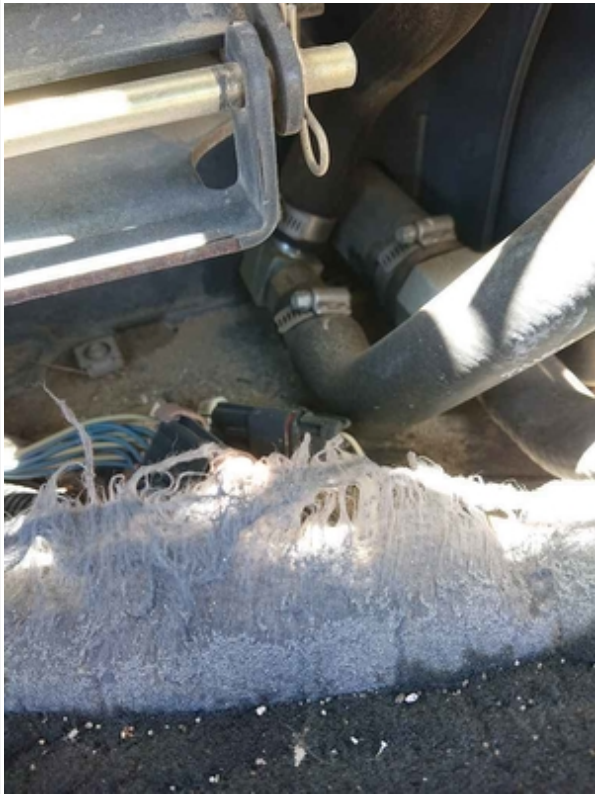
Wet or Damp Hydraulic Lines / Fittings	No
Appearance of Hydraulic Lines / Fittings	2
Hydraulic Lines / Fittings Condition	Hydraulic lines & fittings are clean and in good condition, Worn, cut, or damaged hose covering
Comments	Manifold inaccessible, no leaks noted throughout system
Appearance of Hydraulic Lines / Fittings Photos
