Inspection Report (Mini Excavator)

Year	2015
Make	Bobcat
Model	E26
Serial Number	B33212850
Hour Meter Reading	2565

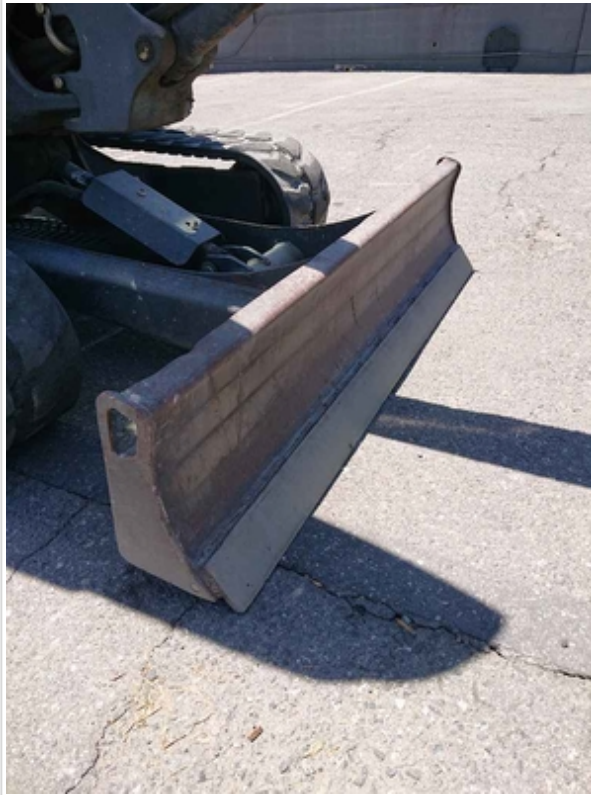
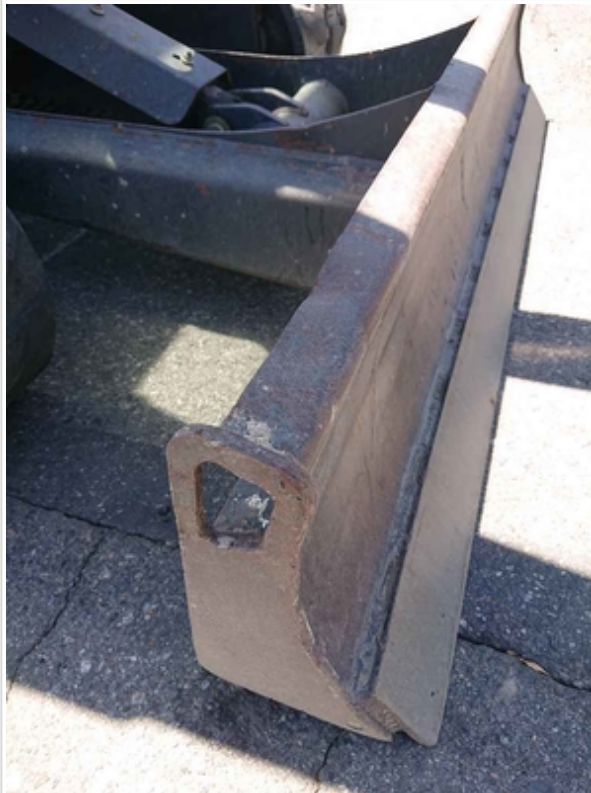
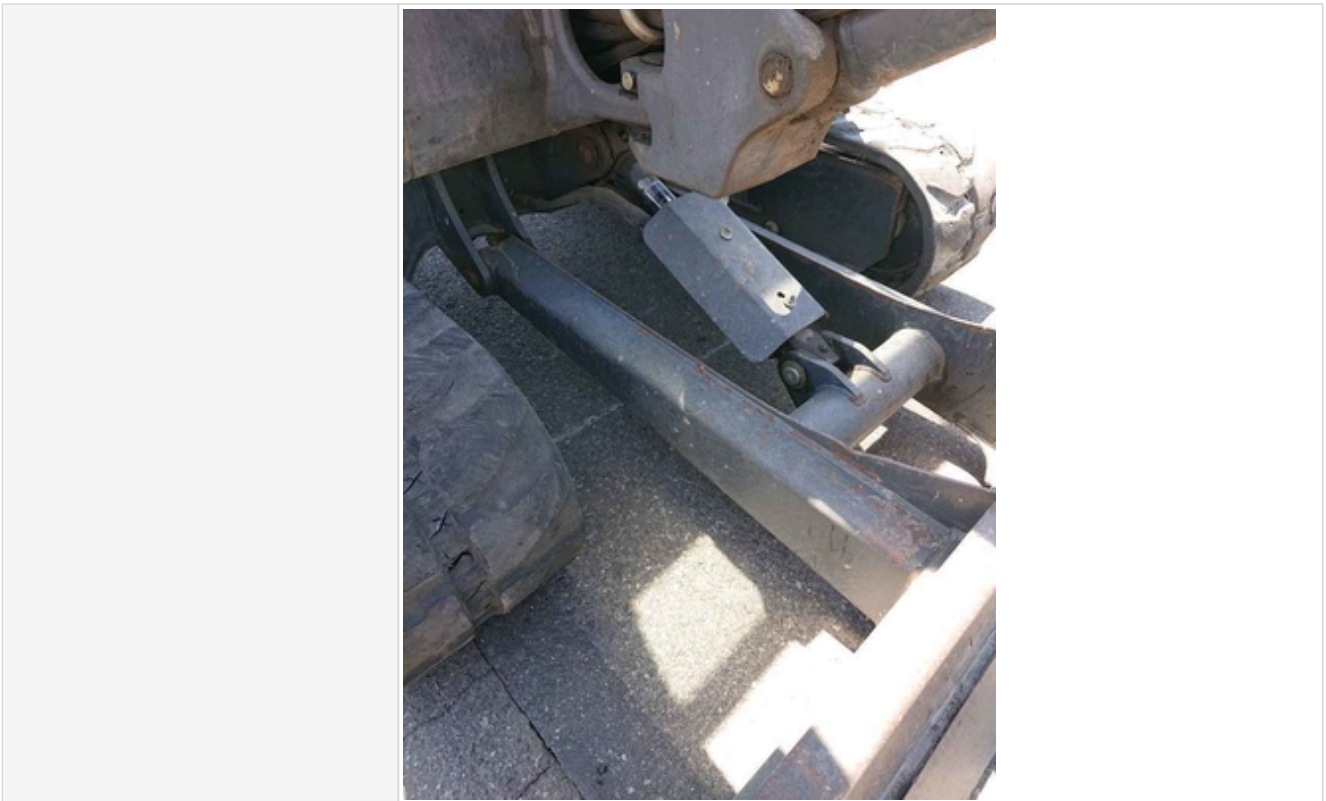
Comments	Blade/edges in good condition
Blade Photos

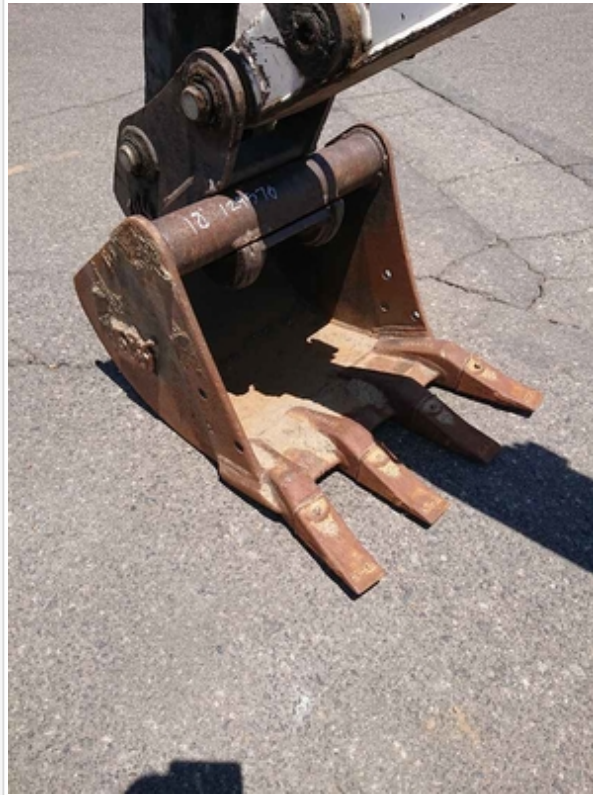
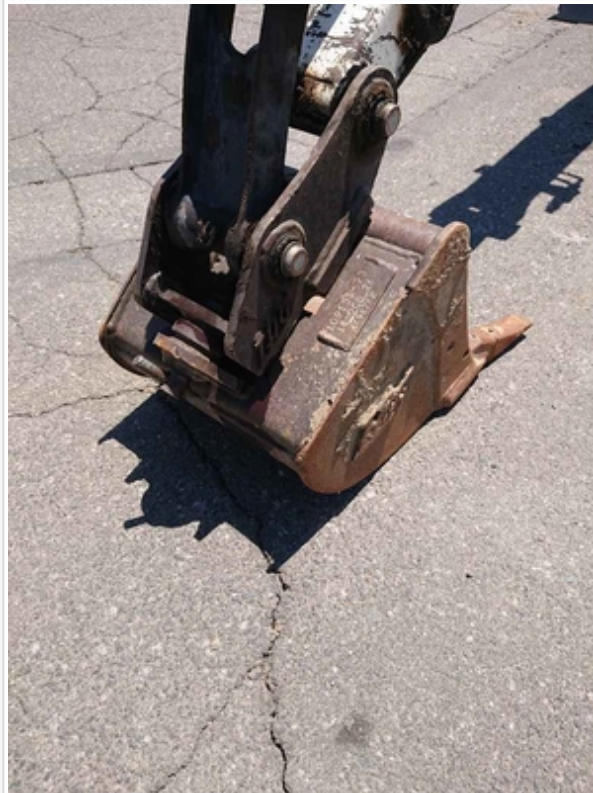
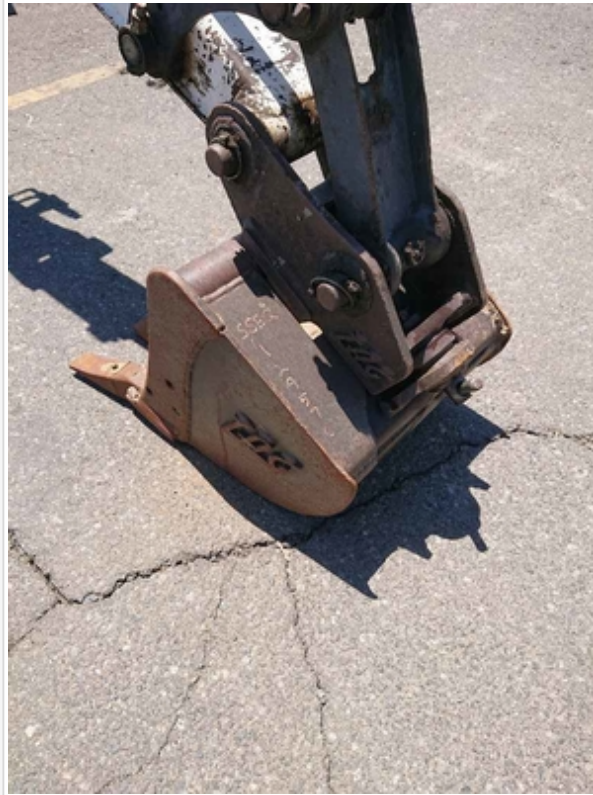
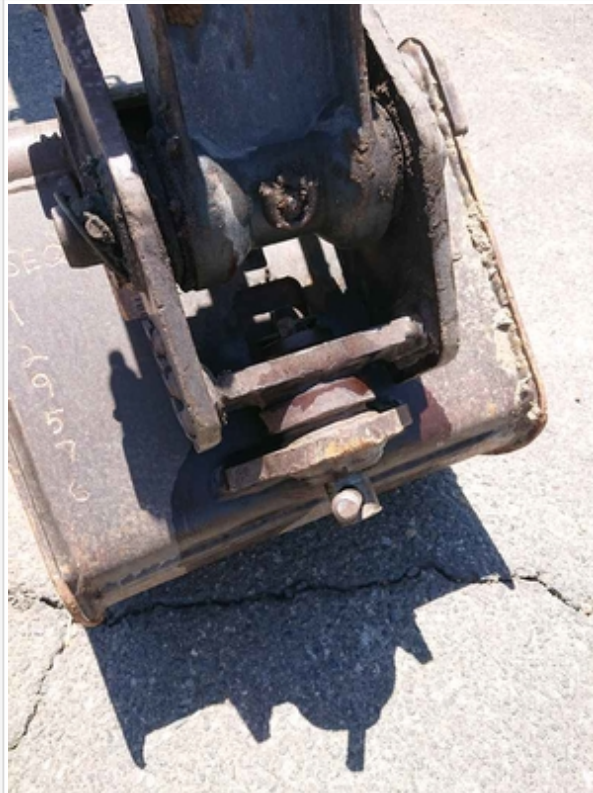
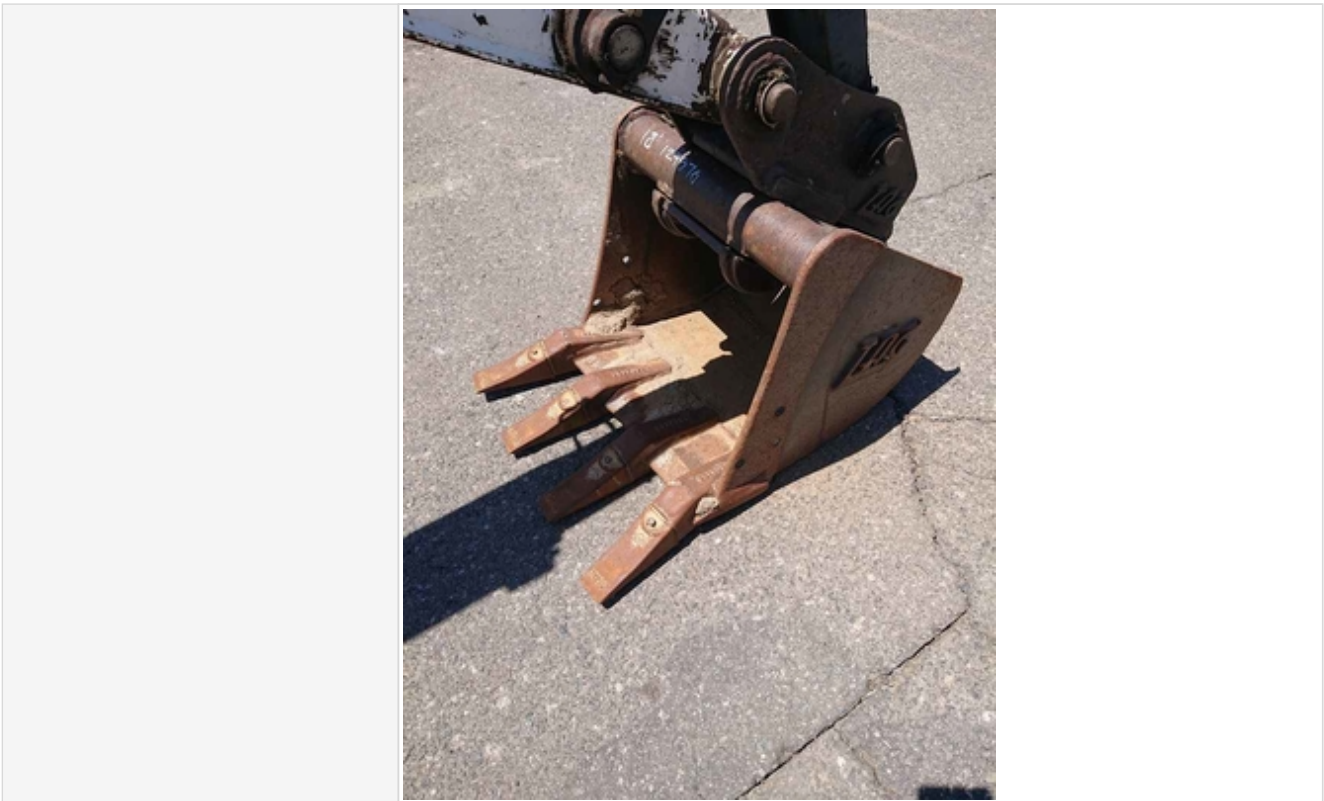
Bucket Photos

Instructions	<p>Evaluate the following on a 4 point scale (leave comments where an explanation is appropriate):</p> <p>4 = Like New, Recently Replaced 3 = Normal Wear & Tear 2 = Above Average Wear 1 = Service Required</p>
Bucket Condition	<p>3 - Normal Wear & Tear</p>
Comments	<p>Normal wear</p>

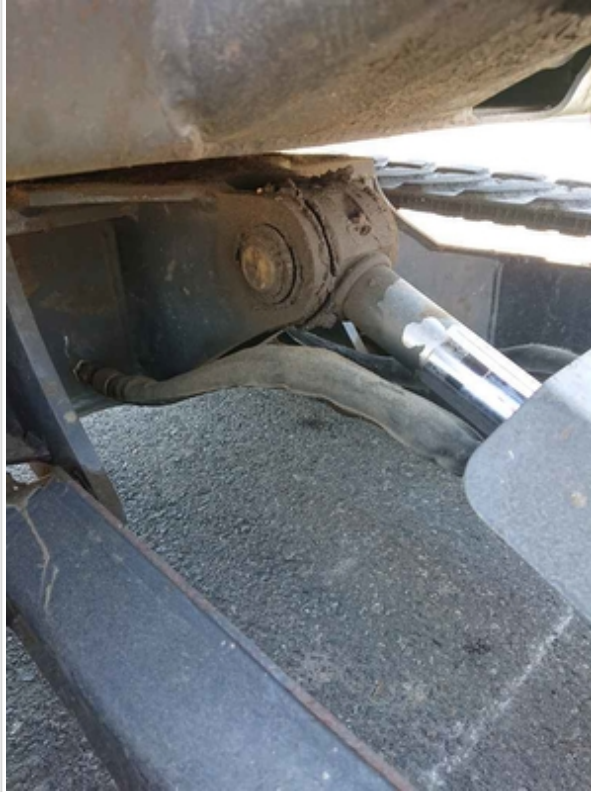
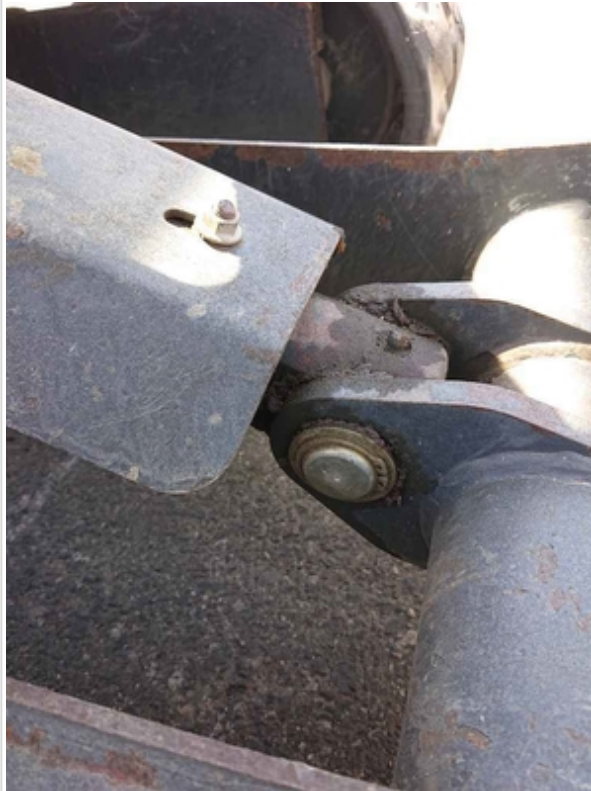
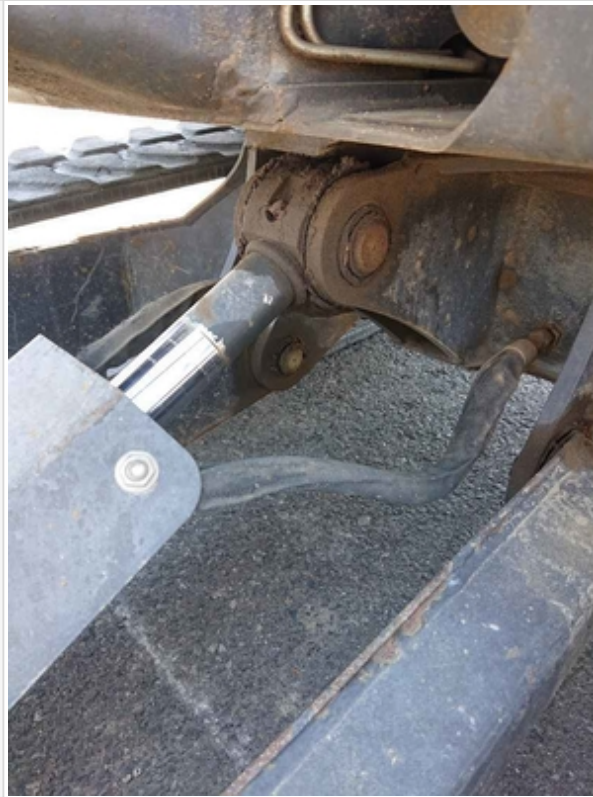
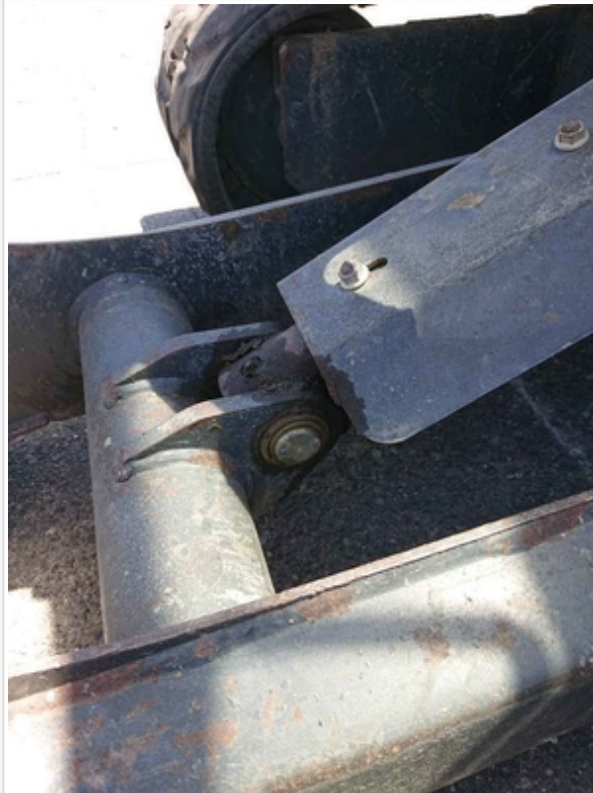
Blade Cylinder Photos

Blade Condition	0
Blade Edge	3 - Normal Wear & Tear
Comments	see bucket photos, teeth are like new
Blade Hose & Fittings	3 - Normal Wear & Tear
Comments	See all other blade photos
Blade Cylinder	3 - Normal Wear & Tear
