Inspection Report (On-Highway Truck Basic Template)

| Make | Peterbilt |
| Model | 386 |
| Serial Number | 1XPHDP9X7BD118394 |

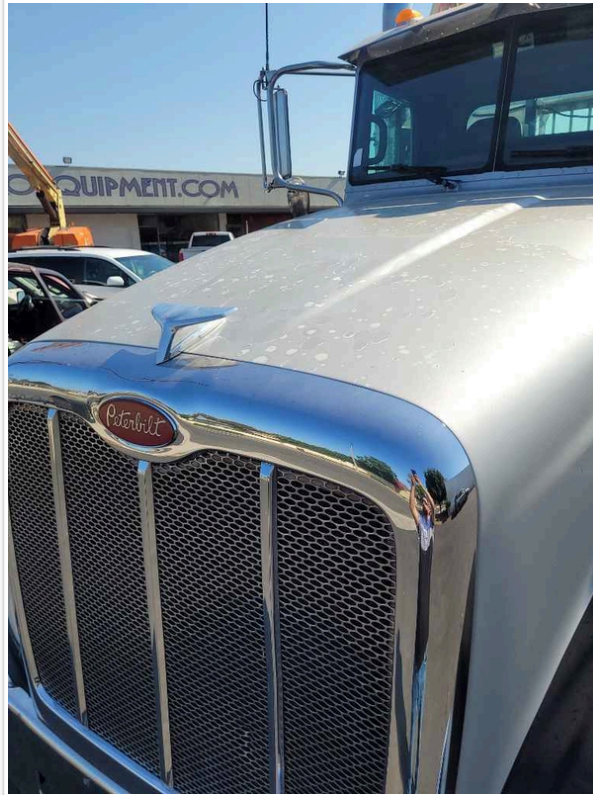
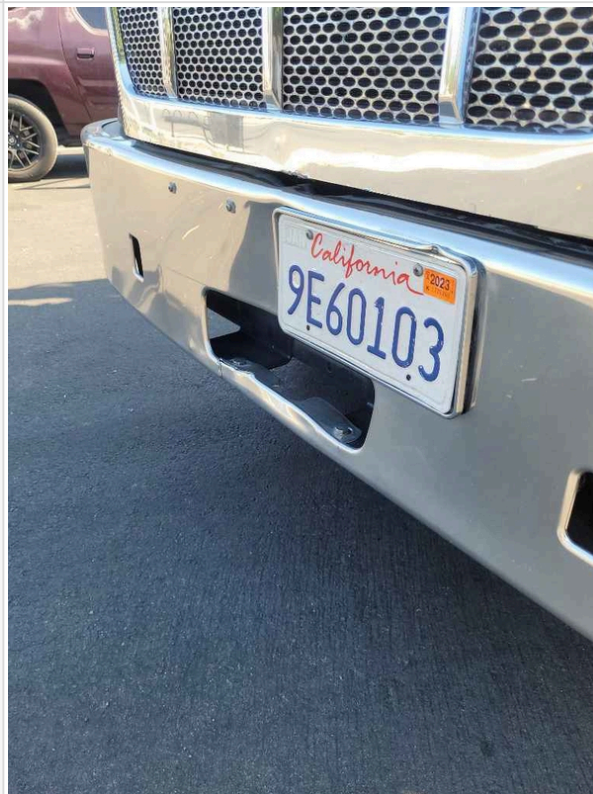
Front Photos

| Front | 3 - Normal Wear & Tear |
| Front Condition | Visible chipped paint or dents, Other (see comments) |

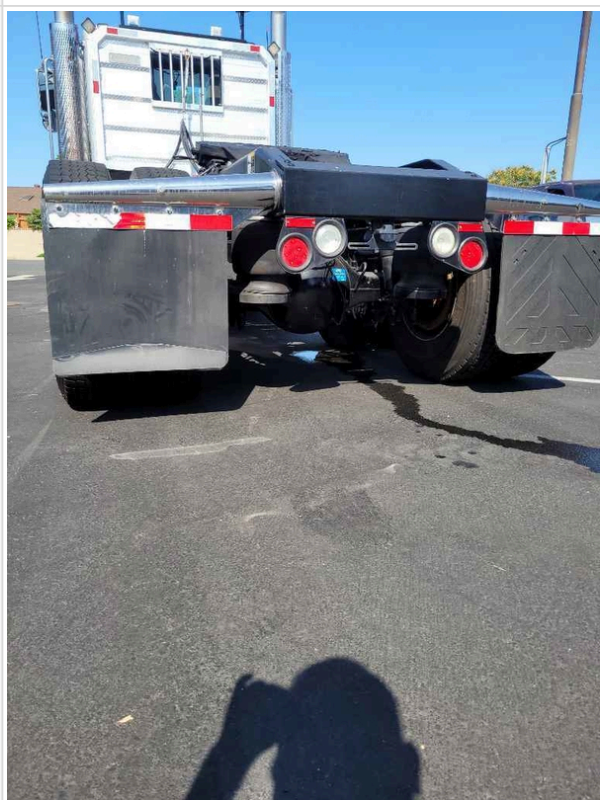
| Rear Photos | | |

| Rear | 4 - Like New, Recently Replaced | |
| Rear Condition | No visible damage | |

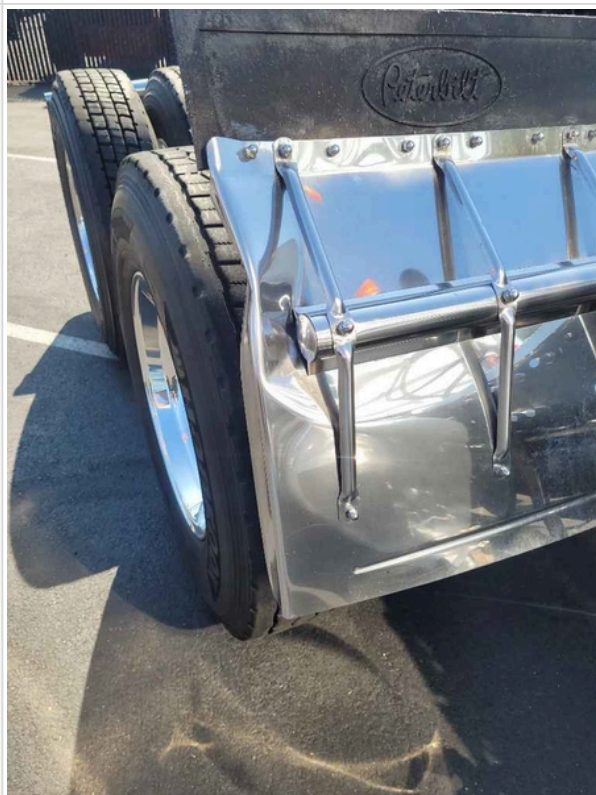
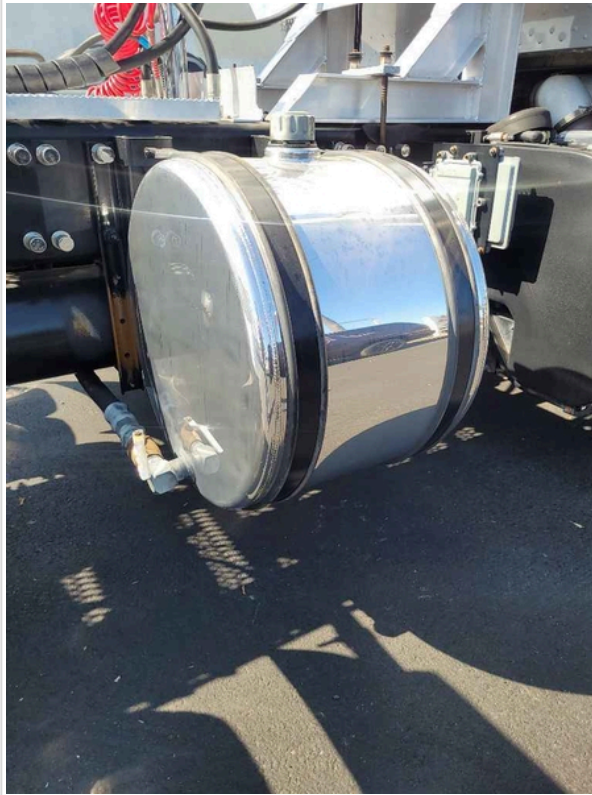
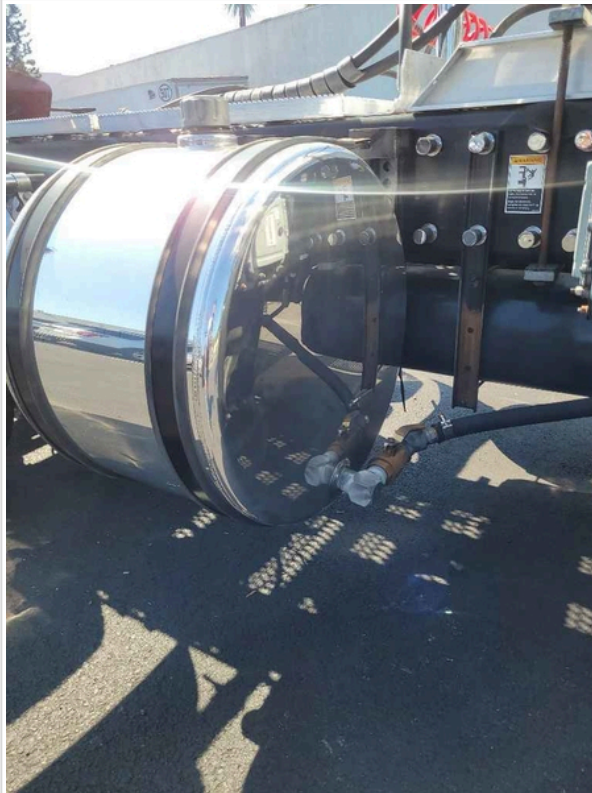
| Right Condition | Visible chipped paint or dents, Other (see comments) |
| Comments | small dent on R/S mud guard the rest looks great |

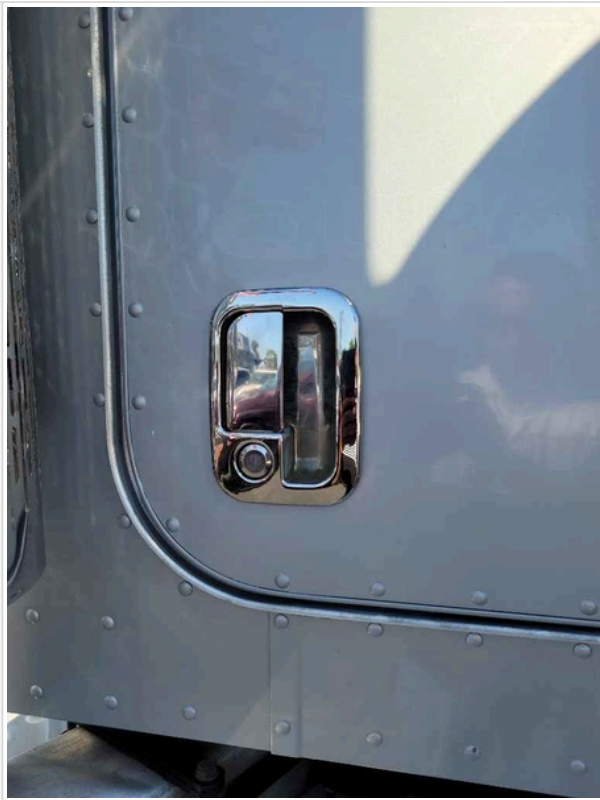
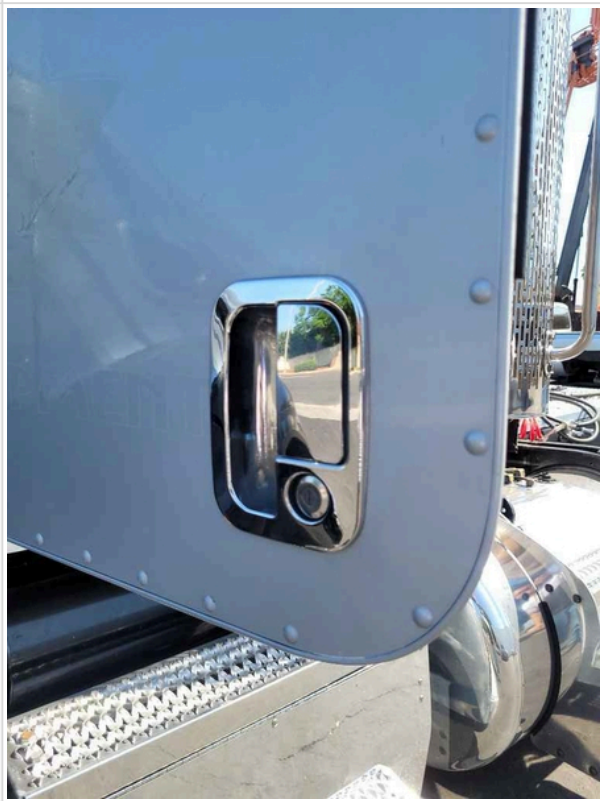
| <p>Doors / Canopy Latches Photos</p> | |

| Doors / Canopy Latches | 4 - Like New, Recently Replaced | |
| Doors / Canopy Latches Condition | No visible damage | |

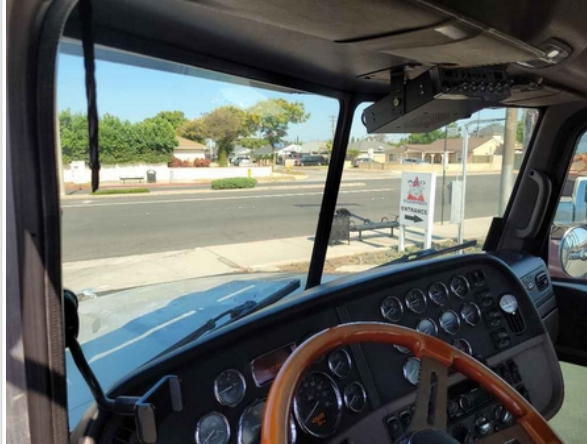
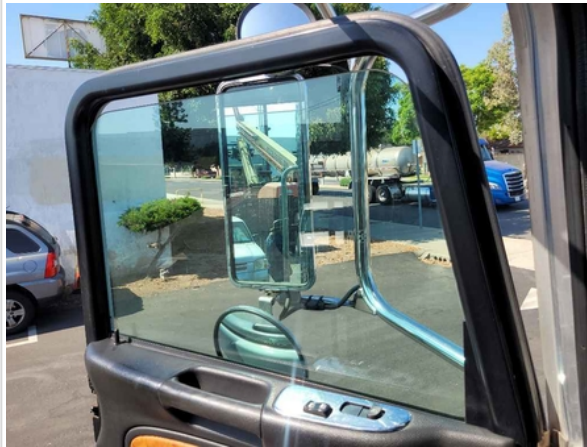
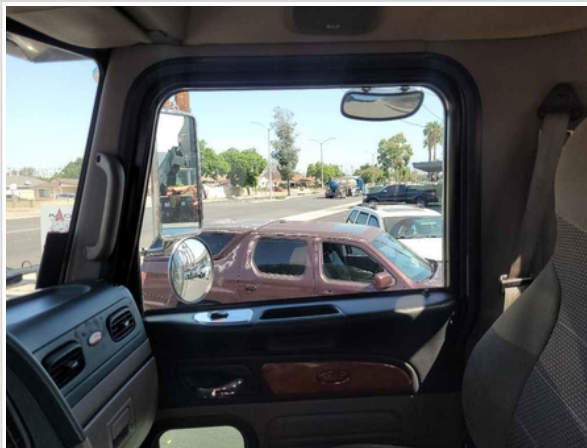
Glass Condition Photos

| <p>Glass Condition</p> | <p>4 - Like New, Recently Replaced</p> |
| <p>Glass Condition Notes</p> | <p>Glass intact, no visible damage</p> |

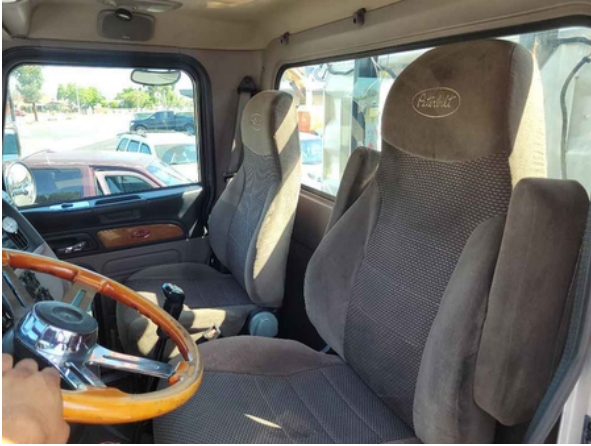
| Operator Cabin Photos | |

| Operator Cabin | 3 - Normal Wear & Tear |
| Comments | interior in really nice condition |

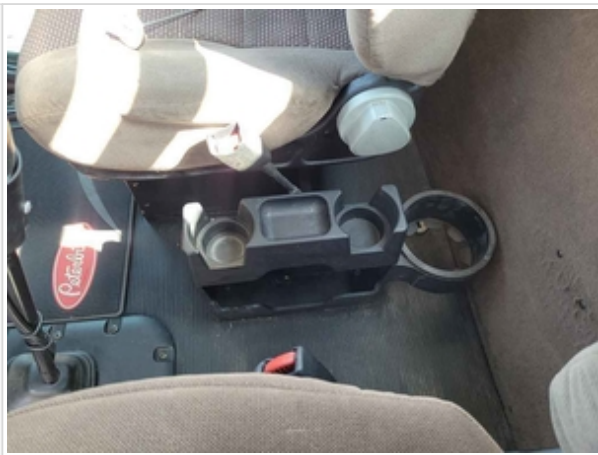
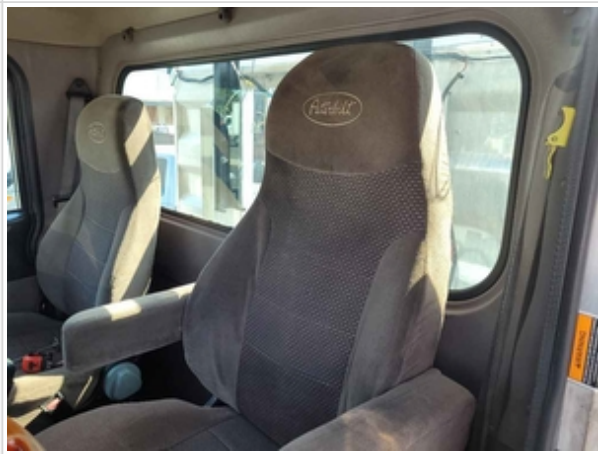
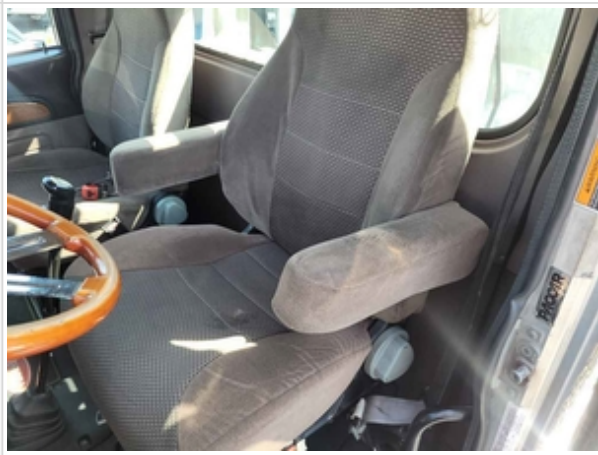
| <p>Operator's Seat & Arm Rests Photos</p> | | |

| <p>Operator's Seat & Arm Rests</p> | <p>4 - Like New, Recently Replaced</p> | |

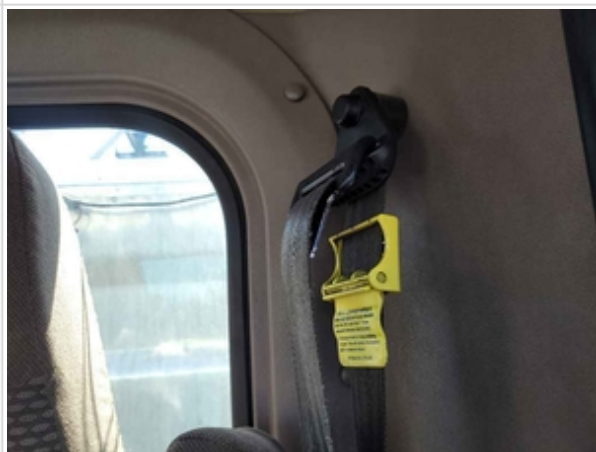
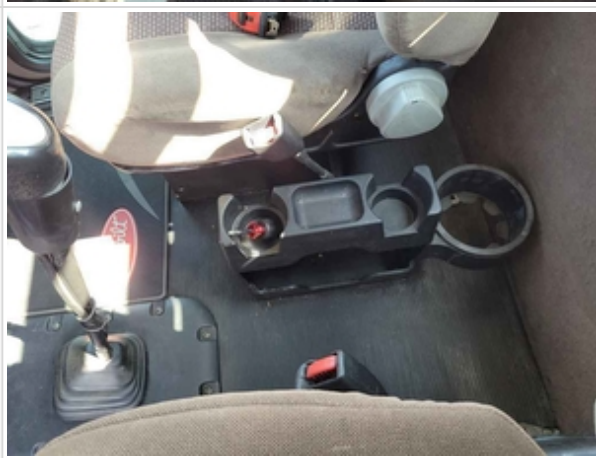
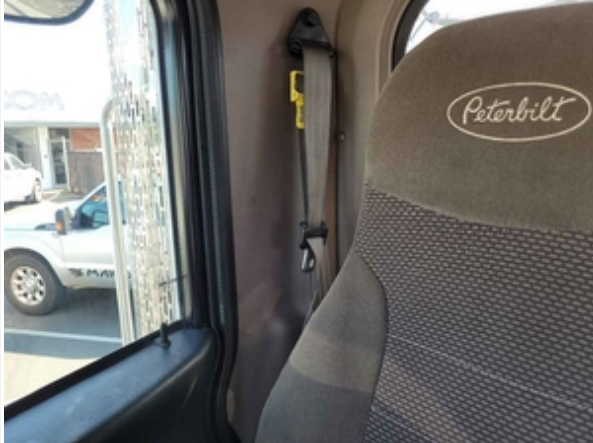
| <p>Seat Belt Photos</p> | |

| <p>Seat Belt</p> | <p>3 - Normal Wear & Tear</p> | |

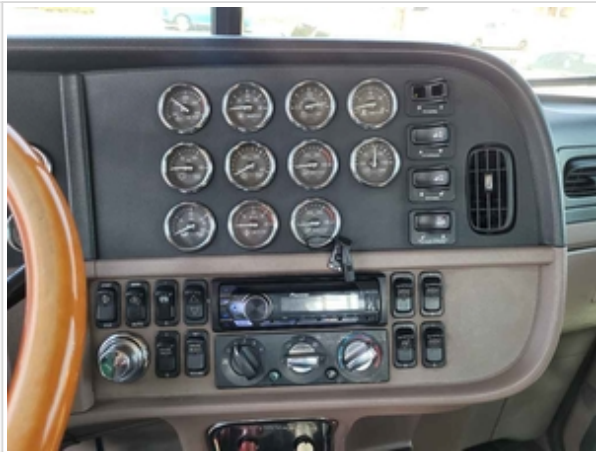
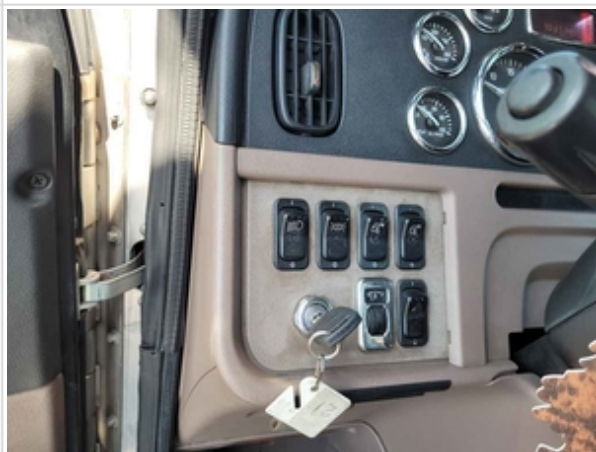
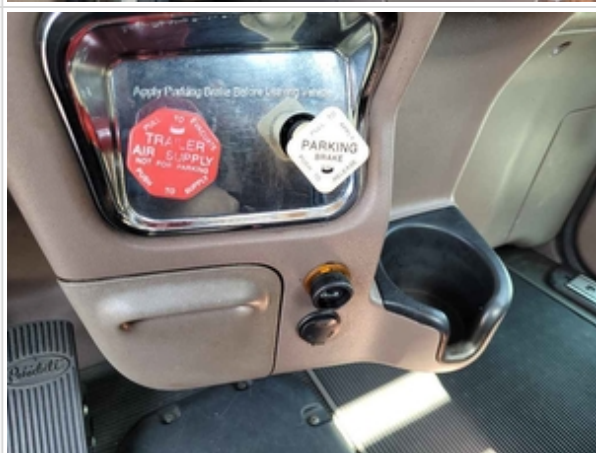
| <p>Controls & Switches Photos</p> | |

| Controls & Switches | 4 - Like New, Recently Replaced |
| Comments | all switches seem to be functioning |

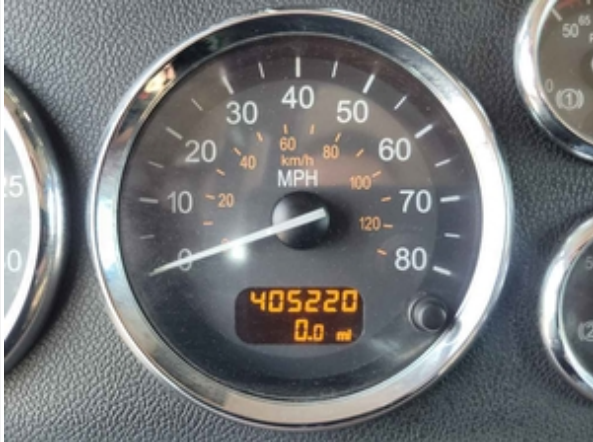
| <p>Odometer Activity Photos</p> | |

| <p>Odometer Activity</p> | <p>4 - Like New, Recently Replaced</p> |

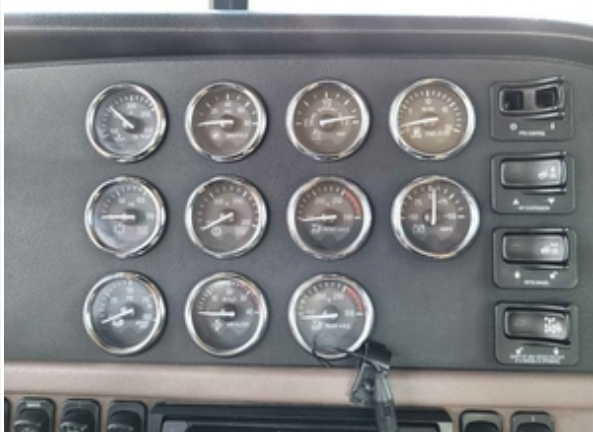
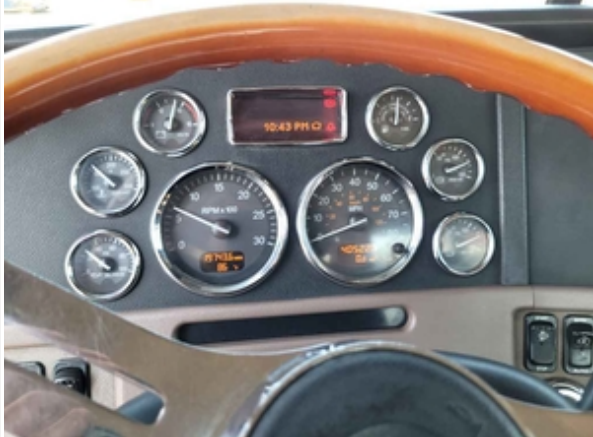
| <p>Other Gauge Activity Photos</p> | |

| <p>Other Gauge Activity</p> | <p>4 - Like New, Recently Replaced</p> |

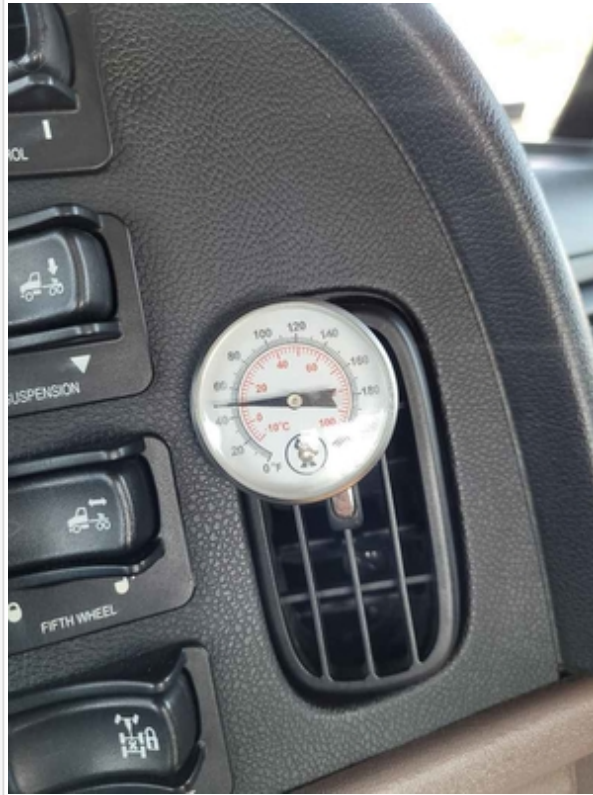
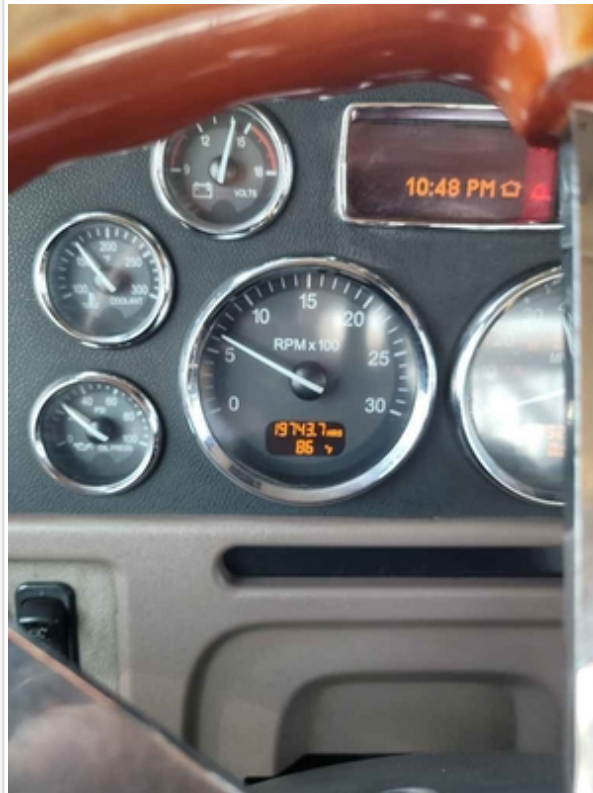
Heater & A/C Photos

| <p>Heater & A/C</p> | <p>4 - Like New, Recently Replaced</p> |
| <p>Comments</p> | <p>A/C EXCEEDED 30° TEMP DROP HEATER WORKING WELL</p> |

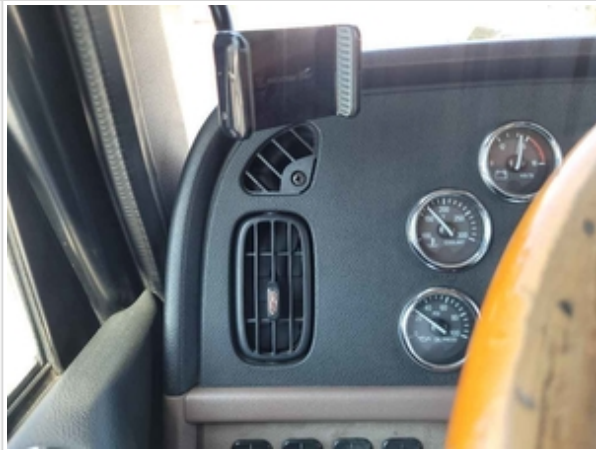
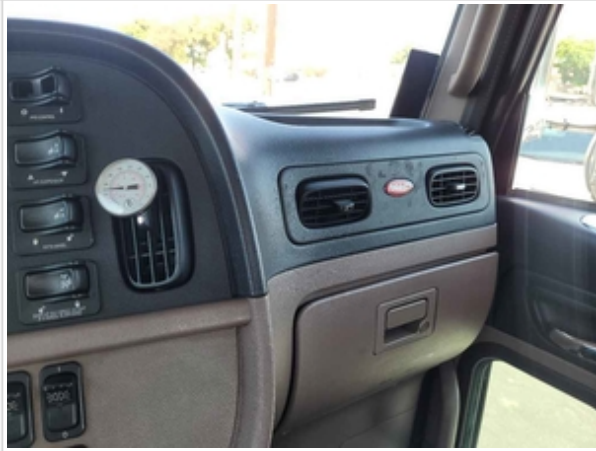
| Fans / Vents Photos | |

Fans / Vents

4 - Like New, Recently Replaced

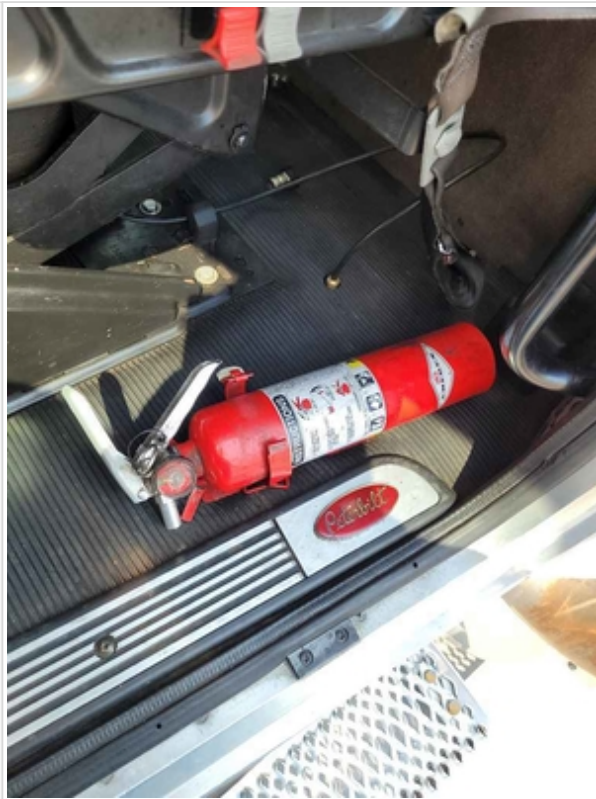
| Fire Extinguisher Photos | |

| Comments | 2 1/2lbs extinguisher not certified |

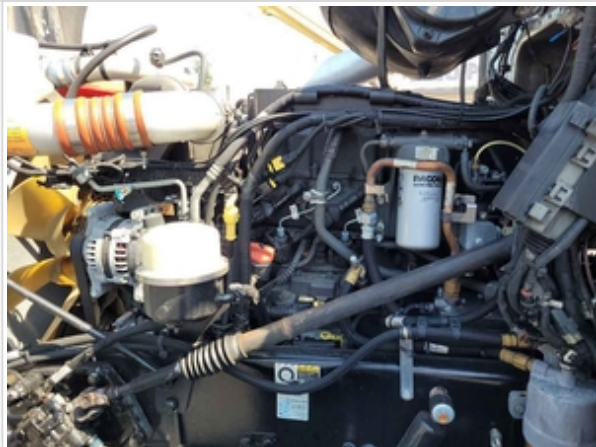
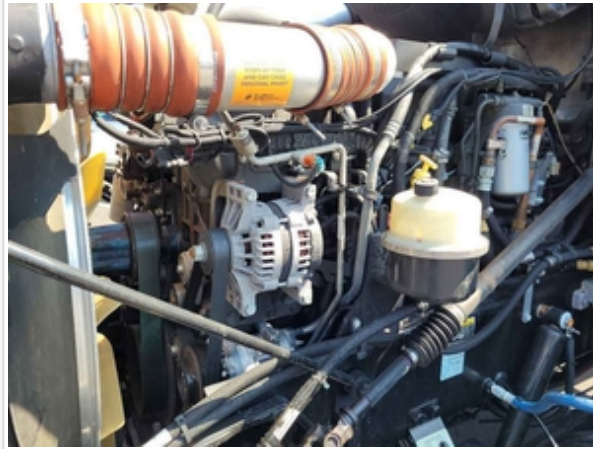
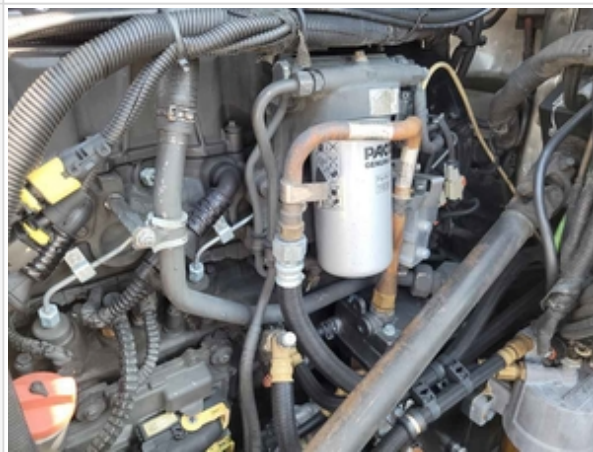
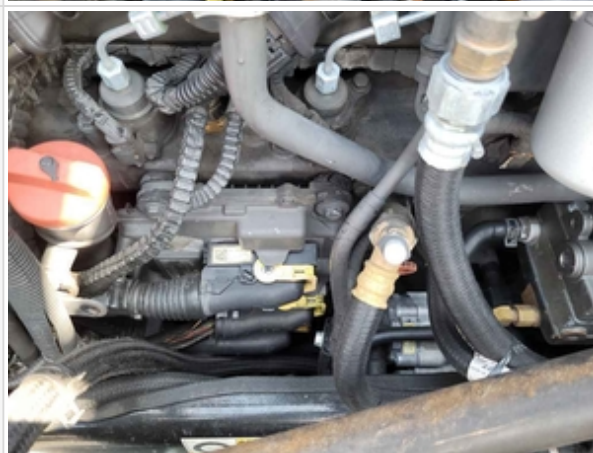
| Engine Photos | |

| Overall Engine Comments | Besides the small oil leak, the Engine looks very well maintained! | |

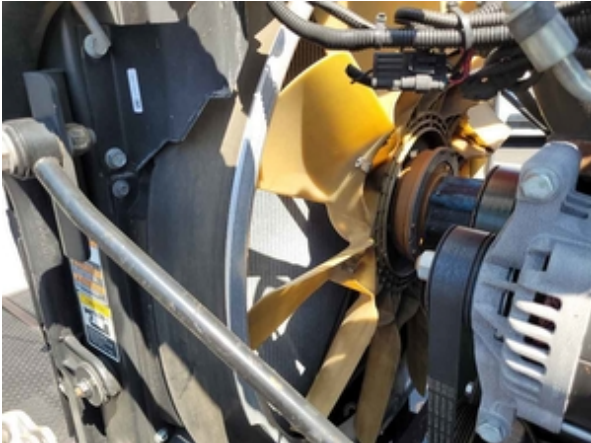
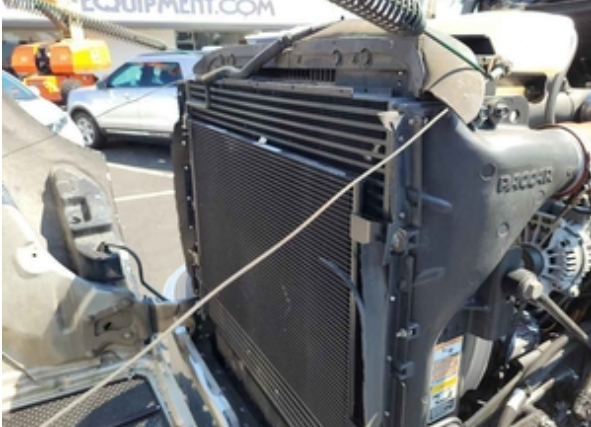
| Radiator Photos | |

| Radiator | 4 - Like New, Recently Replaced |
| Radiator Condition | Radiator fins & components appear to be in good working order, no signs of damage or leaks |

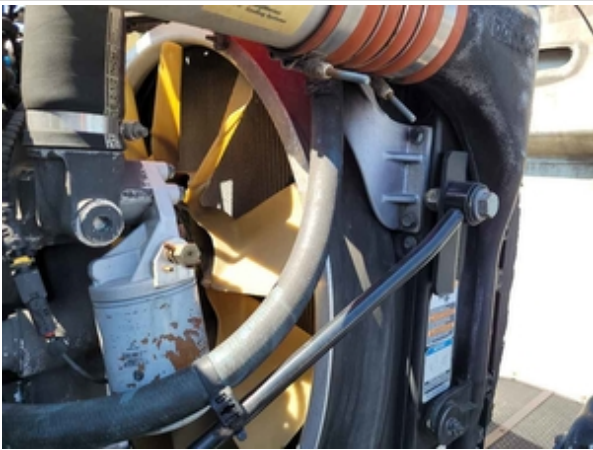
| Belts | 3 - Normal Wear & Tear |
| Belt Condition | Other (see comments) |
| Comments | alternator belt signs of small cracks fan belt good |

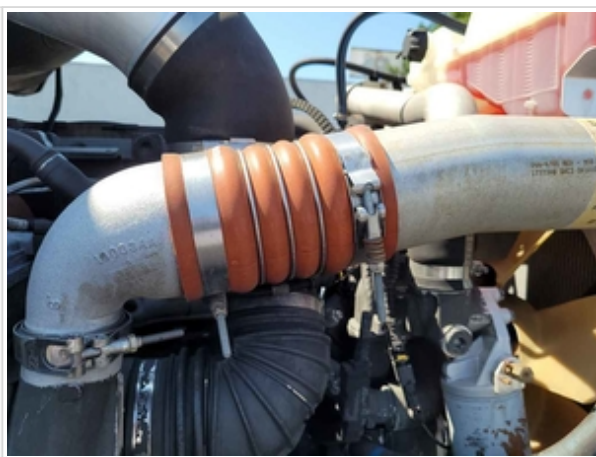
| <p>Hose Photos</p> | |

| Hoses | 4 - Like New, Recently Replaced |
| Hose Condition | Firm, pliant hoses with no signs of wear or leaks |

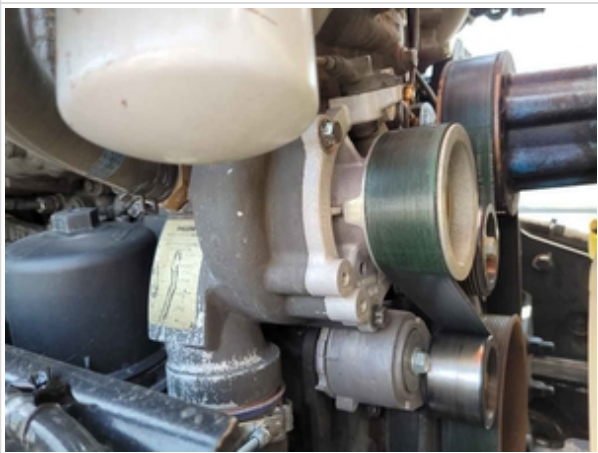
| Water Pump Photos | | |

| Water Pump | 4 - Like New, Recently Replaced | |
| Water Pump Condition | No unusual pump noises heard | |

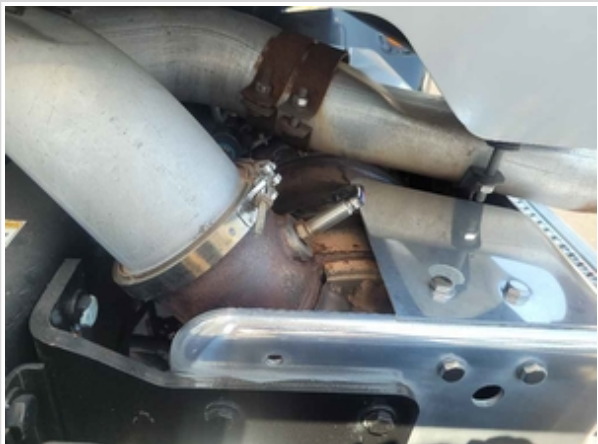
| DPF Photos | | |

| DPF Condition | 4 - Like New, Recently Replaced | |
| DPF Condition Notes | Filter housing is intact with no signs of damage or malfunction, DPF indicator is not illuminated | |

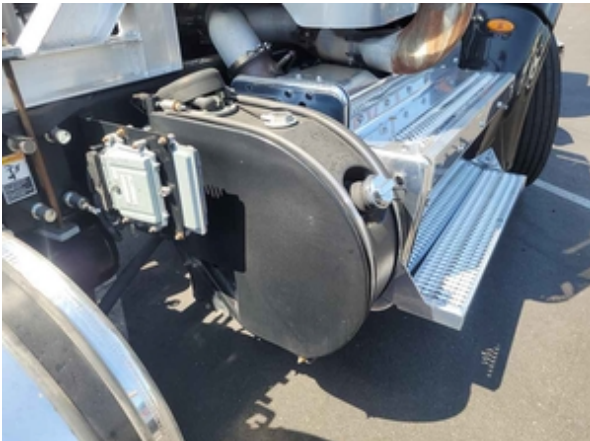
| DEF Tank Photos | | |

| DEF Tank | 4 - Like New, Recently Replaced | |
| DEF Tank Condition | Area around DEF tank cap is clean, fluid is clear & appears free of contaminants | |

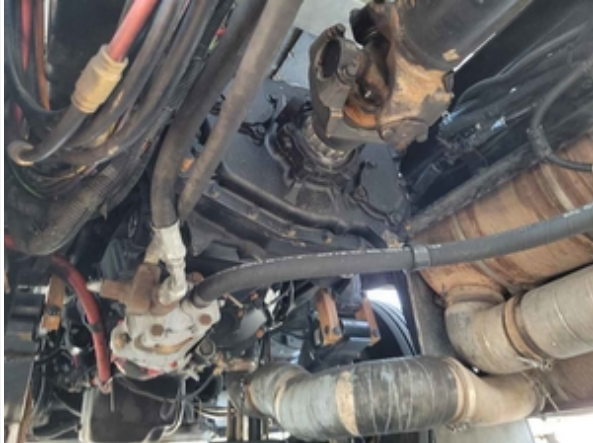
| Drivetrain | |
|---|---|
| Transmission Condition Photos | |

| Drivetrain | |
|---|---|
| Transmission | 4 - Like New, Recently Replaced |
| Transmission Condition | No unusual noises or vibrations |

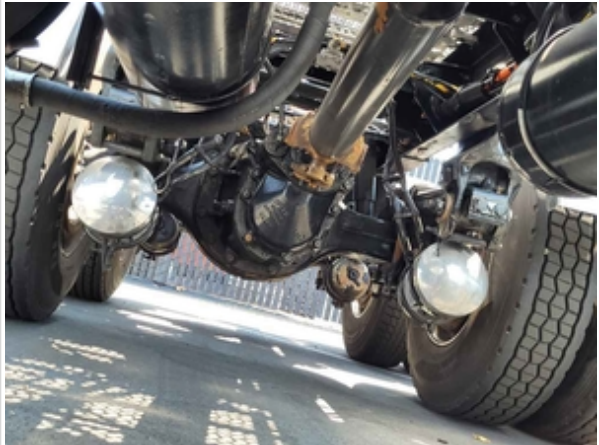
| Rear Differential Photos | | |

| Rear Differential | 4 - Like New, Recently Replaced | |
| Rear Differential Condition | Dry housing appearance, no unusual noises heard during operation | |

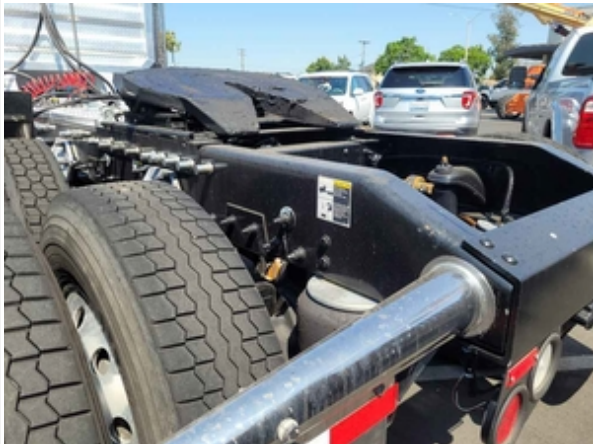
| Frame Photos | |

| Frame | 4 - Like New, Recently Replaced |

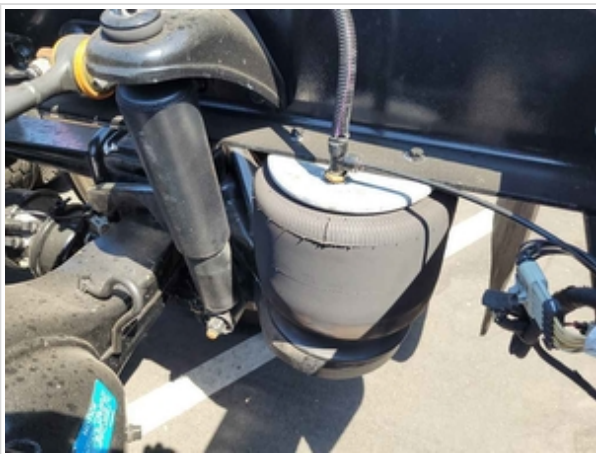
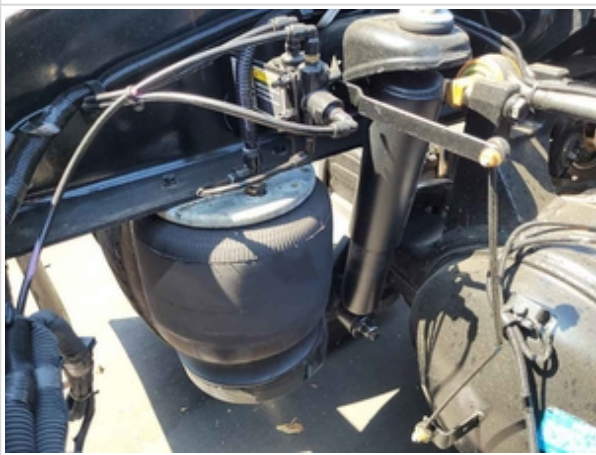
| <p>Suspension Photos</p> | | |

| Suspension | 4 - Like New, Recently Replaced |
| Comments | suspension great condition |

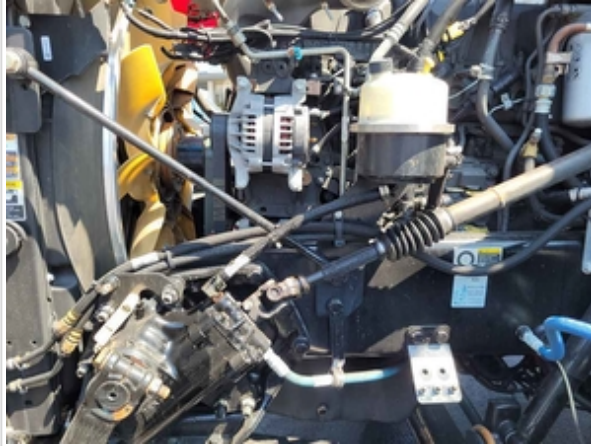
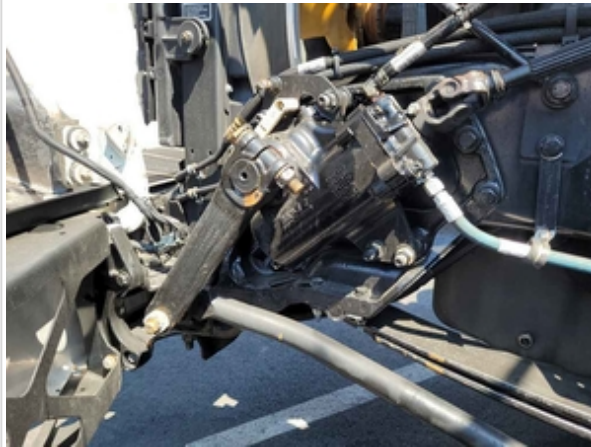
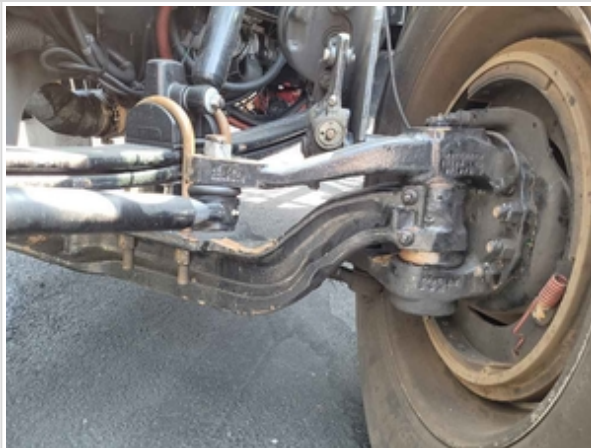
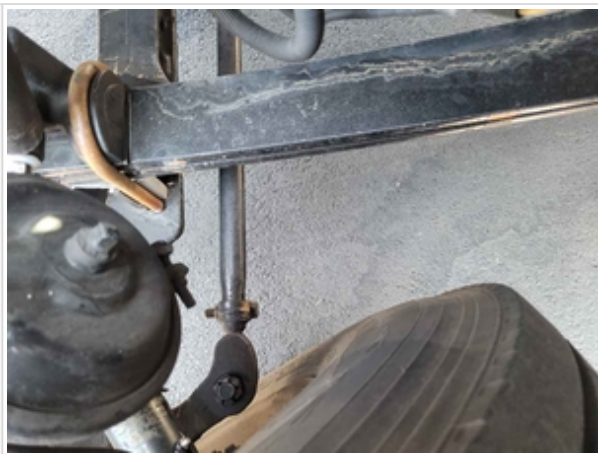
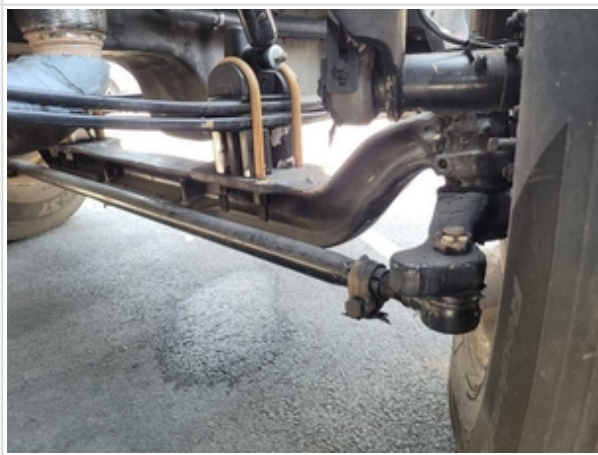
Steering Components Photos

| Steering Components | 3 - Normal Wear & Tear | |
| Comments | reservoir hose to gearbox wet (see page leak?) | |

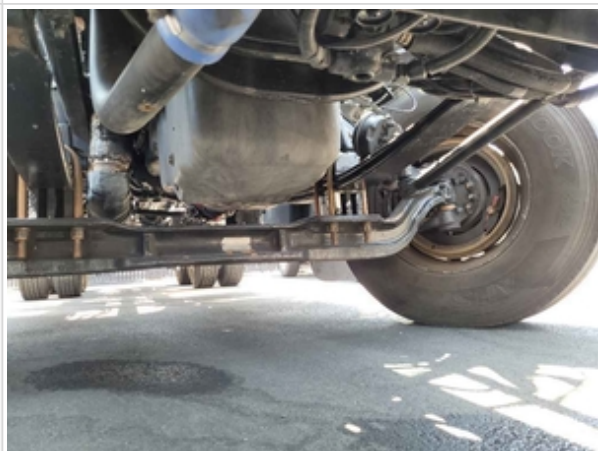
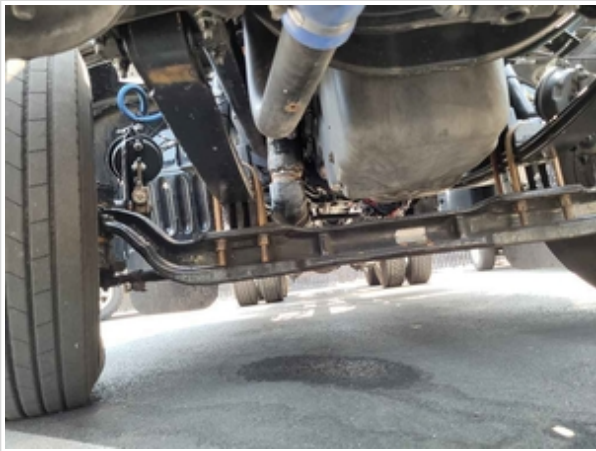
| <p>Steer Axle Condition Photos</p> | | |

| <p>Steer Axle Condition</p> | <p>4 - Like New, Recently Replaced</p> | |

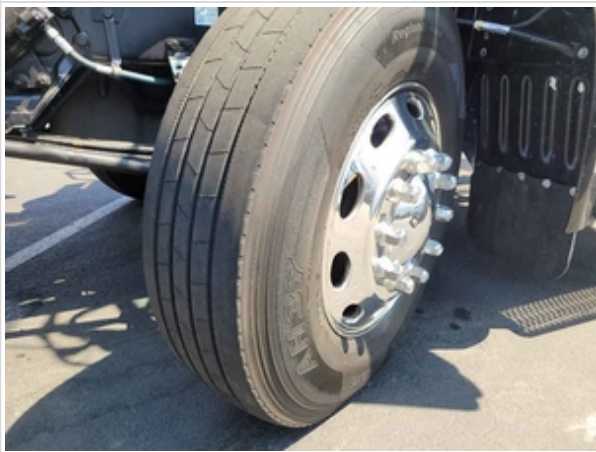
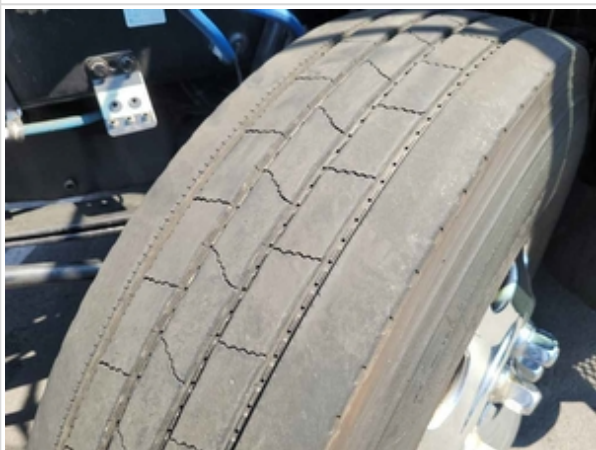
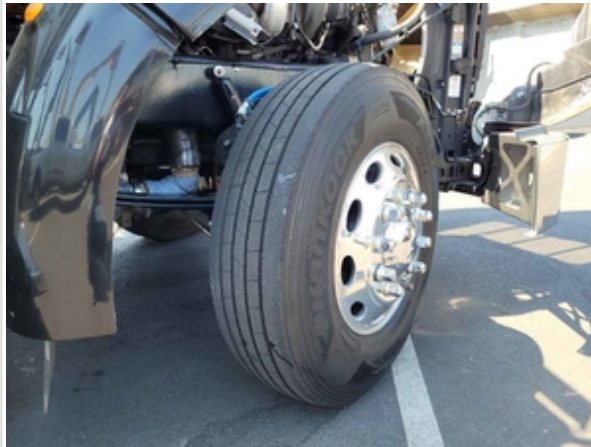
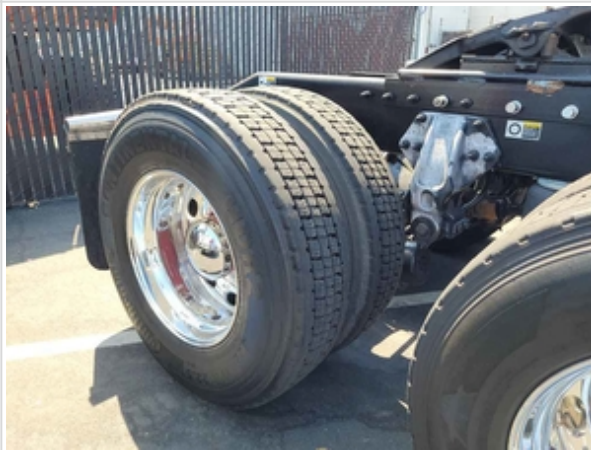
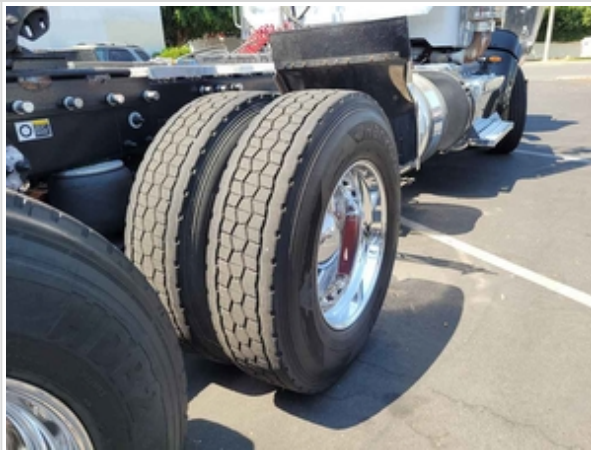
| Wheels & Tires Photos | | |

| Wheels & Tires | 3 - Normal Wear & Tear | |
| Comments | all tires safe to use for operating | |

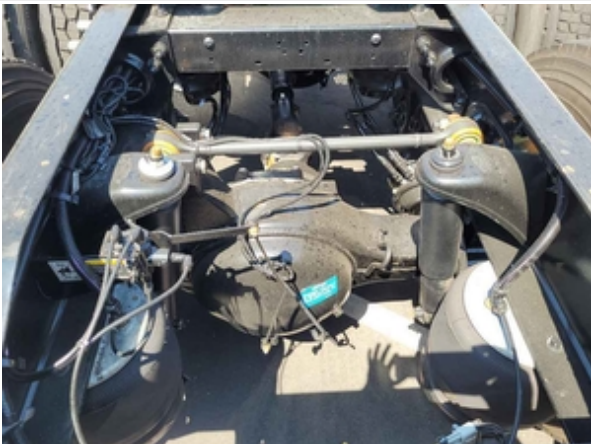
| Axle Condition Photos | |

| Axle Condition | 4 - Like New, Recently Replaced |
| Comments | 3rd axle |

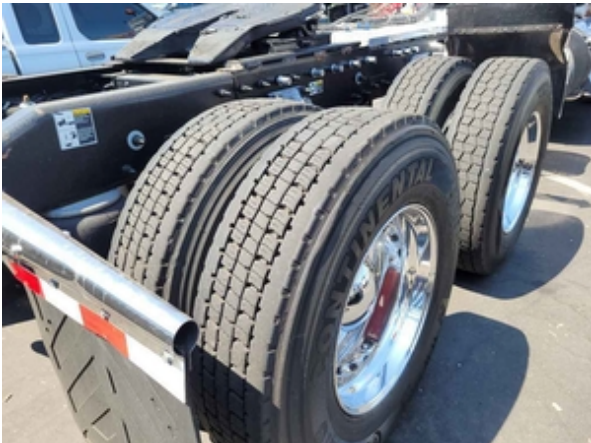
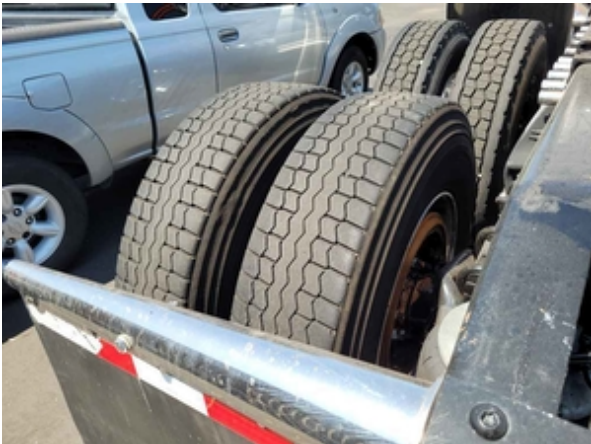
| Wheels & Tires Photos | |

| Wheels & Tires | 3 - Normal Wear & Tear |
| Tire Brand | rs continental ls michelin |

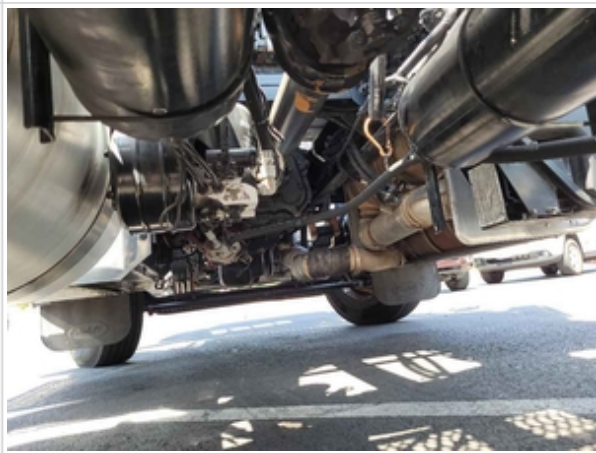
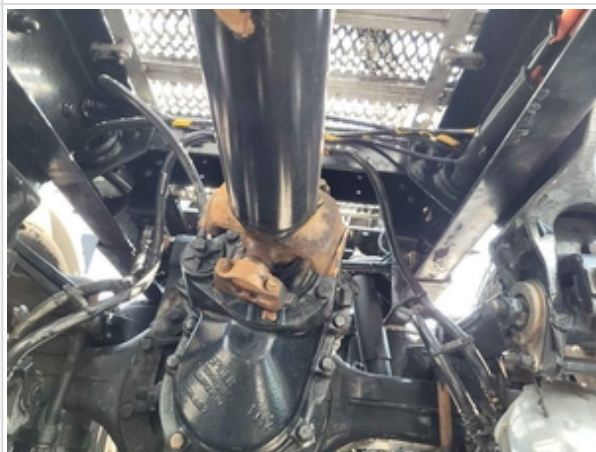
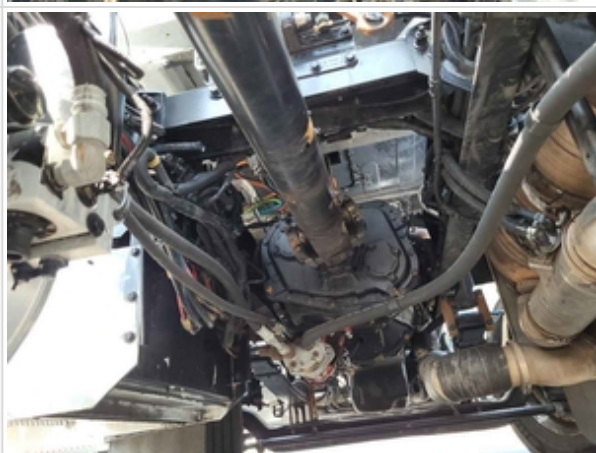
| Overall Chassis & Undercarriage Photos | |

| Overall Chassis | 4 - Like New, Recently Replaced |
