Inspection Report (On-Highway Lube Truck)

Year	2011
Make	Peterbilt
Model	367
Serial Number	1NPTLU0X1BD130009
Truck Odometer Reading	275,694miles 3,070hours
Current Inspection / State Cert / DOT	completed 4/20/22 @270,214 miles
Previous Application (e.g., earth moving, mining, demolition, etc)	asphalt and general construction

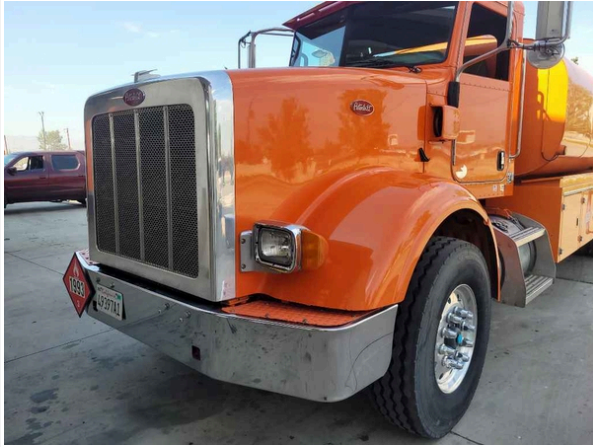
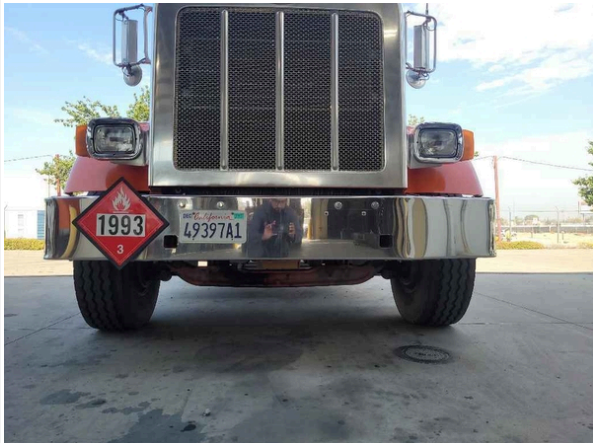
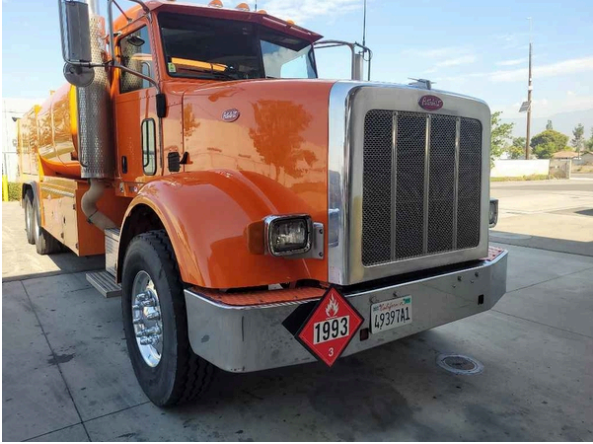
Front	4 - Like New, Recently Replaced
Front Condition	No visible damage
Front Photos

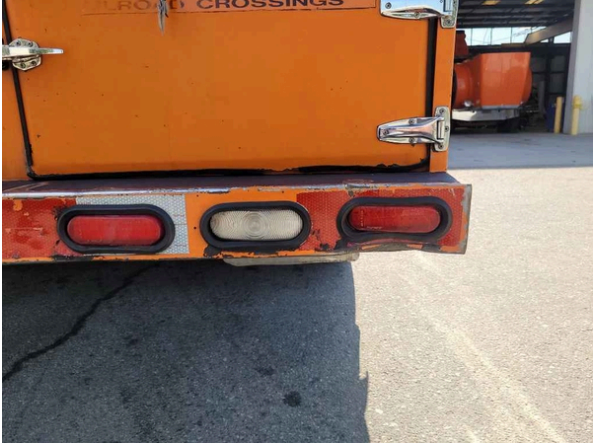
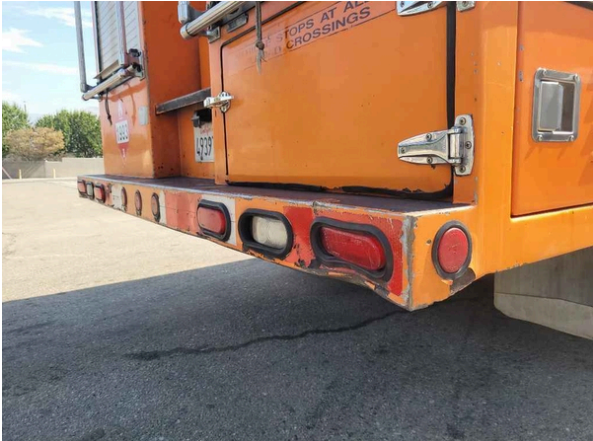
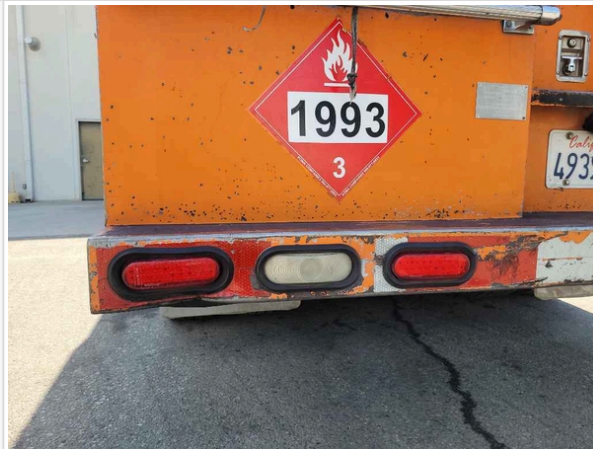
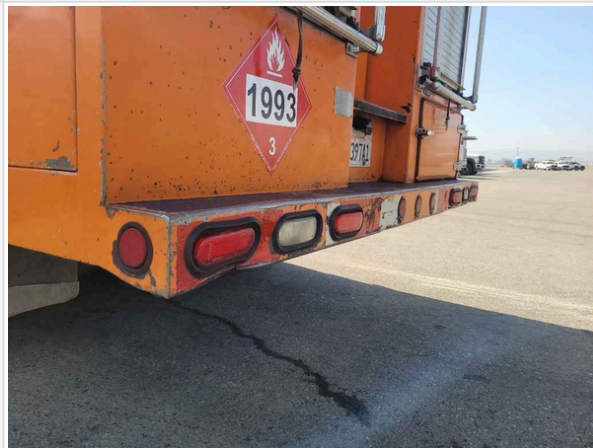
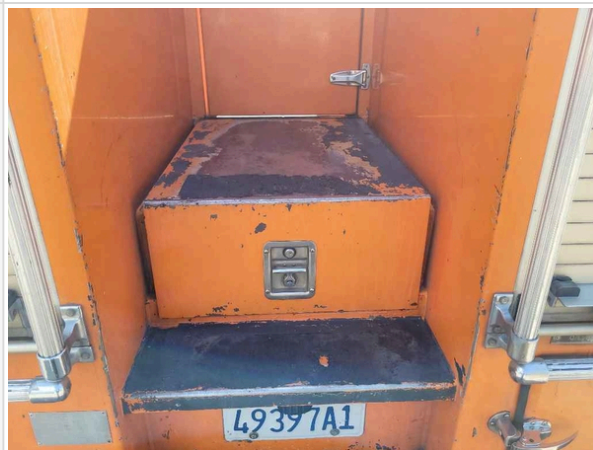
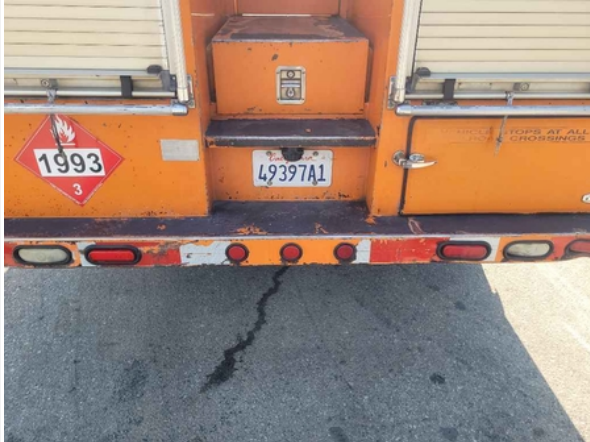
Rear	3 - Normal Wear & Tear	
Rear Condition	Visible chipped paint or dents, Other (see comments)	
Comments	small dents on bottom corners of bumper	
Rear Photos

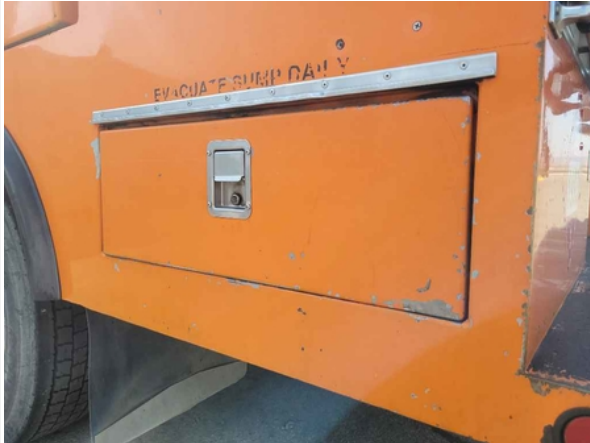
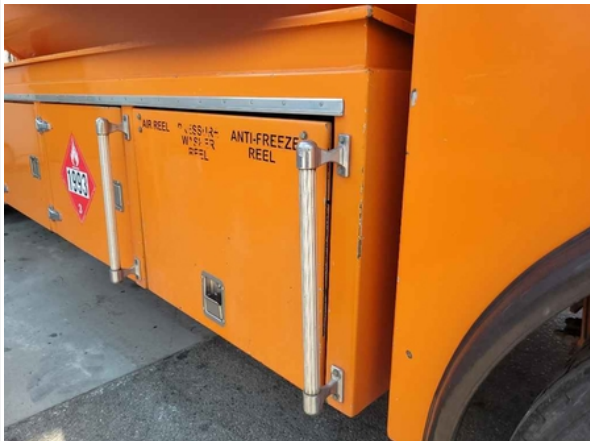
Left	3 - Normal Wear & Tear	
Left Condition	No visible damage, Other (see comments)	
Comments	minor scuff marks, small paint chips, small rust area on diesel fuel tank (2")	
Left Photos

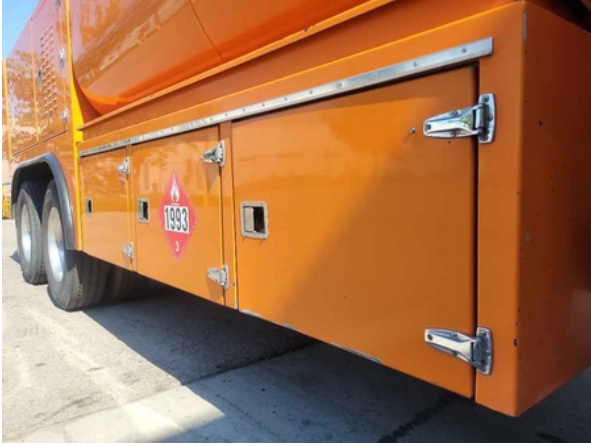
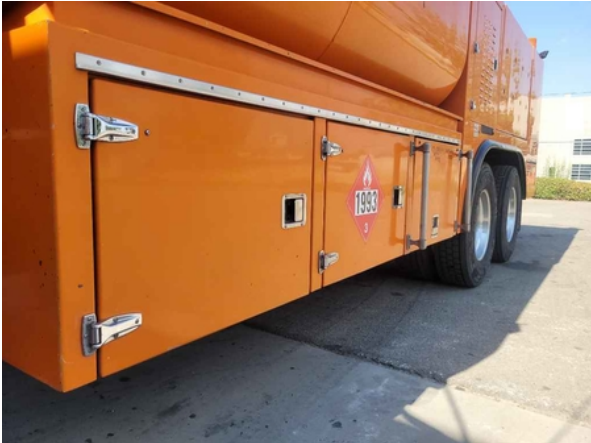
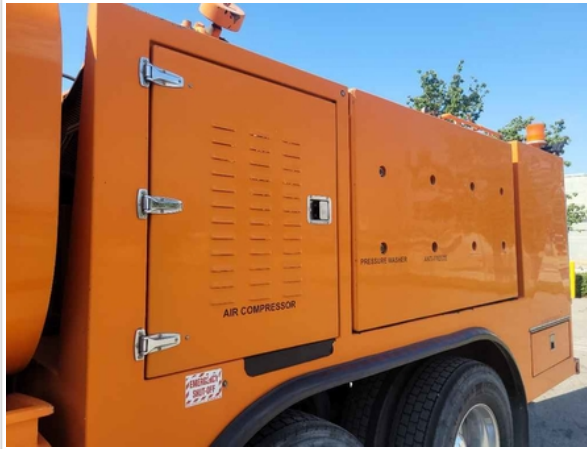
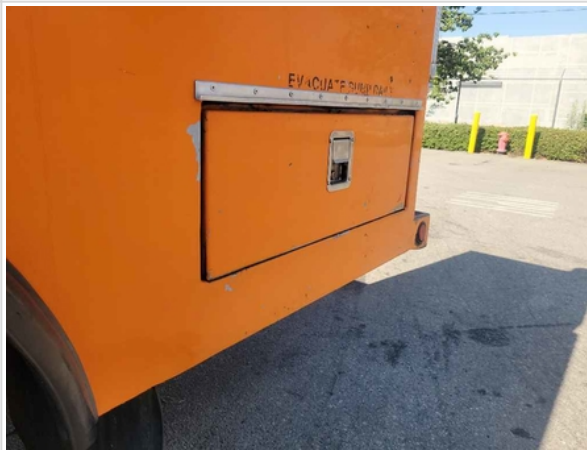
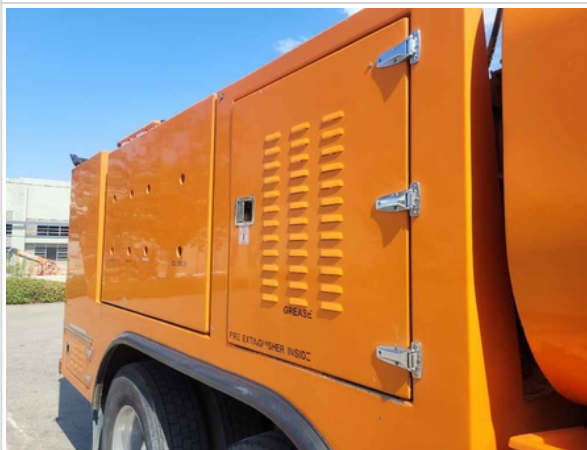
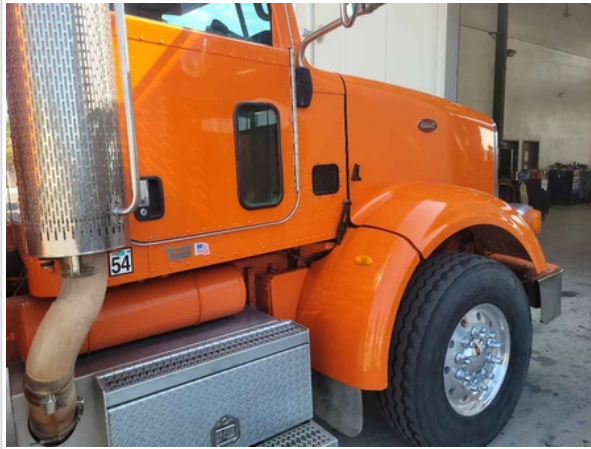
Body Panels (Any Rust Damage?)	3 - Normal Wear & Tear	
Body Panel Condition	No visible damage, good paint condition and panel fitment, Other (see comments)	
Comments	minor scuff marks on side cabinets	
Body Panels Photos

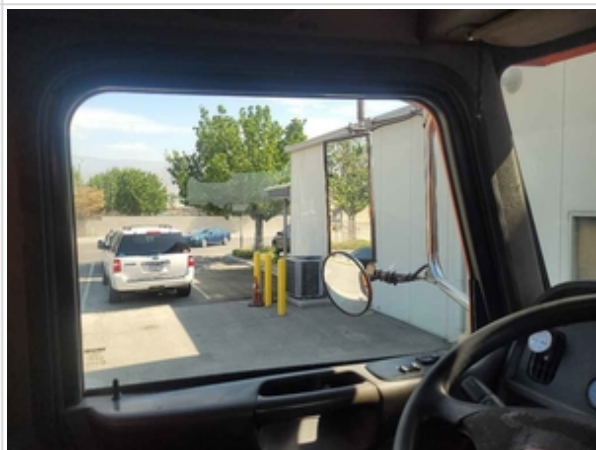
Glass Condition	4 - Like New, Recently Replaced	
Glass Condition Notes	Glass intact, no visible damage	
Glass Condition Photos

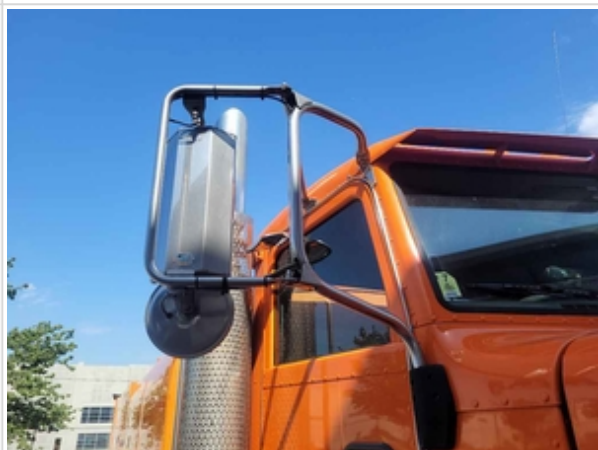
Mirrors	4 - Like New, Recently Replaced	
Mirror Condition Notes	Mirrors present and intact, no visible damage	
Mirrors Photos

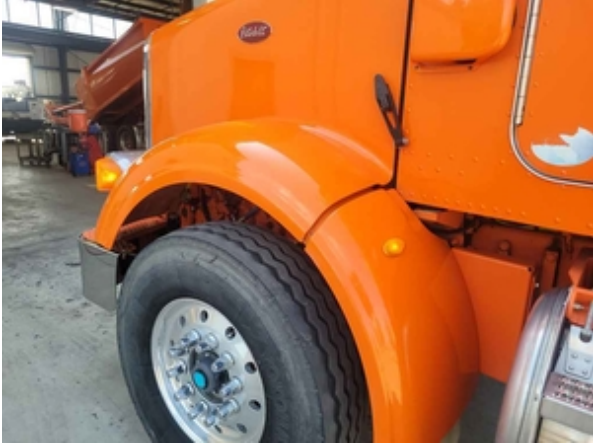
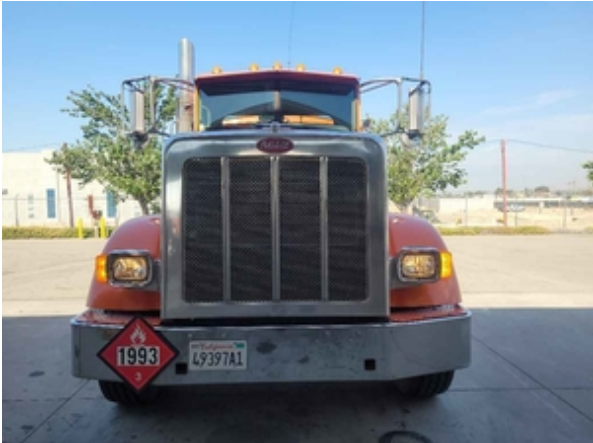
Lighting System	4 - Like New, Recently Replaced	
Lighting System Condition	No visible damage, lighting system is operational, Other (see comments)	
Comments	all auxiliary work lights functional!	
Lighting System Photos

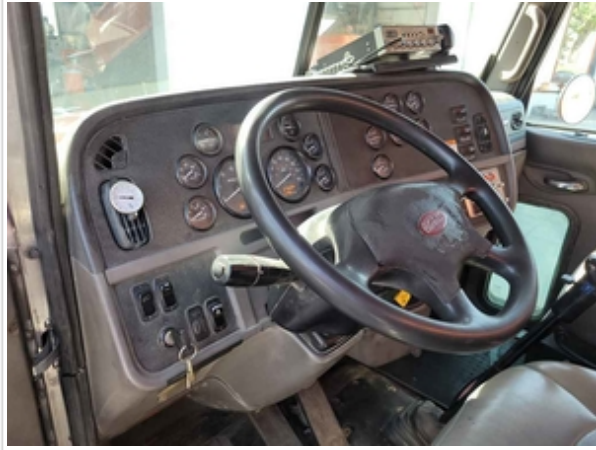
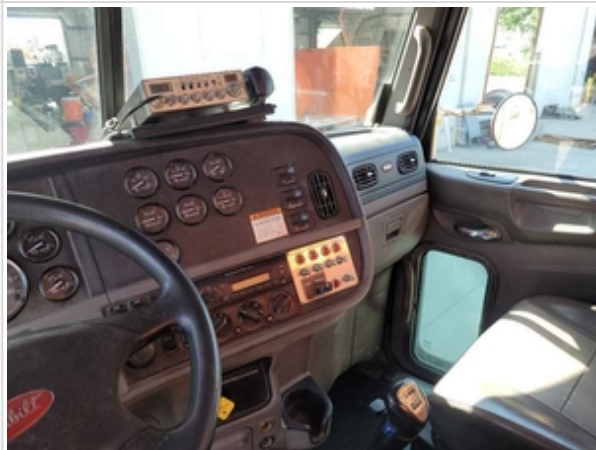
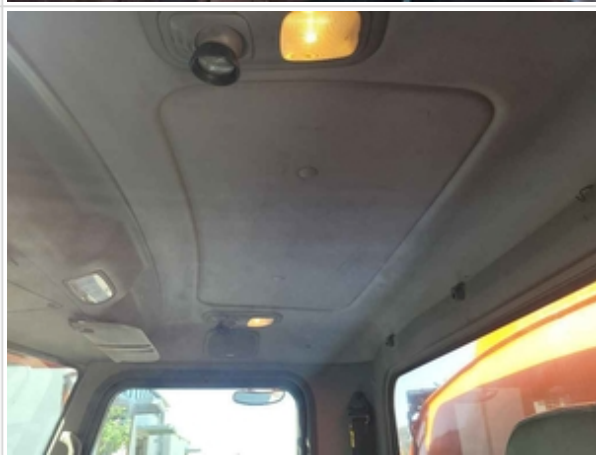
Operator Cabin	3 - Normal Wear & Tear
Comments	normal wear and tear
Operator Cabin Photos

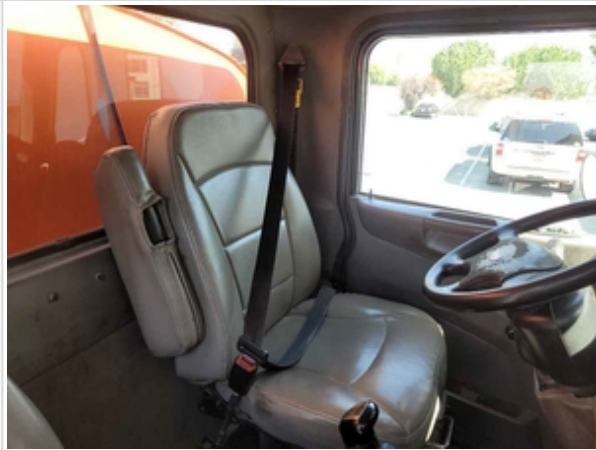
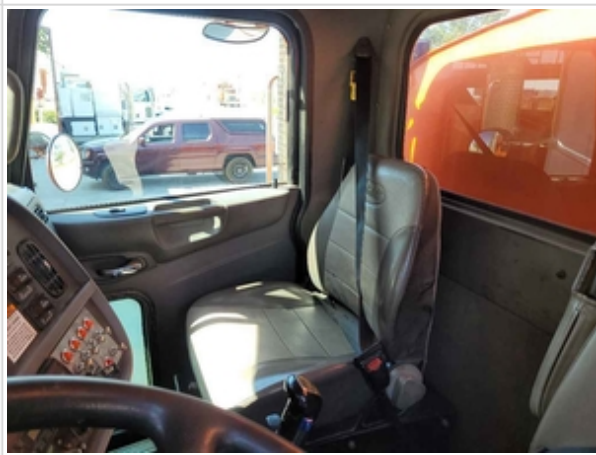
Seat Belt	3 - Normal Wear & Tear

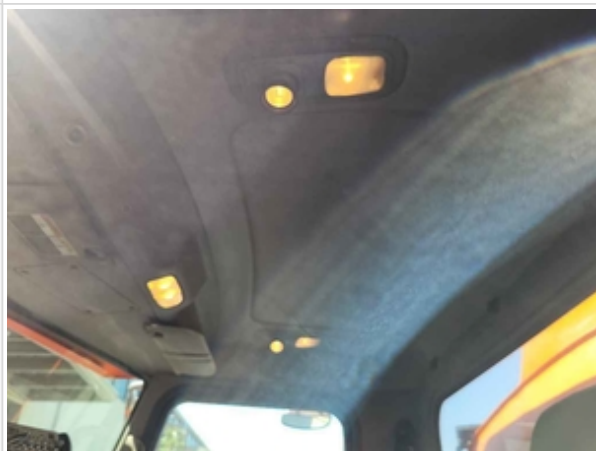
<p>Cabin Lights</p>	<p>3 - Normal Wear & Tear</p>
<p>Cabin Lights Photos</p>

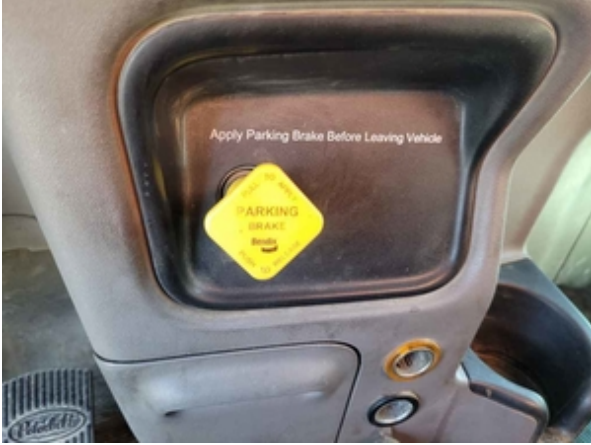
Controls & Switches	3 - Normal Wear & Tear	
Comments	A/C & Heater fan speed control only works in position #4 (1,2,3, inop.)	
Controls & Switches Photos

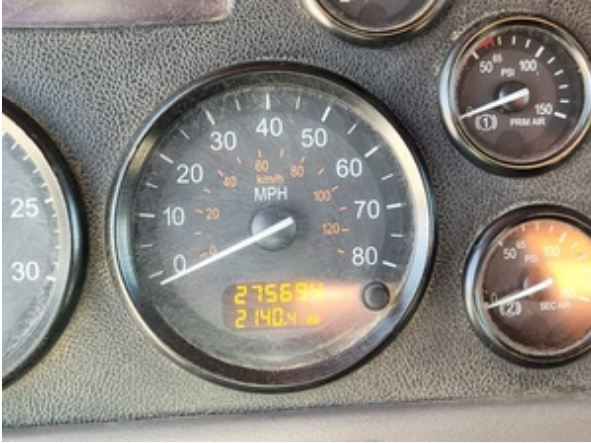
Odometer Activity	3 - Normal Wear & Tear
Odometer Activity Photos

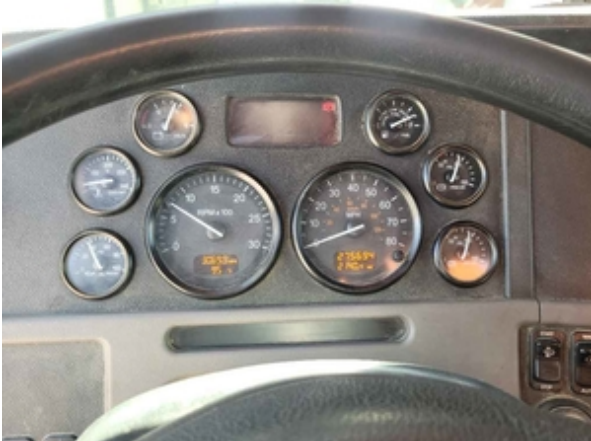
Other Gauge Activity	3 - Normal Wear & Tear
Other Gauge Activity Photos

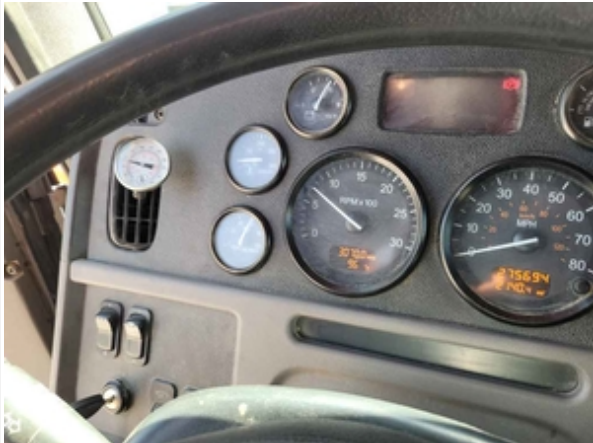
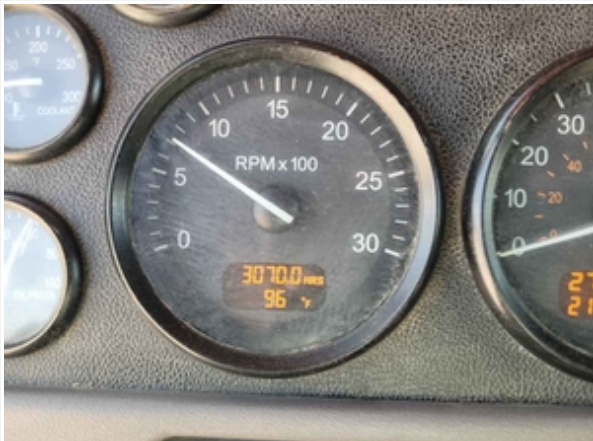
Heater & A/C	4 - Like New, Recently Replaced
Comments	a/c exceeds 30° temperature drop
Heater & A/C Photos

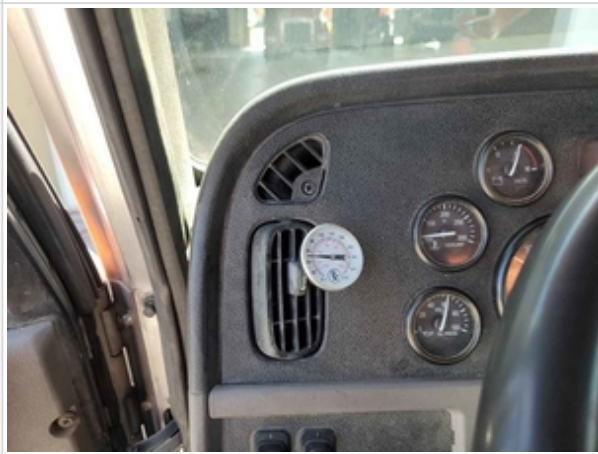
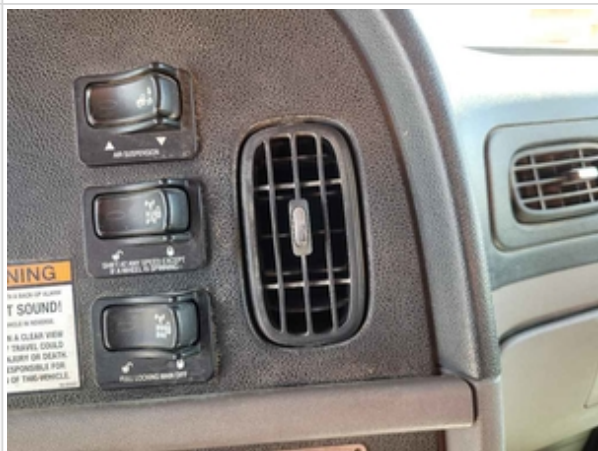
Fans / Vents	3 - Normal Wear & Tear	
Fans / Vents Photos

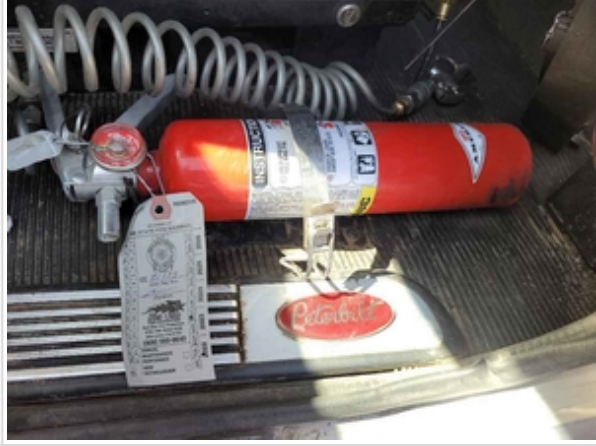
Horn	4 - Like New, Recently Replaced
Reverse Alarm / Backup Signal	7
Backup Camera	0
Other Electronic Devices	0
Fire Extinguisher	4 - Like New, Recently Replaced
Comments	2 1/2 lbs. extinguisher expires May of 2023
Fire Extinguisher Photos

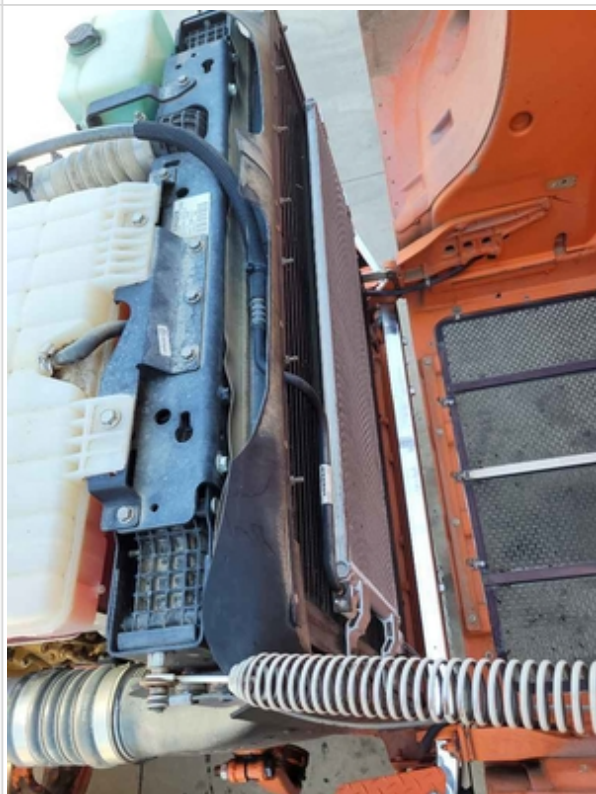
Radiator	3 - Normal Wear & Tear
Radiator Condition	Radiator fins & components appear to be in good working order, no signs of damage or leaks
Radiator Photos

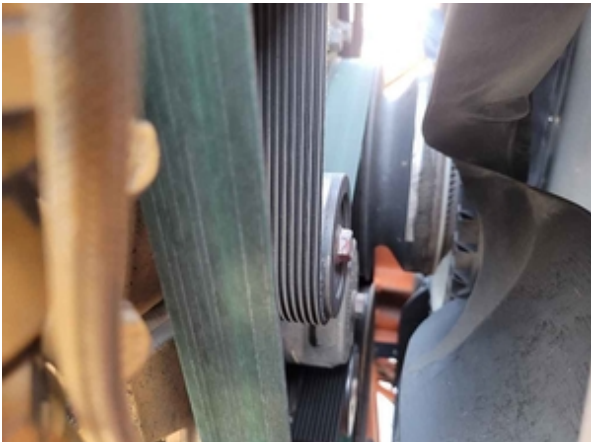
Belts	3 - Normal Wear & Tear
Belt Condition	Belts appear in good condition & alignment with proper tension, Other (see comments)
Comments	alternator serpentine belt showing signs of wear (belt cracks)
Belt Photos

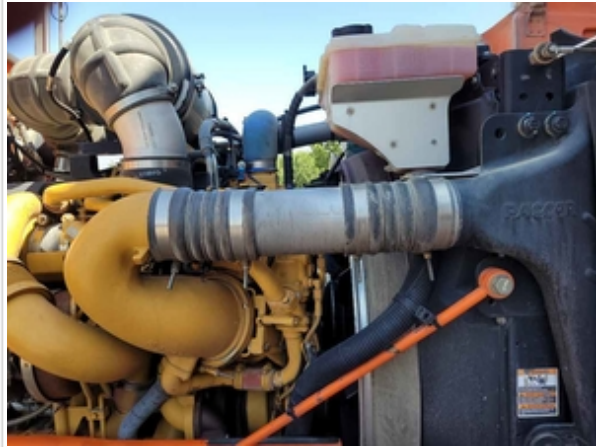
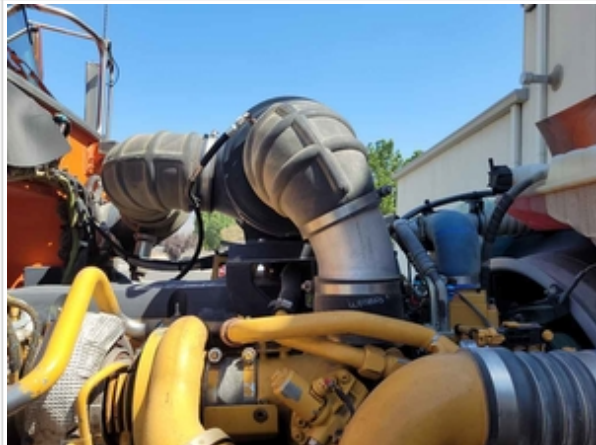
Hoses	3 - Normal Wear & Tear
Hose Condition	Firm, pliant hoses with no signs of wear or leaks
Hose Photos

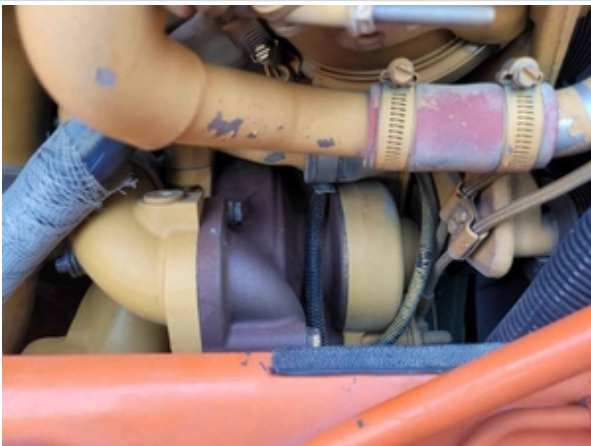
Water Pump	4 - Like New, Recently Replaced	
Water Pump Condition	No unusual pump noises heard, Other (see comments	
Comments	may have been recently replaced (looks new)	
Water Pump Photos

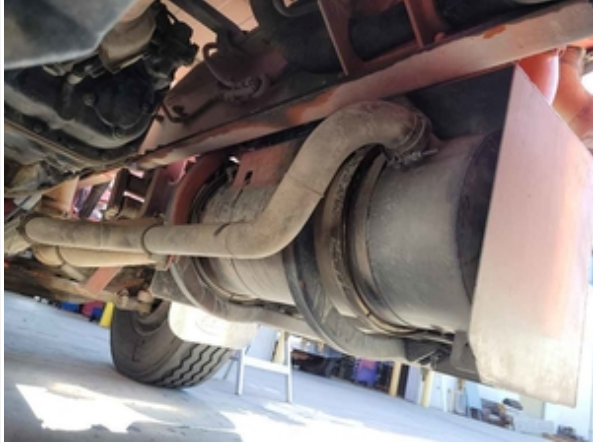
Fuel Leaks	No
Equipped with DPF (Diesel Particulate Filter)	Yes
DPF Condition	3 - Normal Wear & Tear
DPF Condition Notes	Filter housing is intact with no signs of damage or malfunction, DPF indicator is not illuminated
DPF Photos

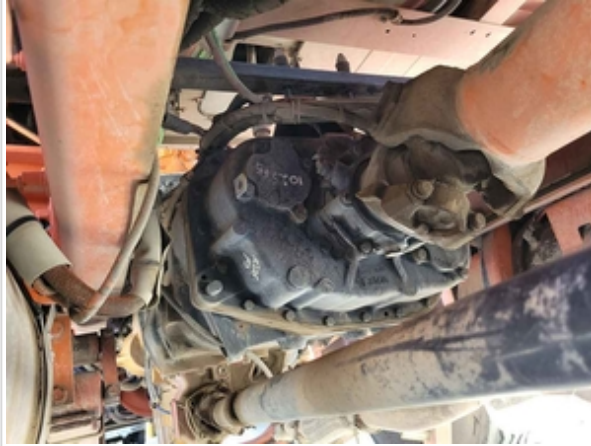
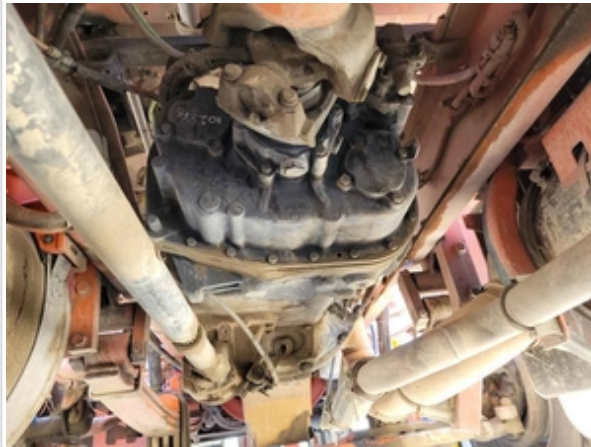
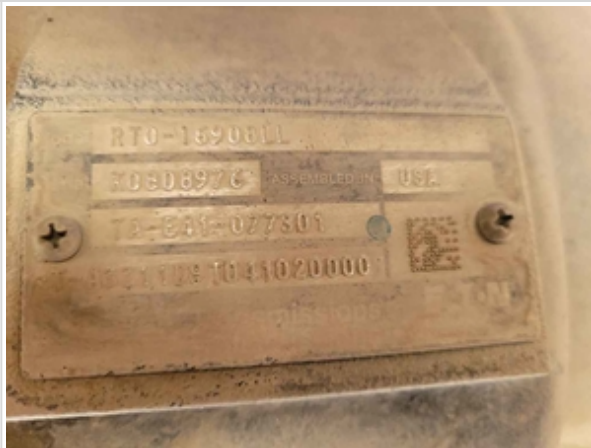
Transmission Condition Photos

Drivetrain	
Transmission Info (Make/Model)	Eaton 13spd
Drive Type	4X2
Overdrive	N/A
Transmission	3 - Normal Wear & Tear
Transmission Condition	No unusual noises or vibrations

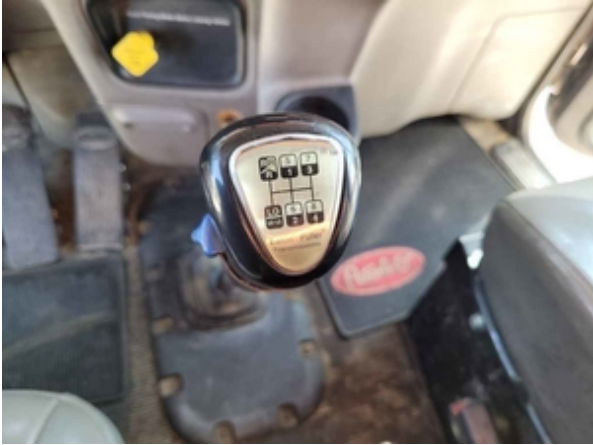
Clutch	3 - Normal Wear & Tear
Clutch Condition	Clutch is functioning as expected
Shift Lever	3 - Normal Wear & Tear
Shift Lever Condition	Good forward and reverse function
Shift Lever Photos

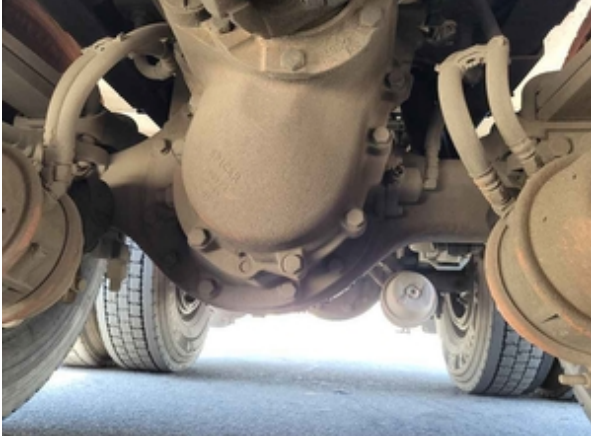
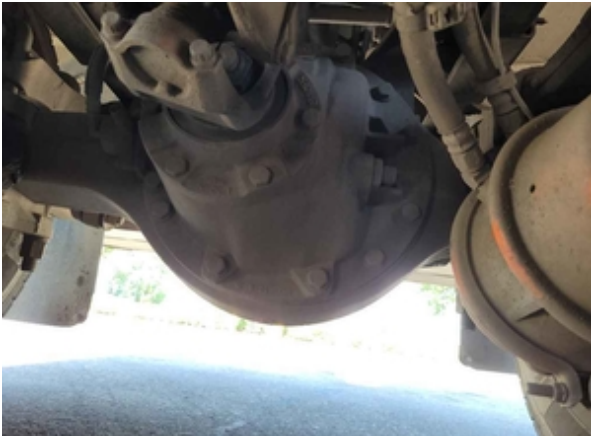
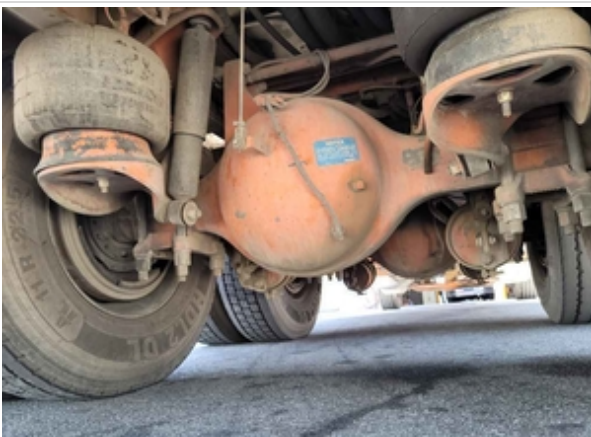
Rear Differential Photos

Differential	Check condition of the differential(s). Take photos and notes as relevant.
Rear Differential	3 - Normal Wear & Tear
Rear Differential Condition	Dry housing appearance, no unusual noises heard during operation, Other (see comments)
Comments	both rear axles same condition

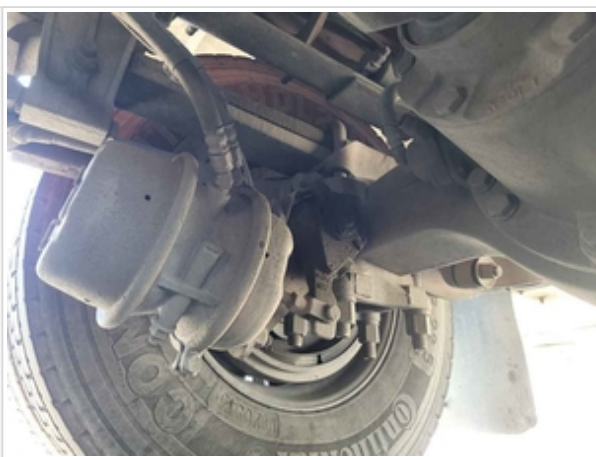
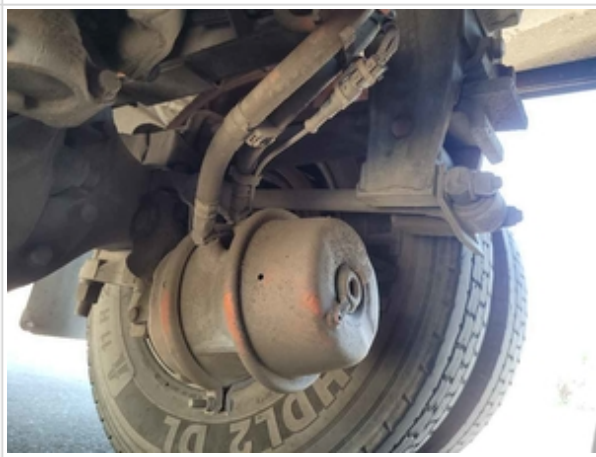
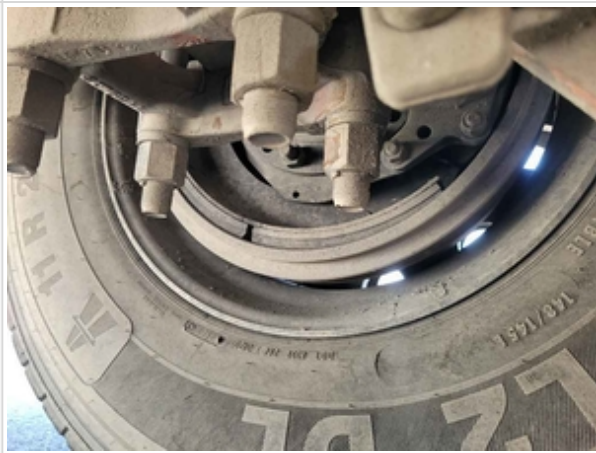
<p>Air Brake System Photos</p>

Front Differential	0
Brake System Type	Air Brakes
Air Brakes Build Correct Pressure	Yes
Air Brake System Leaks	No
Comments	brakes pass regular air brake inspection
Air Brake Hose Condition	3 - Normal Wear & Tear

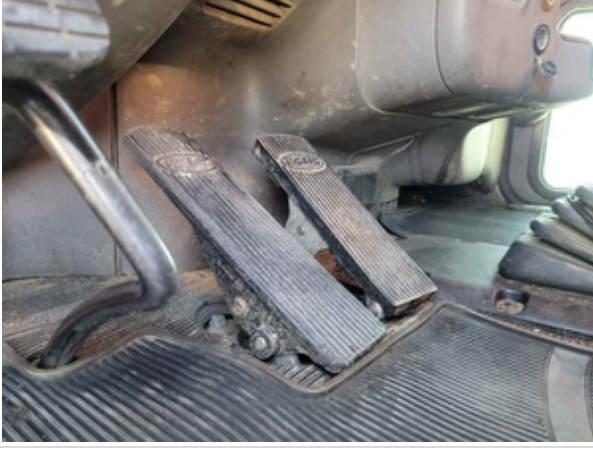
Foot Brake	3 - Normal Wear & Tear	
Foot Brake Condition	Good brake function	
Foot Brake Photos

Engine Brake Configuration	1 Position	
Engine Brake	3 - Normal Wear & Tear	
Parking Brake	4 - Like New, Recently Replaced	
Parking Brake Condition	Good brake function	
Overall Drivetrain Comments	All components above average condition Front right brake shoes at 50% life left

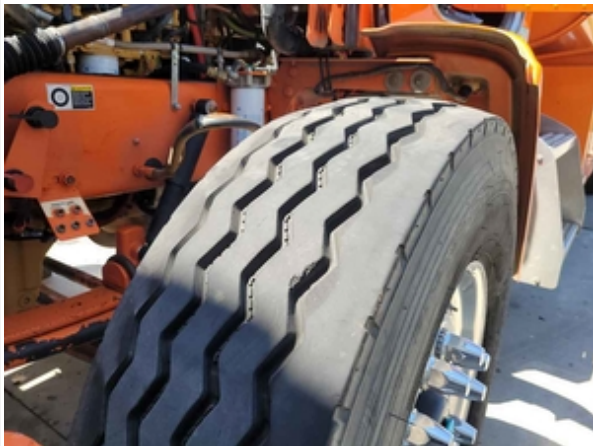
Tire Brand	Yokohama
Tire Size	315/80R/22.5 & 11R/22.5 for the rear
Front Left Tire - Ratio Remaining	50%
Front Left Tire Photos

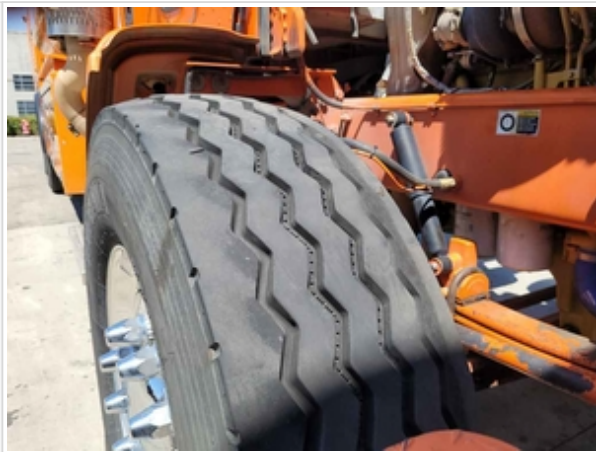
Front Right Tire Photos

Front Right Tire - Ratio Remaining	70%

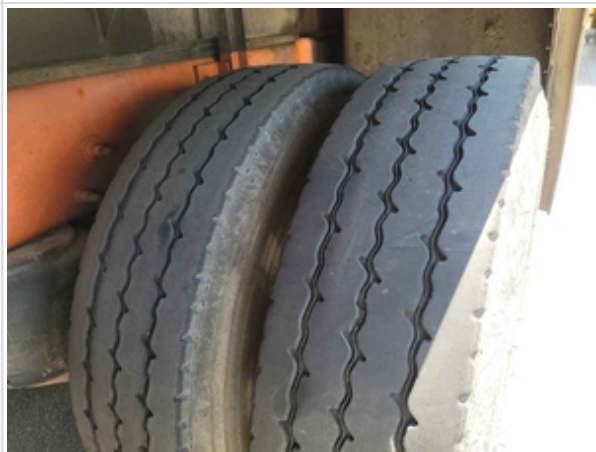
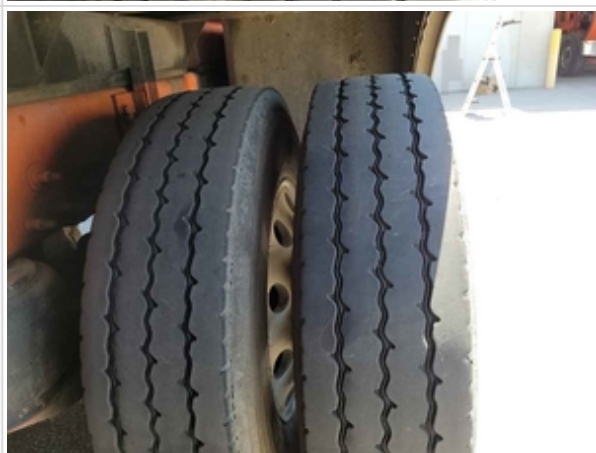
Rear Right Tire - Ratio Remaining	30%
Rear Right Tire Photos

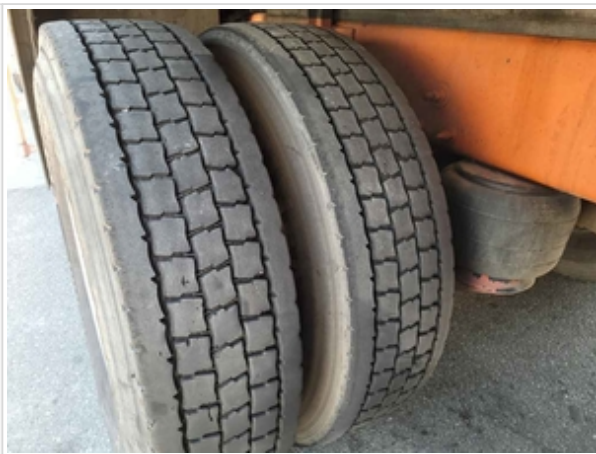
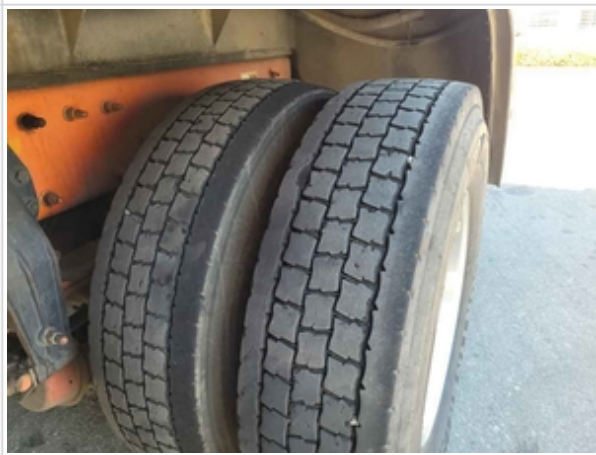
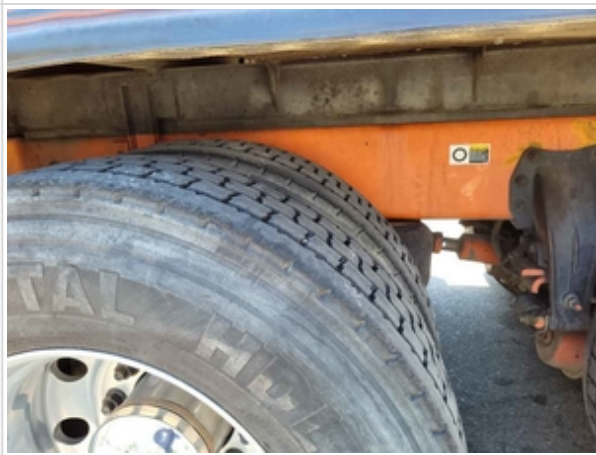
<p>Rear Left Tire Photos</p>

<p>Rear Left Tire - Ratio Remaining</p>	<p>50%</p>

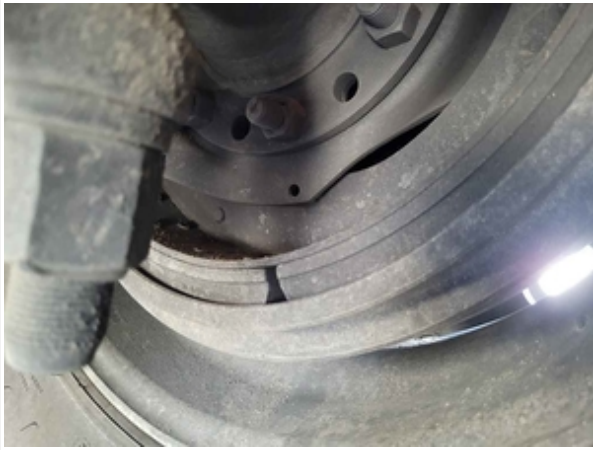
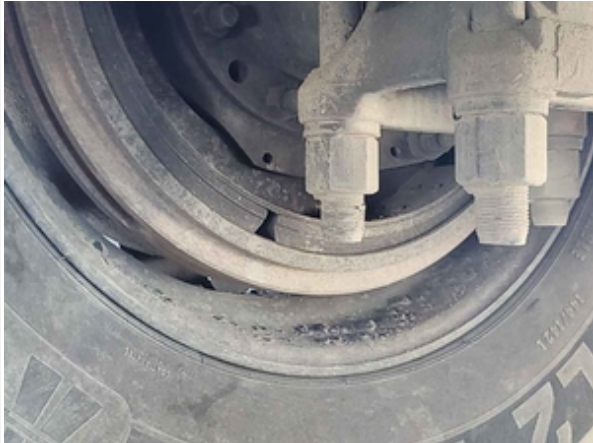
Brake Shoe Thickness	90%
Brake Shoe Photos

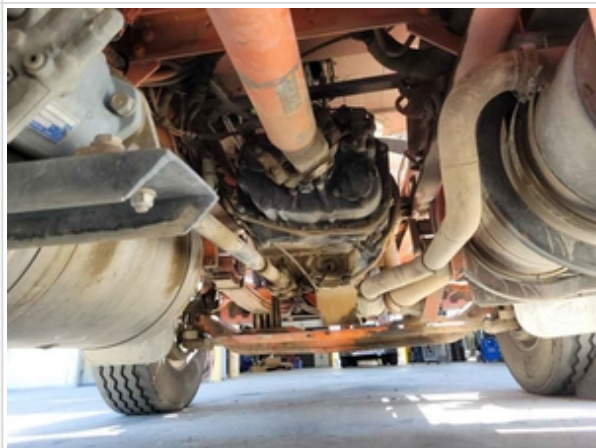
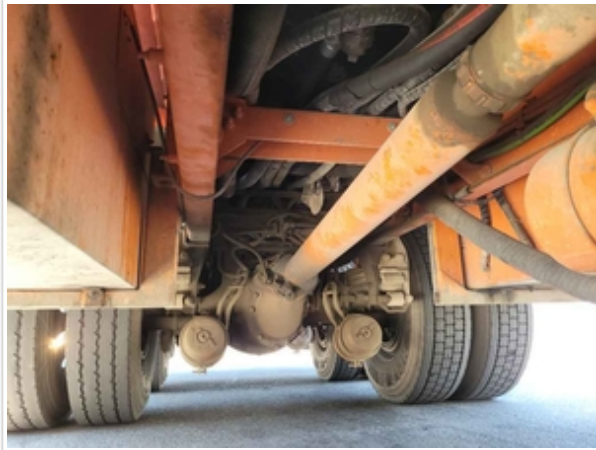
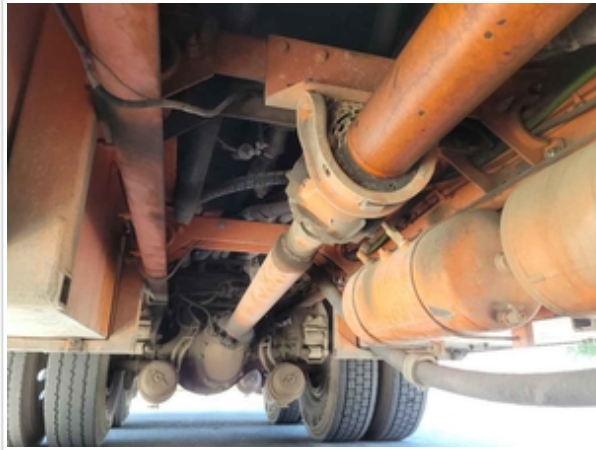
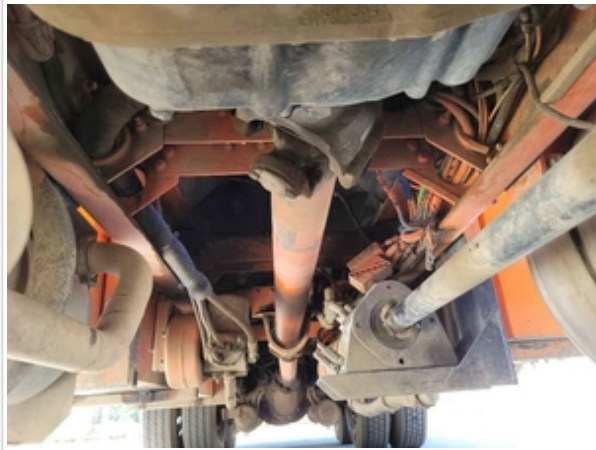
Overall Chassis	4
Overall Chassis & Undercarriage Photos

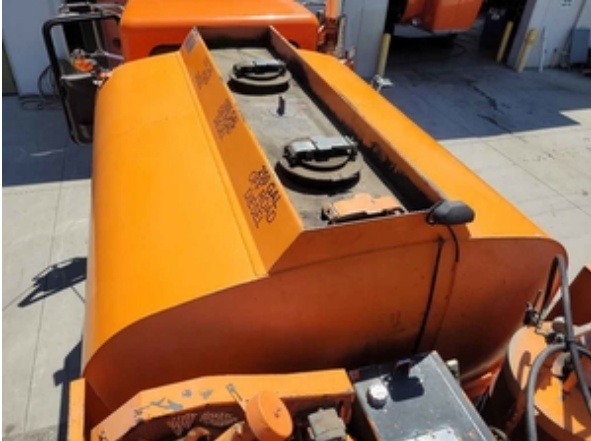
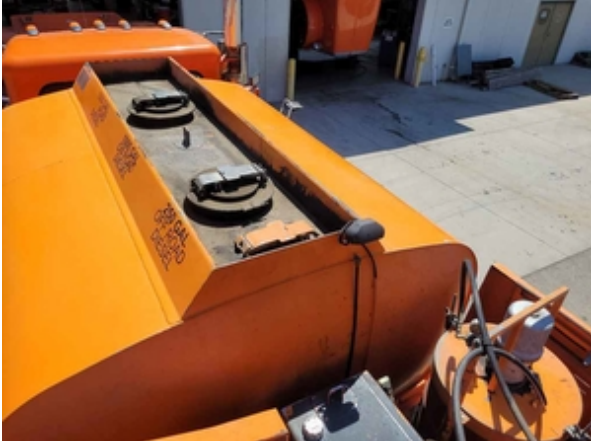
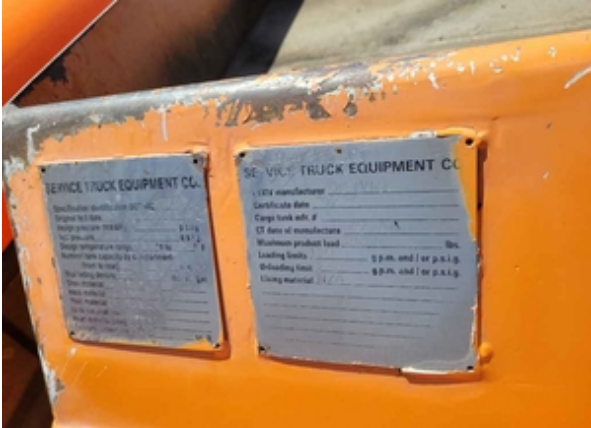
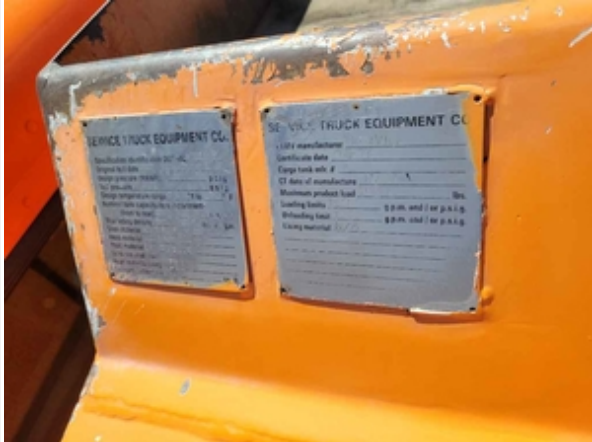
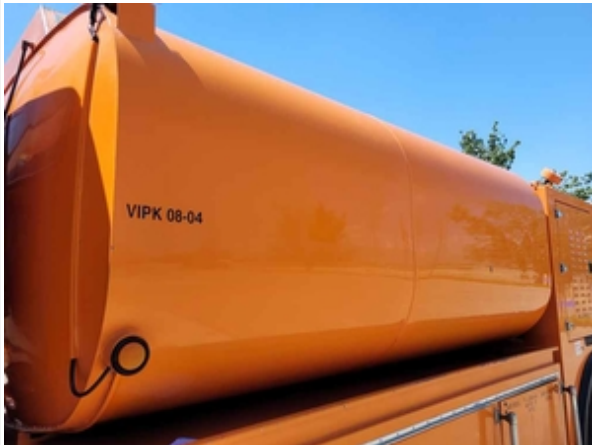
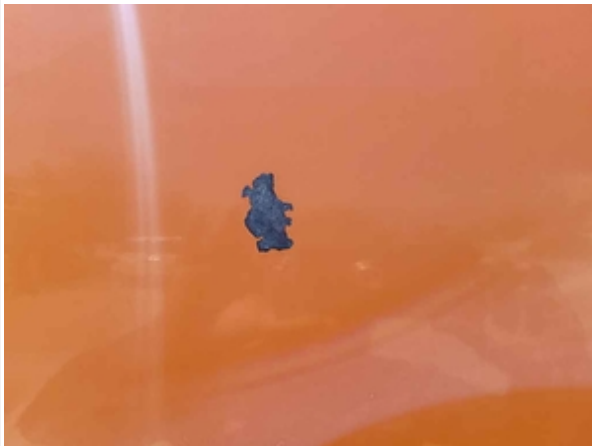
Fuel Tanks	Describe the number, configuration, capacity, and contents of all fuel tanks equipped on the vehicle
Number of Tanks	3
Fuel Tank(s) Contents & Capacity	2 x 1000gal. diesel 1 x 250gal. Gas
Fuel Tank(s) Exterior Condition	3

Comments	small rust mark on exterior left side tank
Fuel Tank Exterior Photos

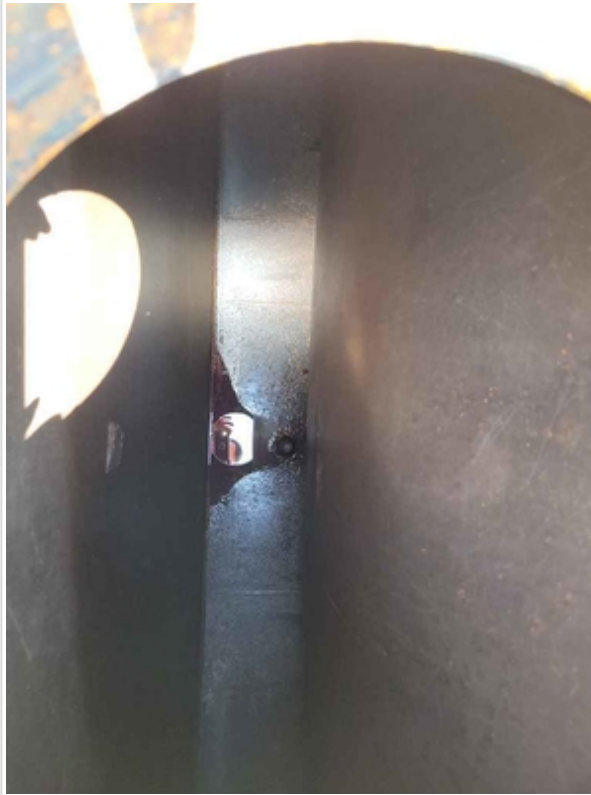
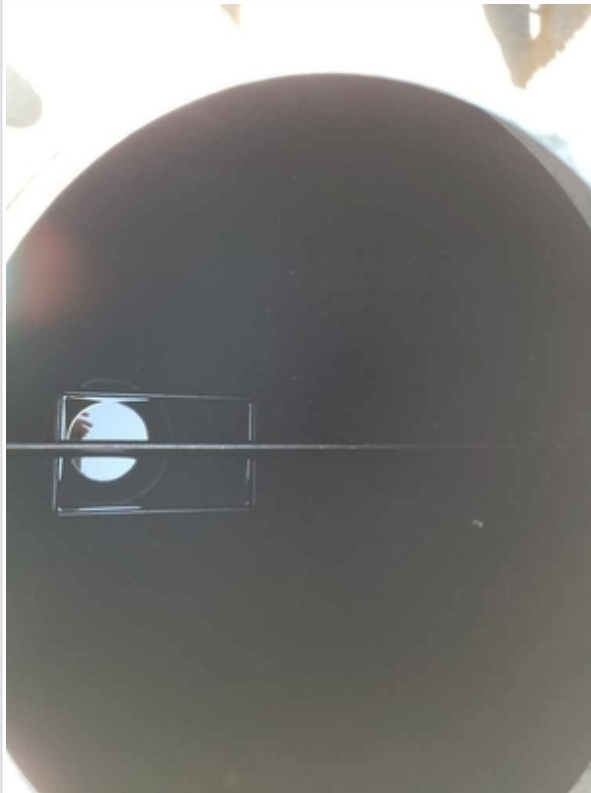
Fuel Tank Interior Photos

Tank Baffles Intact?	Yes

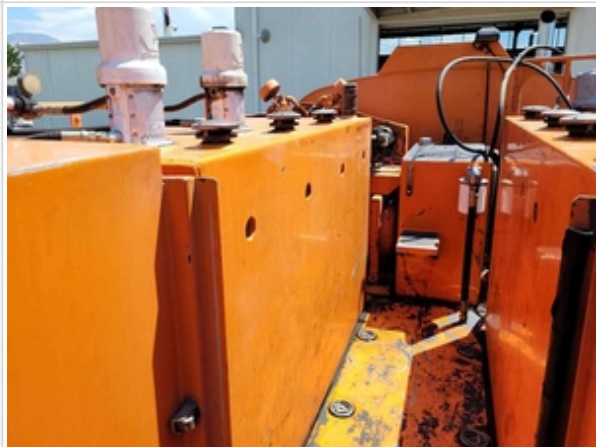
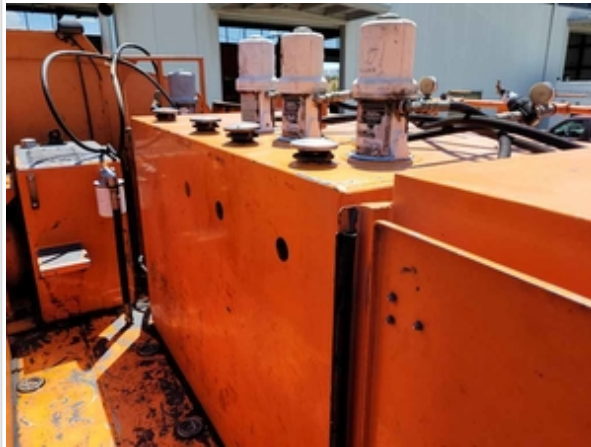
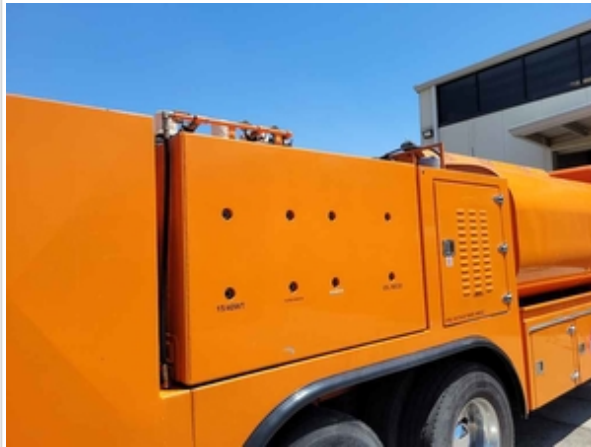
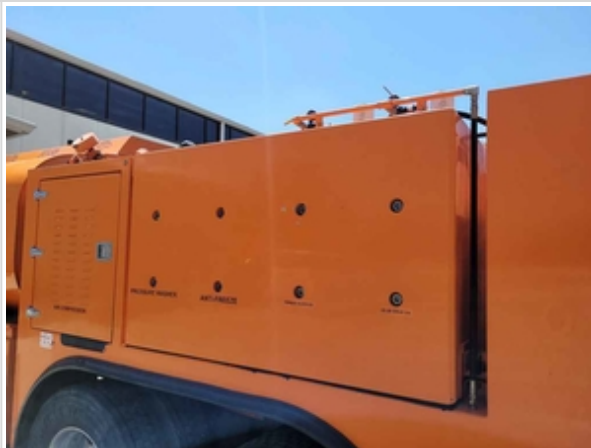
Oil & Fluid Reservoirs	Check the condition of the vehicle's hydraulic system
Number of Tanks	6
Pumps Installed on Tanks	Yes
Number of Pumps	5
Tank Configuration (Contents, Capacities)	Tanks store Eng. oil, Antifreeze, Gear oil, Hydraulic oil, 50w. Oil., water and grease
Exterior Tank(s) Condition	3
Exterior Tank(s) Photos
