Inspection Report (On-Highway Lube Truck)

Year	2011
Make	Peterbilt
Model	367
Serial Number	1NPTLU0X1BD130009
Truck Odometer Reading	275,694miles 3,070hours
Current Inspection / State Cert / DOT	completed 4/20/22 @270,214 miles
Previous Application (e.g., earth moving, mining, demolition, etc)	asphalt and general construction

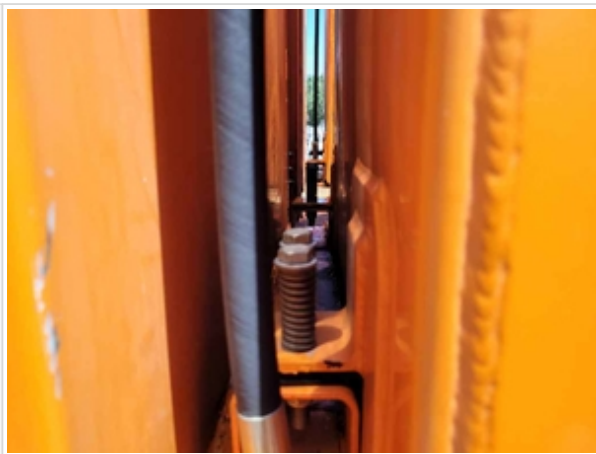
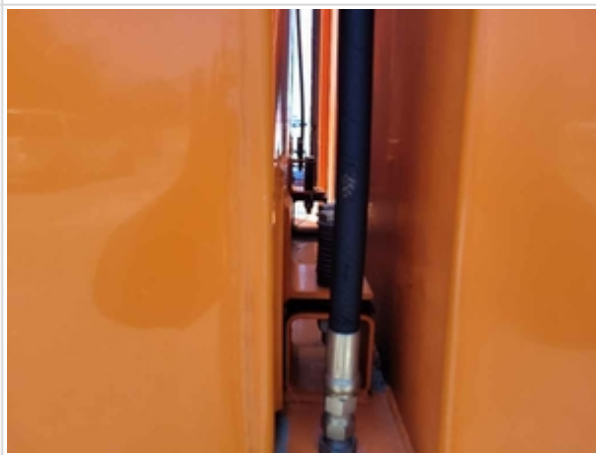
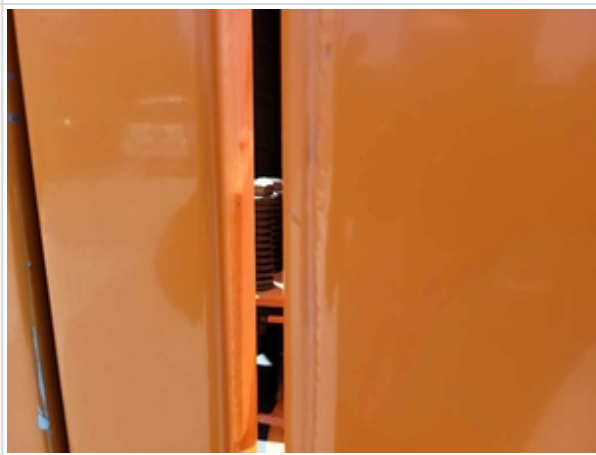
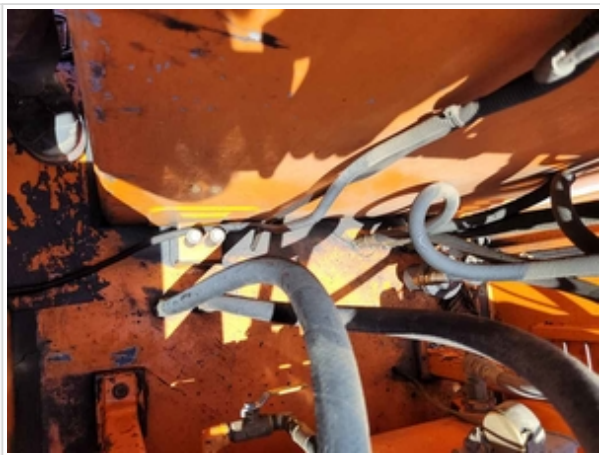
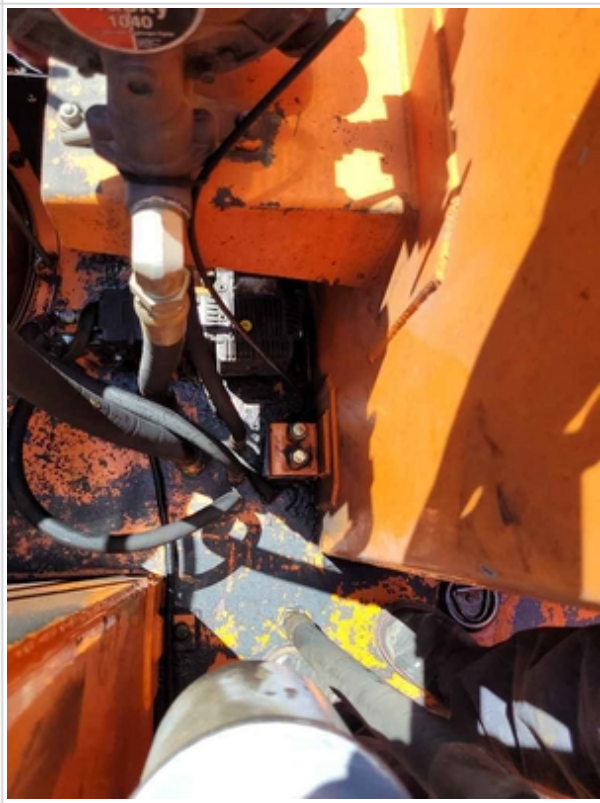
Mounting Bolts Photos

Mounting Bolts

3

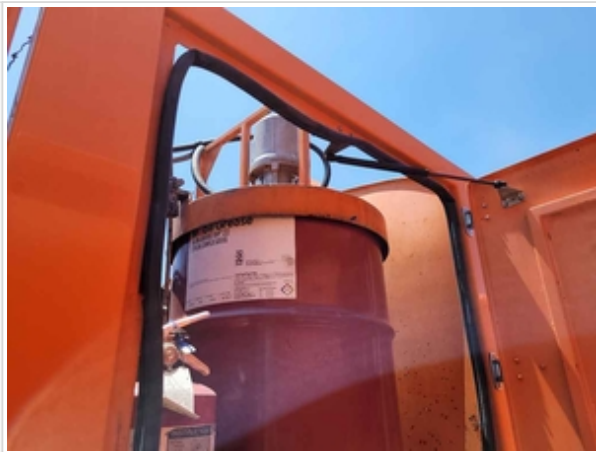
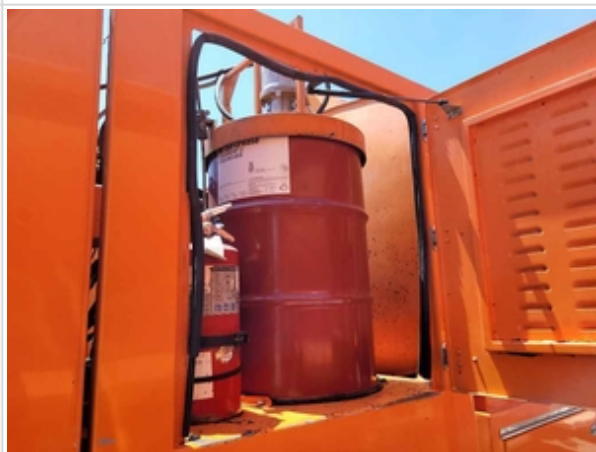
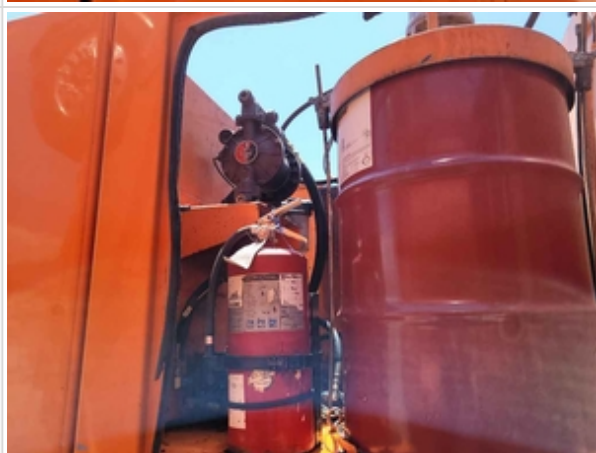
Grease Pump Photos

Pump(s) Functionality	4
Grease Pump Installed	Yes
Grease Pump Condition	3
Grease Pump Functionality	5

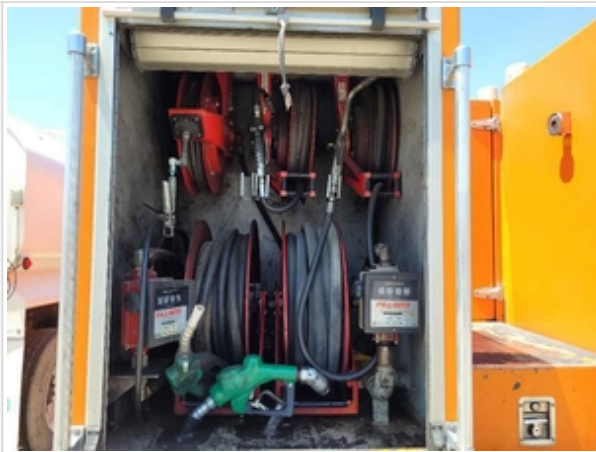
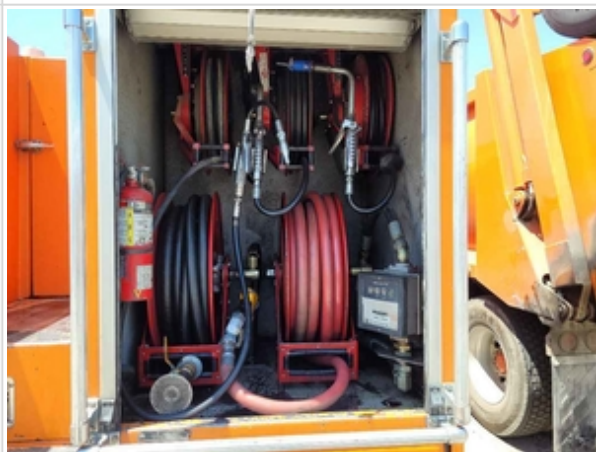
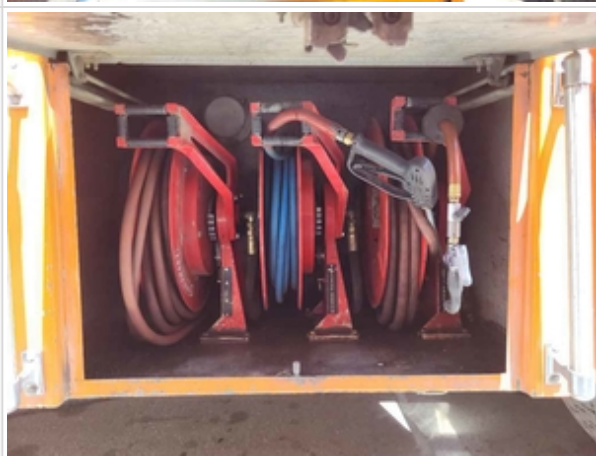
Hose Reels & Nozzles Photos

Hose Reels & Nozzles	3

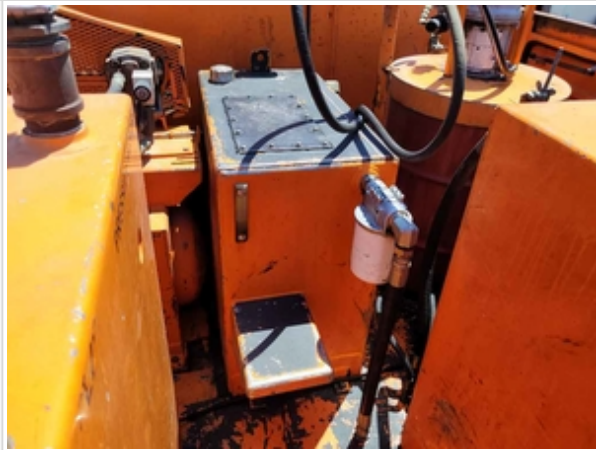
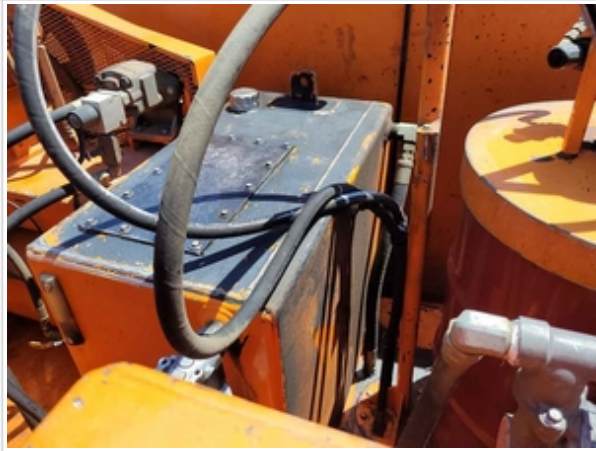
Hydraulic Tank Photos

Truck Hydraulics	Check the condition of the vehicle's hydraulic system
Hydraulic PTO	Yes
Mounting Type	transmission mounted, driveshaft driven
Hydraulic Tank Capacity	100 gallon?
Hydraulic Tank Condition	3

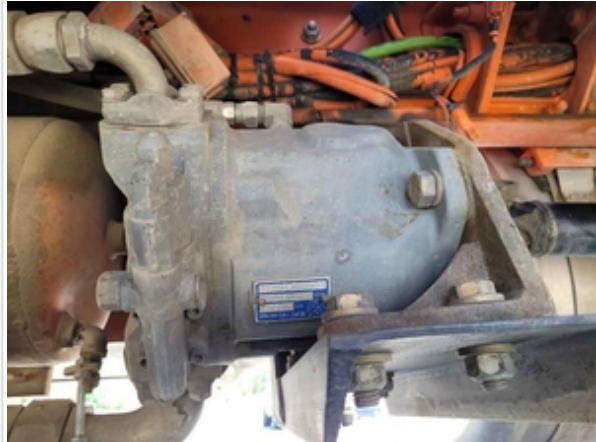
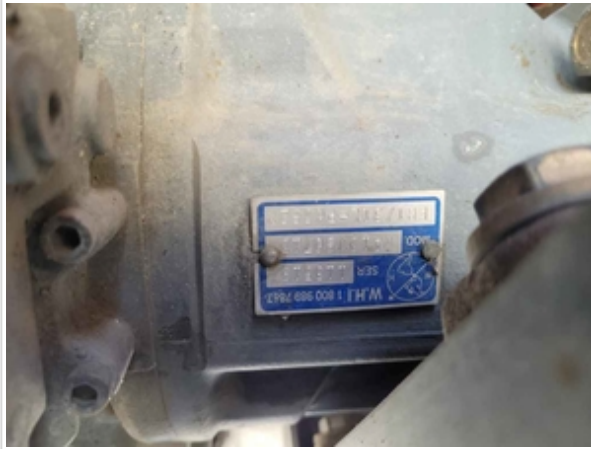
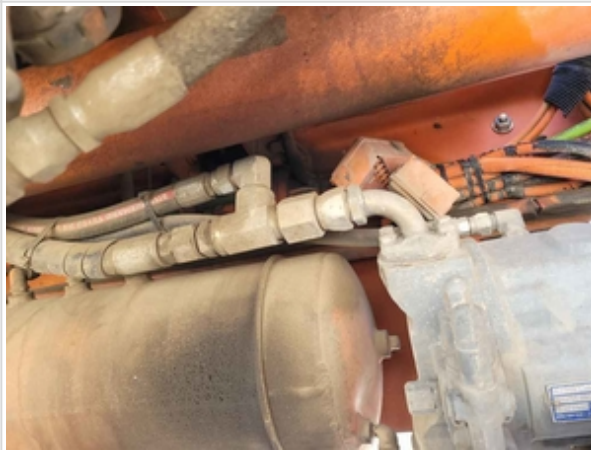
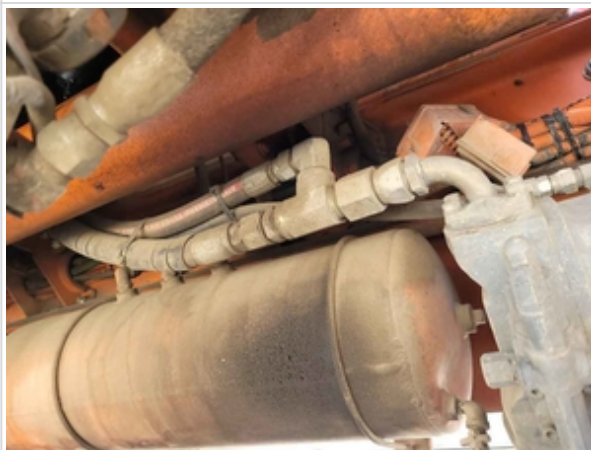
PTO Condition	3
Unusual Noises Heard	No
Leaks Found	No
Hydraulic Hoses & Fittings	3
Hydraulic Hoses & Fittings Photos

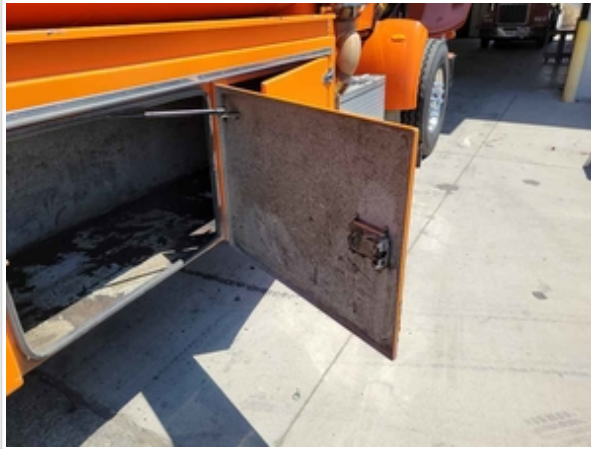
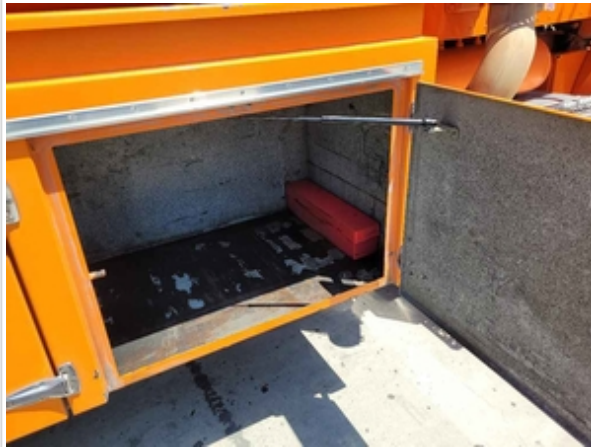
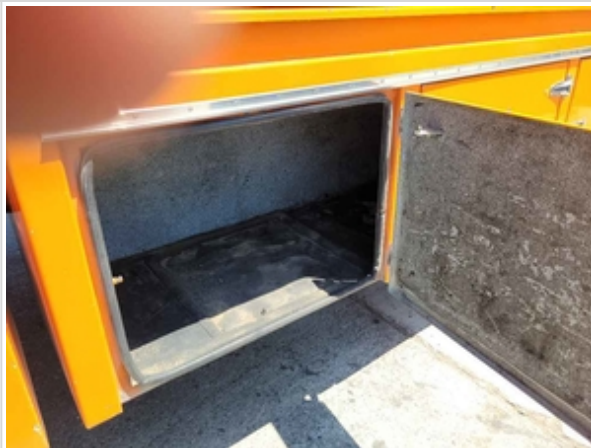
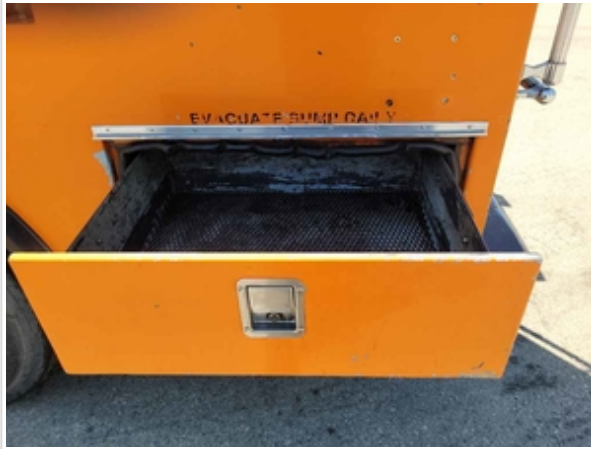
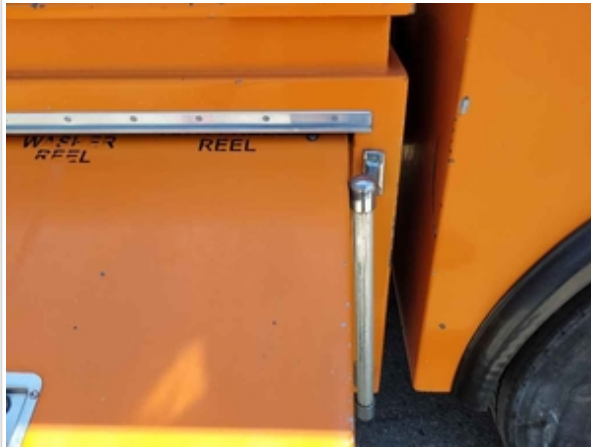
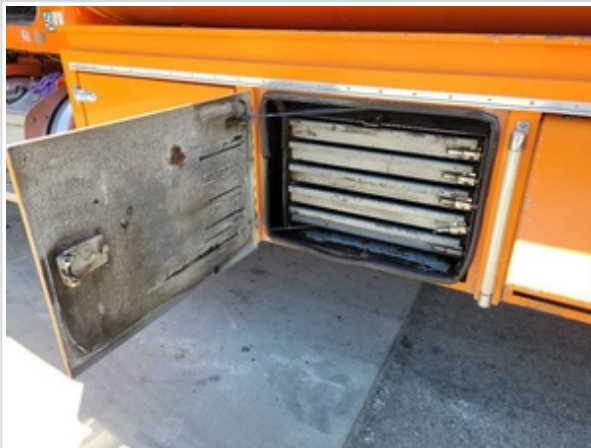
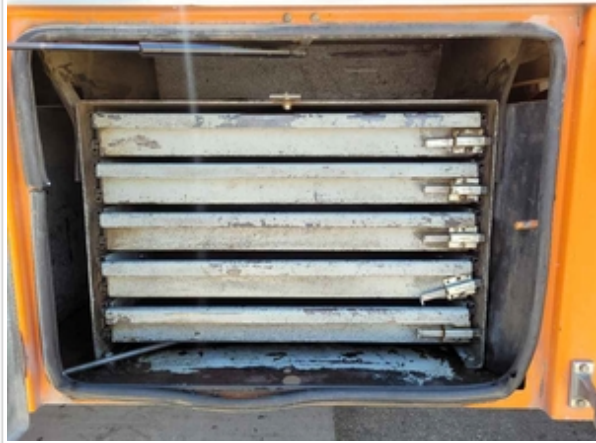
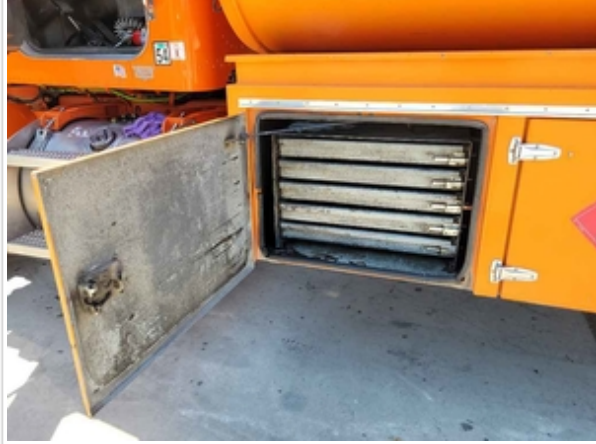
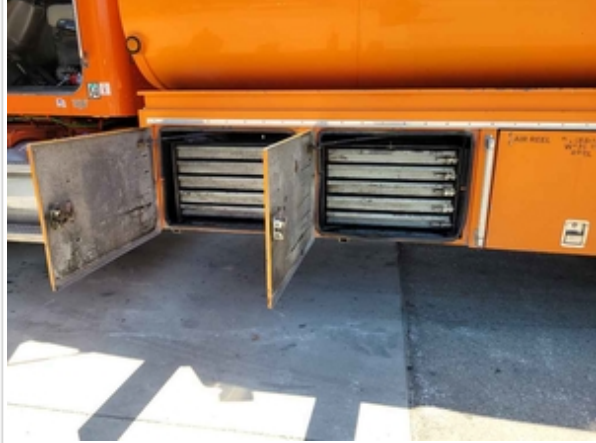
Storage	Check the condition of all storage cabinets (interior & exterior), latches, locks, hinges, and slide out features if applicable.
Toolboxes & Cabinets	3
Comments	some left side toolbox latches (slide out tool storage) broken
Toolboxes & Cabinets Photos

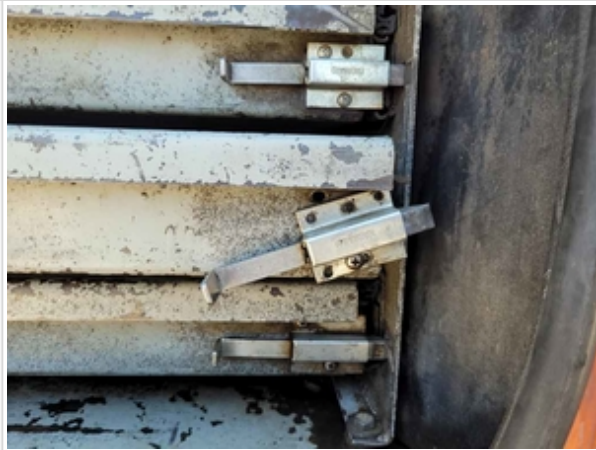
<p>Latches & Locks Photos</p>

Latches & Locks	3
Comments	door latches all good, left side tool storage internal latches broken

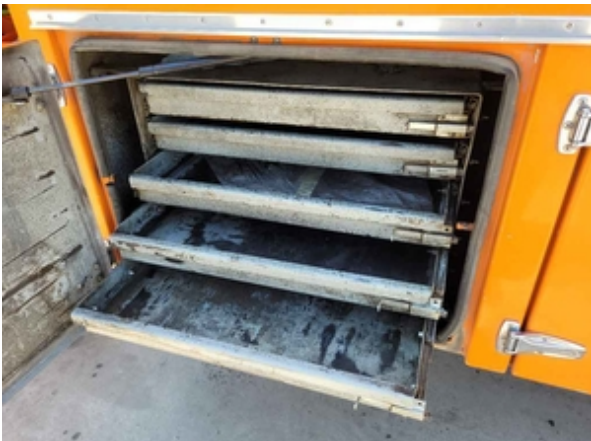
Slide Out Features	Yes	
Slide Out Configuration	oil filter waste drawer and left side tool storage	
Slide Out(s) Condition/Function	3	
Slide Out(s) Photos

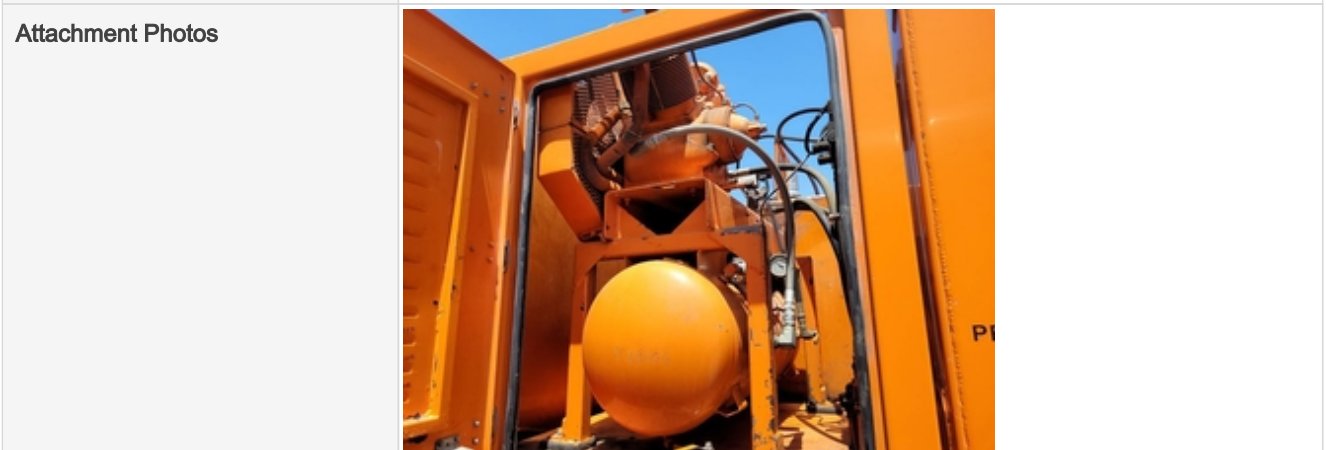
Attachment Type	pto driven air compressor and waste oil suction and discharge pump
Attachment Make	n/a
Attachment Size / Specs	30 gallon
Attachment Condition	3 - Normal Wear & Tear
