Inspection Report (Boom Lift)

Year	2013
Make	JLG
Model	1350 SJP
Serial Number	0300172111
Hour Meter Reading	2072.0
Previous Application (e.g., earth moving, mining, demolition, etc)	Rental

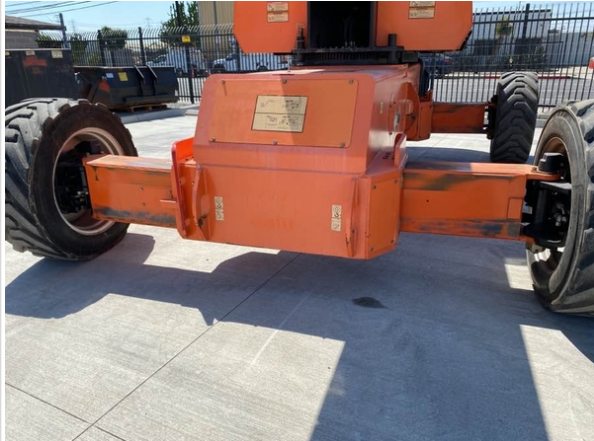
Instructions	<p>Evaluate the following on a 4 point scale (leave comments where an explanation is appropriate):</p> <p>4 = Like New, Recently Replaced 3 = Normal Wear & Tear 2 = Above Average Wear 1 = Service Required</p> <p>Things to look for:</p> <ul style="list-style-type: none"> - cosmetic damage - minor surface rust - repaint (and overspray) - cracked or damaged glass - major rust (cancer) - cracks / visible welds
Front	3 - Normal Wear & Tear
Comments	Normal wear front side in good condition
Front Photos

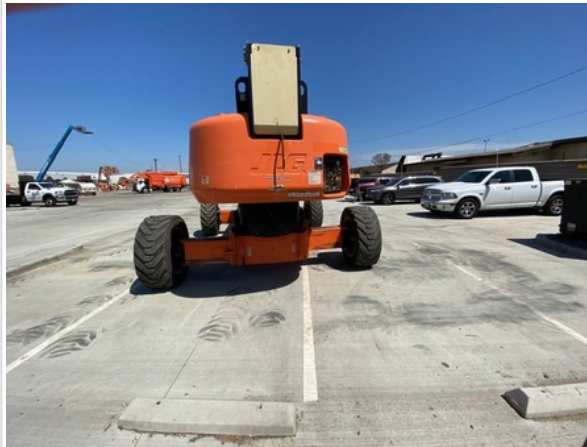
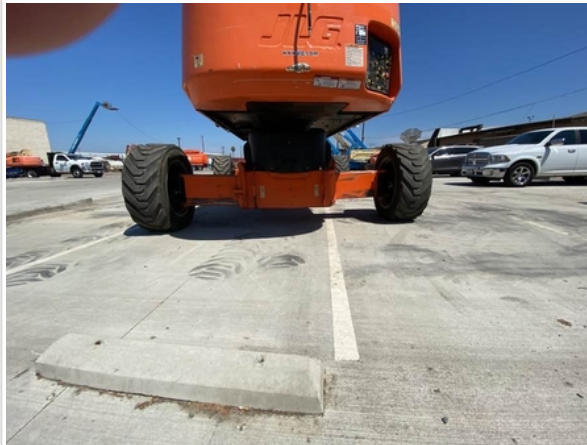
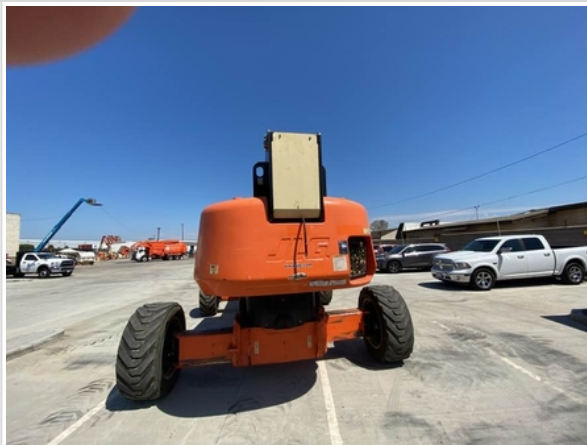
Rear Photos

Rear

3 - Normal Wear & Tear

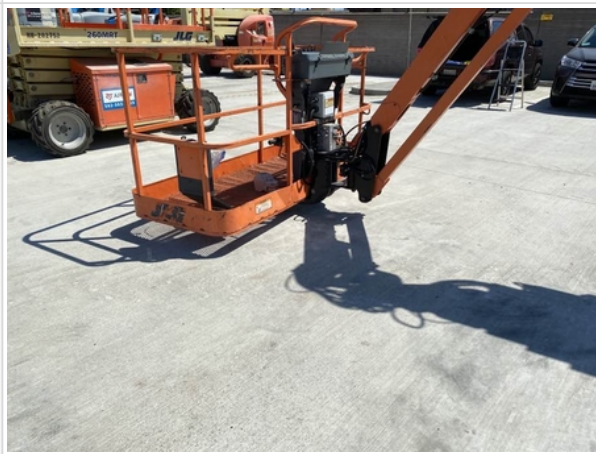
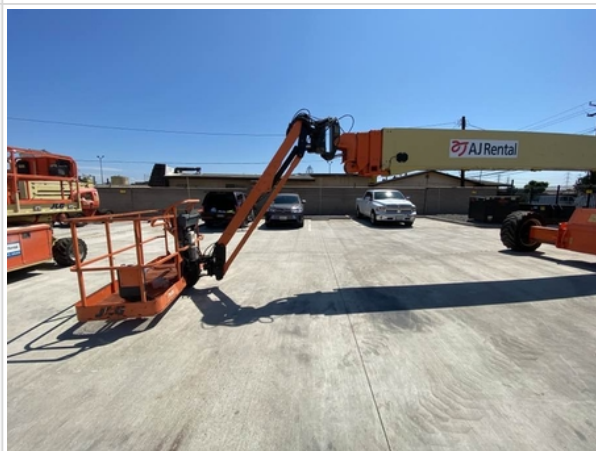
<p>Left</p>	<p>3 - Normal Wear & Tear</p>
<p>Left Photos</p>

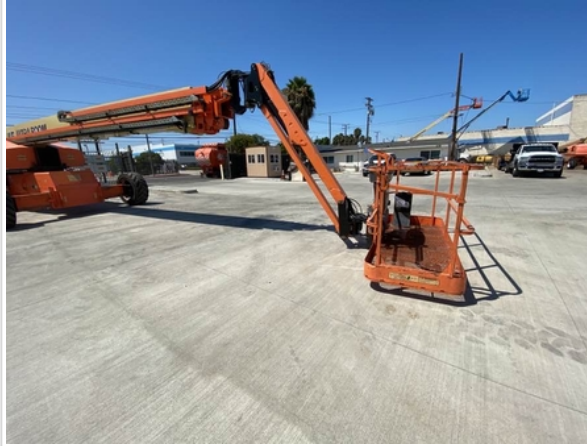
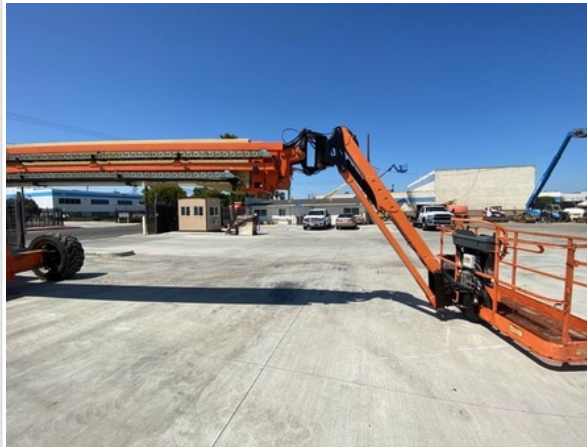
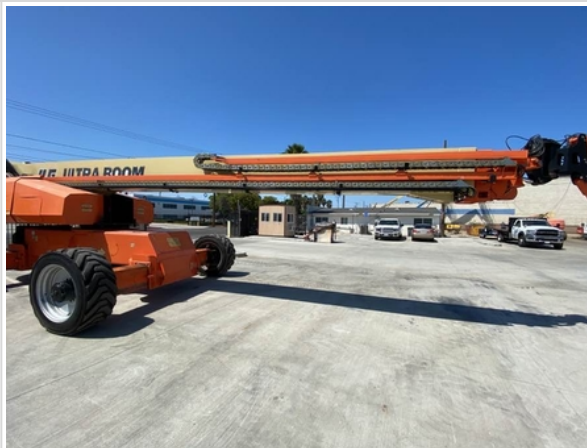
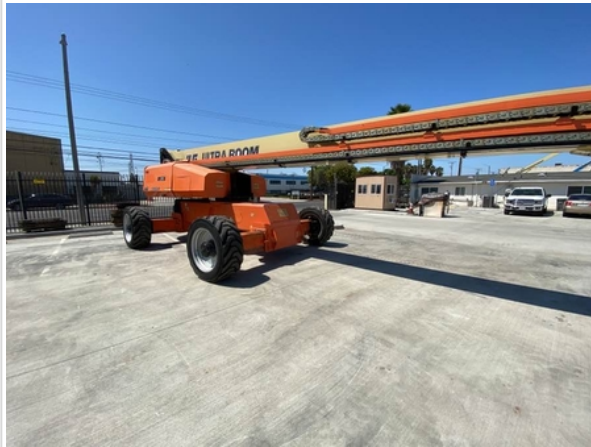
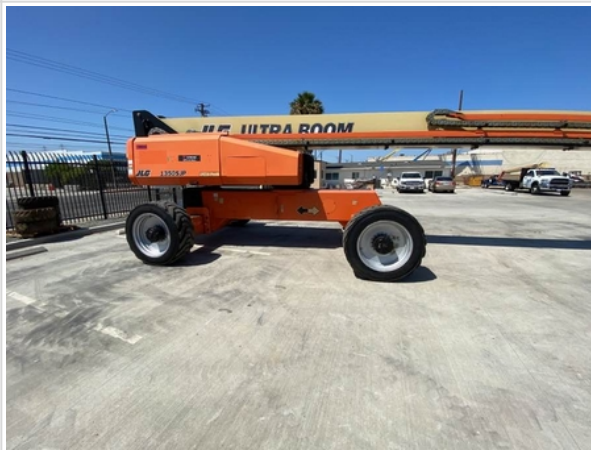
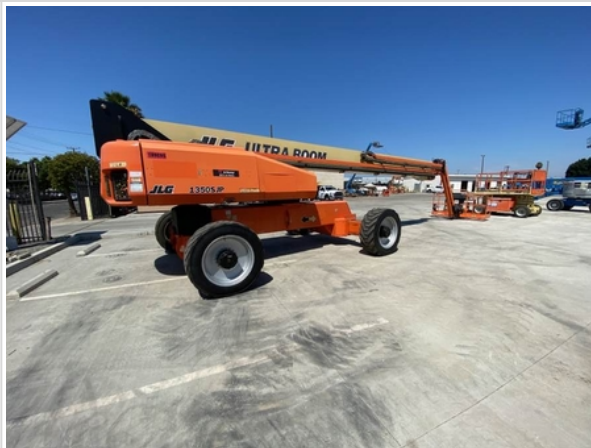
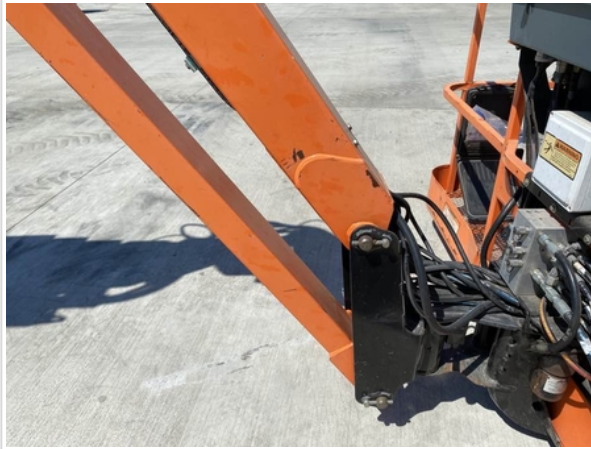
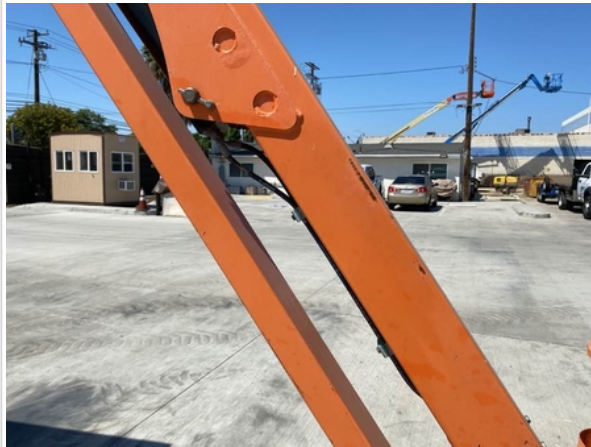
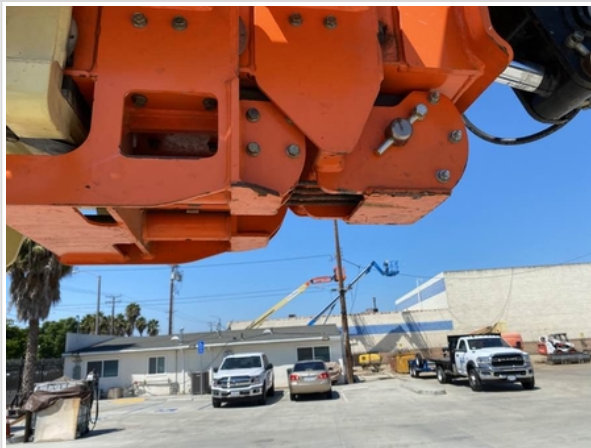
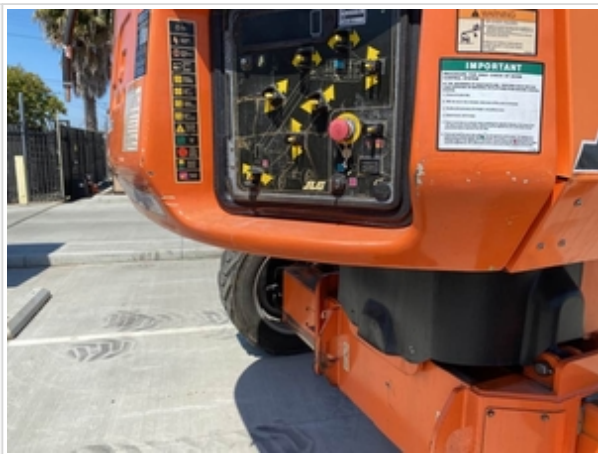
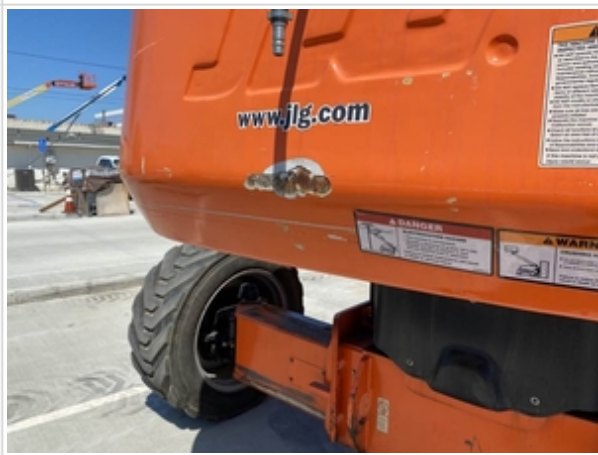
Right Photos

Right	3 - Normal Wear & Tear	
Comments	No major damage just scuff marks

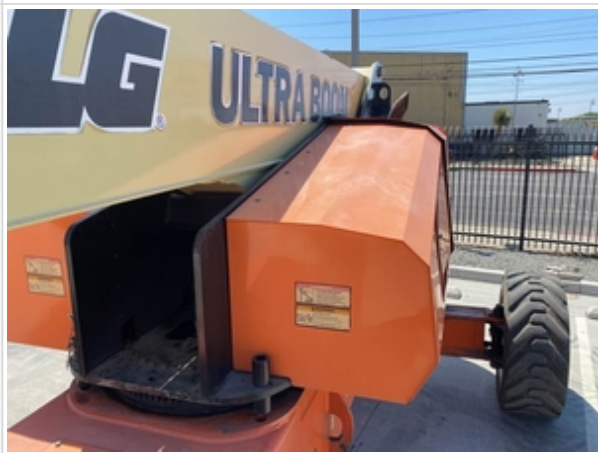
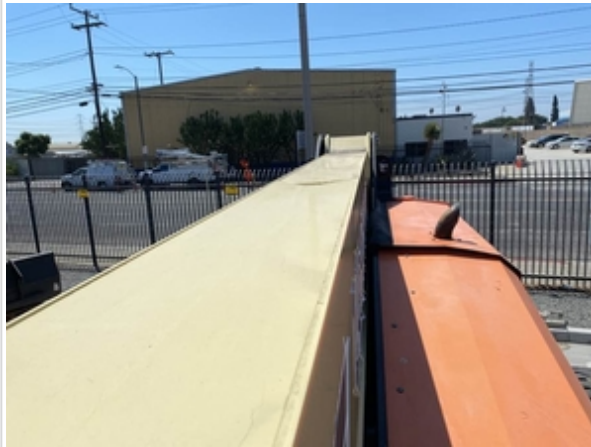
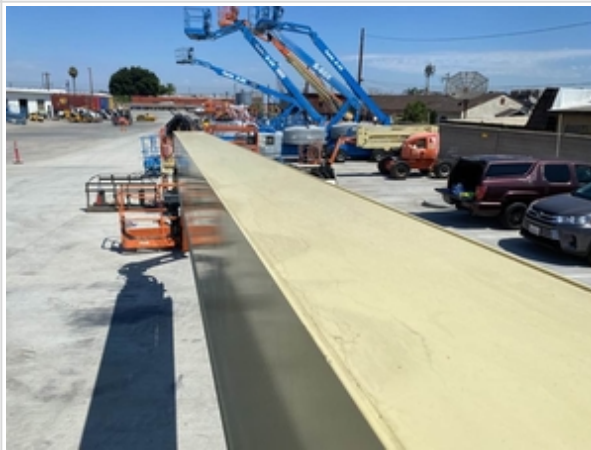
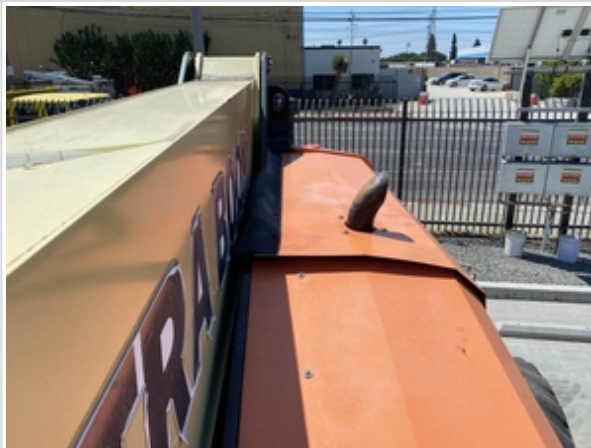
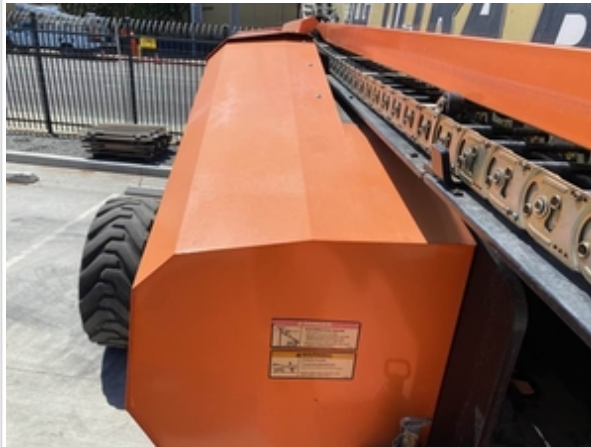
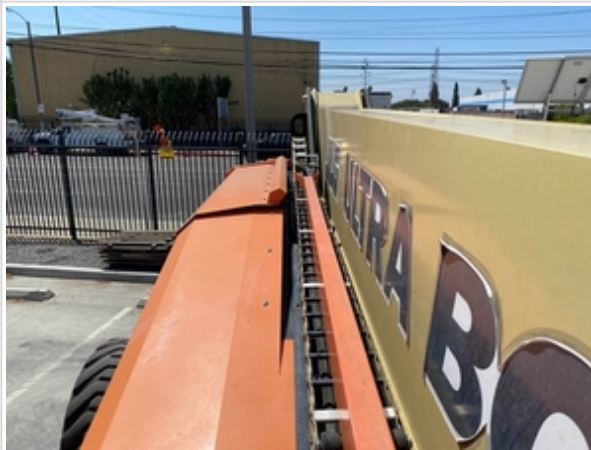
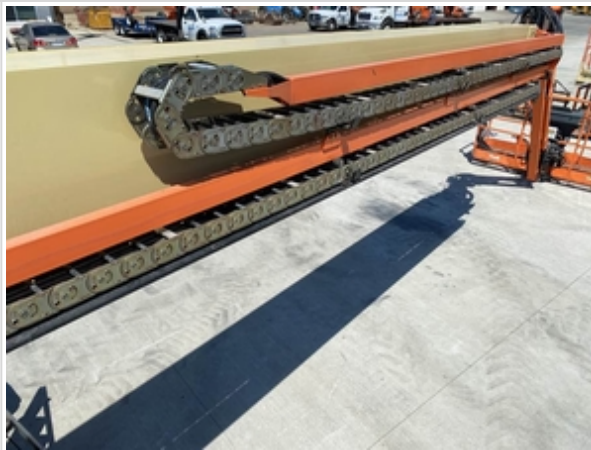
<p>Upper</p>	<p>3 - Normal Wear & Tear</p>	
<p>Upper Photos</p>

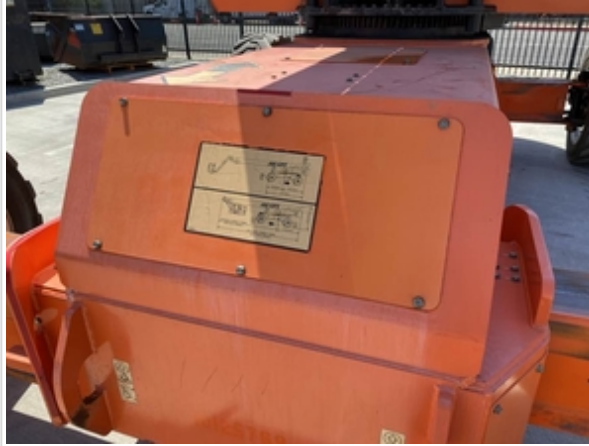
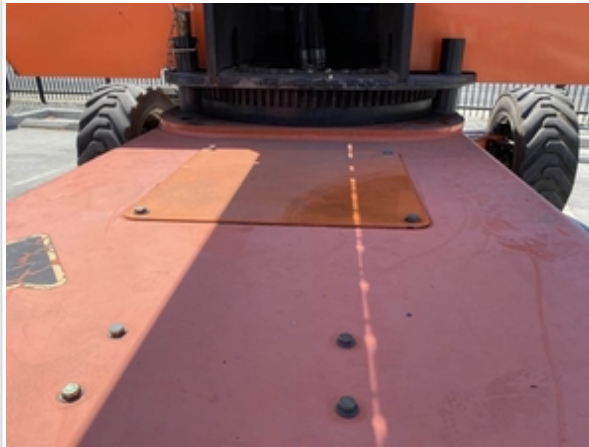
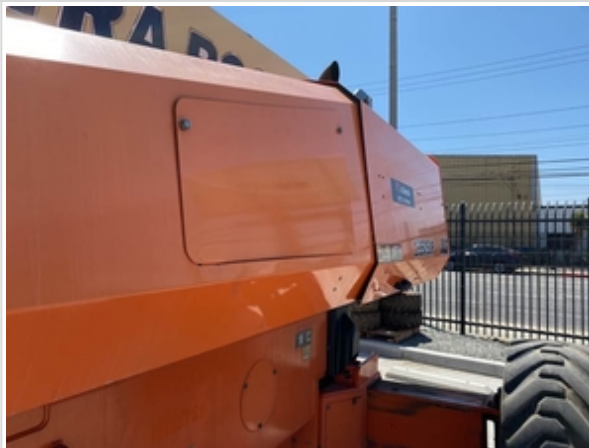
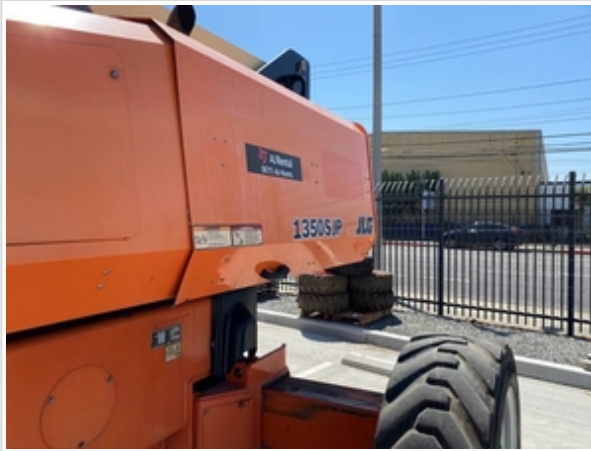
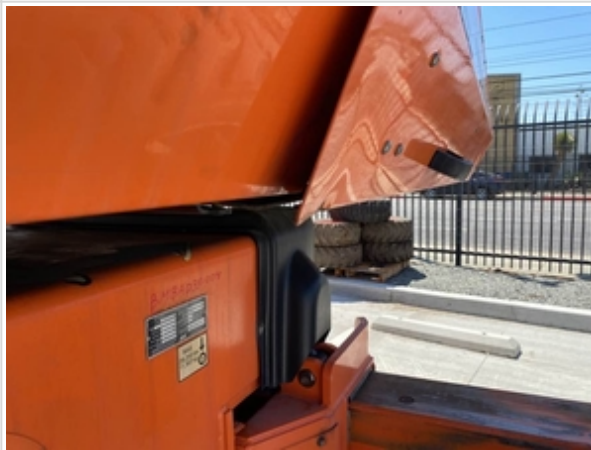
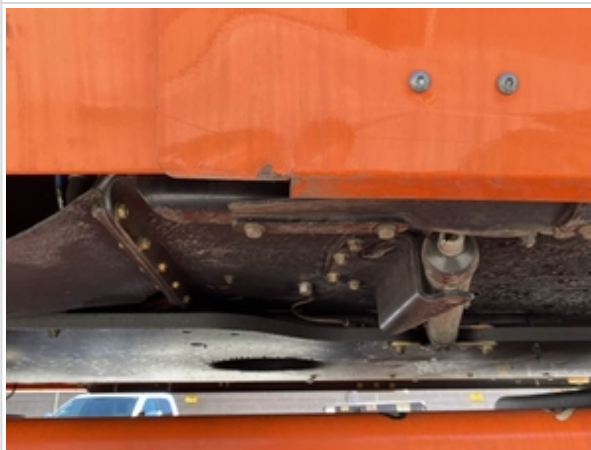
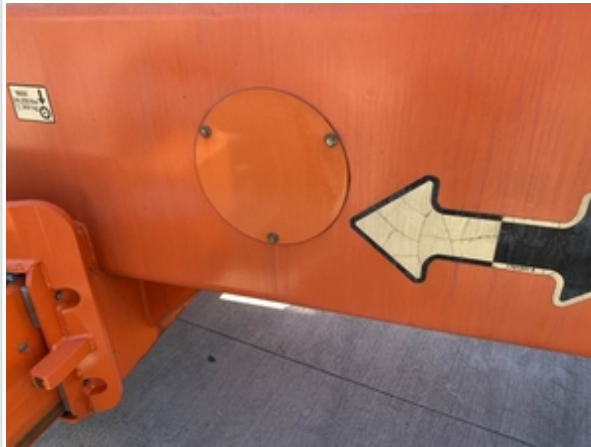
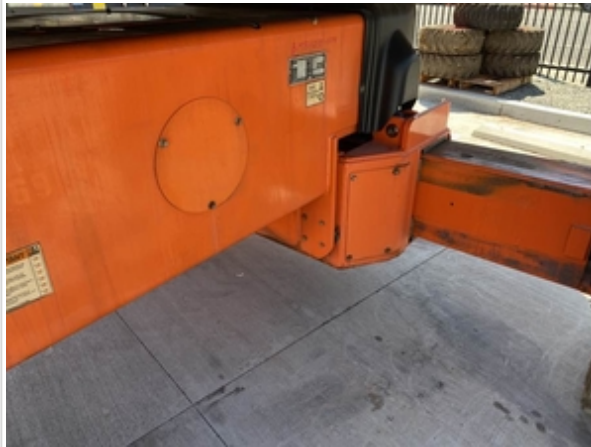
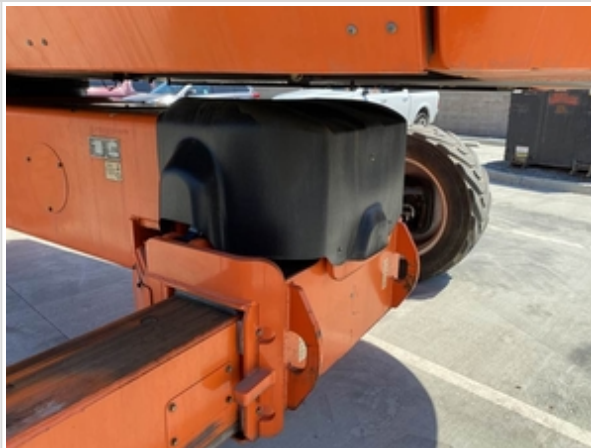
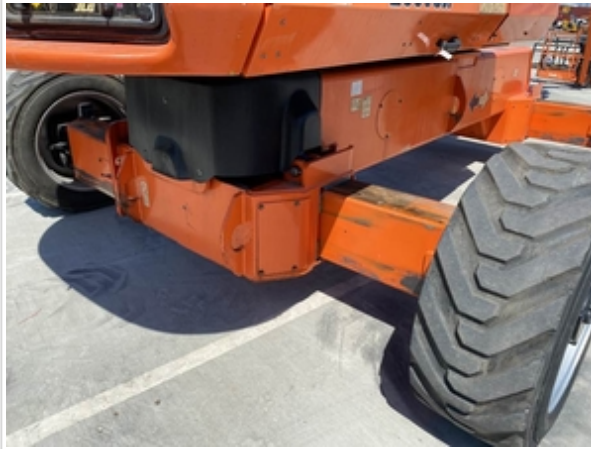
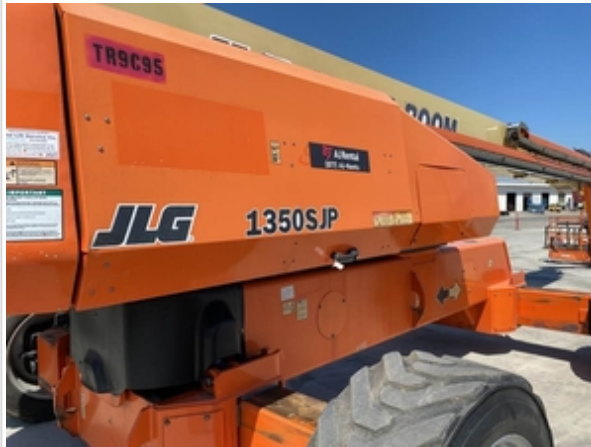
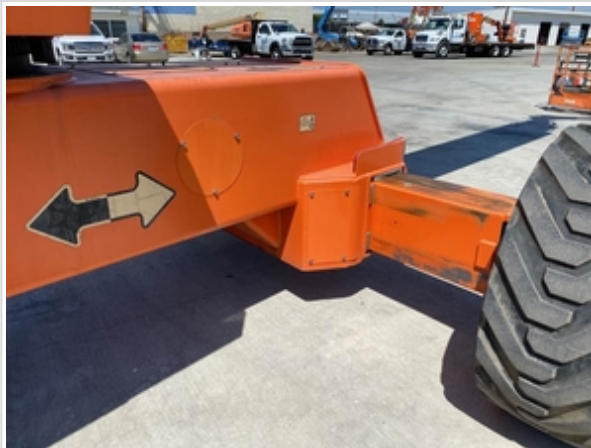
Body Panels Photos

<p>Body Panels (Any Damage?)</p>	<p>3 - Normal Wear & Tear</p>	
<p>Comments</p>	<p>Small dent on left side top body panel</p>

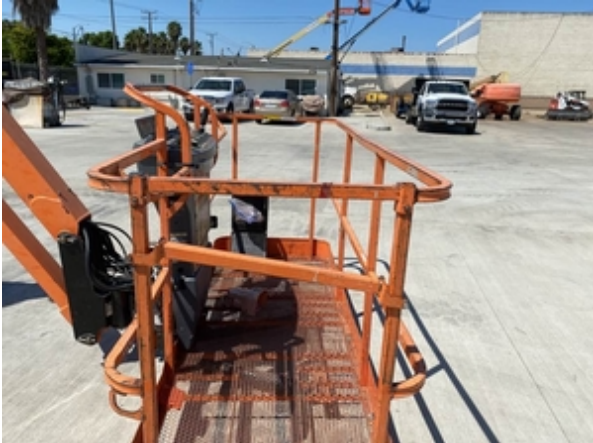
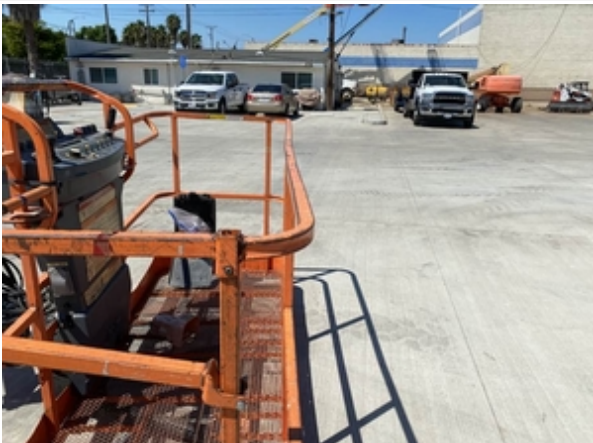
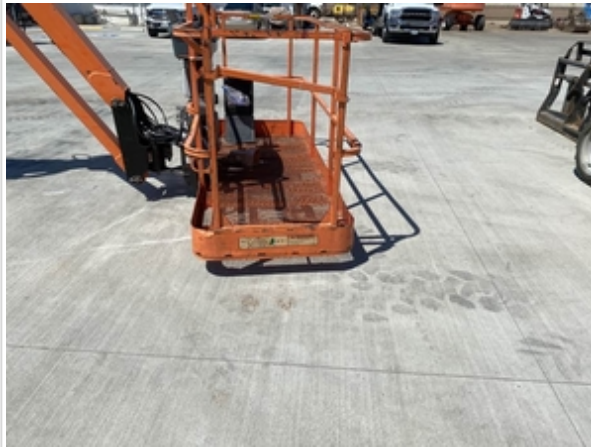
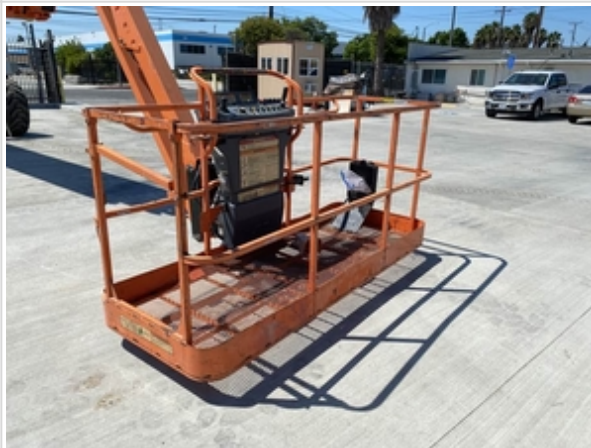
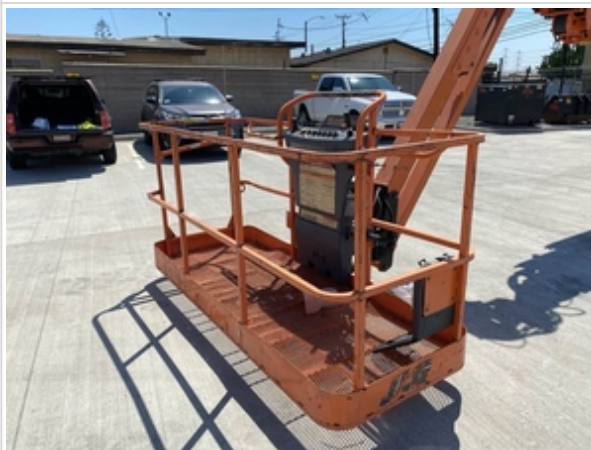
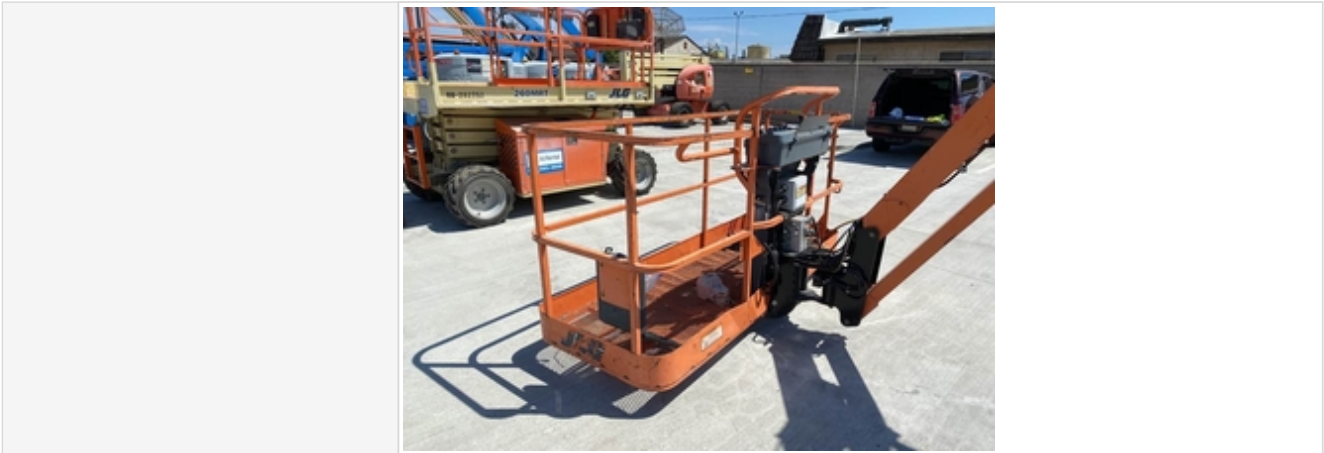
Hand Rails	3 - Normal Wear & Tear	
Comments	Front side top man basket rail bent	
Hand Rails Photos

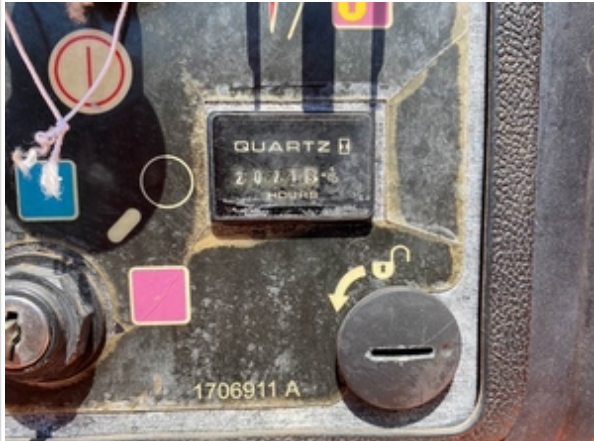
Hour Meter Activity	3 - Normal Wear & Tear
Hour Meter Activity Photos

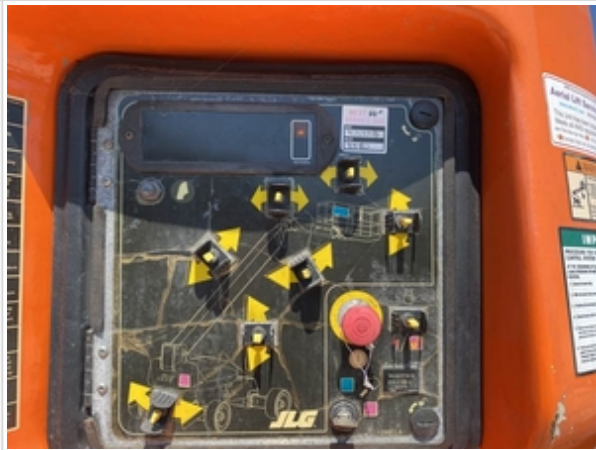
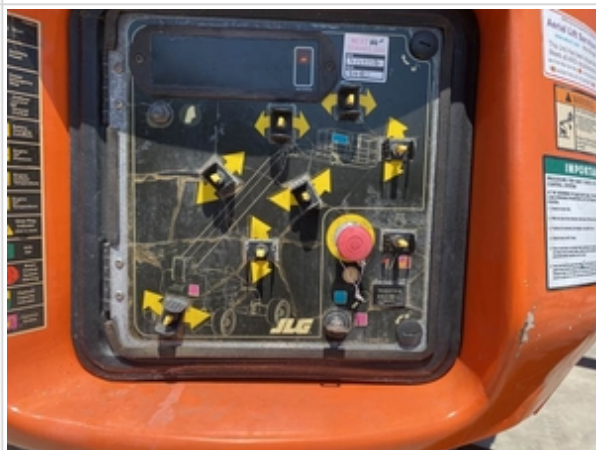
Other Gauge Activity	3 - Normal Wear & Tear
Other Gauge Activity Photos	 
Controls & Switches	3 - Normal Wear & Tear
Controls & Switches Photos

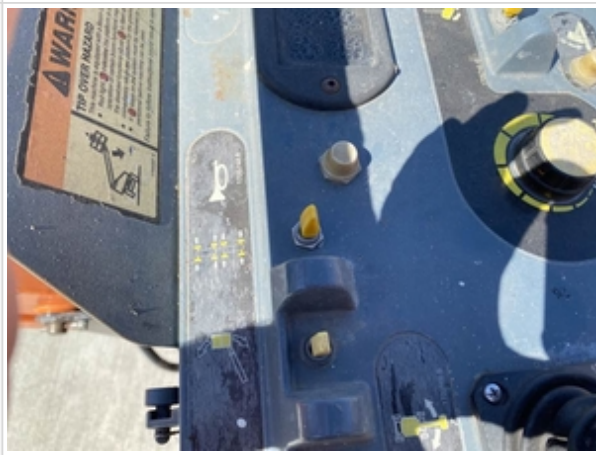
Horn	3 - Normal Wear & Tear
Horn Photos

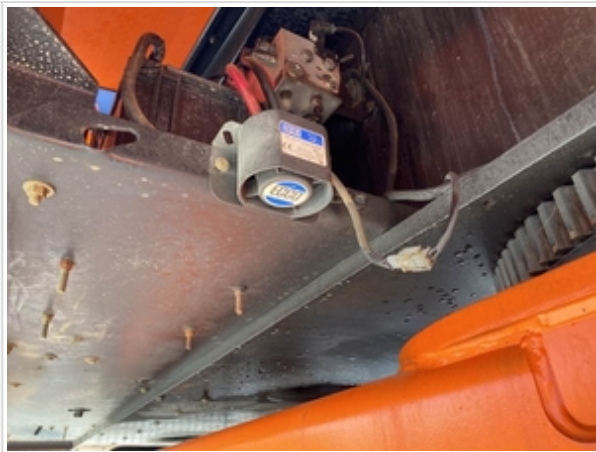
Travel Alarm	3 - Normal Wear & Tear

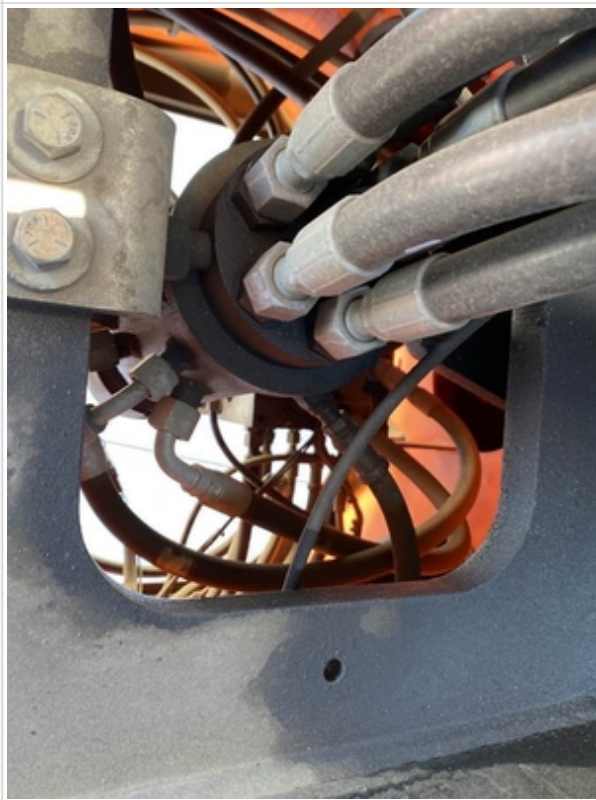
A photograph showing a travel alarm sensor mounted on a metal structure of a boom lift. The sensor is a small, cylindrical device with a blue label and a white cable. It is positioned near a large orange component, likely part of the boom or bucket assembly.
Swing Brake	3 - Normal Wear & Tear
Swing Break Photos

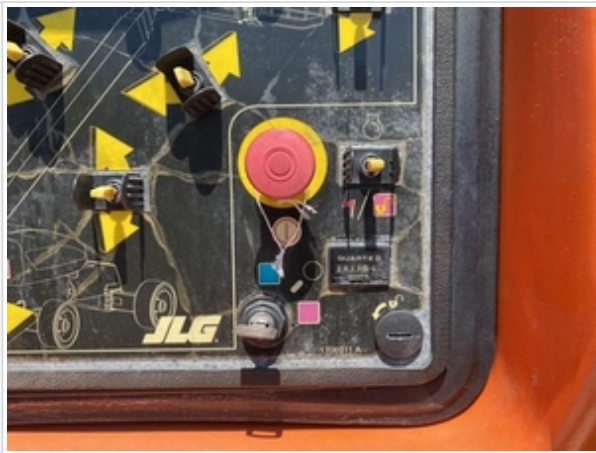
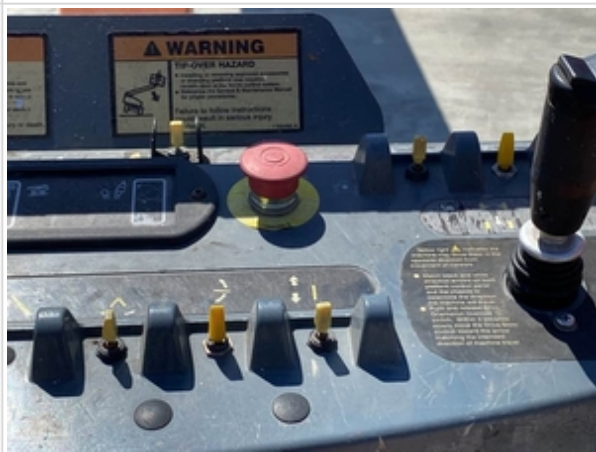
<p>Safety Lock Out / Stop Photos</p>

A photograph showing a close-up view of the swing brake mechanism. The brake is a large, black, curved component that is part of the swing system. It is surrounded by various cables, hoses, and metal parts. The brake is mounted on a metal structure, and the overall appearance is that of a well-maintained but used component.
Safety Lock Out / Stop	3 - Normal Wear & Tear

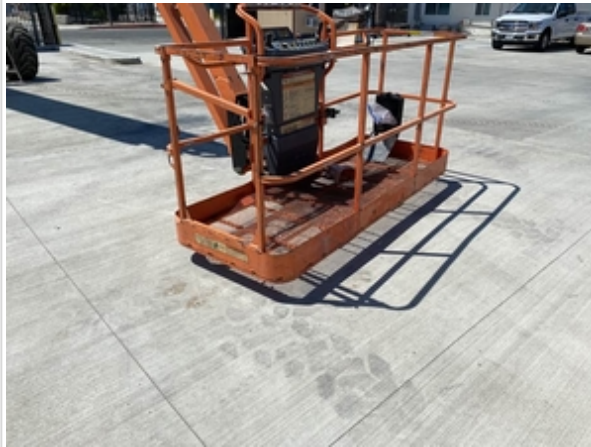
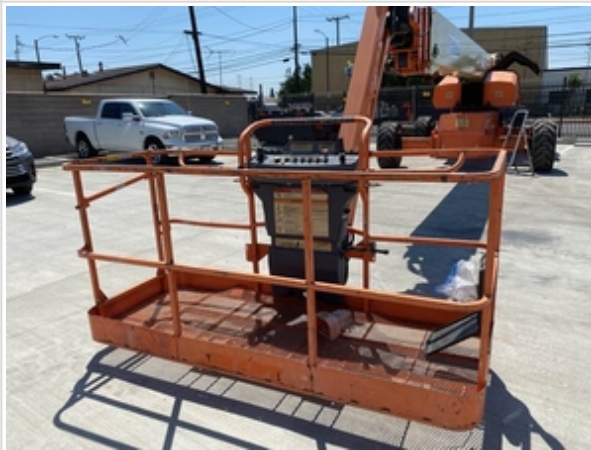
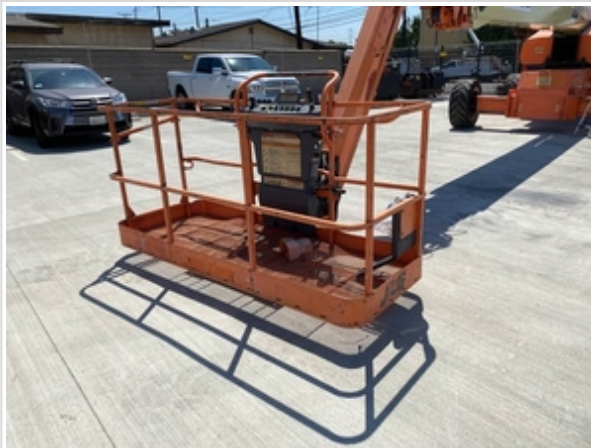
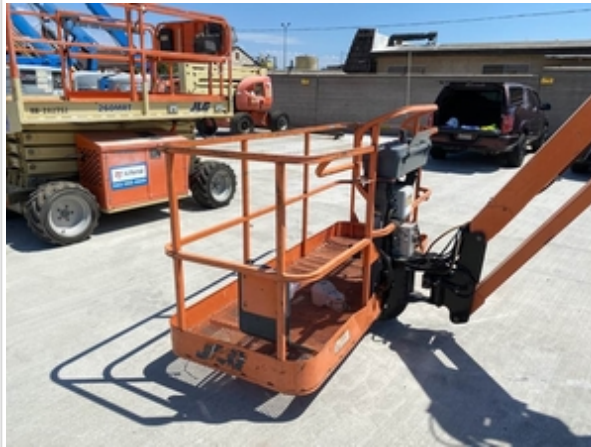
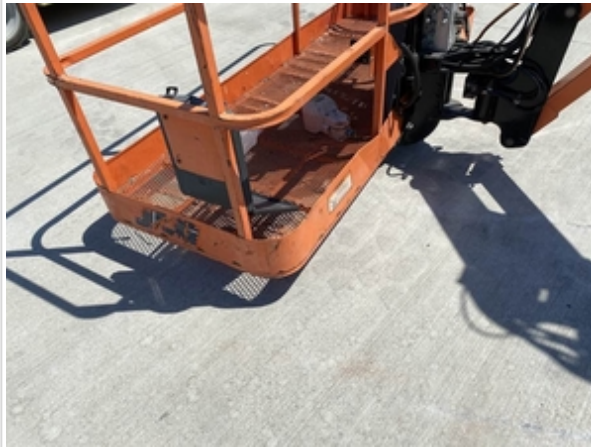
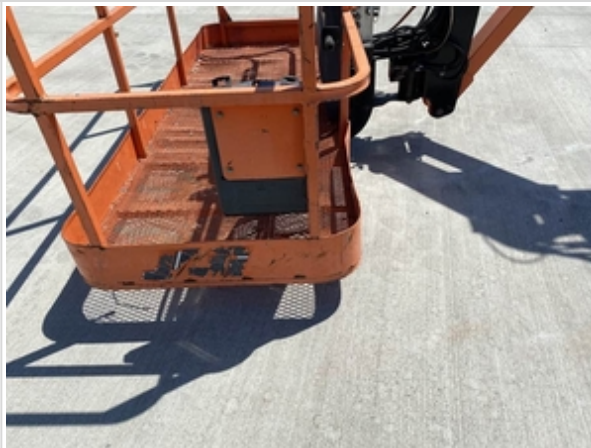
<p>Platform Safety Rails & Appearance</p>	<p>3 - Normal Wear & Tear</p>
<p>Comments</p>	<p>A few bent areas and small cracks at bottom panels top platform side rail bent</p>
<p>Platform Safety Rails & Appearance Photos</p>

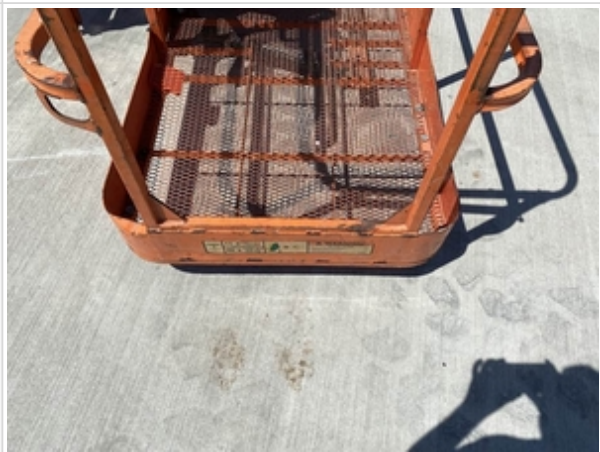
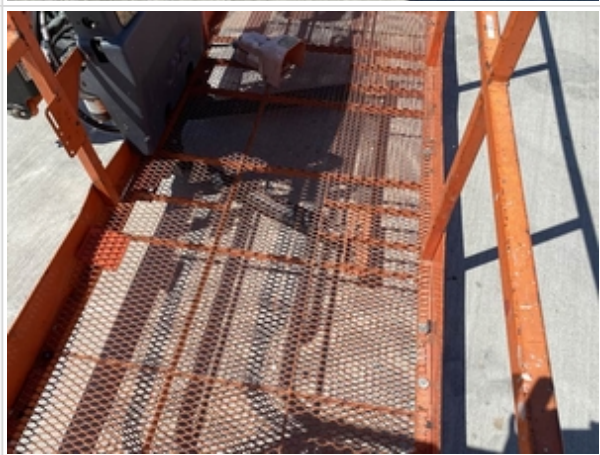
<p>Platform Floor</p>	<p>3 - Normal Wear & Tear</p>	
<p>Platform Floor Photos</p>

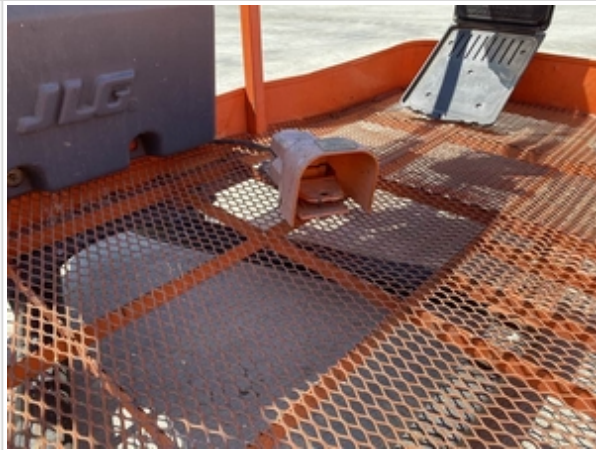
Platform Controls Photos

<p>Platform Controls</p>	<p>3 - Normal Wear & Tear</p>

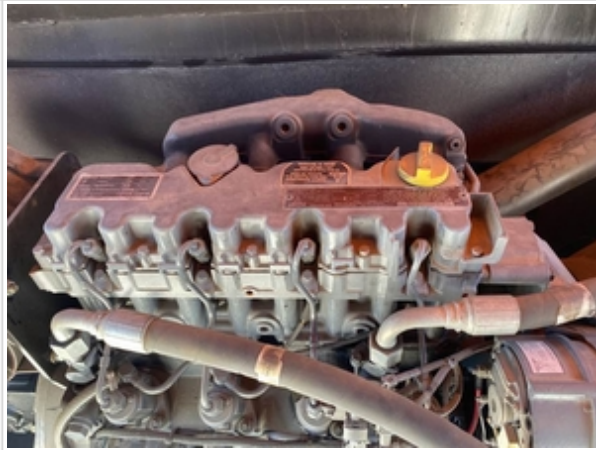
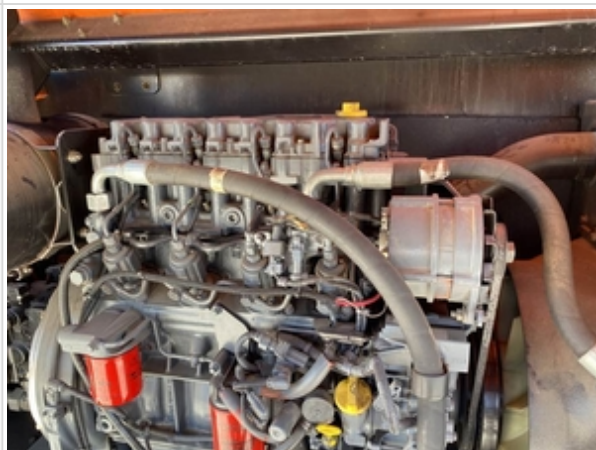
Engine Type (Make, Model, Cylinders, Hp)	Deutz 3.6L 4cyl. 74HP
Engine Serial Number	11396915
Engine Fuel Type	Diesel
Engine Photos

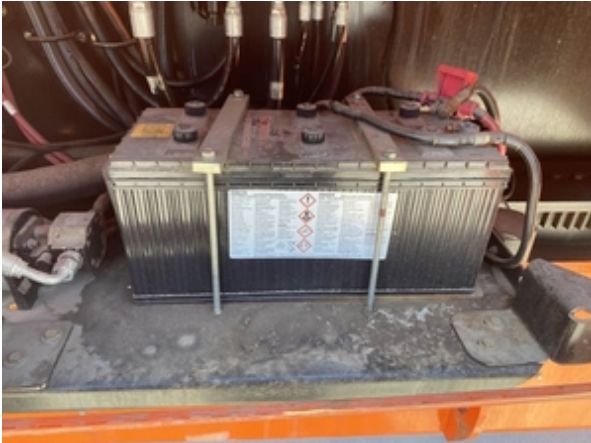
Engine Exhaust Color	Clear
Battery	3 - Normal Wear & Tear
Battery Condition	Like new, recently replaced, Clean & dry appearance, tight connections
Battery Condition Photos

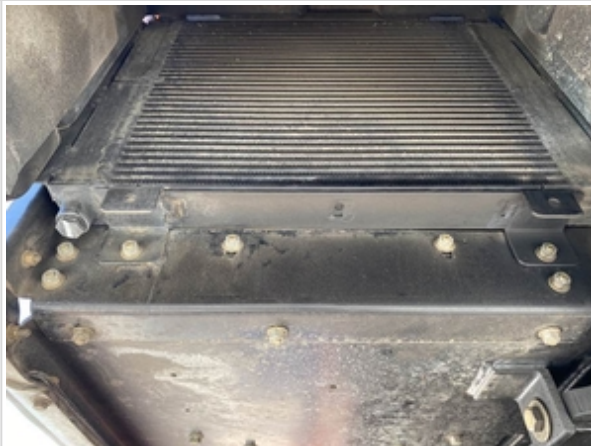
Radiator Photos

Radiator	3 - Normal Wear & Tear
Radiator Condition	Radiator fins & components appear to be in good working order, no signs of damage or leaks, Other (see comments)
Comments	Bottom left mounting bracket cracked at radiator

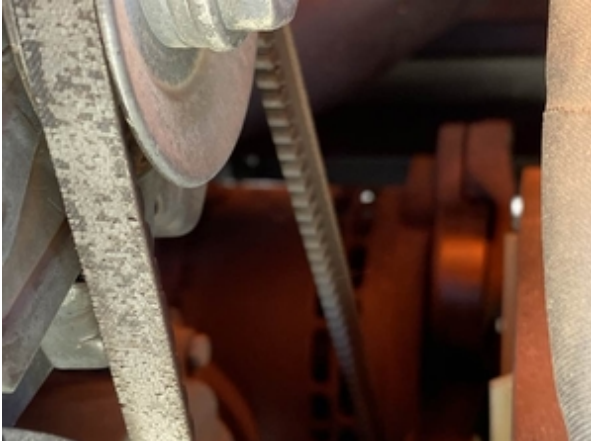
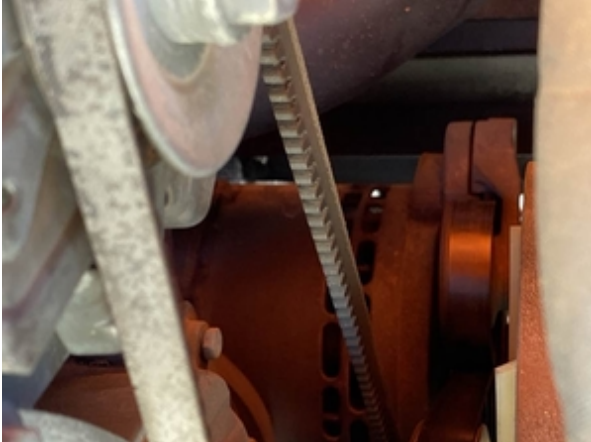
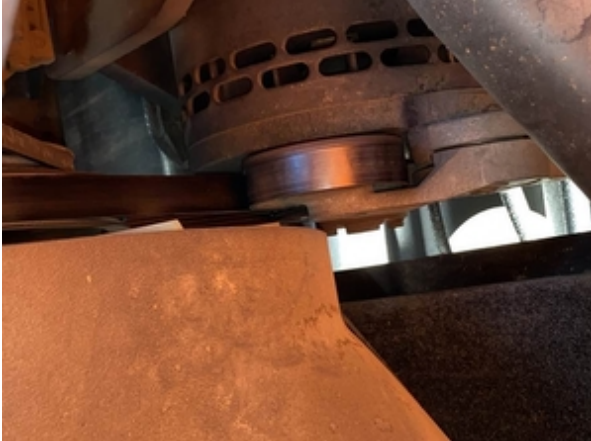
Belts	3 - Normal Wear & Tear
Belt Photos

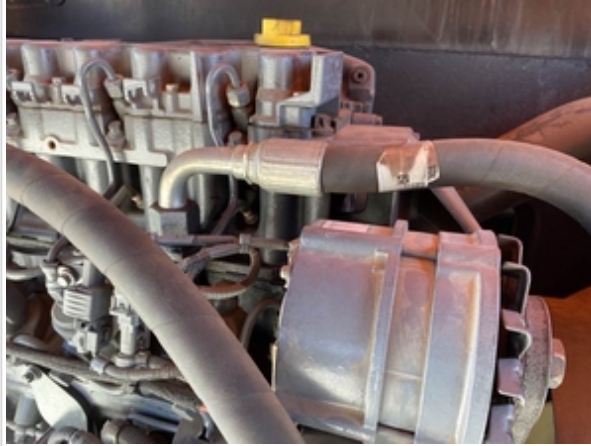
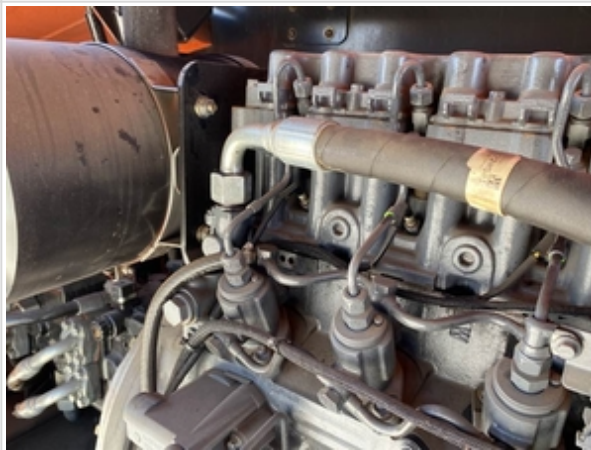
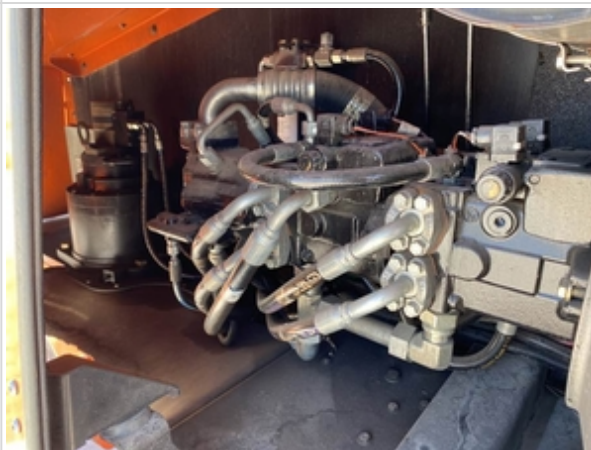
Hose Photos

Hoses	3 - Normal Wear & Tear
Hose Condition	Firm, pliant hoses with no signs of wear or leaks, Dried seepages observed, Other (See commentss
Comments	90% of hose in great shape, a few hoses cracked and a few showing seepage

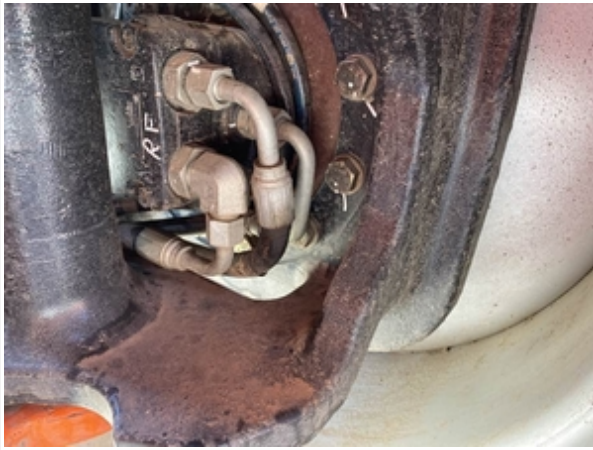
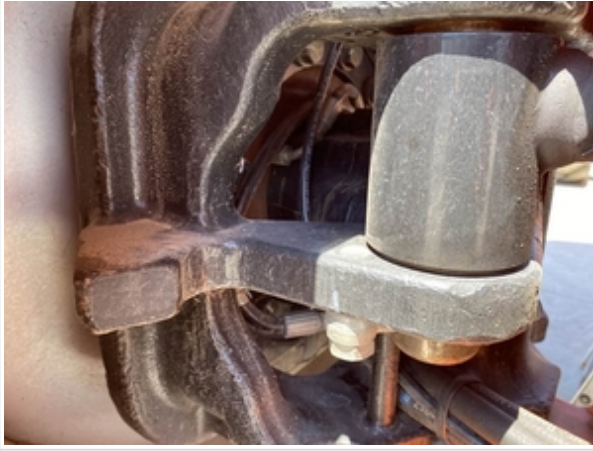
Transmission	0
Clutch	0
Shift Lever	0
Foot Brake	0
Inching Brake	0
Parking Brake	3 - Normal Wear & Tear
Parking Brake Condition	Good brake function
Parking Brake Photos

Overall Drivetrain Comments	All drive motors and brakes look solid!

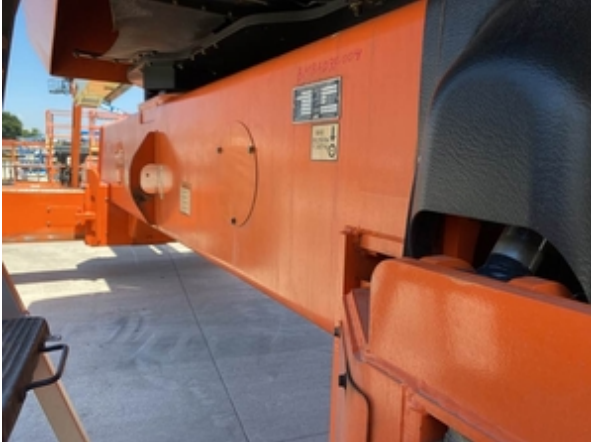
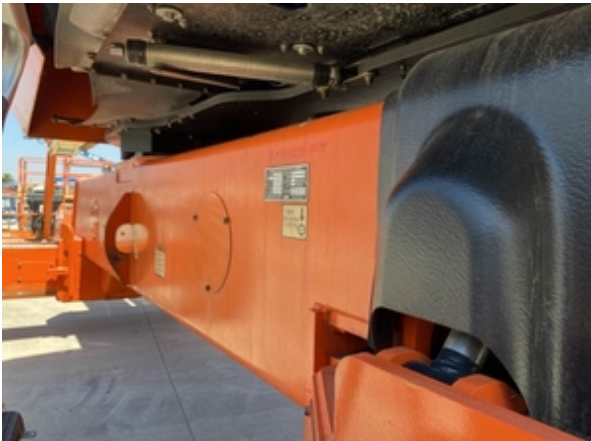
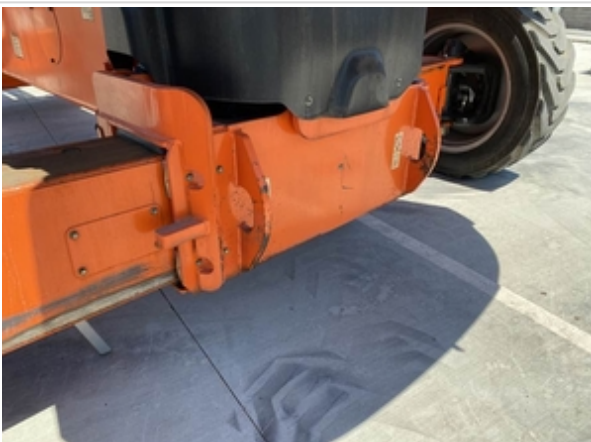
Instructions	<p>Evaluate the following on a 4 point scale (leave comments where an explanation is appropriate):</p> <p>4 = Like New, Recently Replaced 3 = Normal Wear & Tear 2 = Above Average Wear 1 = Service Required</p>
Frame	3 - Normal Wear & Tear
Frame Photos

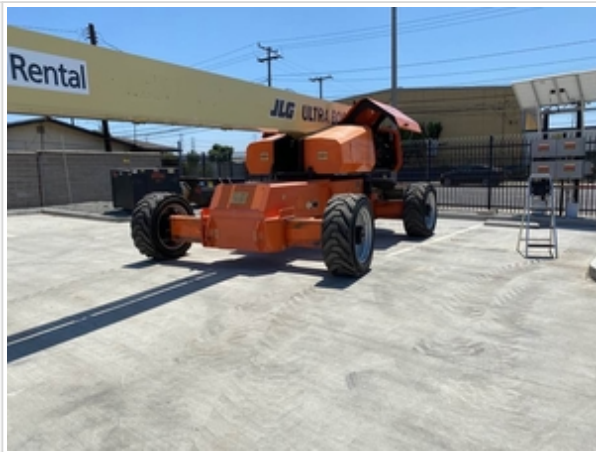
<p>Stance Photos</p>

Stance

3 - Normal Wear & Tear

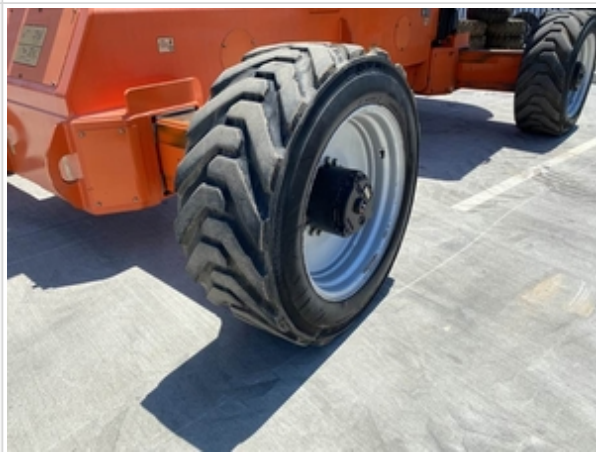
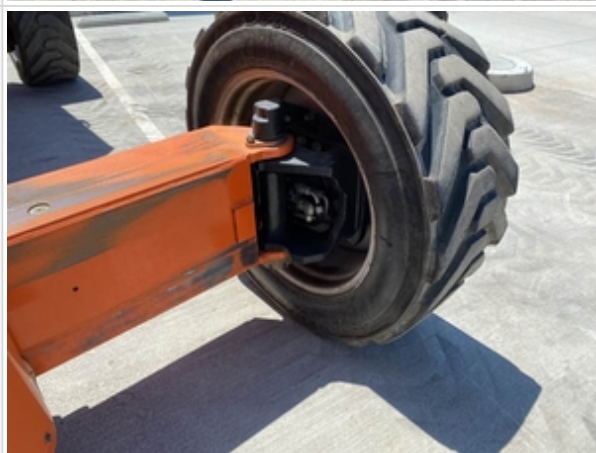
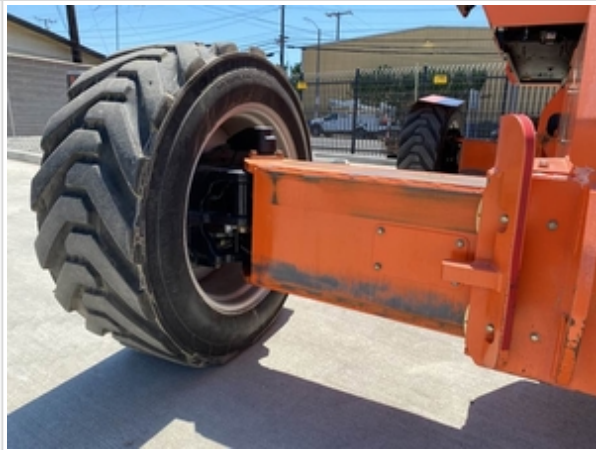
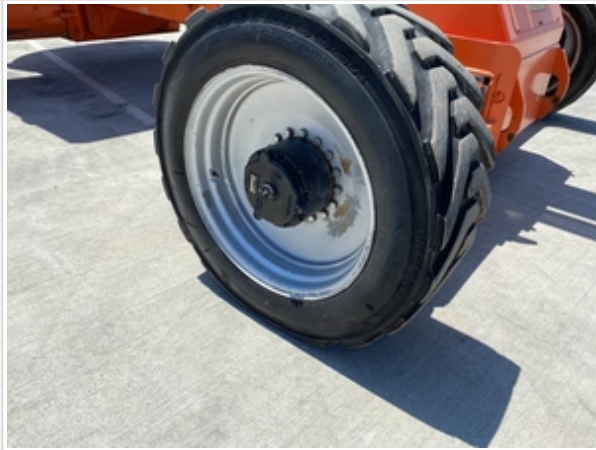
<p>Front Axle Appearance</p>	<p>4 - Like New, Recently Replaced</p>
<p>Front Axle Appearance Photos</p>

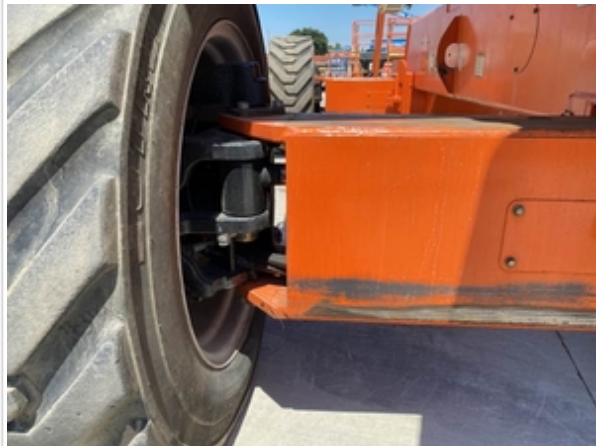
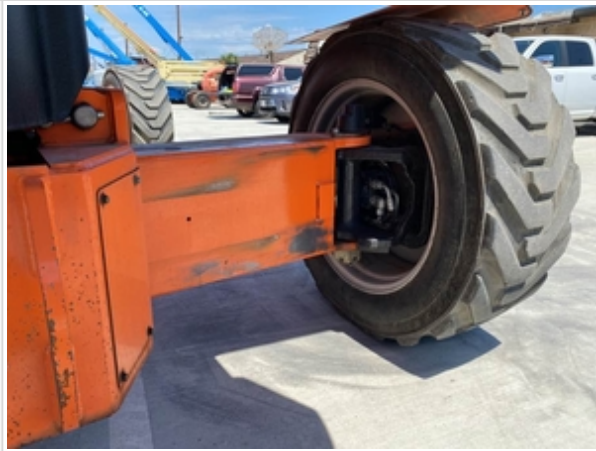
<p>Rear Axle Appearance</p>	<p>4 - Like New, Recently Replaced</p>
<p>Rear Axle Appearance Photos</p>
