Inspection Report (Boom Lift)

Year	2013
Make	JLG
Model	1350 SJP
Serial Number	0300172111
Hour Meter Reading	2072.0
Previous Application (e.g., earth moving, mining, demolition, etc)	Rental

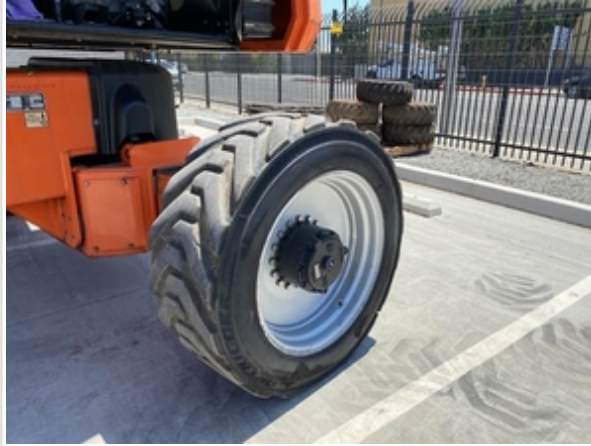
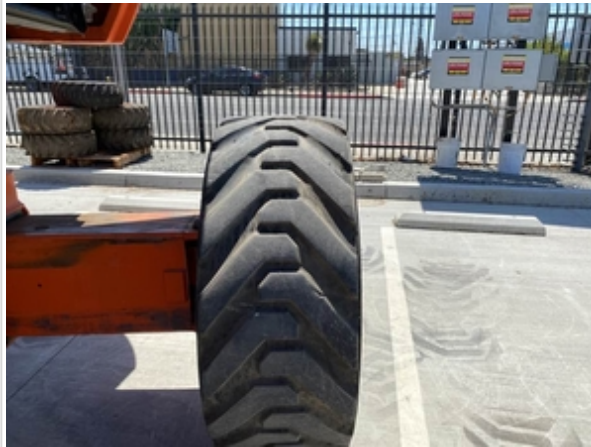
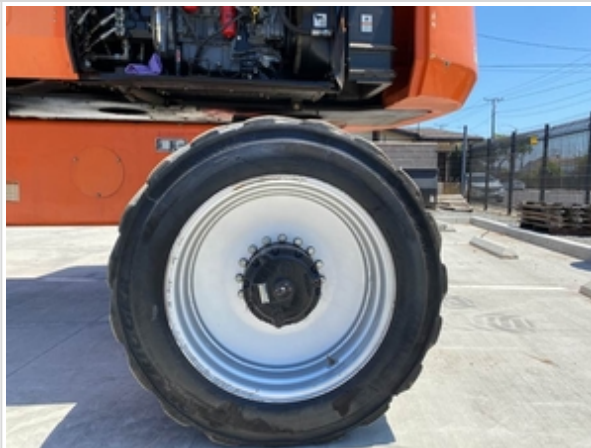
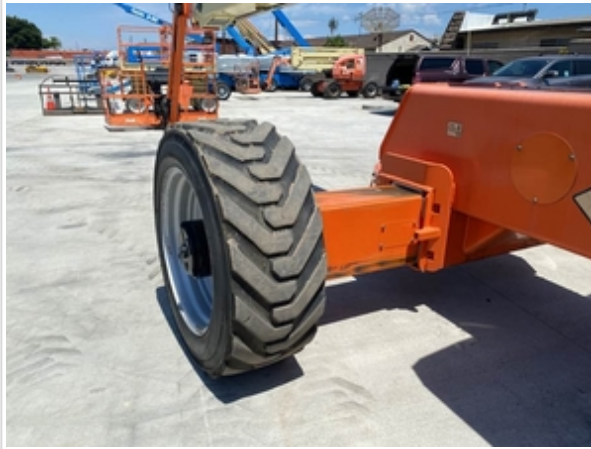
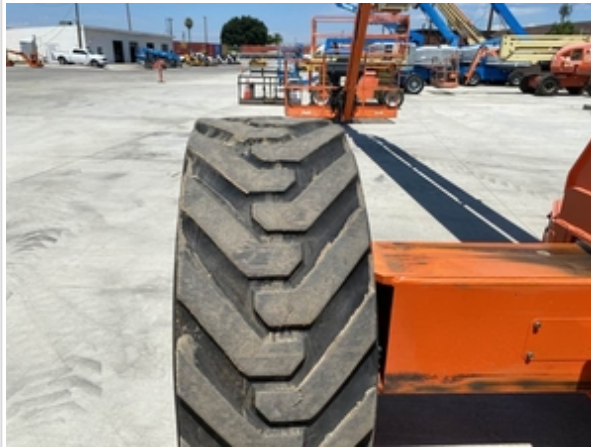
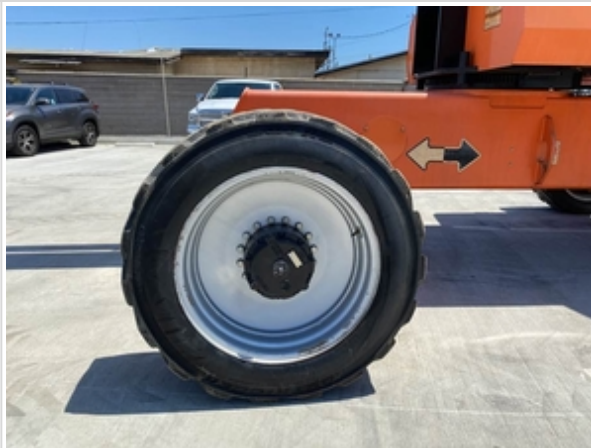
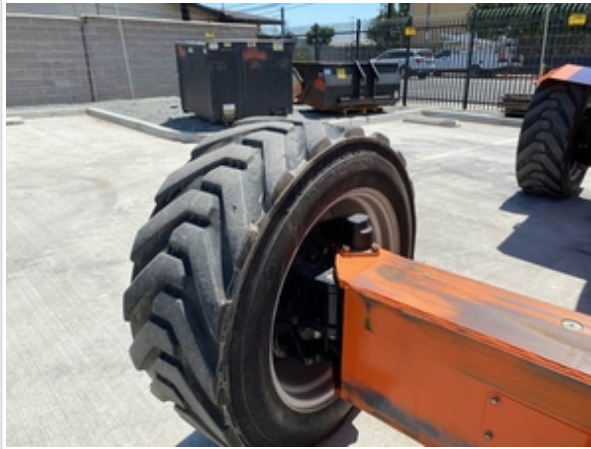
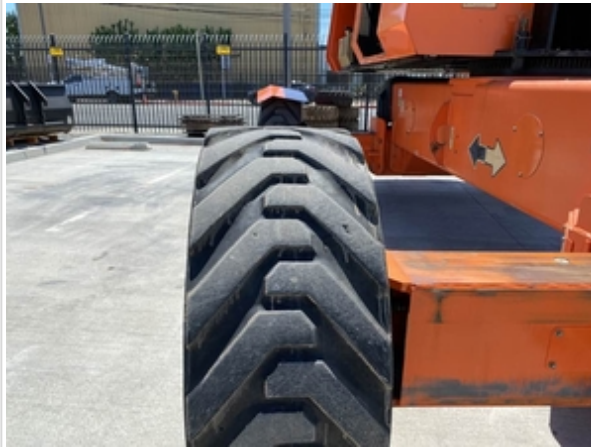
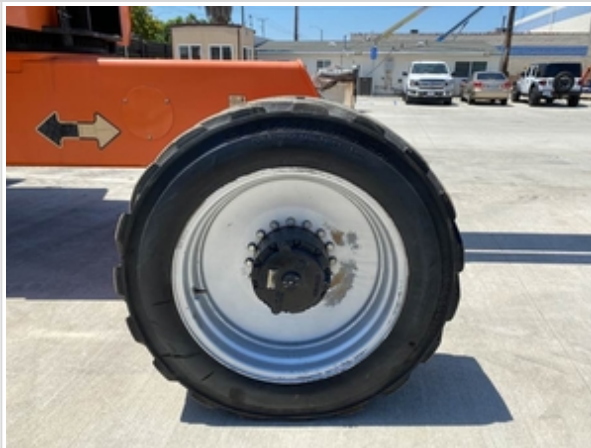
Wheels & Tires Photos

Wheels & Tires	3 - Normal Wear & Tear
Comments	Minor cuts on tires, normal wear, great condition

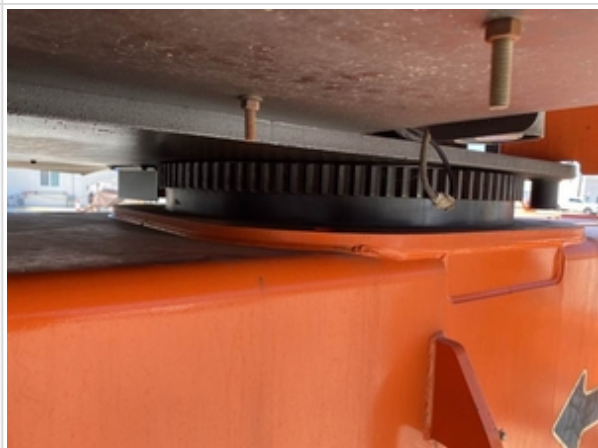
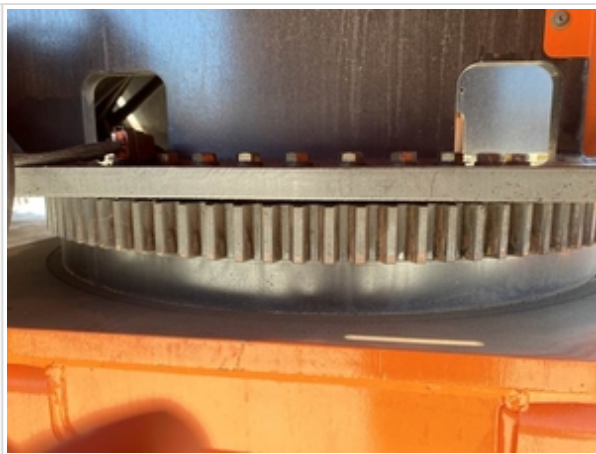
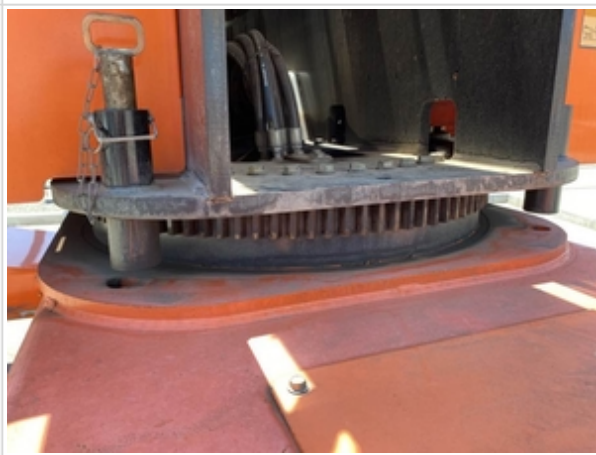
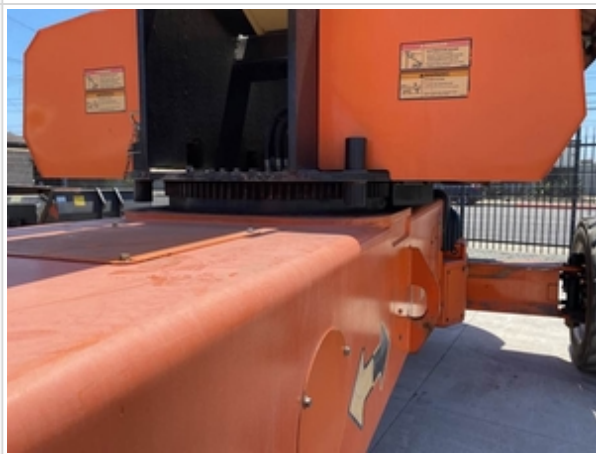
Tire Brand	OTR Outrigger	
Tire Size	445/50D710	
Front Left Tire - Ratio Remaining	70%	
Rear Left Tire - Ratio Remaining	70%	
Front Right Tire - Ratio Remaining	70%	
Rear Right Tire - Ratio Remaining	70%	
Swivel Bearing	3 - Normal Wear & Tear	
Swivel Bearing Photos

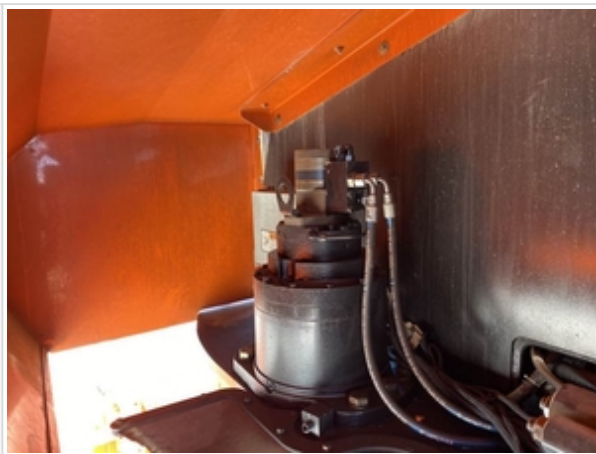
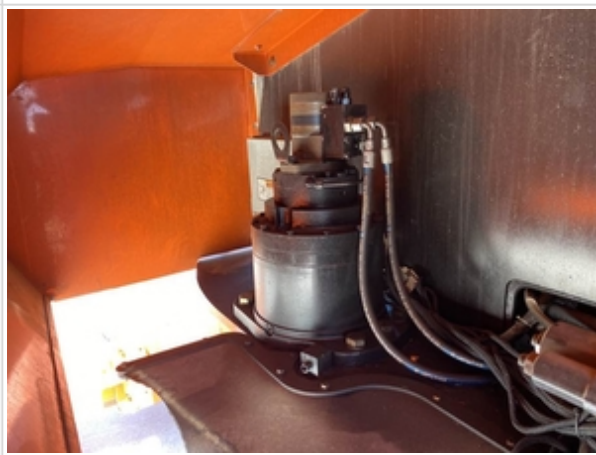
<p>Swivel Bearing Photos</p>

<p>Swivel Motor</p>	<p>3 - Normal Wear & Tear</p>

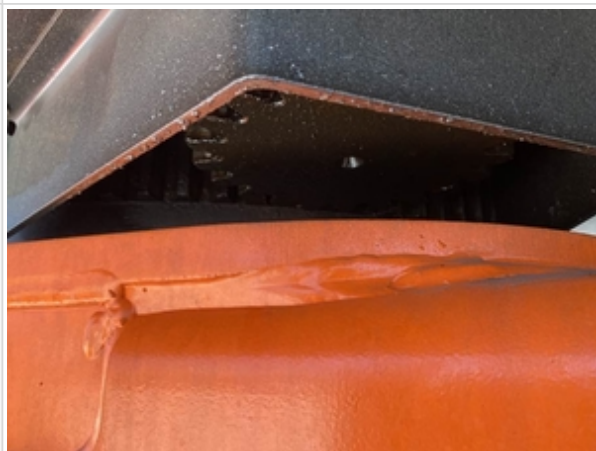
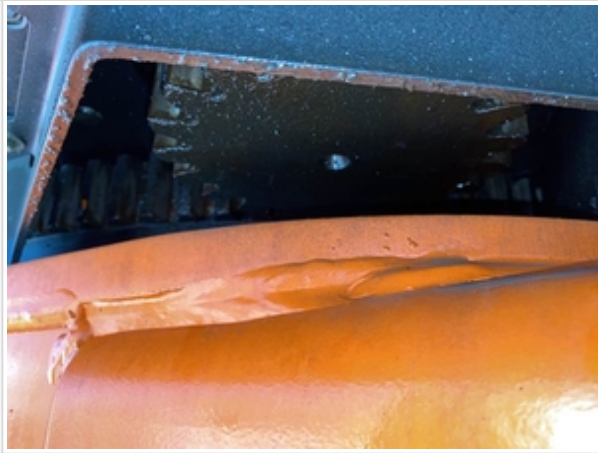
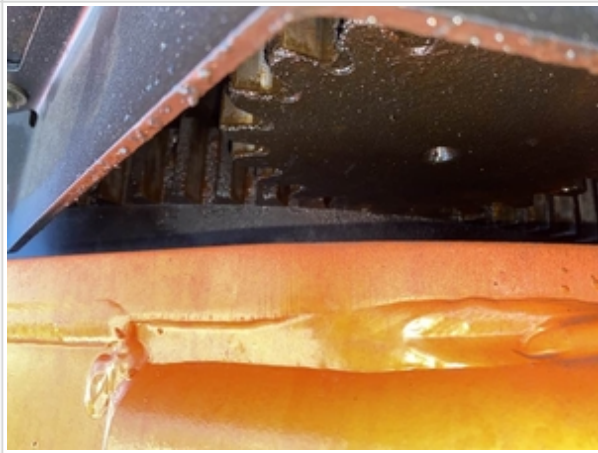
<p>Swivel Joint</p>	<p>3 - Normal Wear & Tear</p>	
<p>Swivel Joint Photos</p>

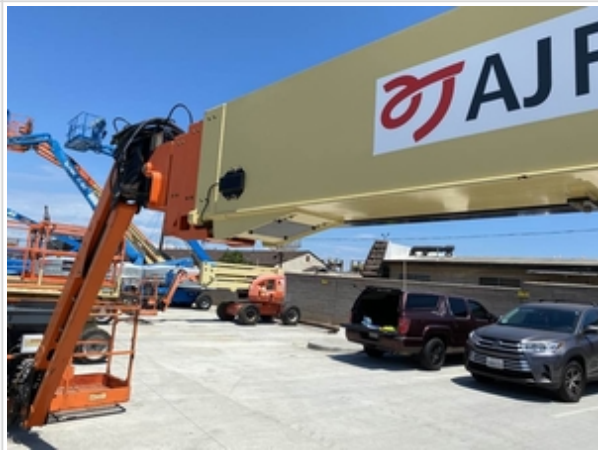
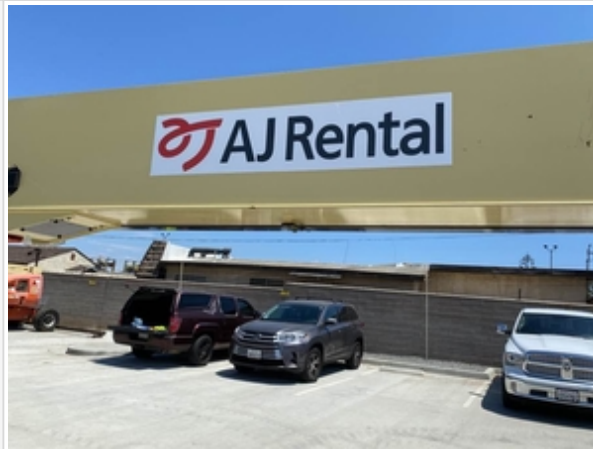
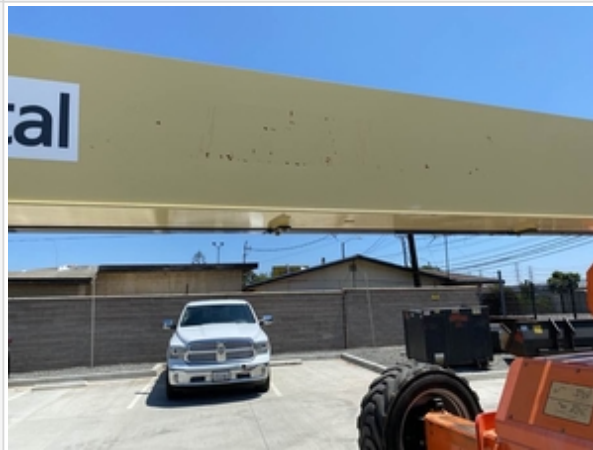
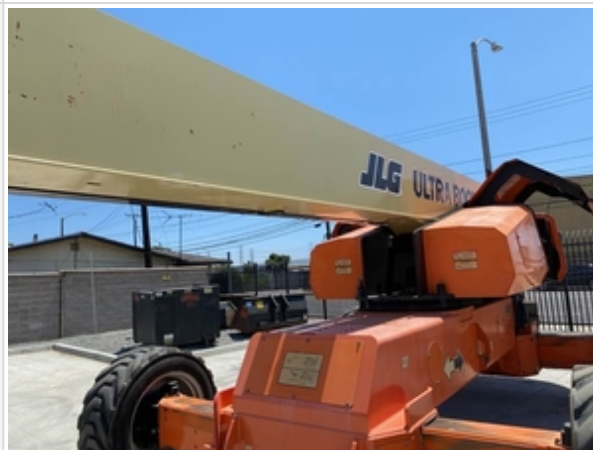
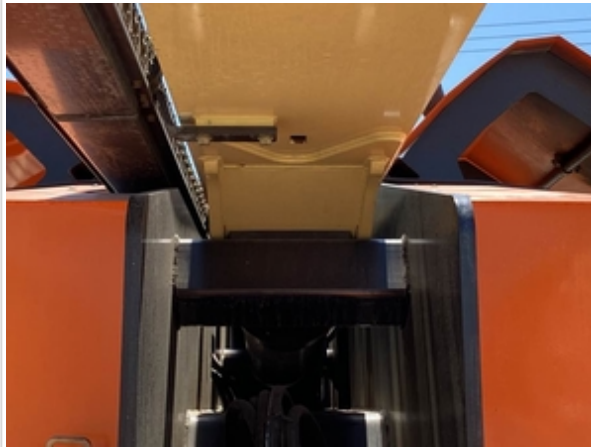
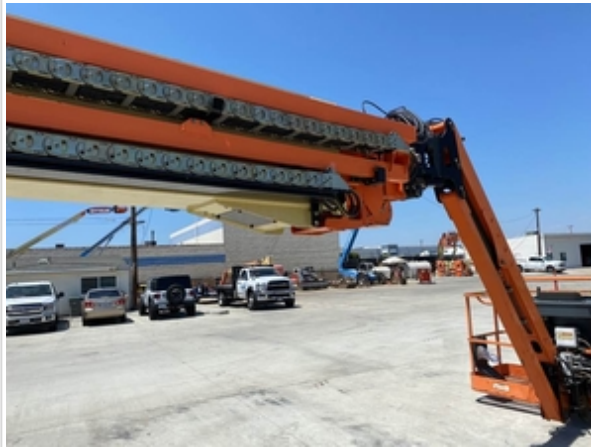
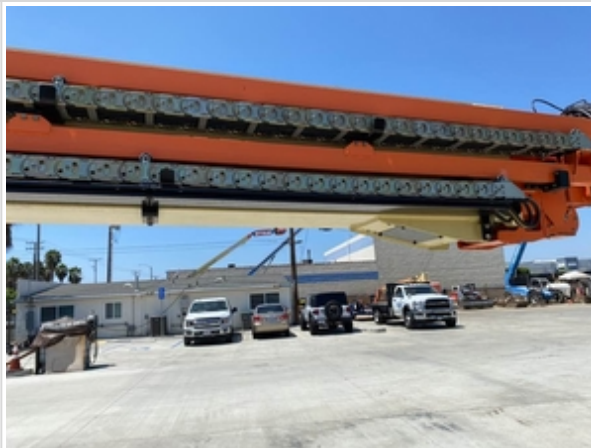
<p>Boom Condition</p>	<p>4 - Like New, Recently Replaced</p>	
<p>Comments</p>	<p>Excellent condition</p>	
<p>Boom Condition Photos</p>

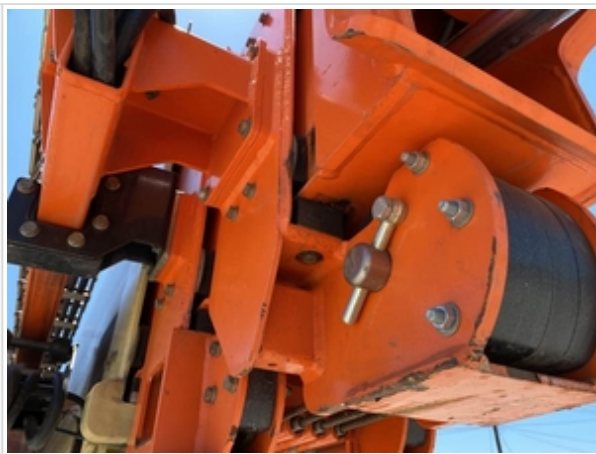
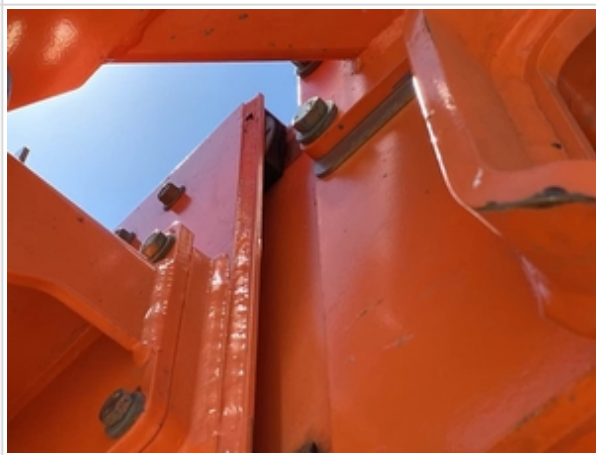
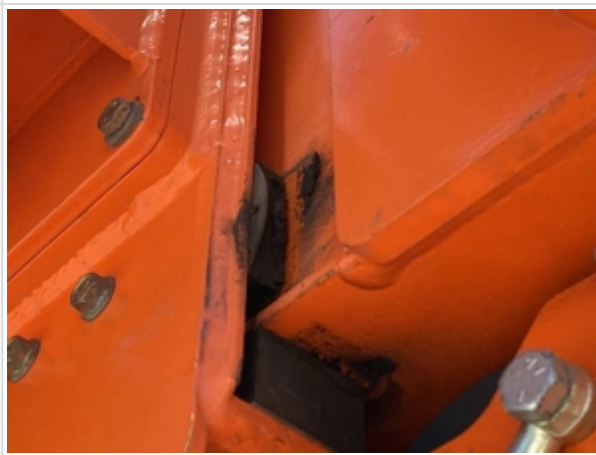
<p>Boom Wear Guides Photos</p>

Boom Wear Guides

3 - Normal Wear & Tear

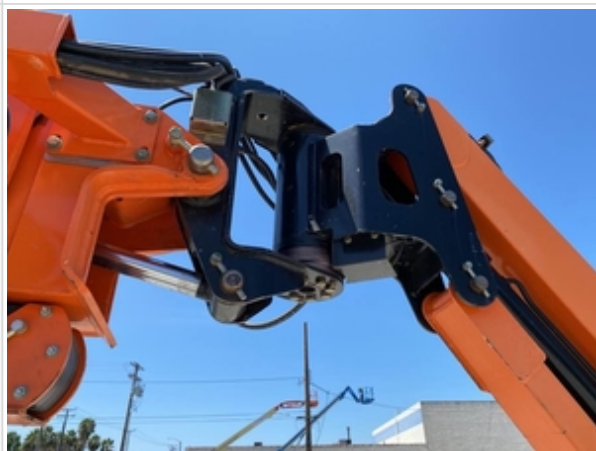
<p>Jib Condition</p>	<p>3 - Normal Wear & Tear</p>	
<p>Jib Condition Photos</p>

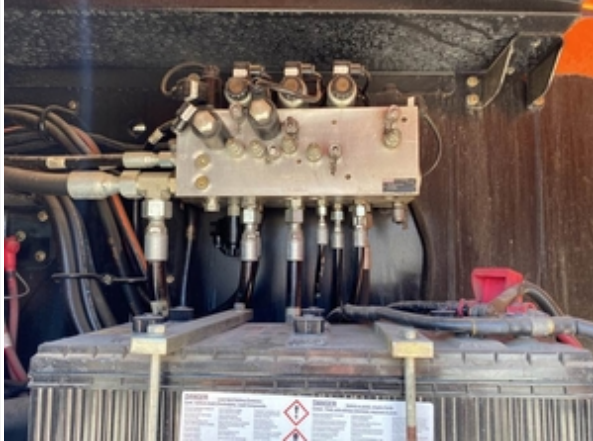
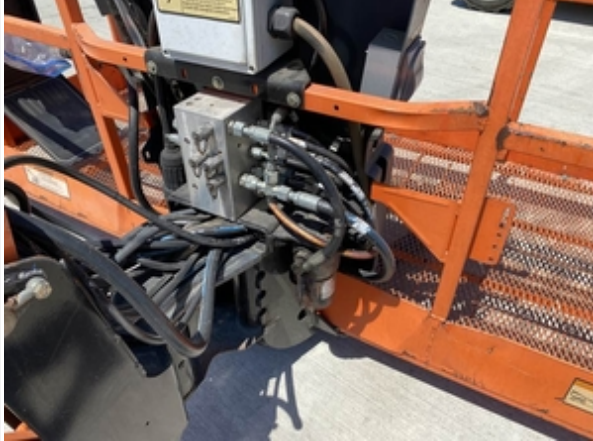
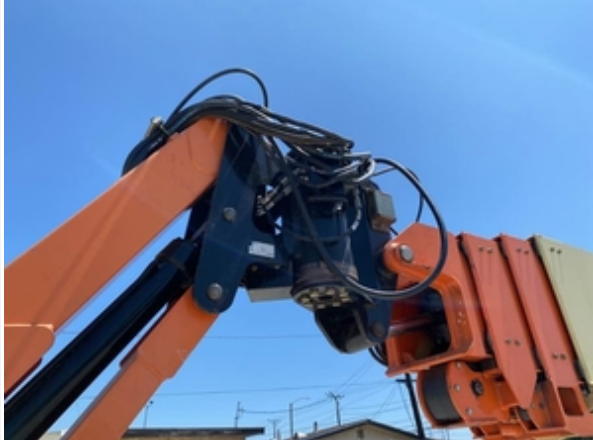
Hydraulic Lines / Fittings Condition	Hydraulic lines & fittings are clean and in good condition, Other (see comments)
Appearance of Hydraulic Lines / Fittings Photos

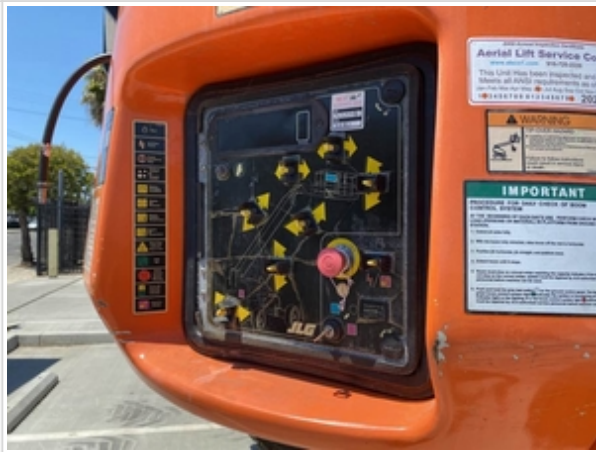
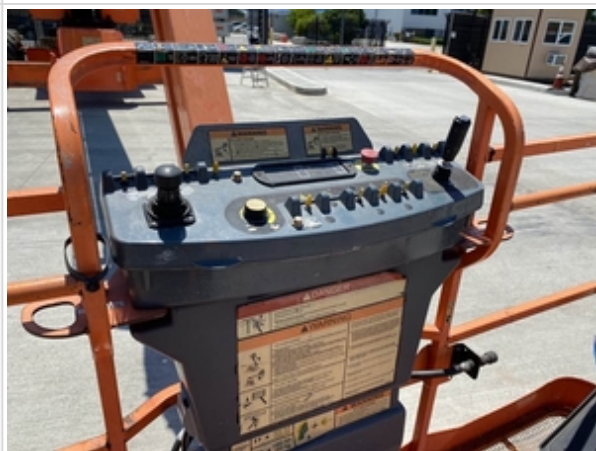
Unusual Noises (Hydraulic Pump)	No	
Hydraulic Pump Notes	No unusual noises heard during operation	
External Controls / Levers	3	
External Controls / Levers Condition	Good function & condition of hydraulic controls	
External Controls / Levers Photos

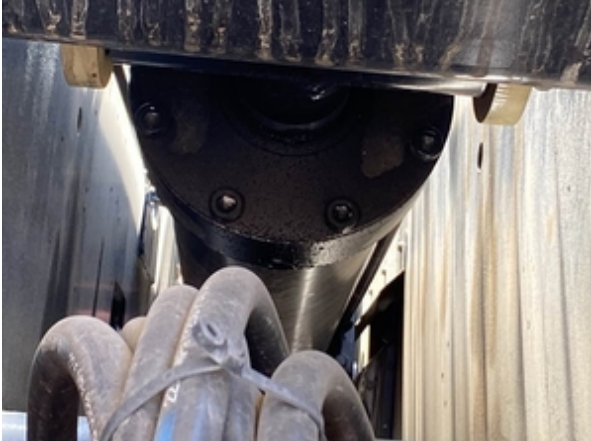
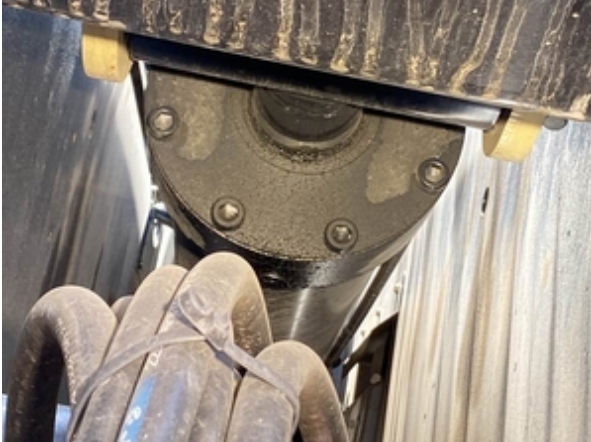
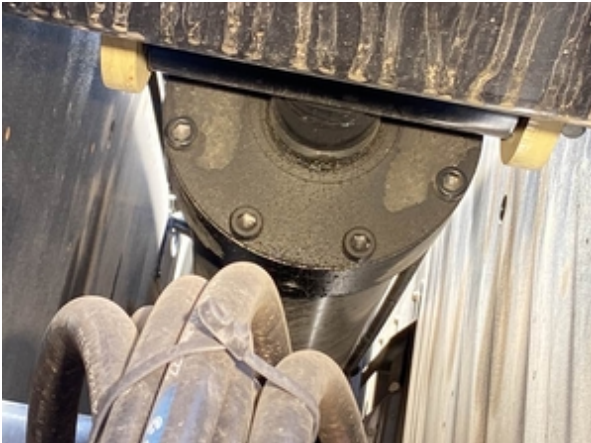
Boom Lift Cylinders: Oil Leaks	No
Comments	Seepage from main boom cylinder rod seal, no drips observed during operation
Boom Lift Cylinders Photos

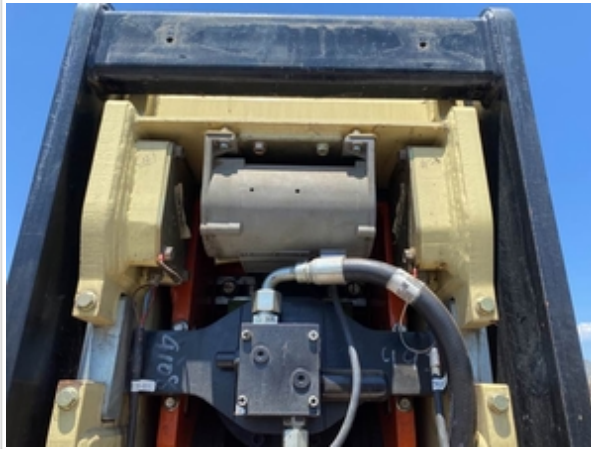
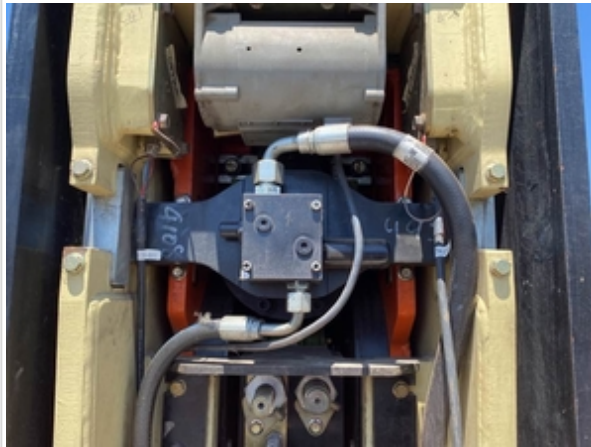
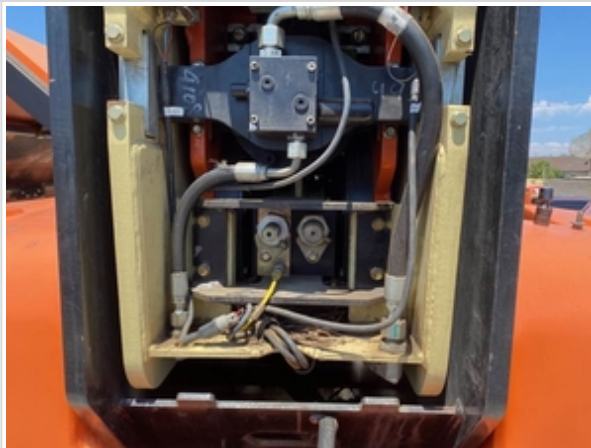
Boom Extension Cylinder Photos

Boom Extension Cylinder	Check the boom extension cylinder. Note any wear, pitting, discoloration, etc. Take photos.
Boom Extension Cylinder: Mounting Pin	4
Boom Extension Cylinder: Oil Leaks	No

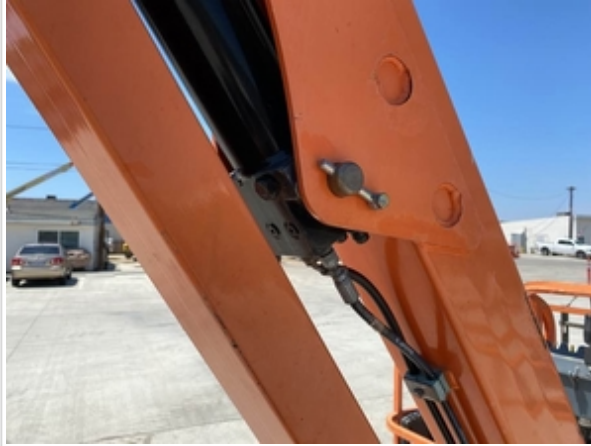
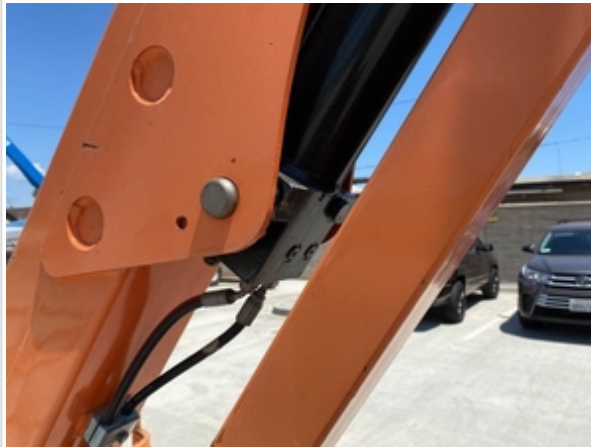
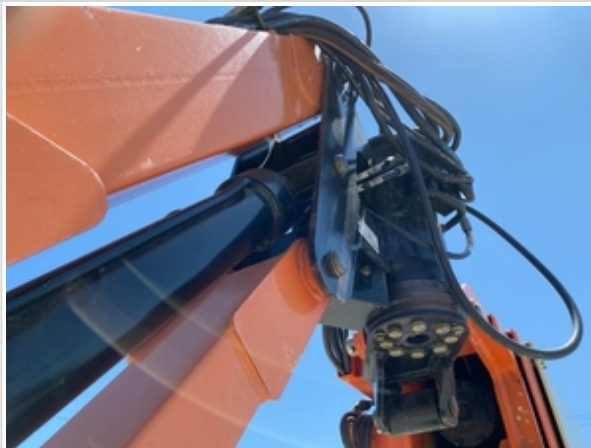
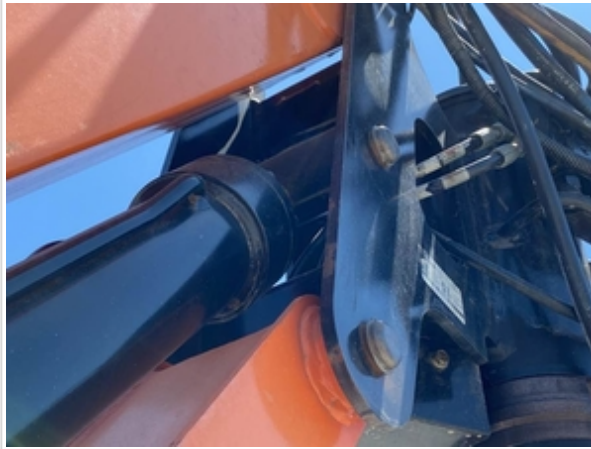
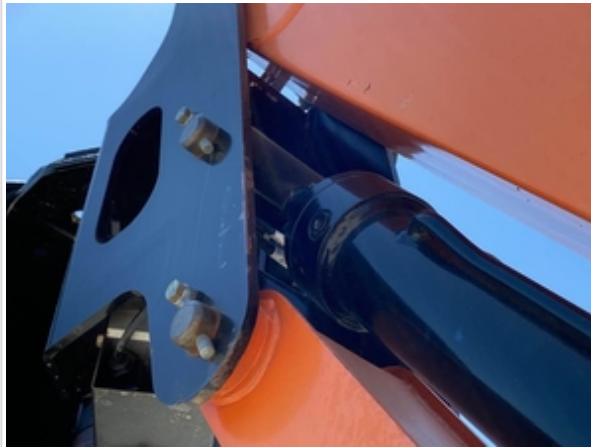
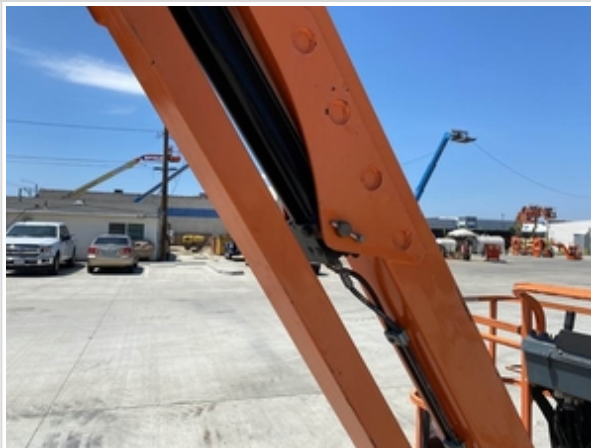
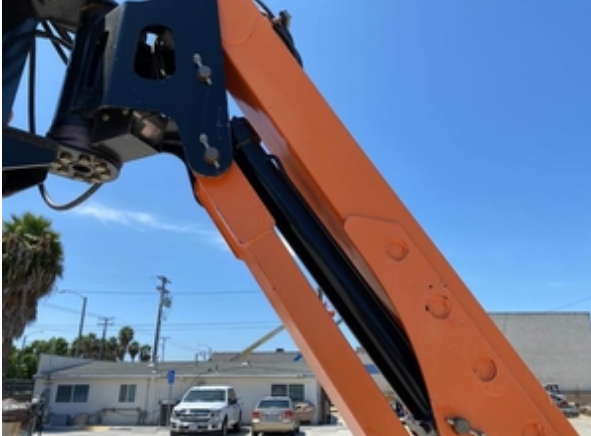
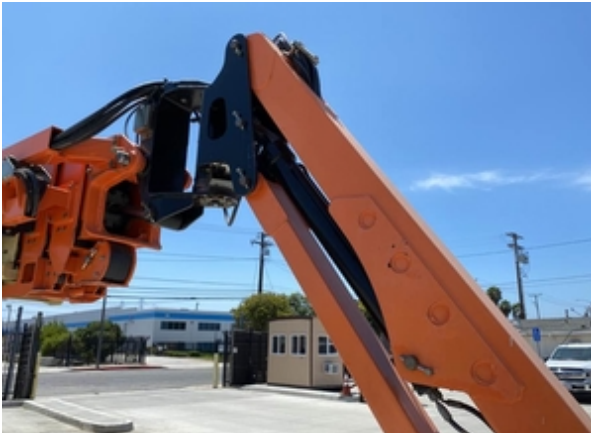
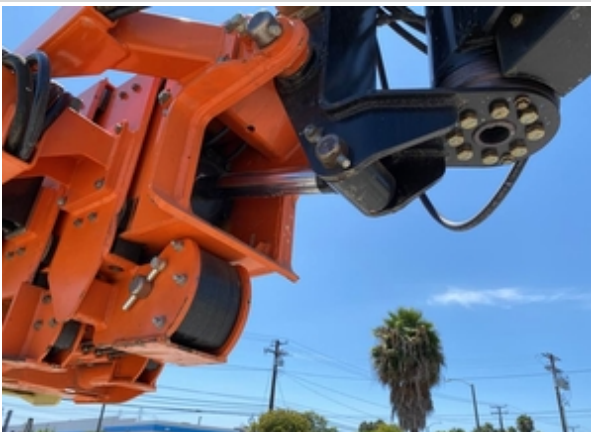
Jib Cylinder Photos

Jib Cylinder	Check the jib cylinder. Note any wear, pitting, discoloration, etc. Take photos.	
Jib Cylinder: Oil Leaks	No	
Jib Cylinder: Mounting Pin	4

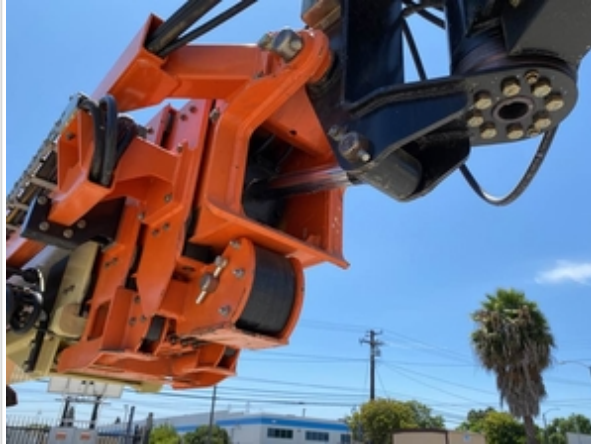
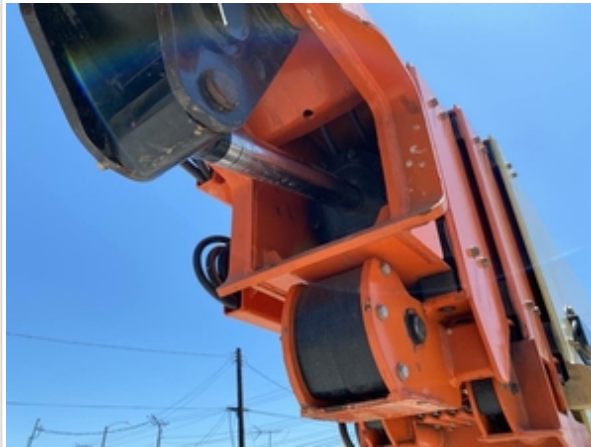
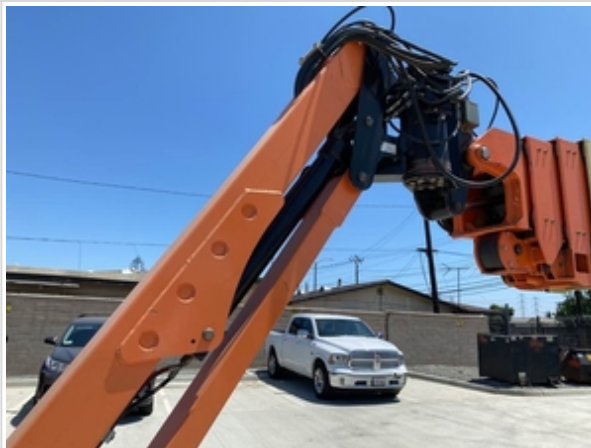
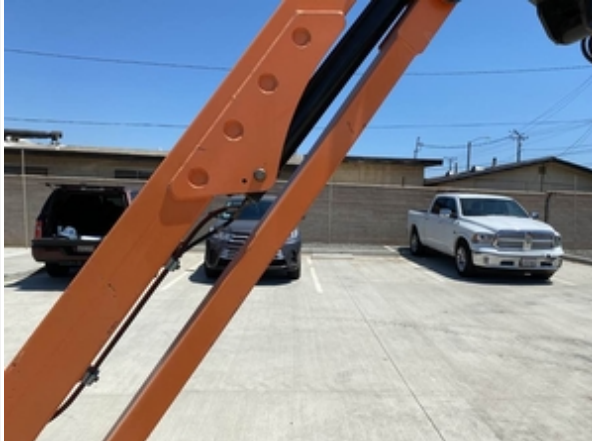
Basket Tilt Cylinder Photos

Basket Tilt Cylinder	Check the basket tilt cylinders. Note any wear, pitting, discoloration, etc. Take photos.
Basket Tilt Cylinder: Mounting Pin	3
Basket Tilt Cylinder: Oil Leaks	No

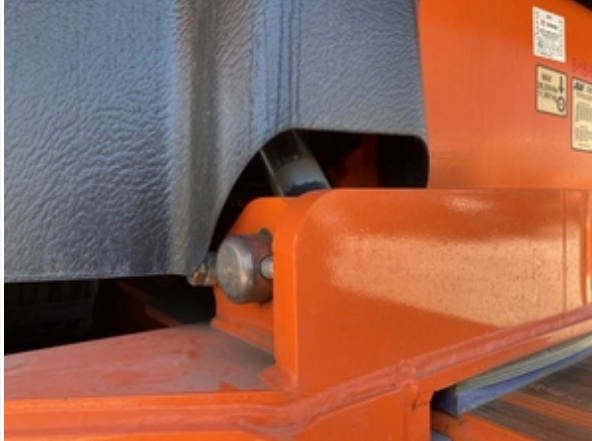
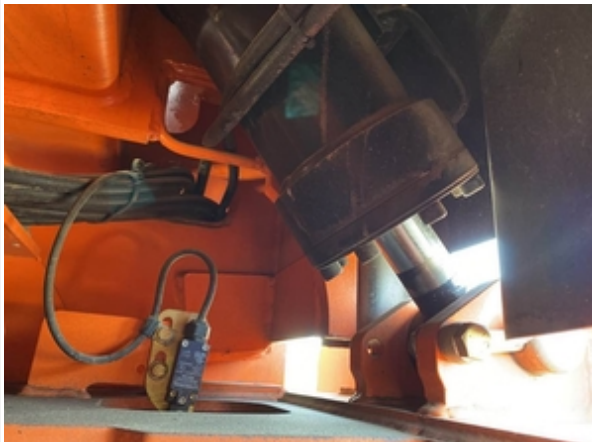
Frame Leveling Cylinders	Check the frame leveling cylinders. Note any wear, pitting, discoloration, etc. Take photos.	
Frame Leveling Cylinders: Mounting Pin	4	
Frame Leveling Cylinders: Oil Leaks	No	
Frame Leveling Cylinders Photos

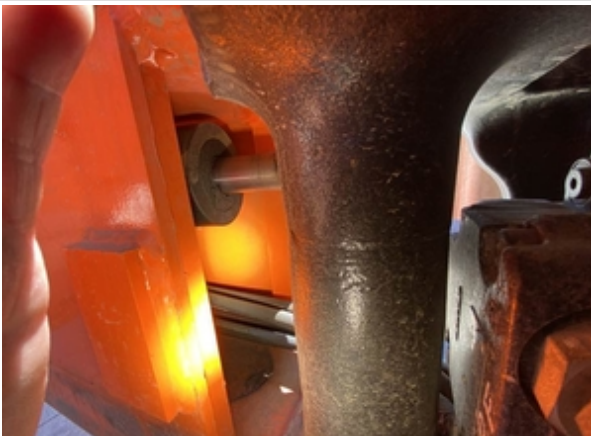
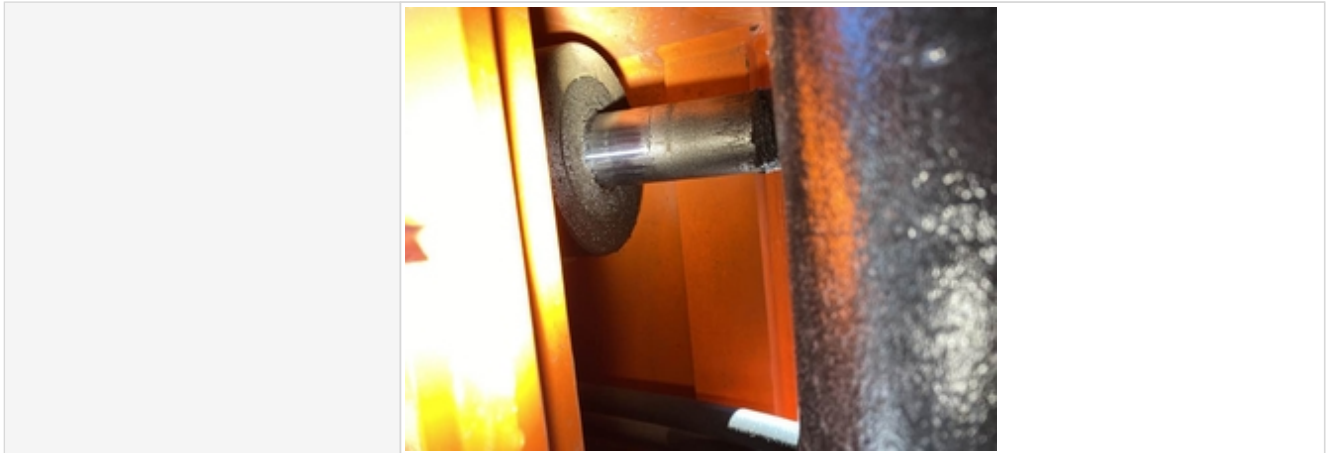
Outrigger Cylinders	Check the outrigger cylinders. Note any wear, pitting, discoloration, etc. Take photos.
Steering Cylinders	Check the steering cylinders. Note any wear, pitting, discoloration, etc. Take photos.
Steering Cylinders: Oil Leaks	No
Comments	Signs of Seepage coming from all 4 steer cylinders, do drips
Steering Cylinders Photos
