General Info

Year	2018
Make	John Deere
Model	26G
Serial Number	1FF026GXVJK263516
Hour Meter Reading	TBD current meter shows 6.5 hours
Previous Application (e.g., earth moving, mining, demolition, etc)	Equipment Rental

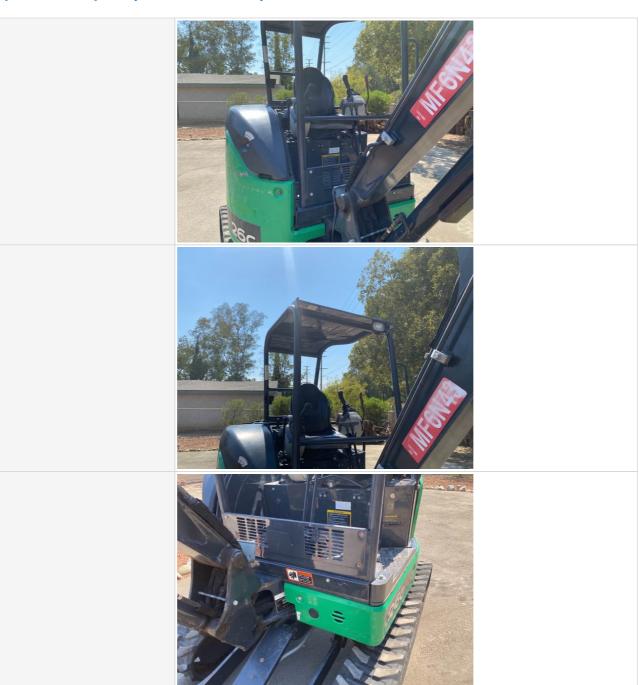
General Appearance Inspection Points	
General Appearance	
Front	3 - Normal Wear & Tear
Front Condition	No visible damage, Other (see comments)
Comments	Normal scuff marks
Front Photos

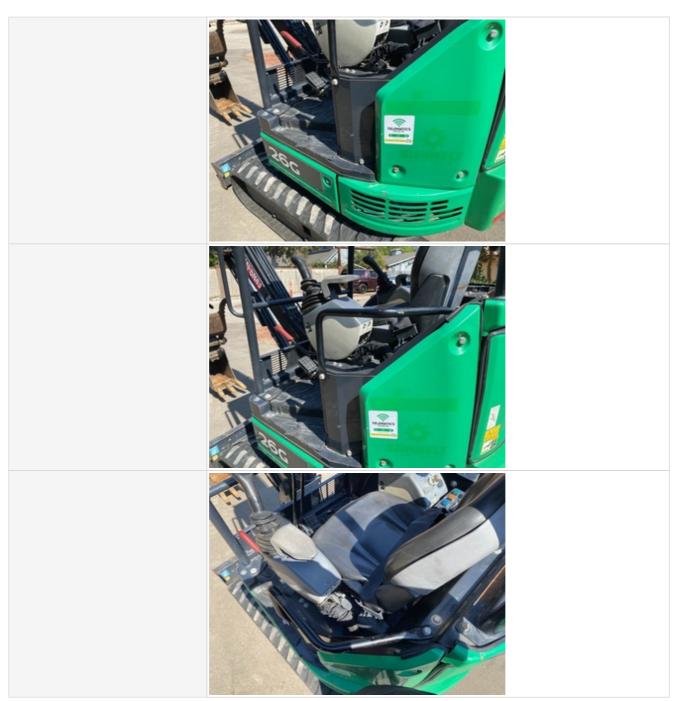
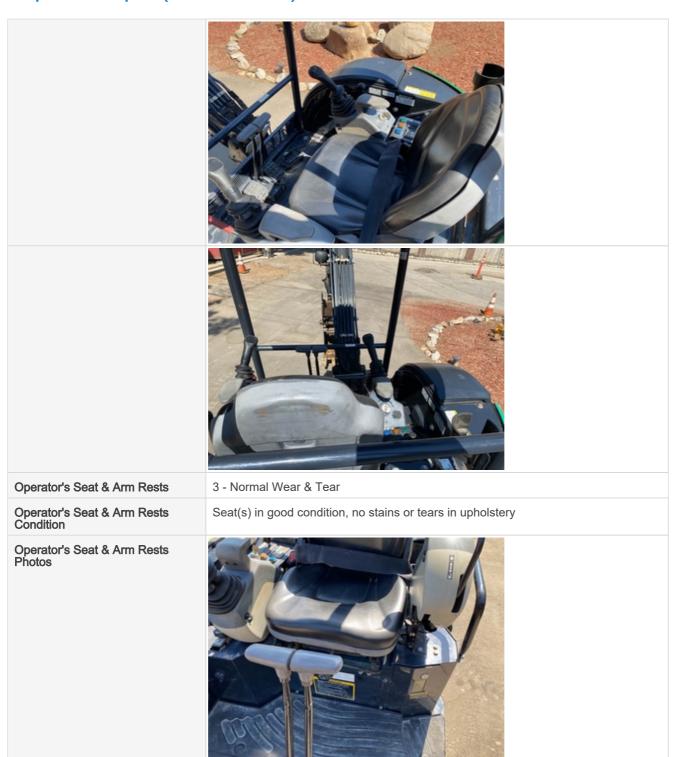
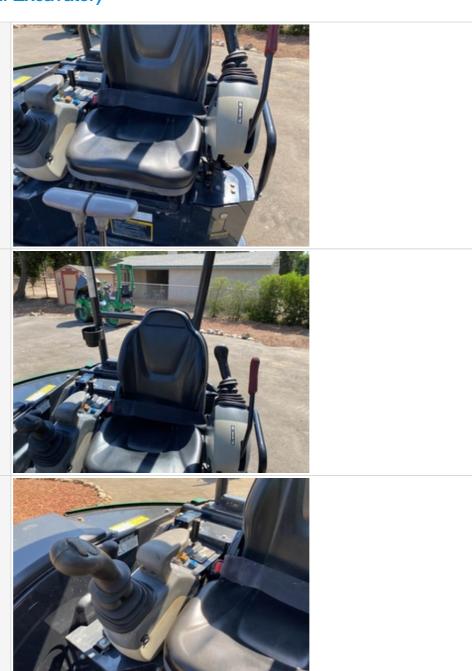
Operator Cabin Photos

4 - Like New, Recently Replaced

Good cabin appearance, solid floors, panels, and ceiling

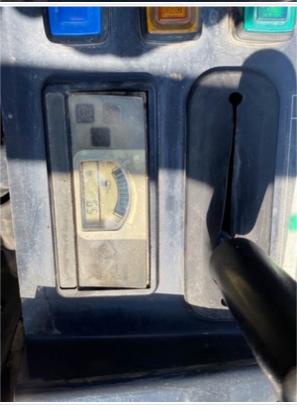
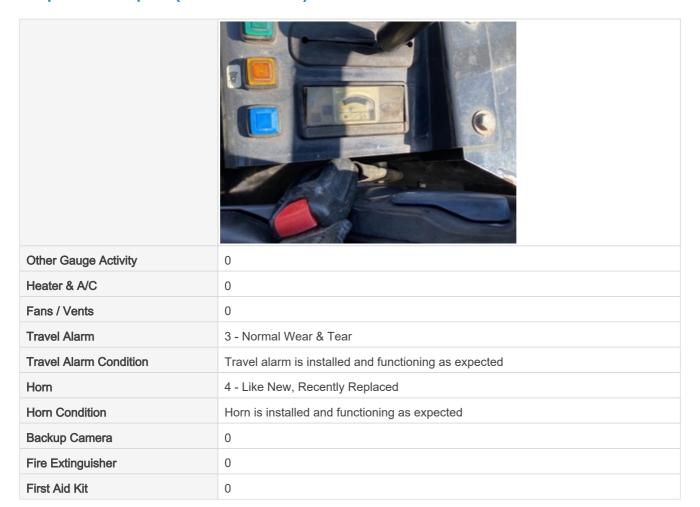
Hour Meter Activity Photos

mapedion report (Min	- Exocitation /
Controls & Switches	3 - Normal Wear & Tear
Controls & Switches Condition	All switches are installed and functional
Controls & Switches Photos	
Hour Meter Activity	3 - Normal Wear & Tear
Hour Meter Condition	Hour meter is functional and in good condition, Hour meter is functional, with some minor wear and/or cosmetic damage, Other (see comments)
Comments	6.5 hours on current hour meter

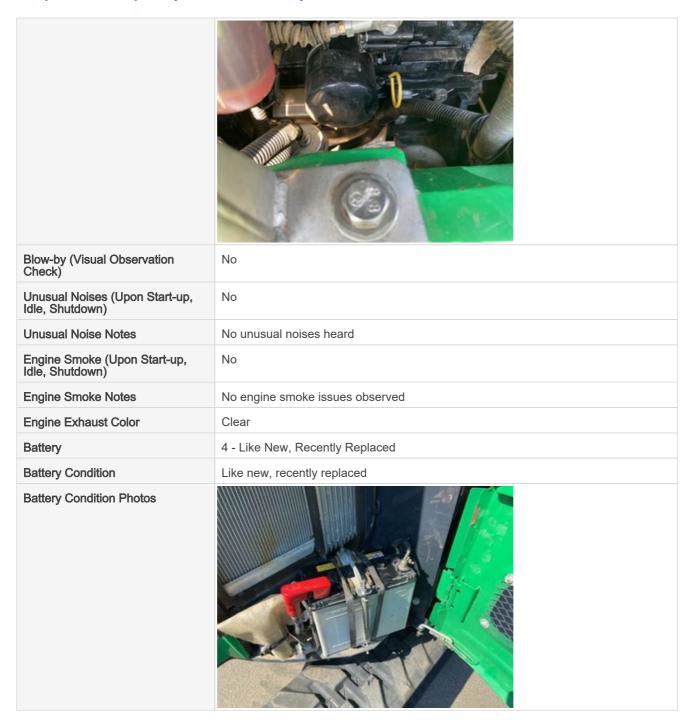
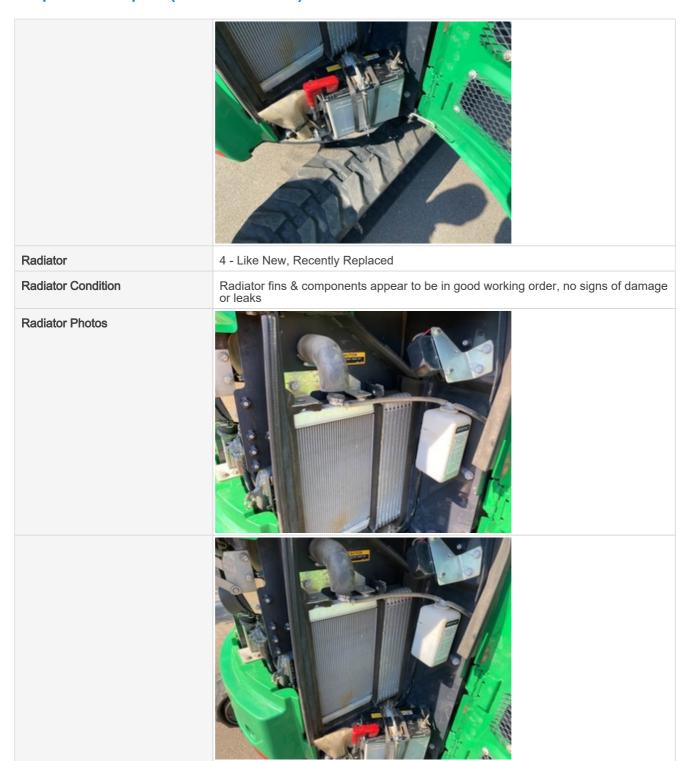
Lingine inspection i onto	
Engine	
Engine Type (Make, Model, Cylinders, Hp)	Yanmar - 3cyl 1.27 L 20HP
Engine Serial Number	19994
Engine Fuel Type	Diesel
Engine Photos

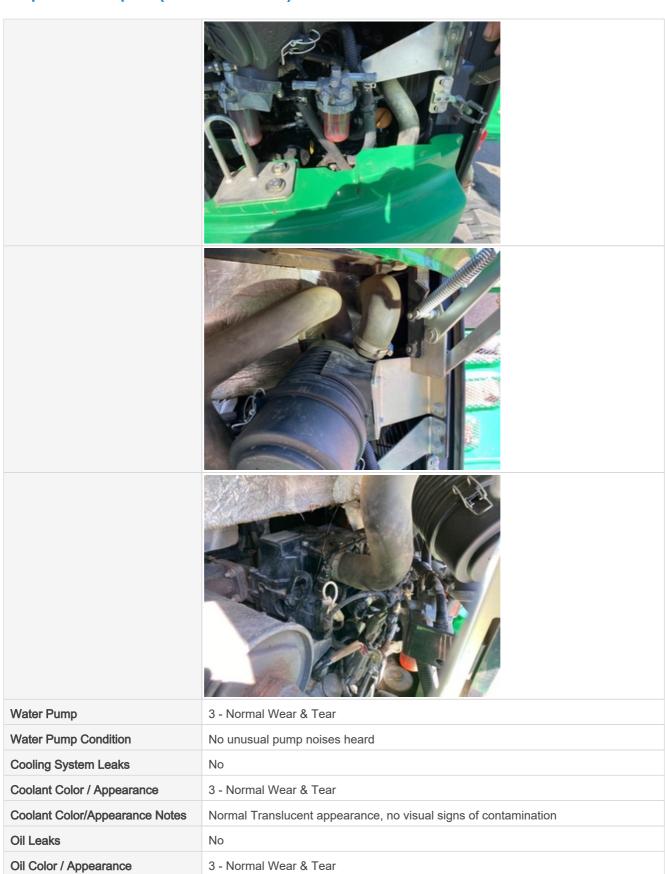
Belts	3 - Normal Wear & Tear
Belt Condition	Belts appear in good condition & alignment with proper tension
Belt Photos	
Hoses	3 - Normal Wear & Tear
Hose Condition	Firm, pliant hoses with no signs of wear or leaks

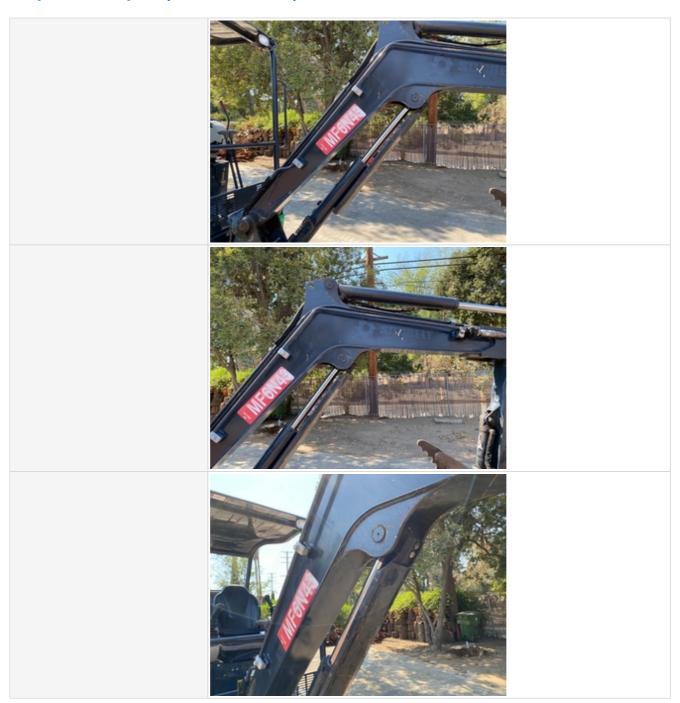
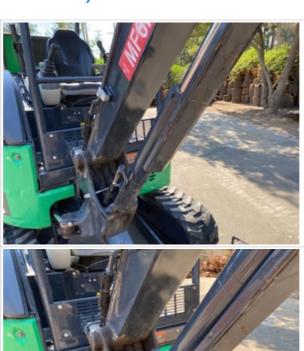
Chassis inspection Points)
Instructions	Evaluate the following on a 4 point scale (leave comments where an explanation is appropriate): 4 = Like New, Recently Replaced 3 = Normal Wear & Tear 2 = Above Average Wear 1 = Service Required
Boom Condition	3 - Normal Wear & Tear
Boom Photos	266

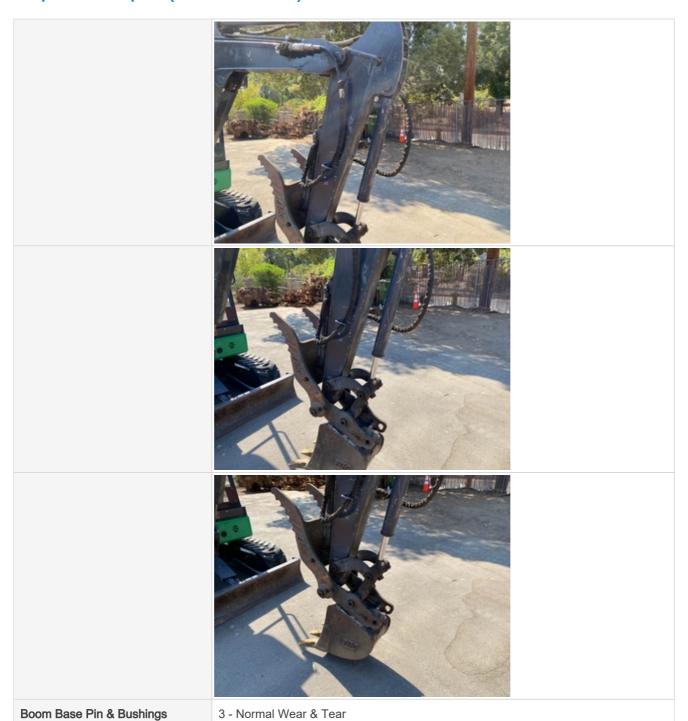
Stick Photos

3 - Normal Wear & Tear

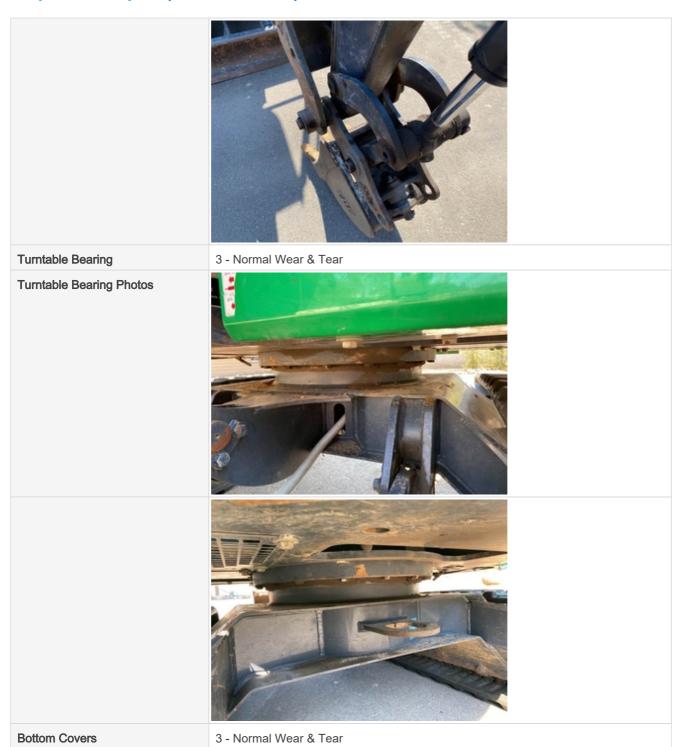
Bottom Covers Photos 3 - Normal Wear & Tear **Overall Chassis**

Overall chasis has no issues and well lubricated.

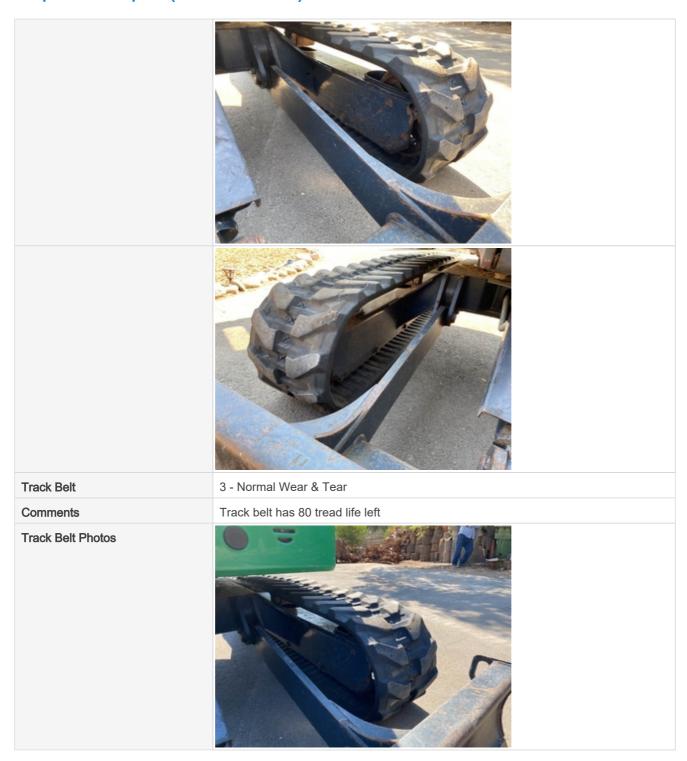
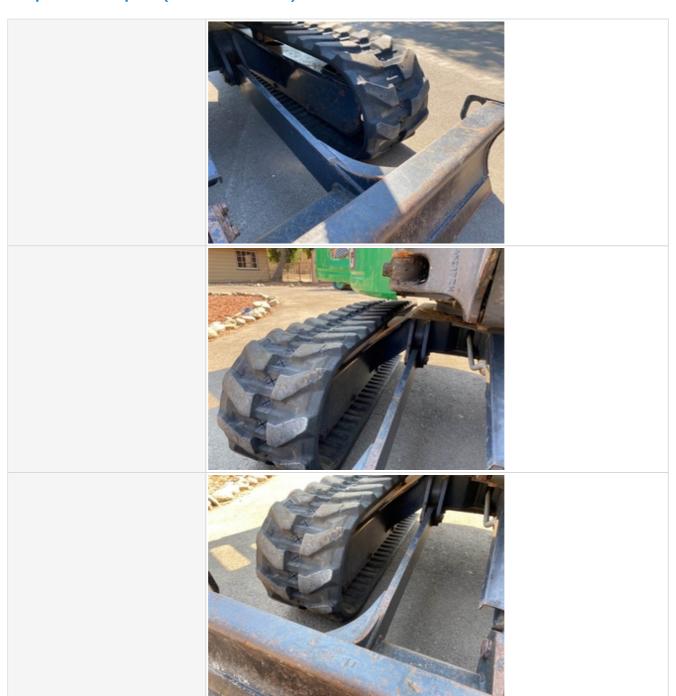
Instructions	Evaluate the following on a 4 point scale (leave comments where an explanation is appropriate):
	4 = Like New, Recently Replaced 3 = Normal Wear & Tear 2 = Above Average Wear 1 = Service Required
D. II. E	
Roller Frames Roller Frames Photos	3 - Normal Wear & Tear

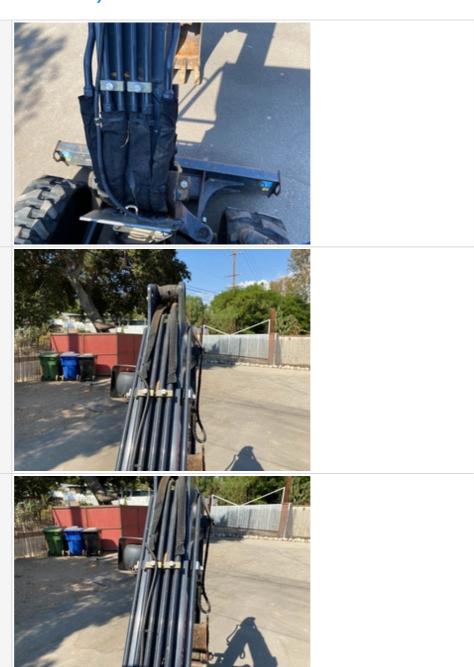
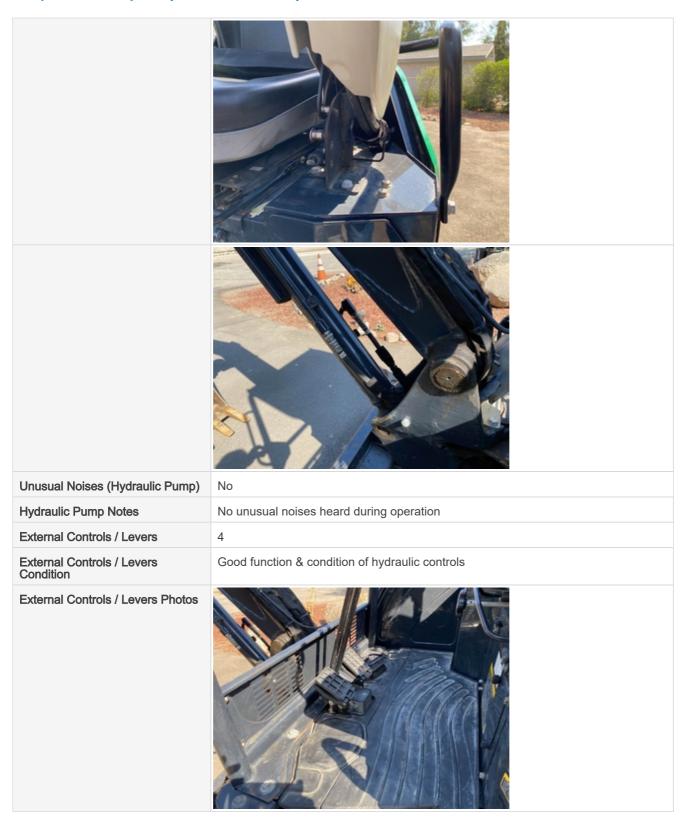
Appearance of Hydraulic Lines / Fittings Photos

Hydraulics Overall	
Wet or Damp Hydraulic Lines / Fittings	No
Appearance of Hydraulic Lines / Fittings	4
Hydraulic Lines / Fittings Condition	Hydraulic lines & fittings are clean and in good condition

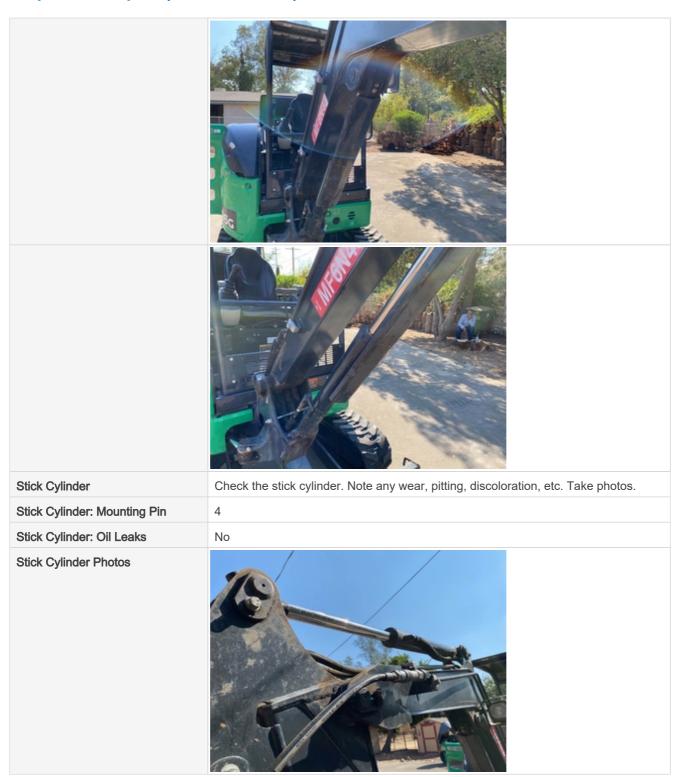
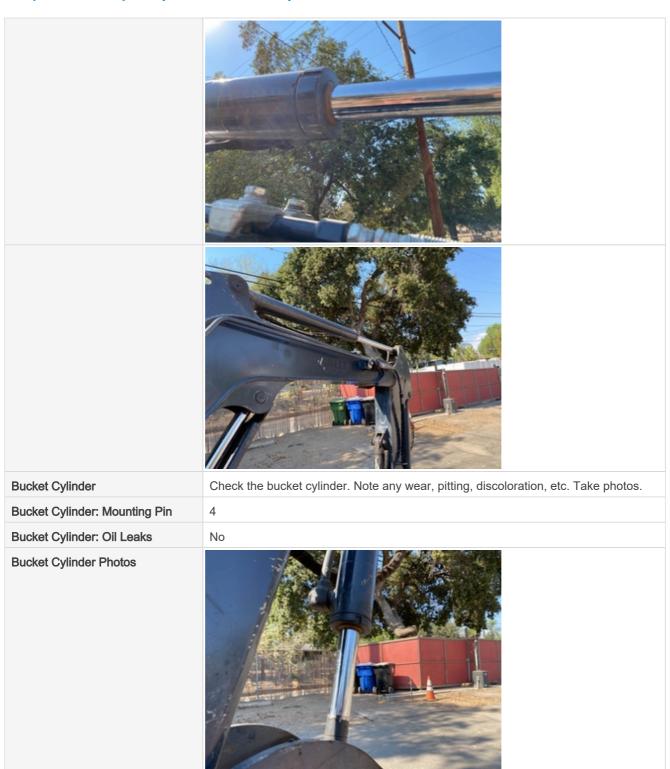
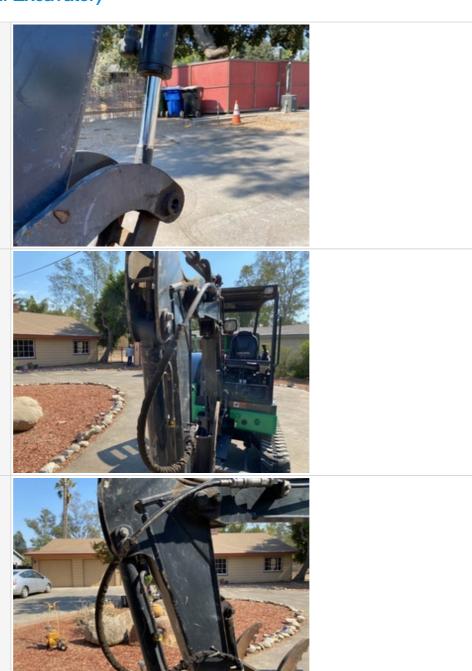
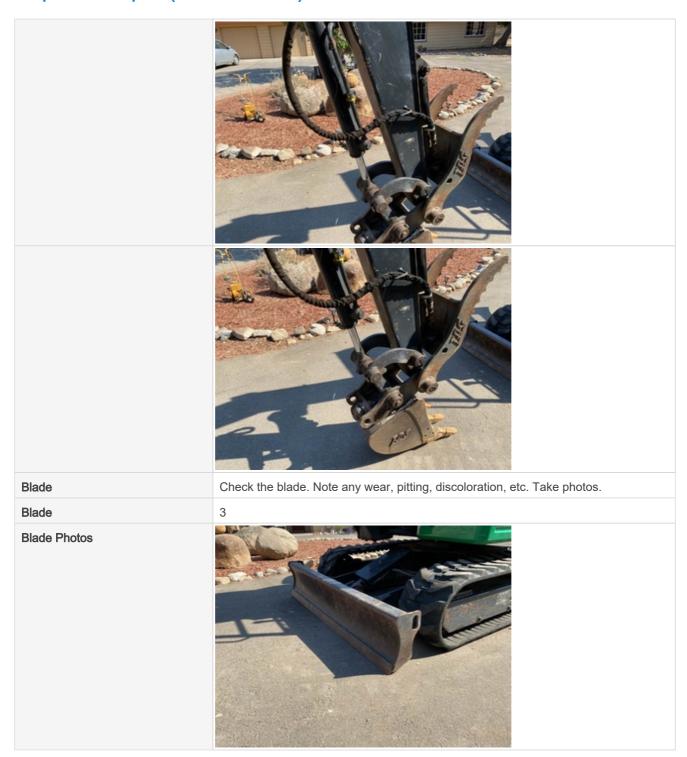
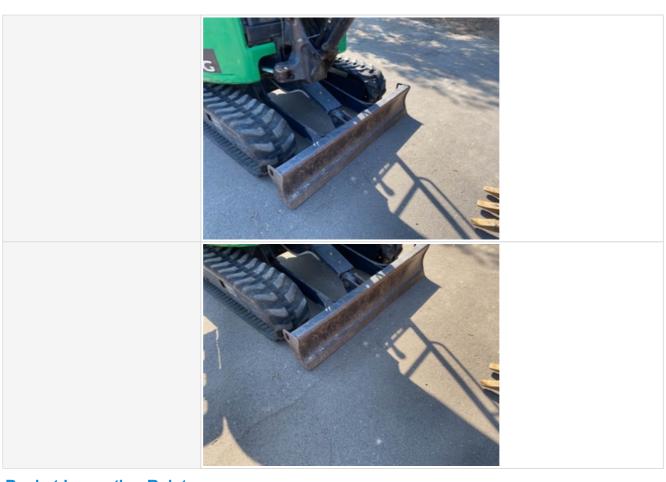
Tryaradiloo Oyiiriadio iriop	
Boom Cylinder	Check the boom cylinder. Note any wear, pitting, discoloration, etc. Take photos.
Boom Cylinder: Mounting Pin	4
Boom Cylinder: Oil Leaks	No
Boom Cylinder Photos
